# **Bison I Wind Facility Post-Construction Inspection Report PU-09-151**

## **NORTH DAKOTA PUBLIC SERVICE COMMISSION**

## **WENCK ASSOCIATES, INC.**

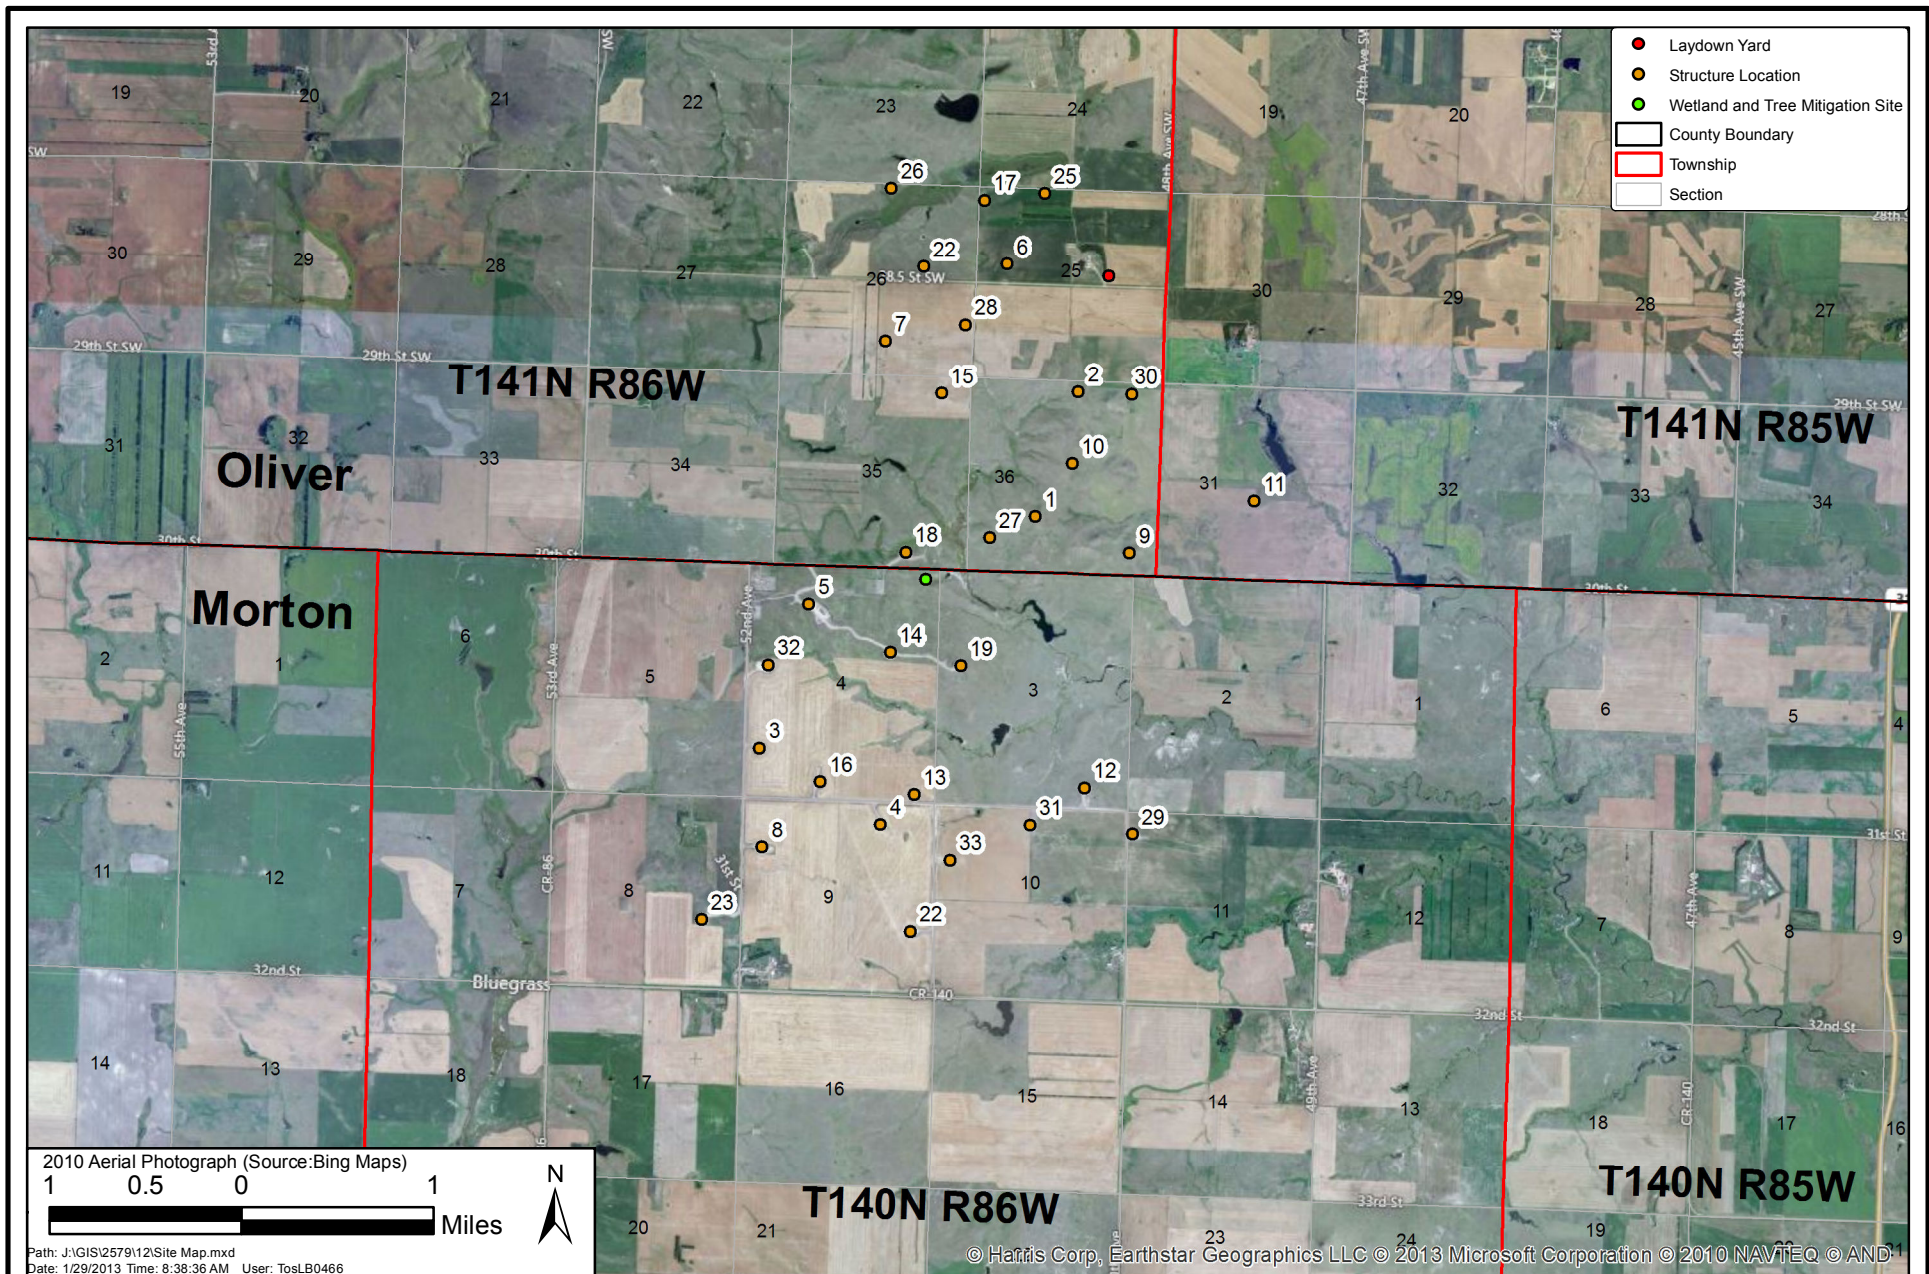
Project Area and Field Observation Map

The Project was built as proposed in the designated project area described in the Application, Application Supplements, and Order (**Figure 1**). Wenck observed 31 wind turbines; 15 turbines were located in Morton County and 16 turbines Oliver County. Associated facilities observed during the site visit included access roads, an electrical substation, meteorological towers and wind monitoring stations, markers indicating the location of underground electrical and feeder lines, and operations and maintenance buildings (**Appendix A; Appendix B**).
