DAKOTA GASIFICATION COMPANY

Re: Case No. PU-593-96-11
Permit No. 84

On May 25, 2011, during the course of a routine patrol of the pipeline, DGC discovered that a butte located in Dunn County located north of our mainline valve no. 3 and just south of the Little Missouri River crossing had caved-in leaving our pipeline exposed in two areas. We have attached as Exhibit 1 a collection of photographs taken shortly after our discovery of the cave-in. DGC's pipeline is the upper pipeline of the two exposed pipelines that appear in the pictures. After an evaluation, DGC took the following actions: lowered the pipeline pressure to approximately 1,000 psi, suspended carbon dioxide deliveries to our two Canadian customers pending further investigation and provided the appropriate notification to the Office of Pipeline Safety. We have since employed engineering experts who have informed us that the longitudinal and bending stresses on the pipeline that occurred as a result of the cave-in are such that the exposed pipeline, as well as 50 feet on either side of the exposed area, must be replaced. Accordingly, this week we are completely de-pressurizing the line so as to perform the necessary

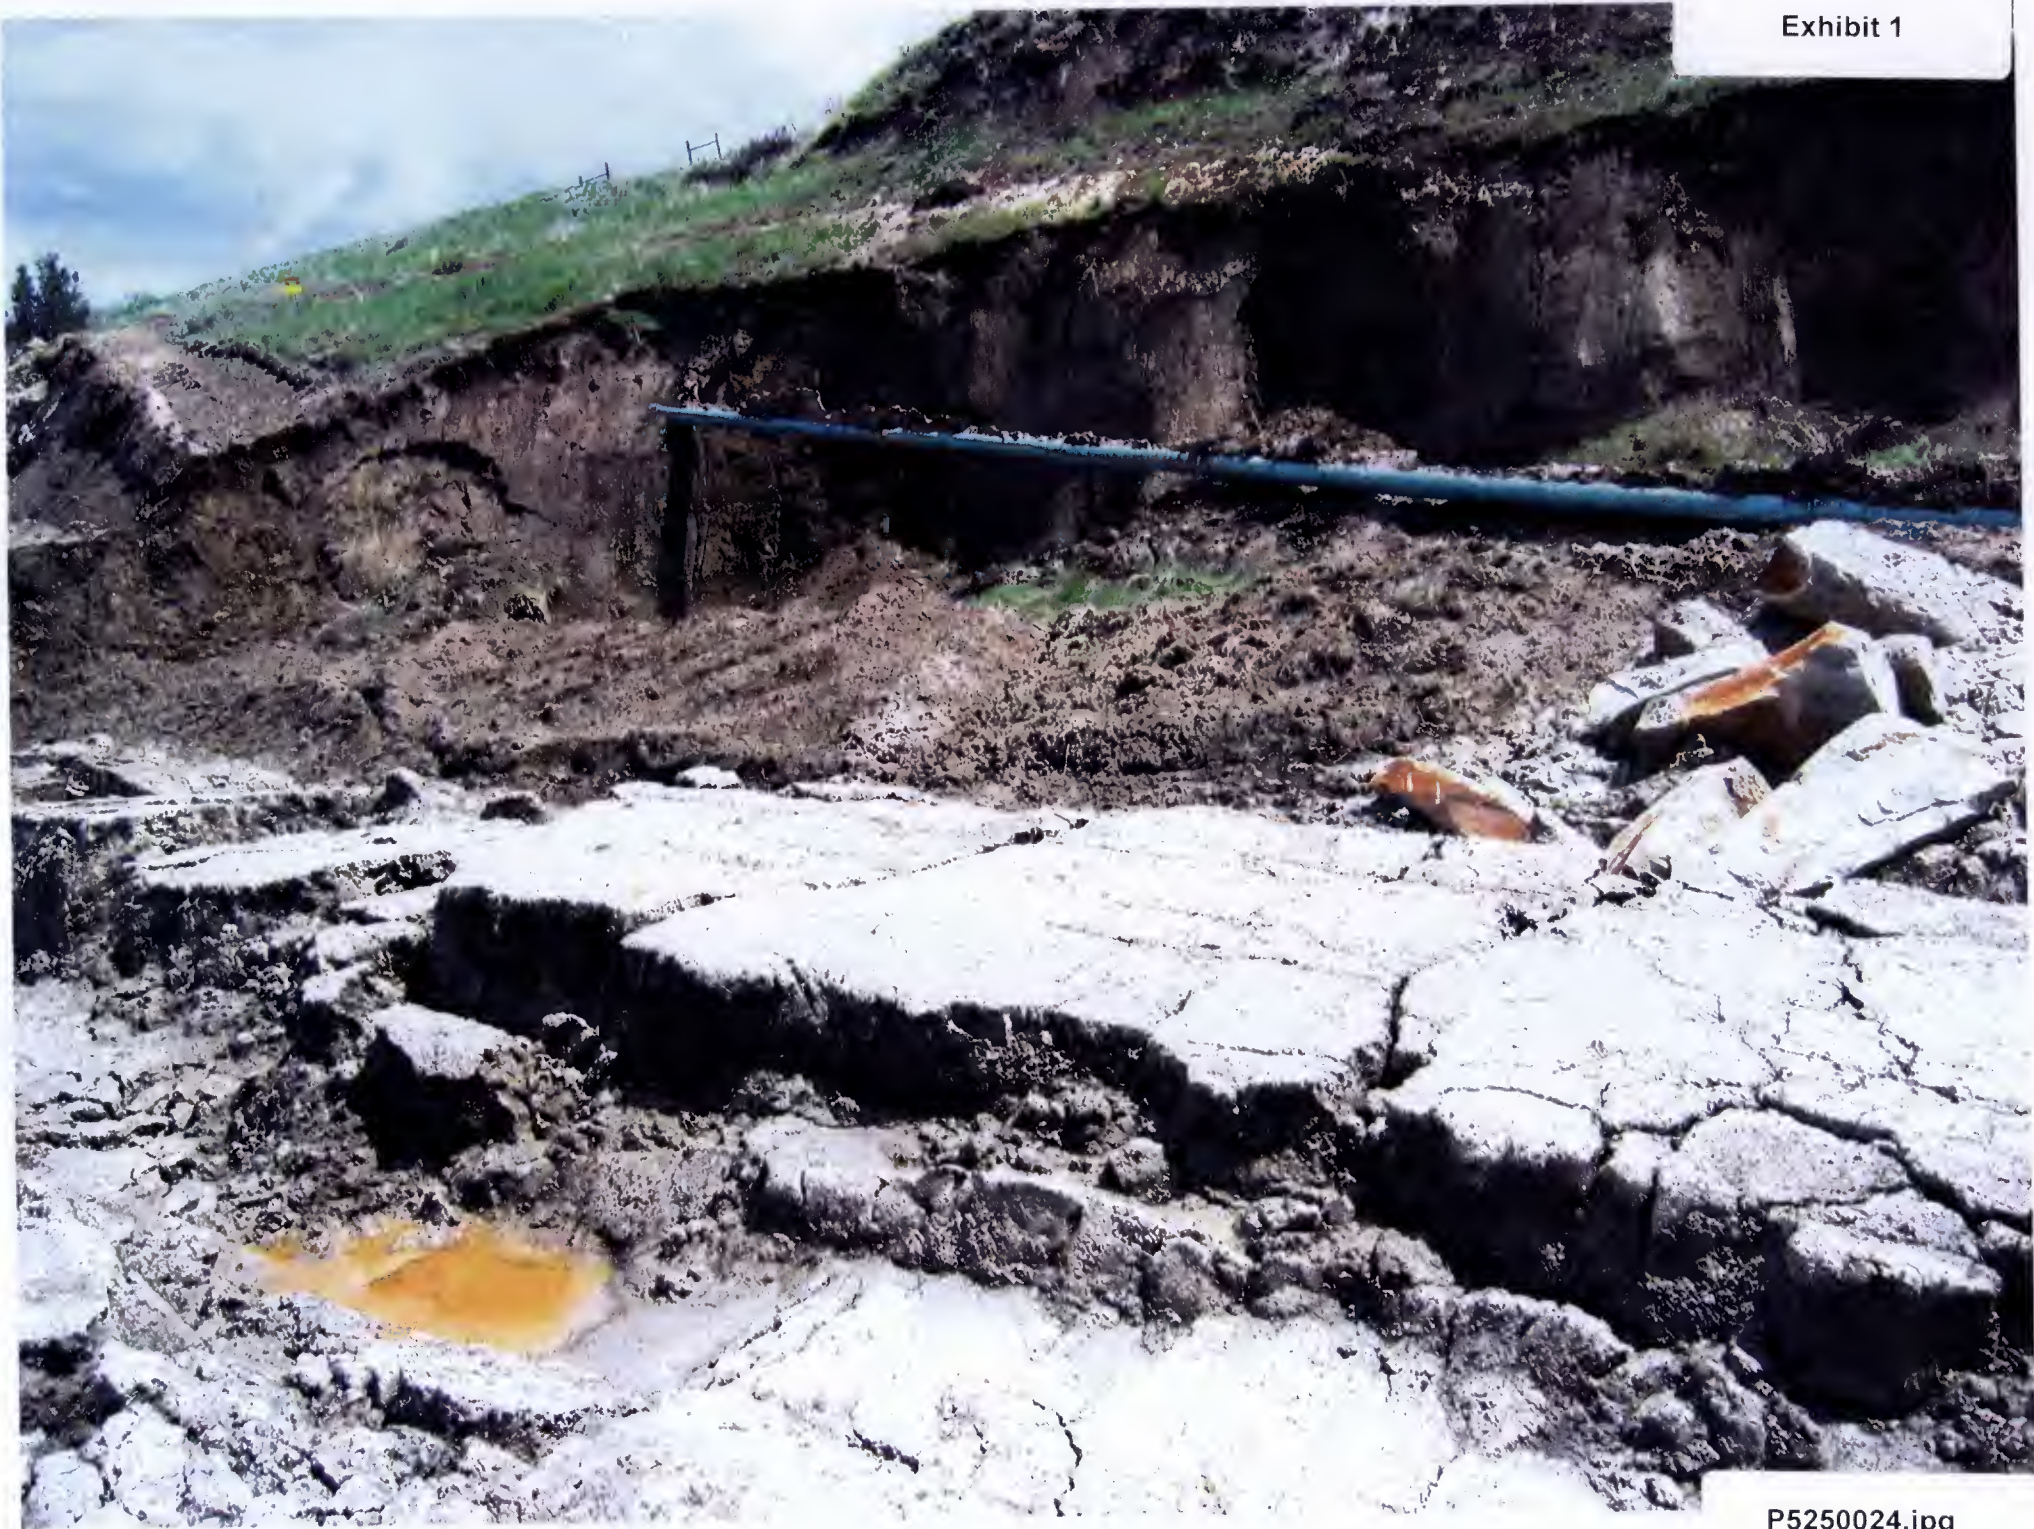
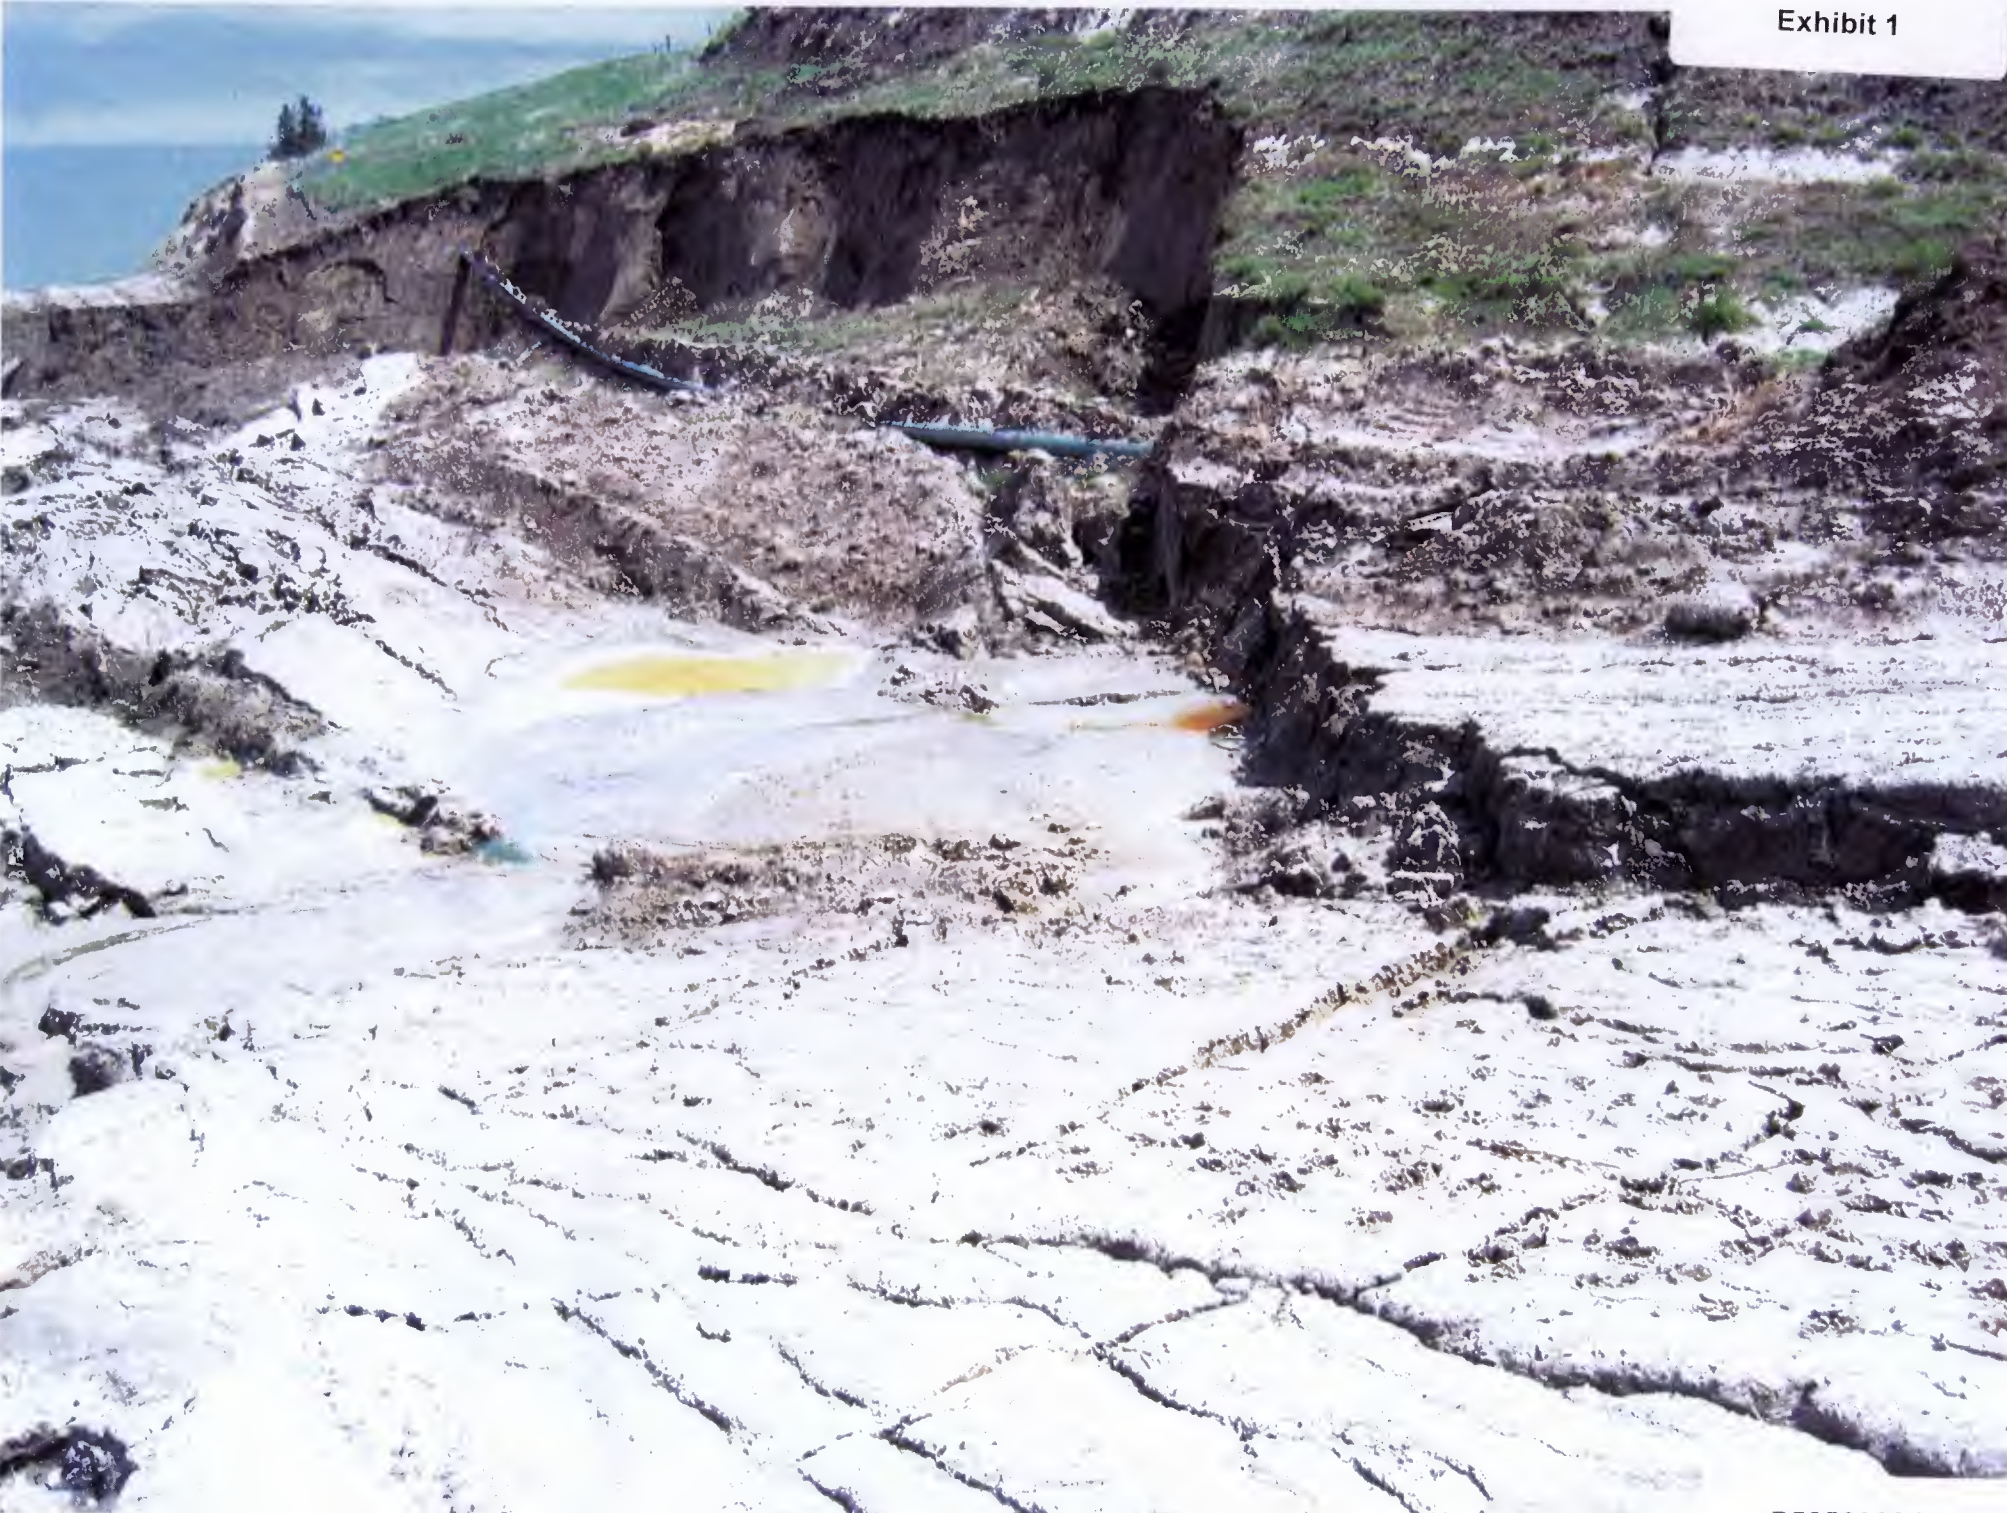
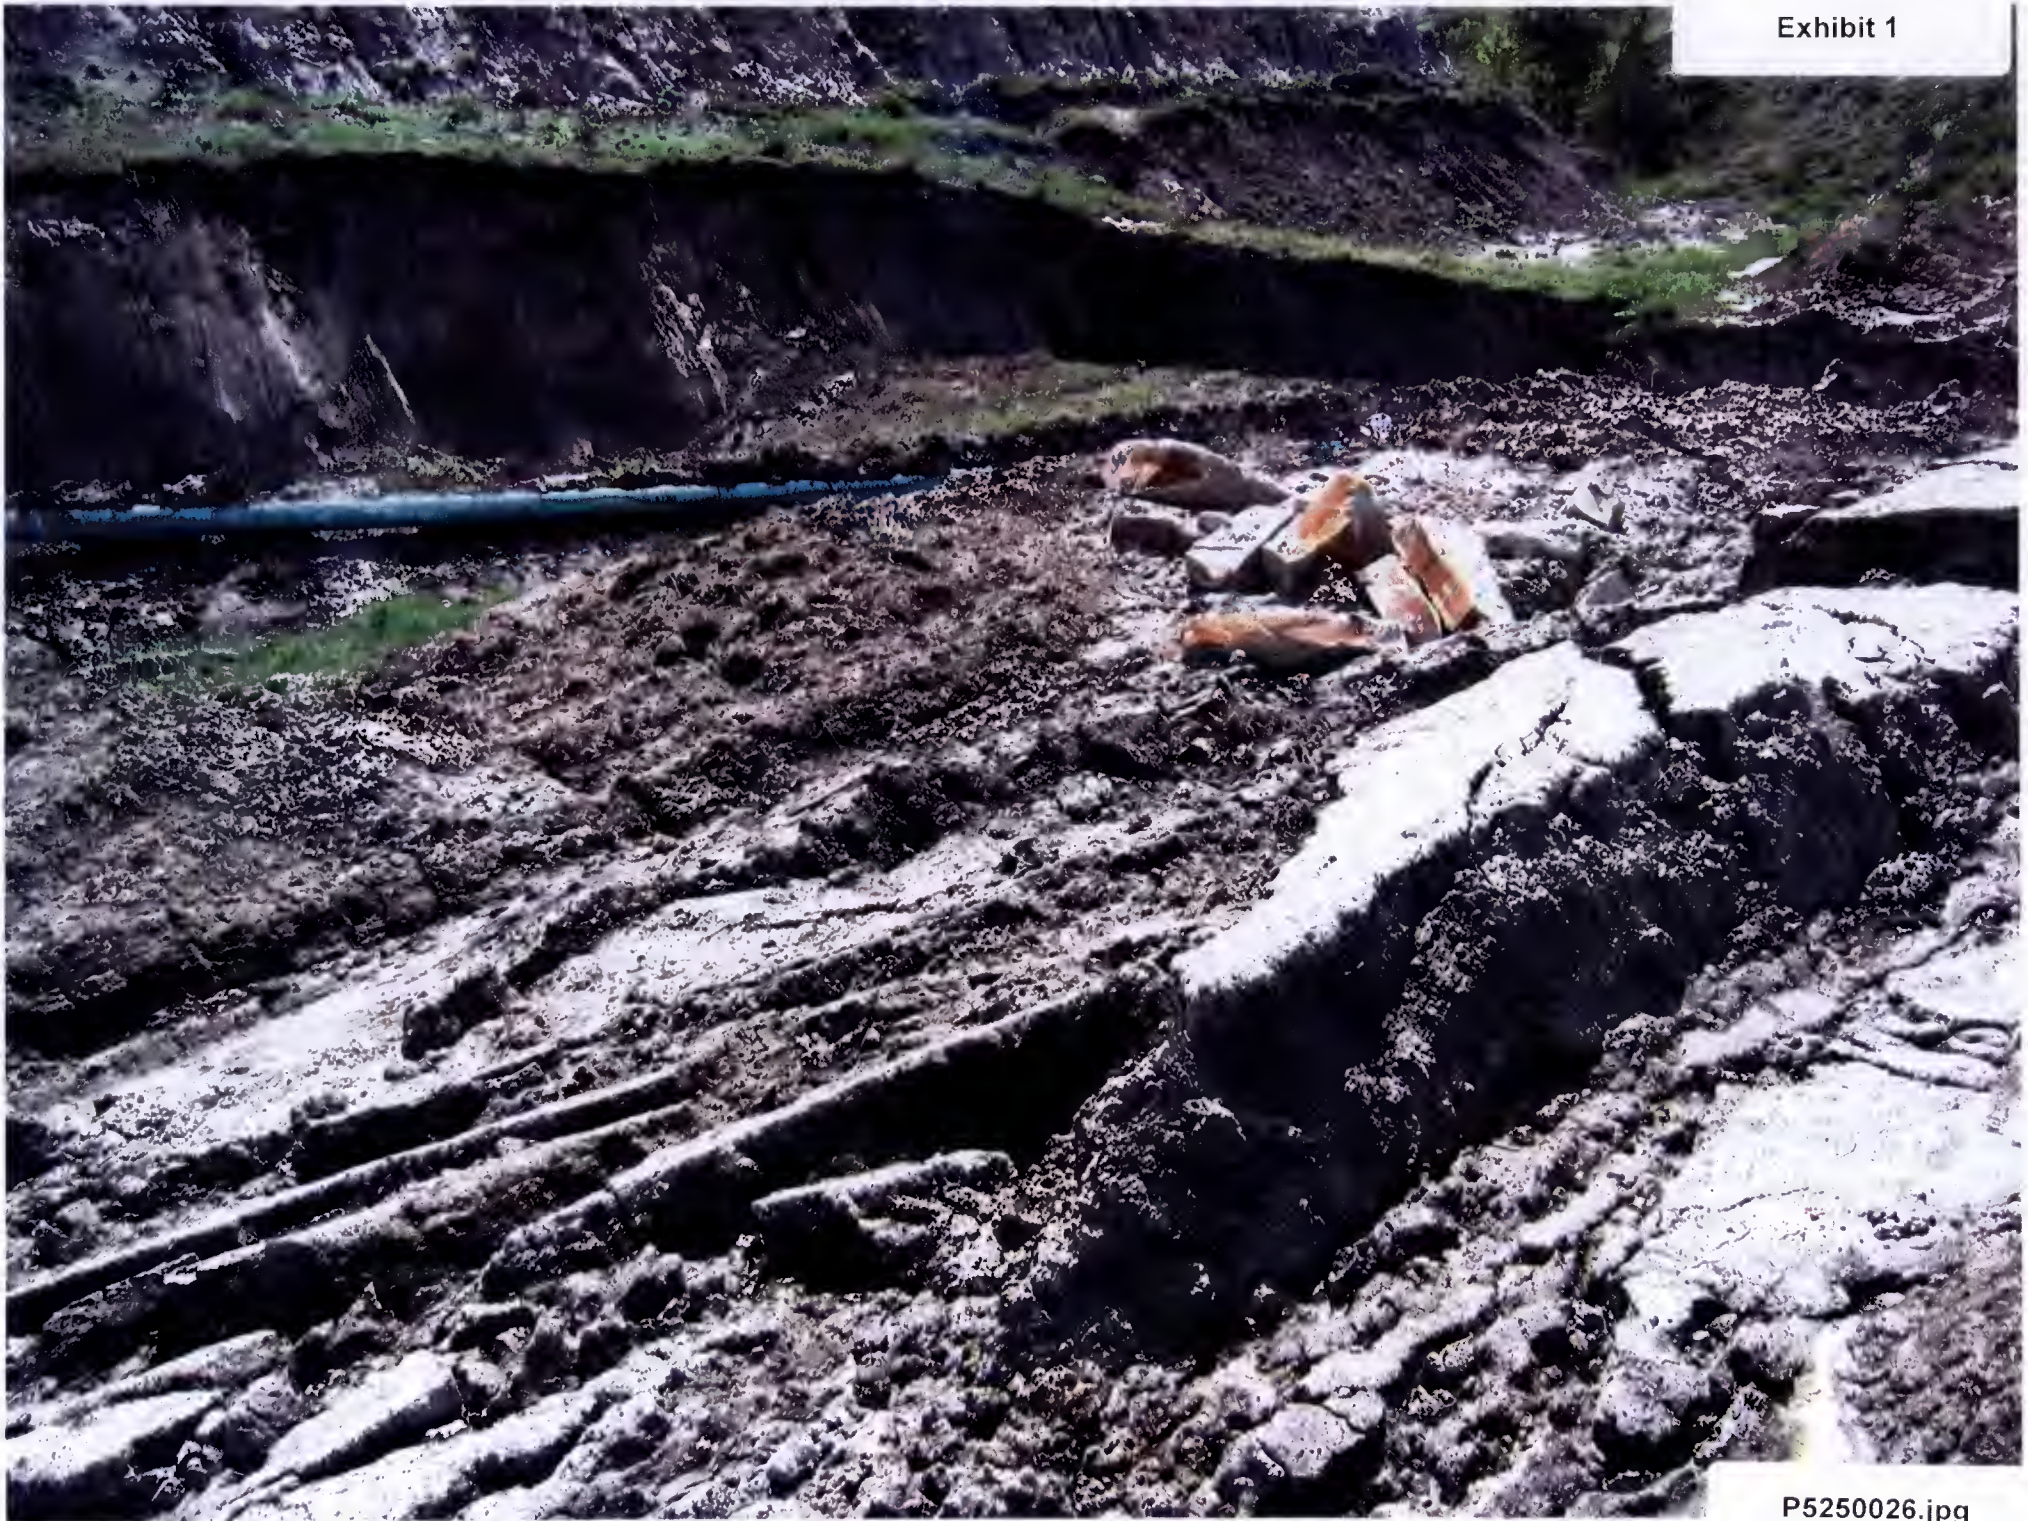
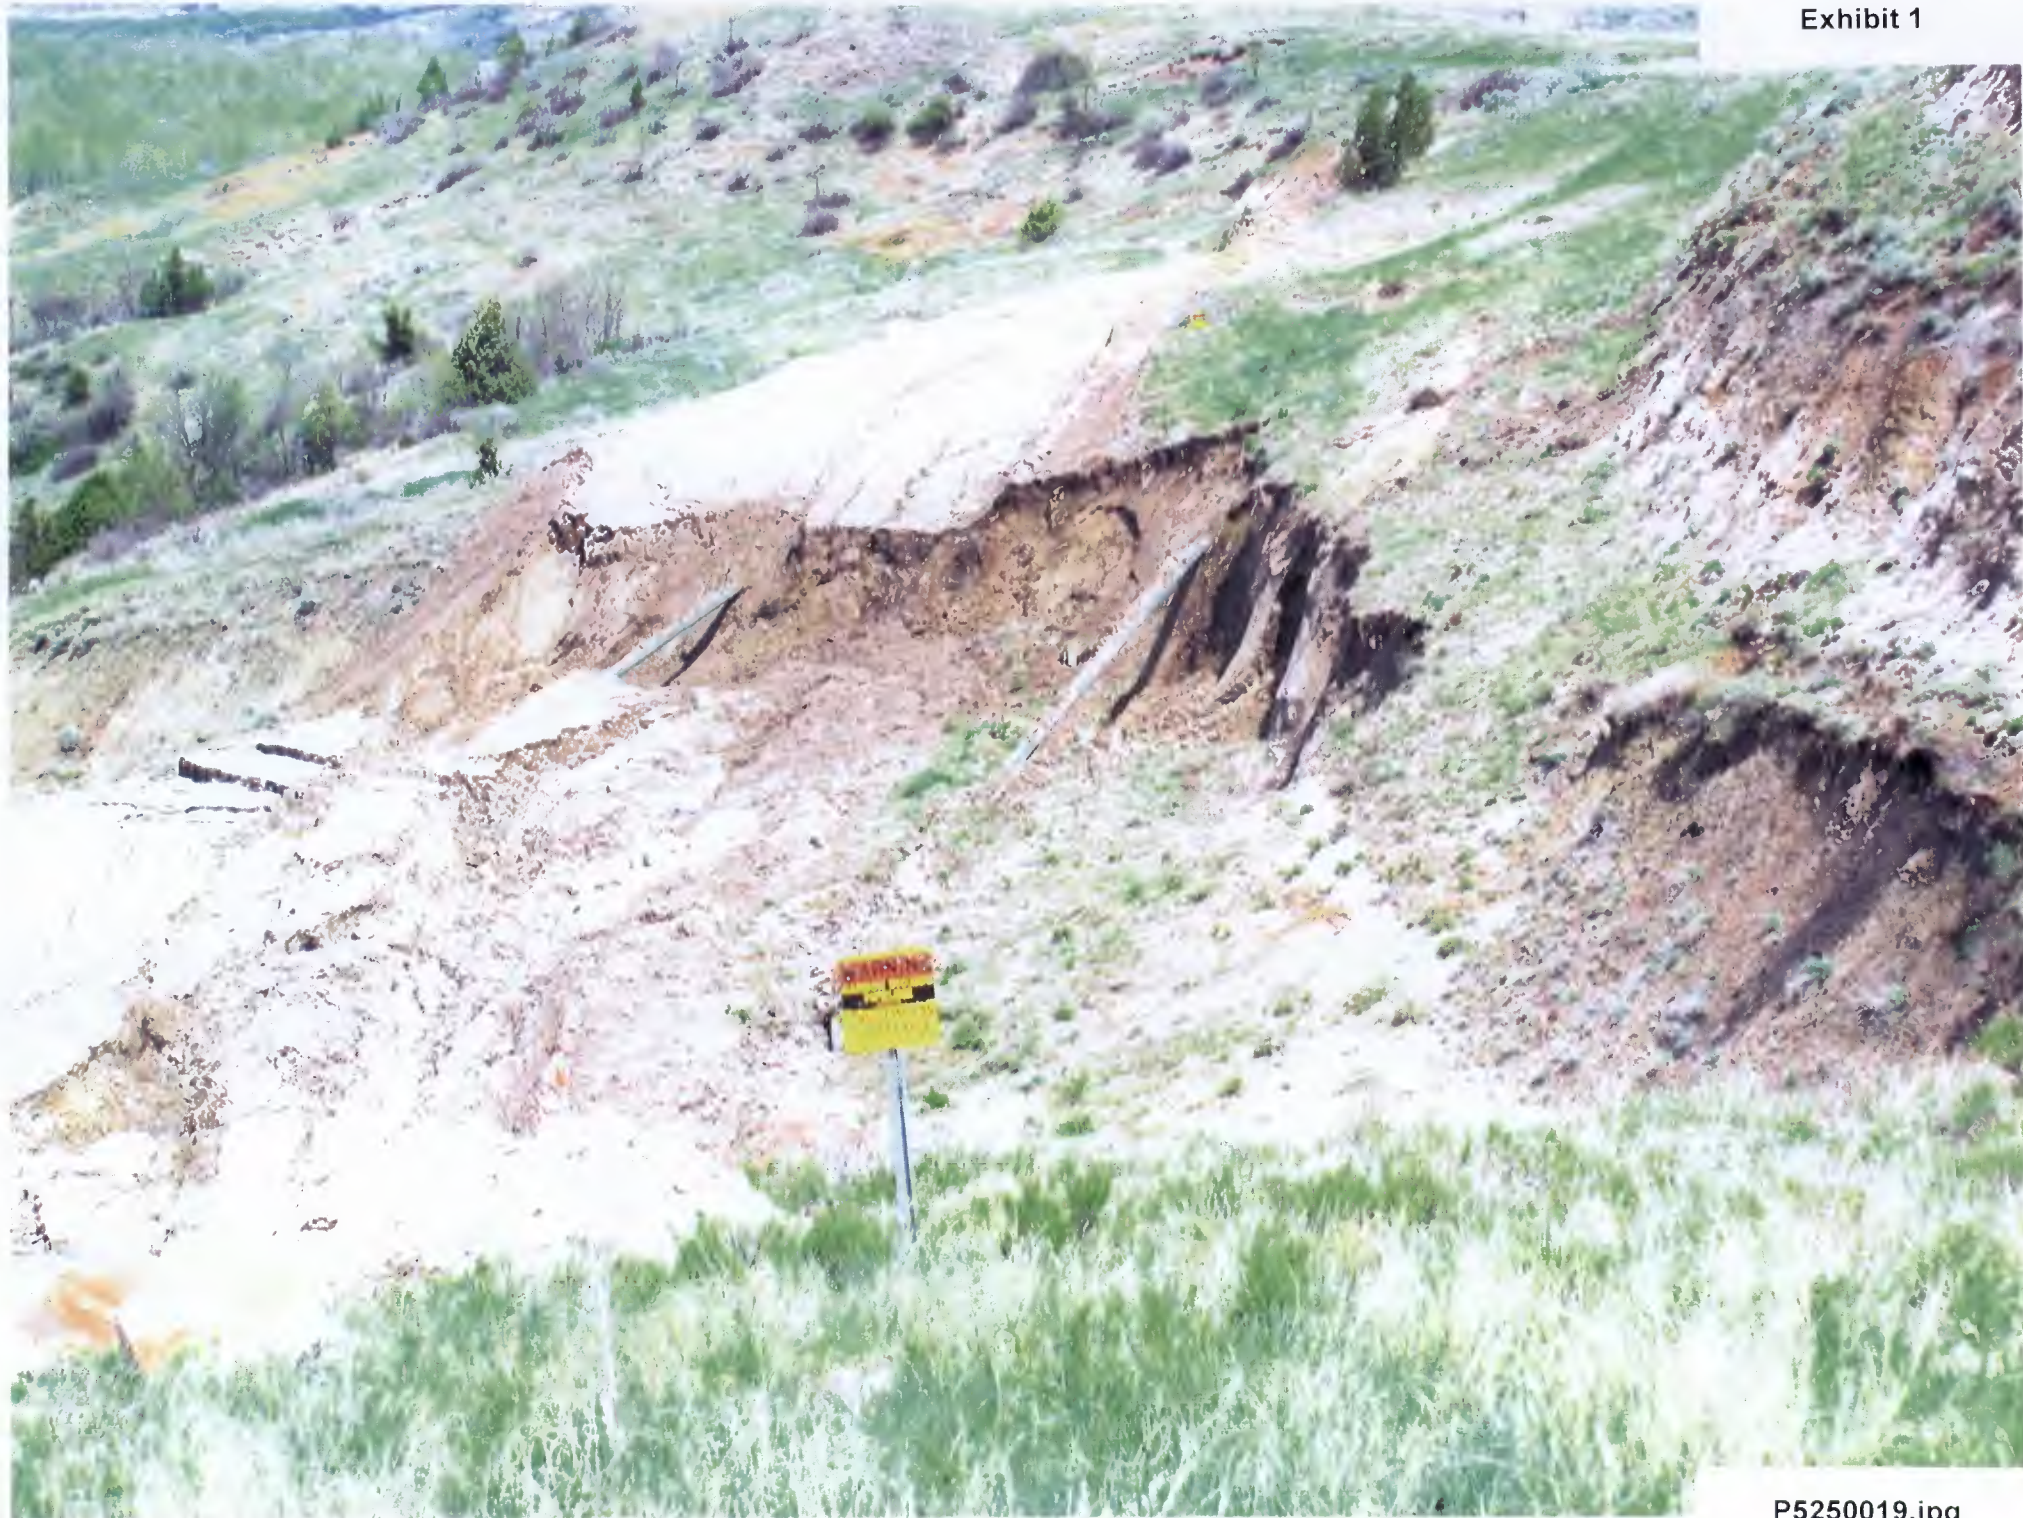
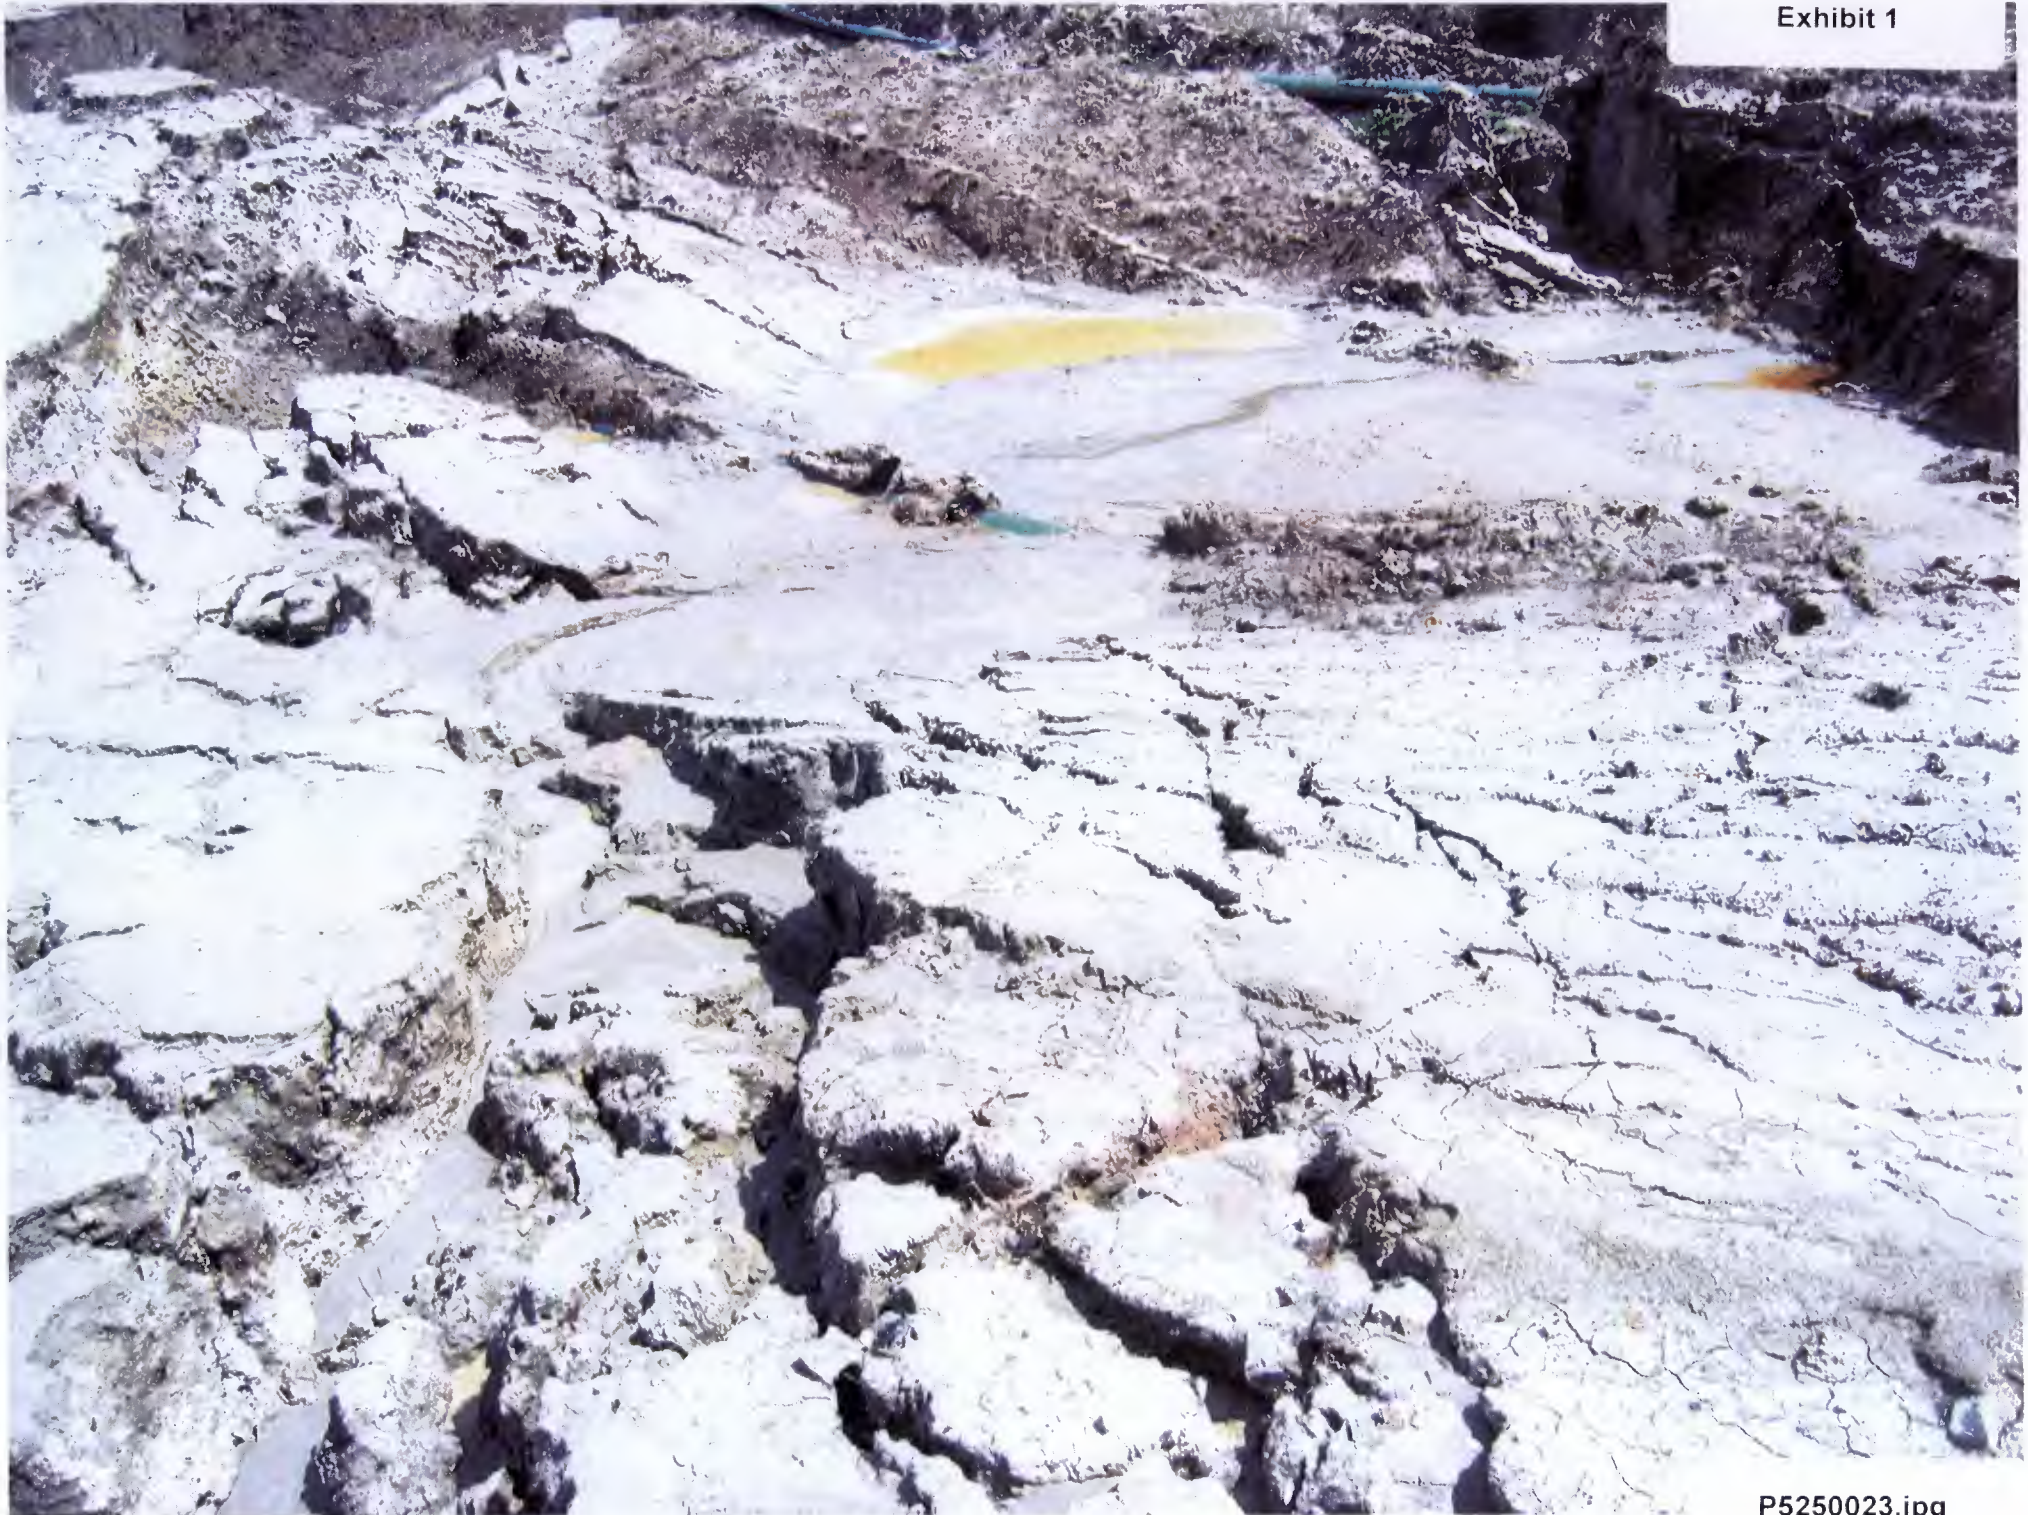
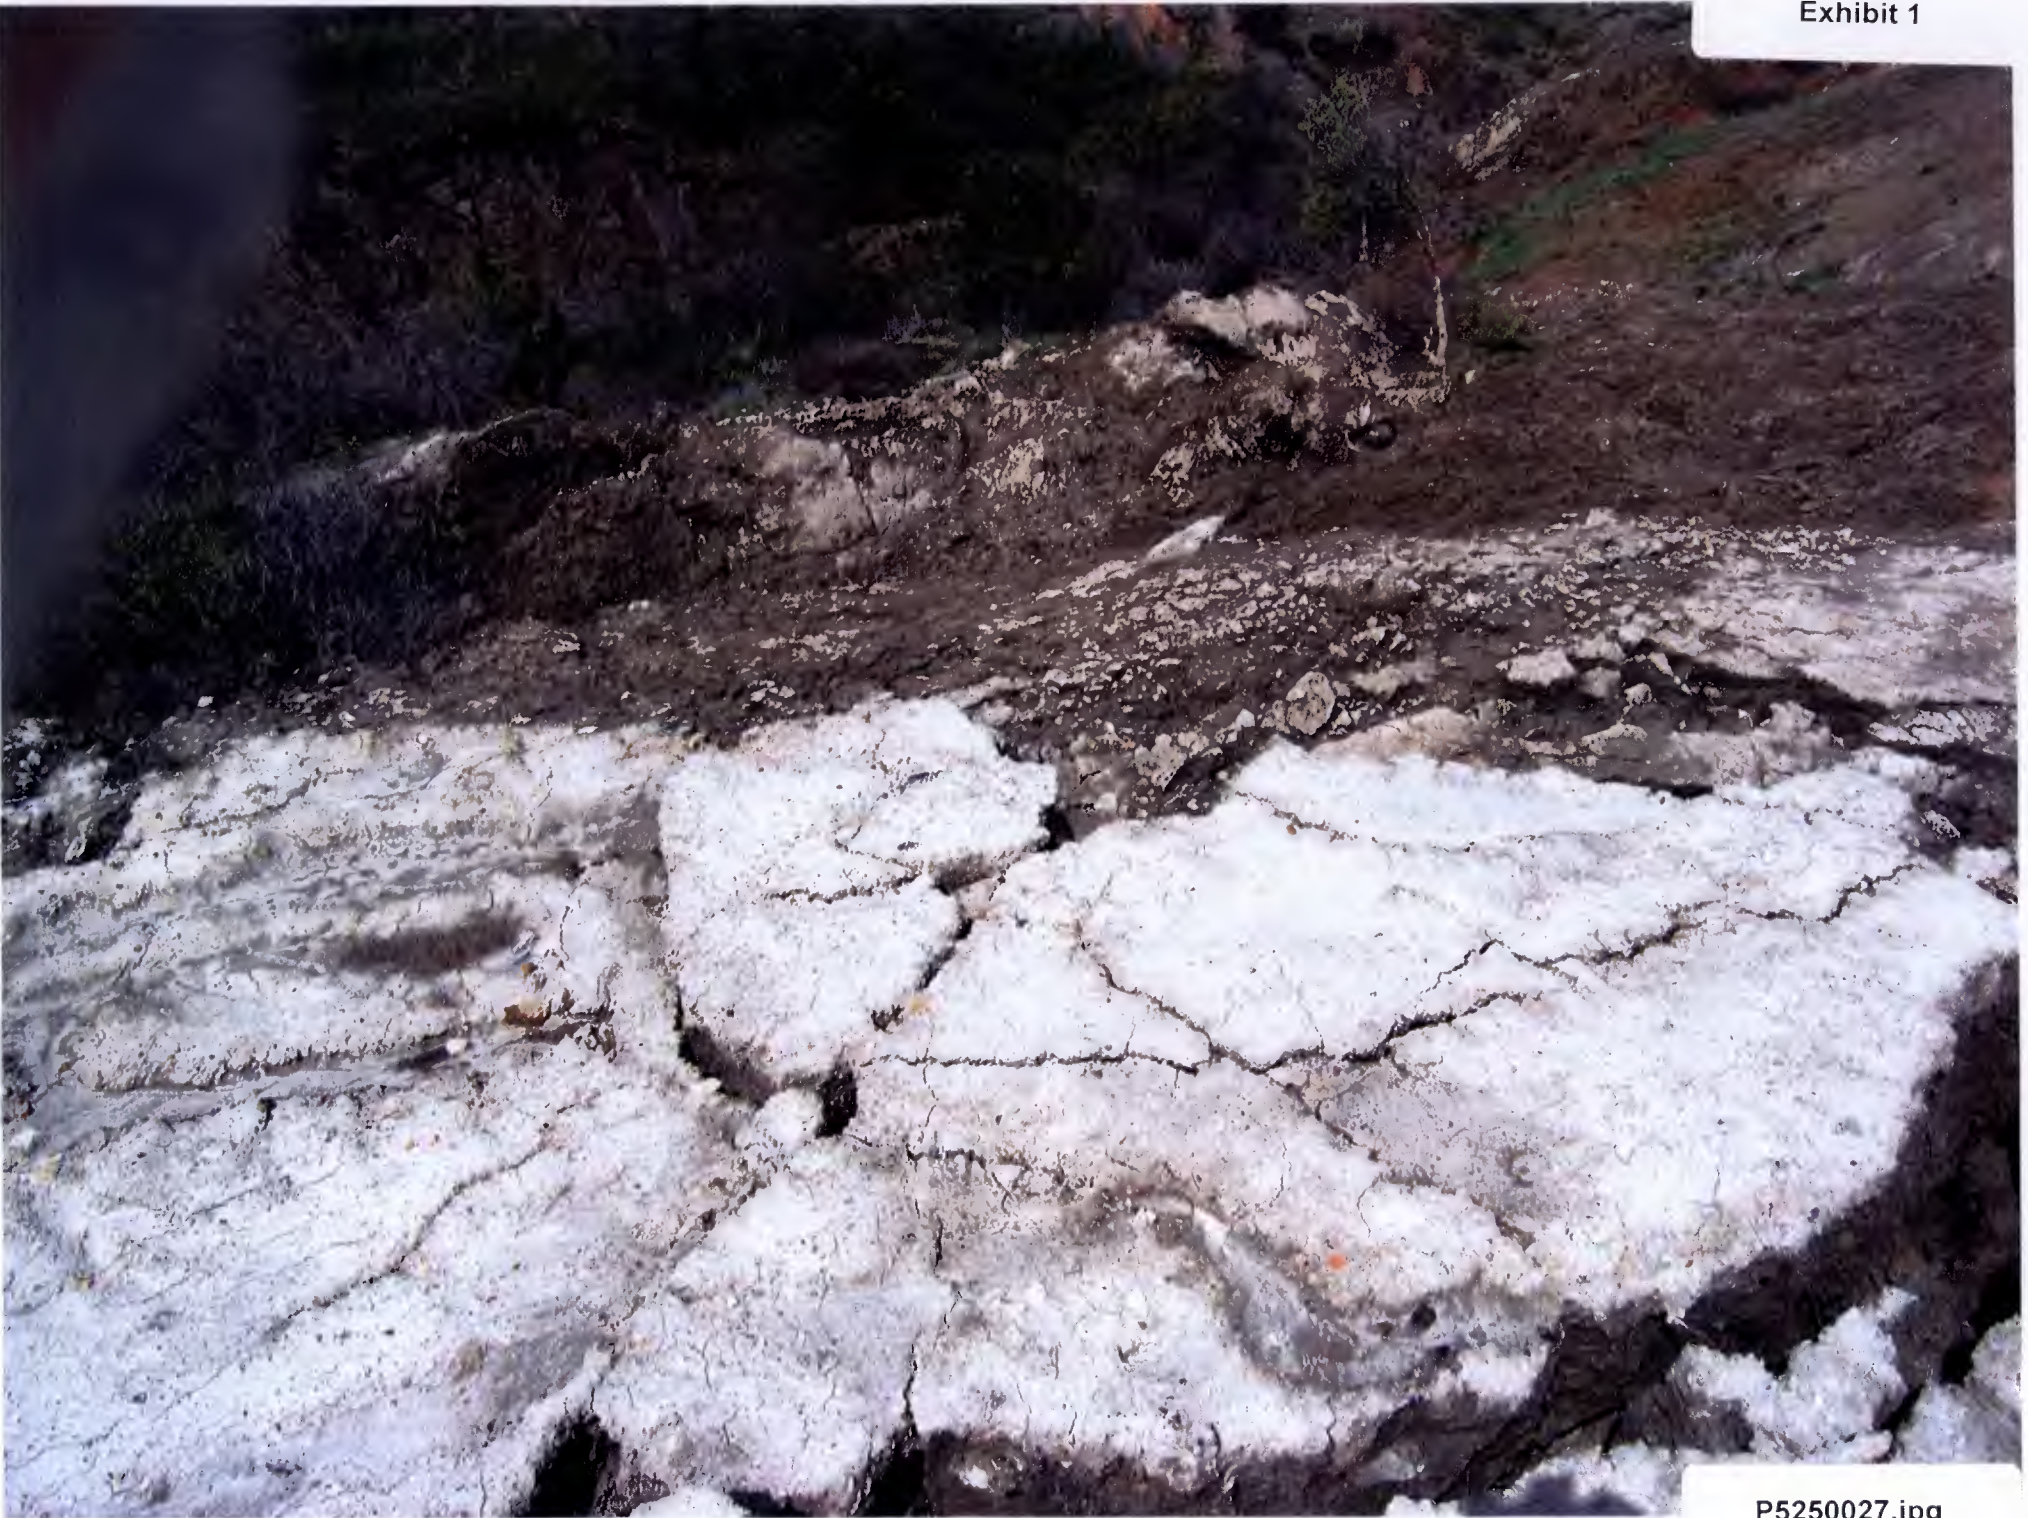
A review of the area of the cave-in leads DGC to believe that the cave-in was caused by slipshod construction practices on Bridger's pipeline. We note that Bridger's contractor had left a ridge of spoil material on the downhill side of DGC's right-of-way which presumably caused water to build up, pool and apply downhill pressure on Bridger's pipeline and trench. We note that it appears Bridger did not use appropriate backfill materials and also failed to compact its backfill. Finally, it appears to us that the Bridger's pipe was laid on backfill instead of being properly laid on the bottom of the trench.

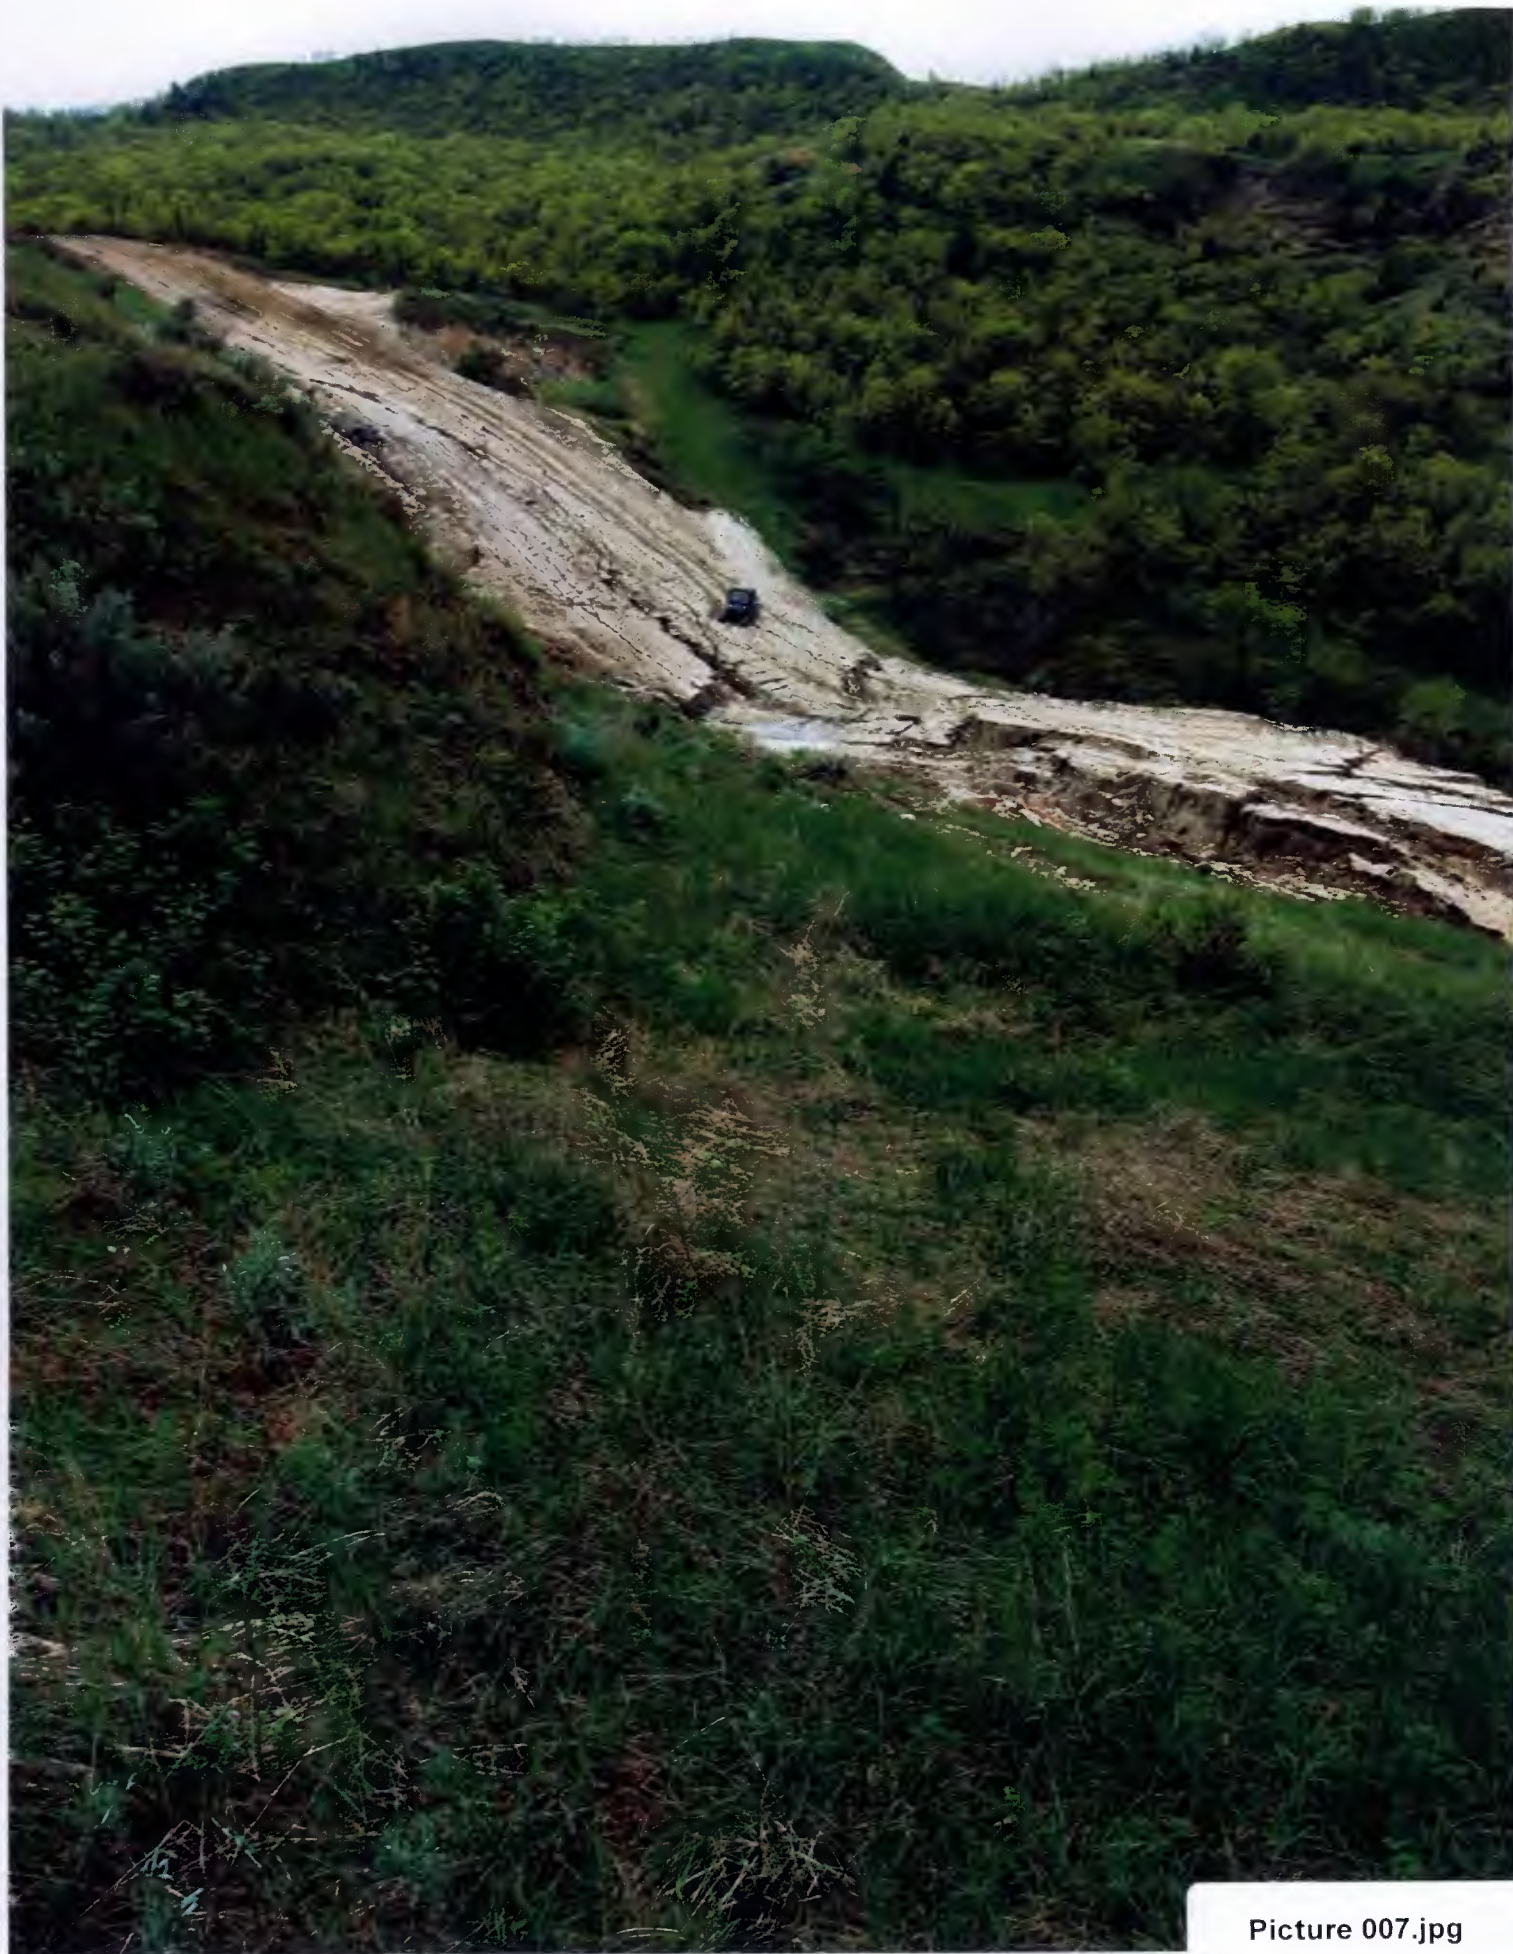
Picture 008.jpg

The attached photographs, which were taken on June 2, 2011, corroborate our suspicions. The photographs set forth in Exhibit 2 were taken in Section 35, T148N, R96W, Dunn County and illustrate that the Bridger pipe is exposed in several areas and that there are similar ridges of spoil material on the DGC right-of-way. The photograph labeled 006 shows a cut-out as a result of the complete lack of erosion control. Photograph 007 shows another hillside wash-out. The Exhibit 3 photographs were taken in Section 2, T147N, R96W, Dunn County and illustrate a similar pool of water in the Bridger right-of-way. The photographs in Exhibit 4 were taken on the north side of the Little Missouri crossing in Sections 23 and 26, T148N, R96W, Dunn County. Please note that in the photograph labeled 010 that there is less than 30 feet centerline to centerline. The photographs labeled 011 and 012 illustrate a large cut-out of a hillside. They, too, indicate the exposed Bridger pipeline. We were quite surprised to find a Caterpillar dozer buried in the Bridger right-of-way as shown in picture 025 in Exhibit 5 taken in Sections 6 and 7, T148N, R95W, Dunn County. Photograph 021 shows a cut-out approximately 20 feet wide. Photograph 022 raises the question as to whether the Bridger pipeline was undermined (look on opposite hill). The final set of pictures set forth in Exhibit 6 were taken in Sections 20 and 28, T149N, R95W, Dunn County and again illustrate the lack of proper backfilling and the use of the native material for this backfilling. Picture 026 again shows a large cut-out without any erosion control present. Photograph 029 shows severe damage to the hillside.
