# **Bridger Pipeline, LLC Inspection Report**

## **Phase 1 – Construction Phase**

**NORTH DAKOTA  
PUBLIC SERVICE COMMISSION**  
600 E. Boulevard Avenue  
Bismarck, ND 58505-0480

August 2011

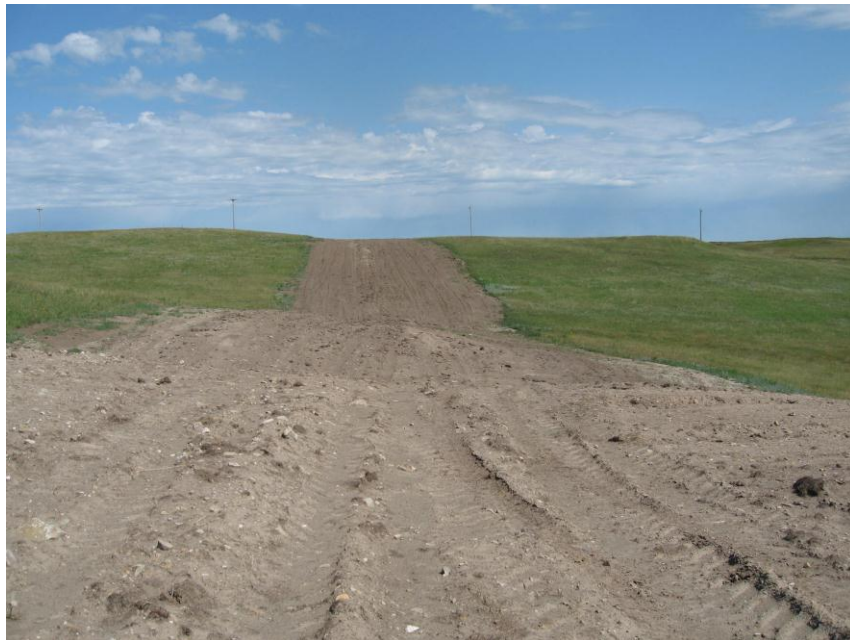
**Photo 6.** Direction: North. This photo shows the right-of-way for the Bridger Pipeline. At the time of our site visit the right-of-way needed final restoration.

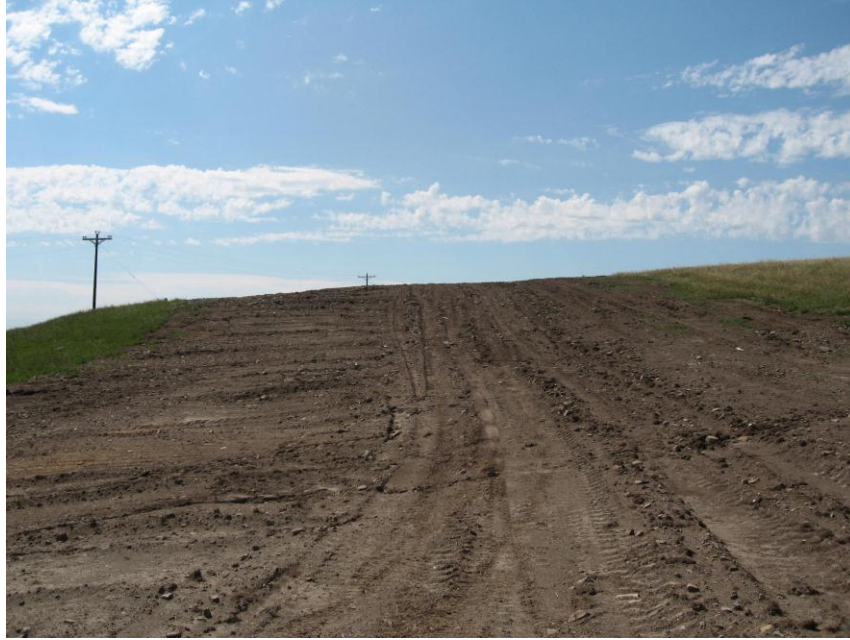
**Photo 7.** Direction: Northeast. This photo shows the right-of-way for the Bridger Pipeline. At the time of our site visit the right-of-way needed final restoration.

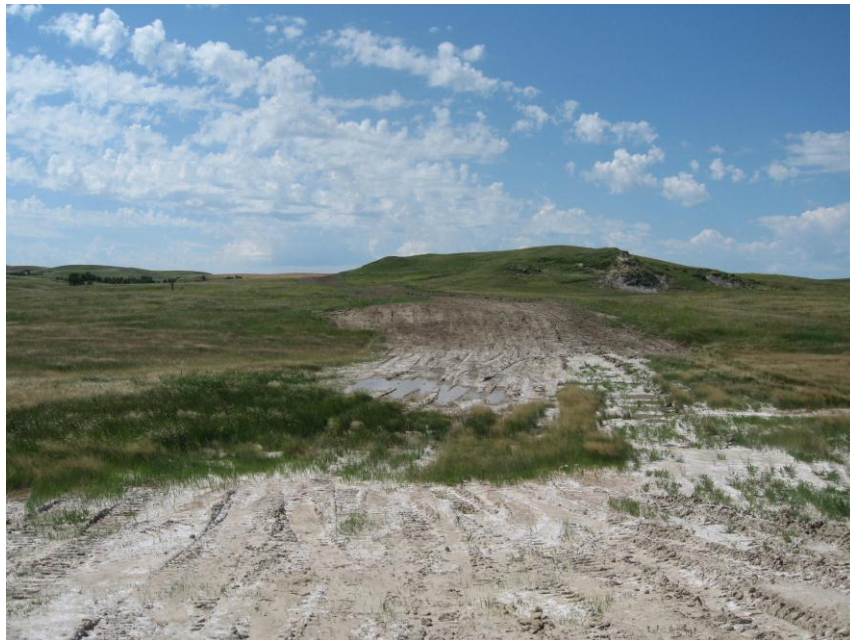
**Photo 8.** Direction: North. This photo shows the right-of-way for the Bridger Pipeline. At the time of our site visit the right-of-way needed final restoration.

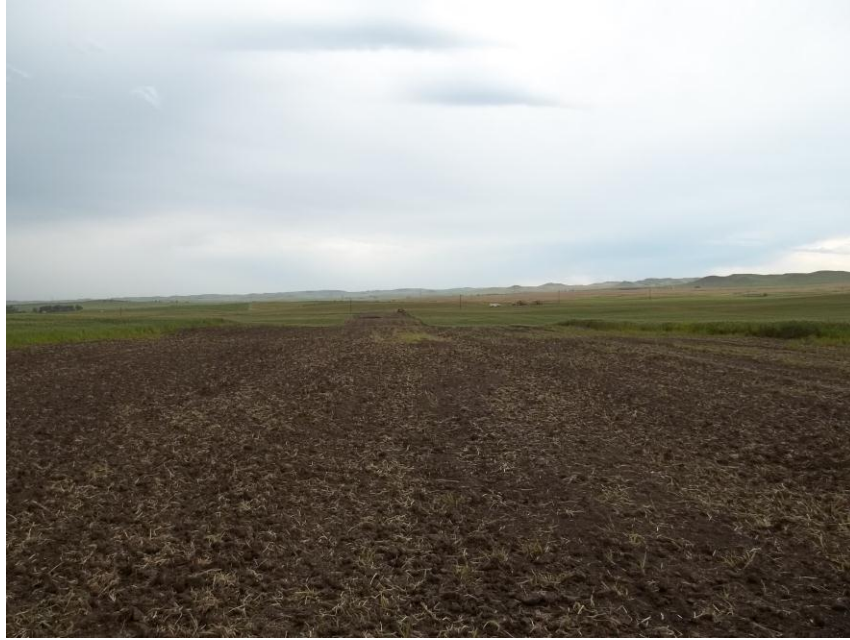
**Photo 9.** Direction: South. This photo shows the right-of-way for the Bridger Pipeline. At the time of our site visit the right-of-way needed final restoration.

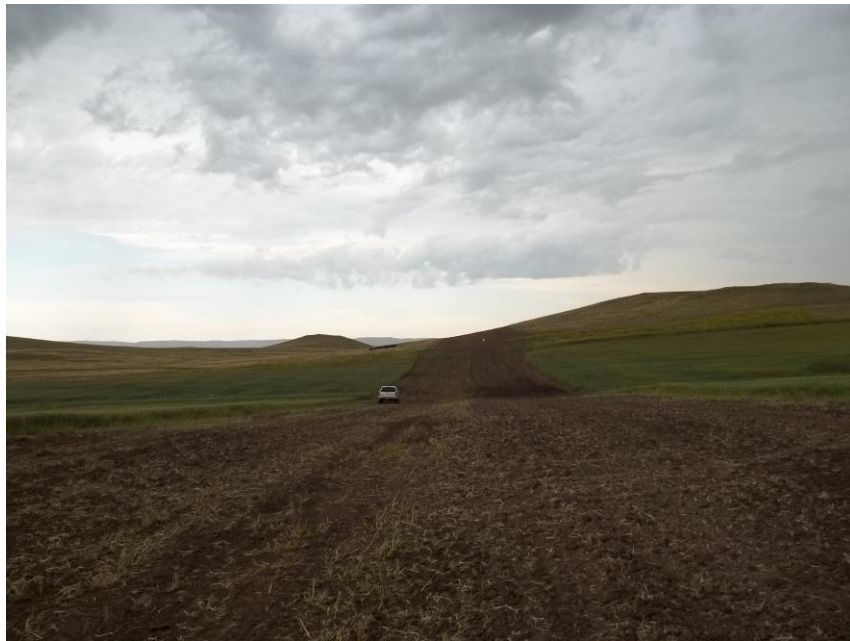
**Photo 10.** Direction: North. This photo shows the right-of-way for the Bridger Pipeline. At the time of our site visit the right-of-way needed final restoration.

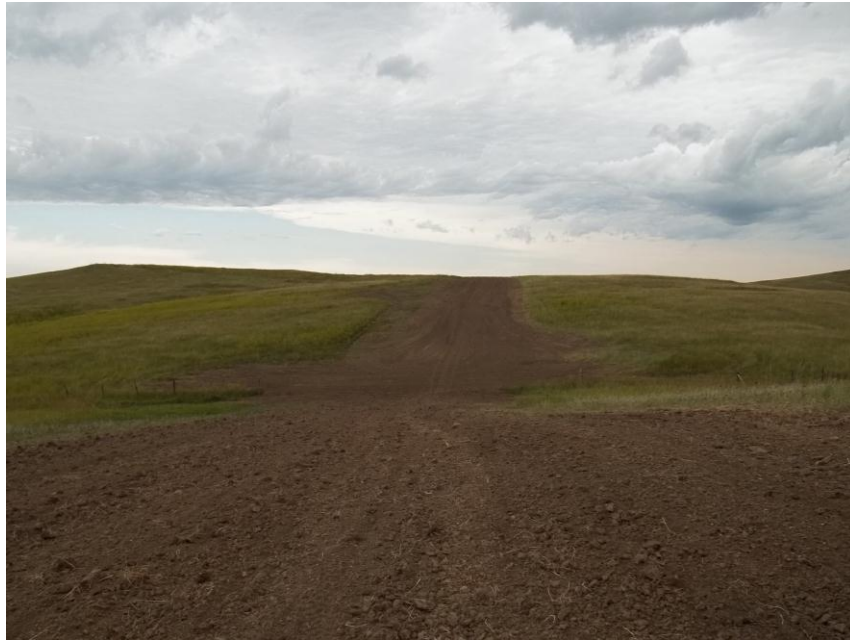
**Photo 13.** Direction: North. This photo shows the right-of-way for the Bridger Pipeline. At the time of our site visit the right-of-way needed final restoration.

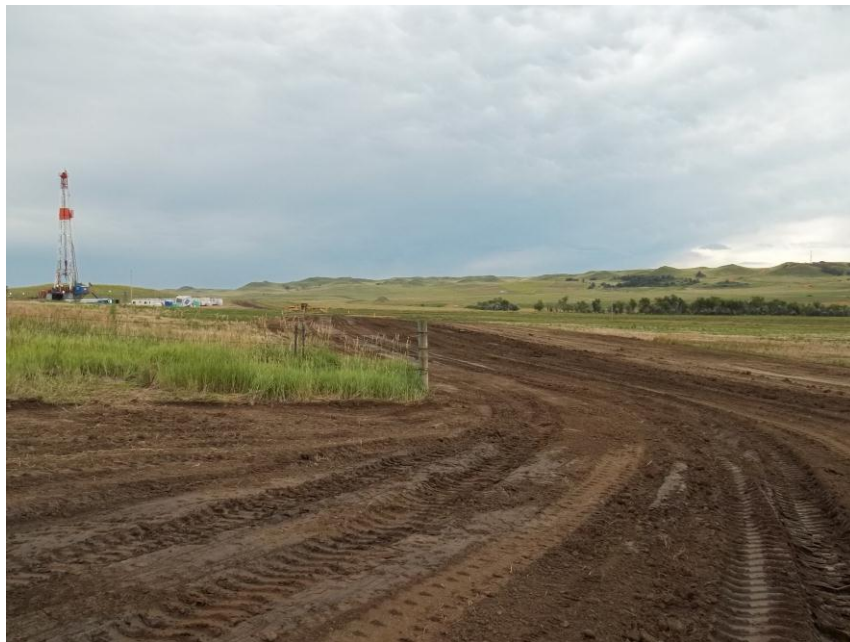
**Photo 14.** Direction: Southwest. This photo shows the right-of-way for the Bridger Pipeline. At the time of our site visit the right-of-way needed final restoration.

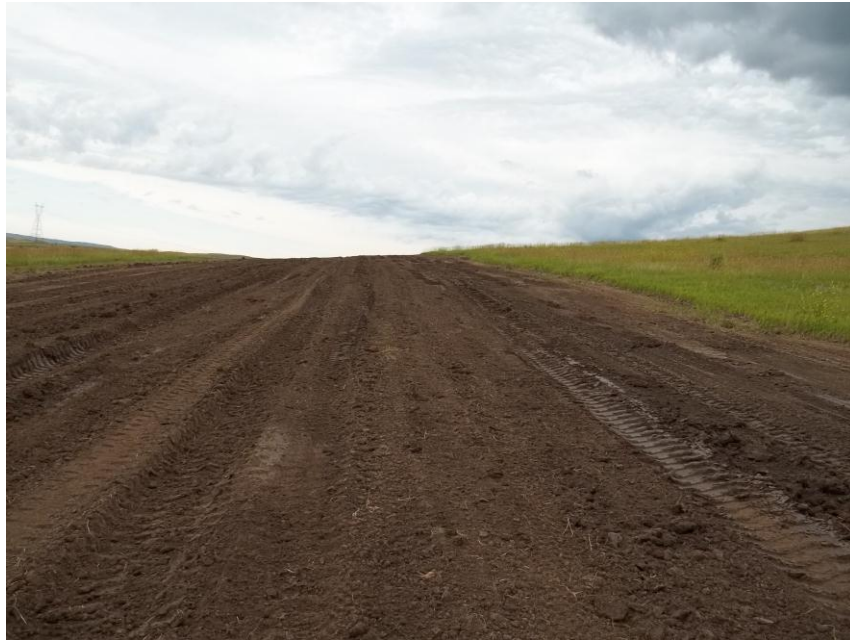
**Photo 15.** Direction: Northeast. This photo shows the right-of-way for the Bridger Pipeline. At the time of our site visit the right-of-way needed final restoration.

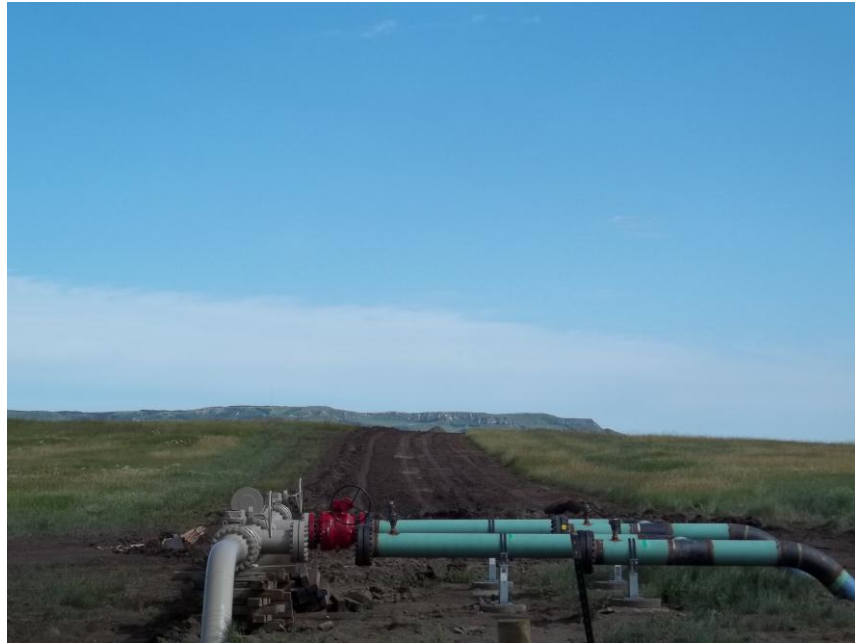
**Photo 17.** Direction: North. This photo shows the right-of-way for the Bridger Pipeline. At the time of our site visit the right-of-way needed final restoration.

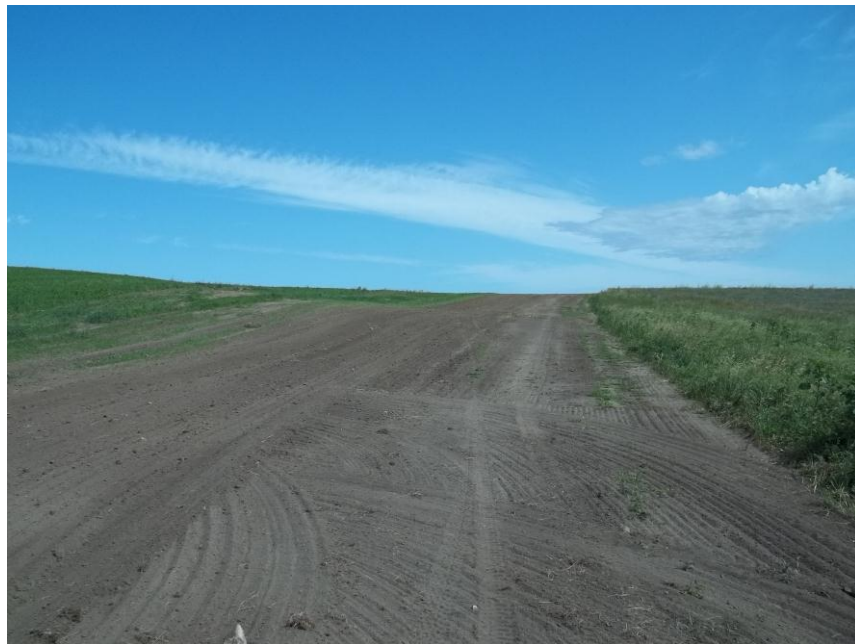
**Photo 18.** Direction: North. This photo shows the right-of-way for the Bridger Pipeline. At the time of our site visit the right-of-way needed final restoration.

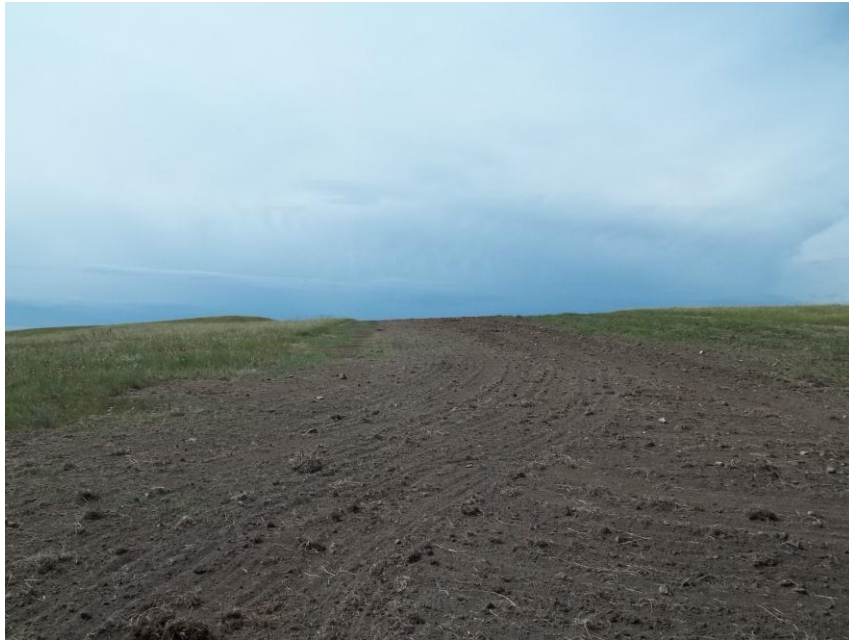
**Photo 19.** Direction: South. This photo shows the right-of-way for the Bridger Pipeline. At the time of our site visit the right-of-way needed final restoration.

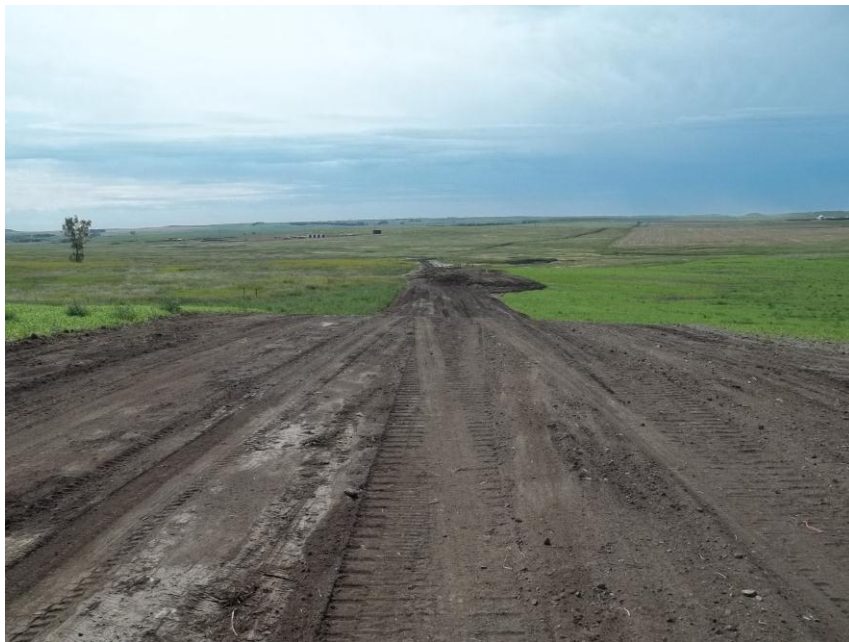
**Photo 20.** Direction: South. This photo shows the right-of-way for the Bridger Pipeline. At the time of our site visit the right-of-way needed final restoration.

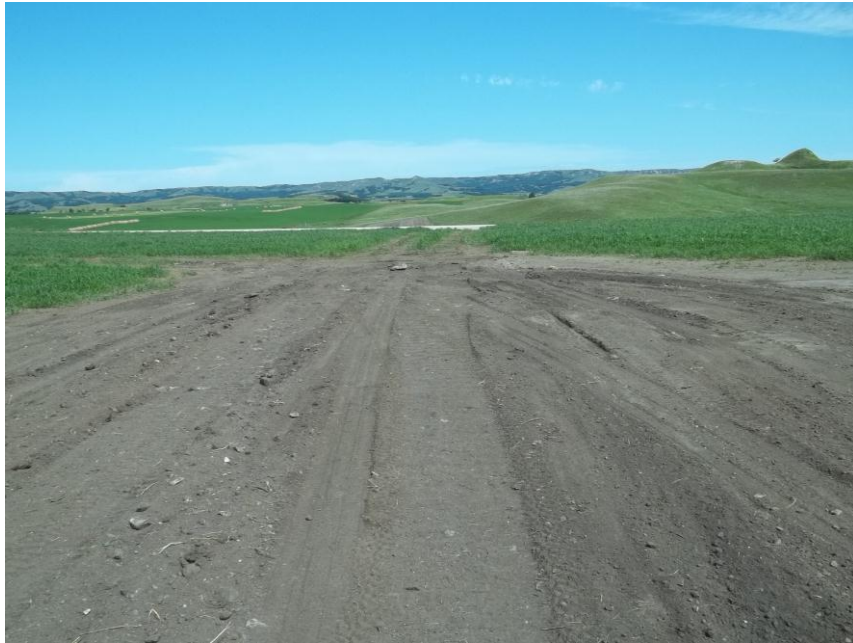
**Photo 21.** Direction: North. This photo shows the right-of-way for the Bridger Pipeline. At the time of our site visit the right-of-way needed final restoration.

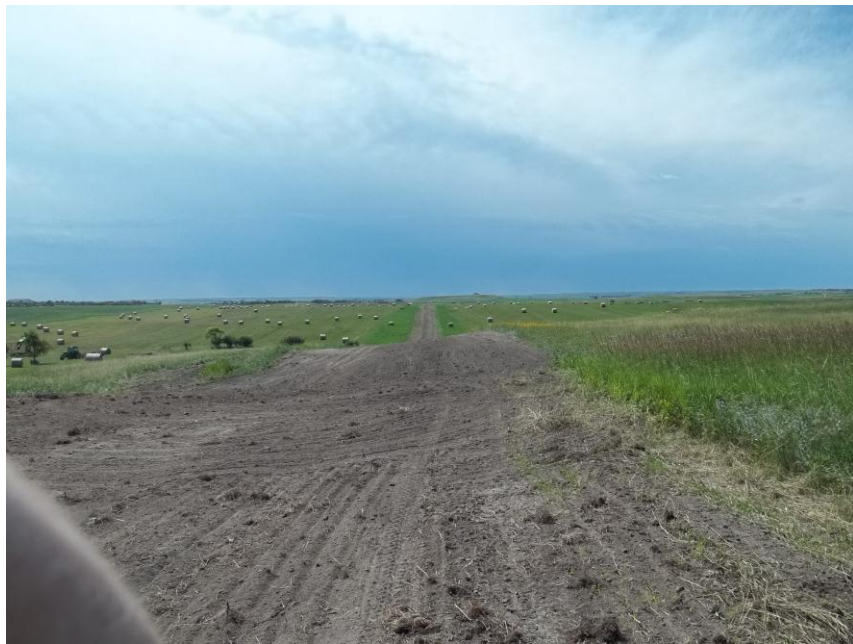
**Photo 22.** Direction: South. This photo shows the right-of-way for the Bridger Pipeline. At the time of our site visit the right-of-way needed final restoration.

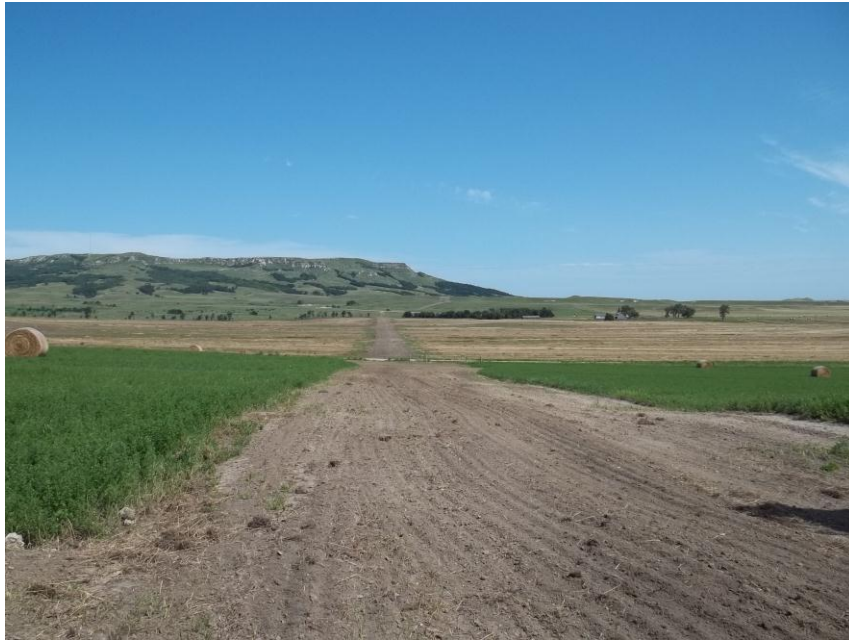
**Photo 23.** Direction: North. This photo shows the right-of-way for the Bridger Pipeline. At the time of our site visit the right-of-way needed final restoration.

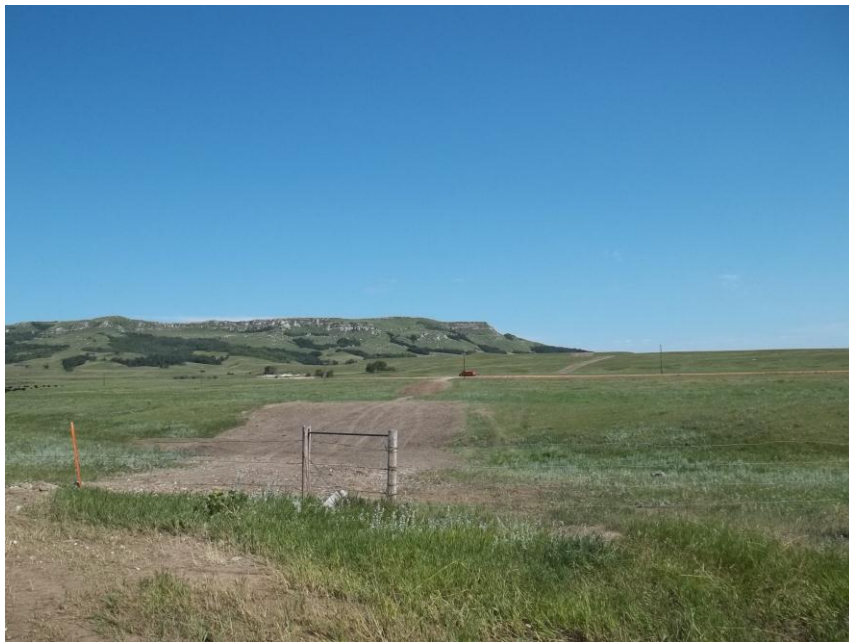
**Photo 24.** Direction: North. This photo shows the right-of-way for the Bridger Pipeline. At the time of our site visit the right-of-way needed final restoration.

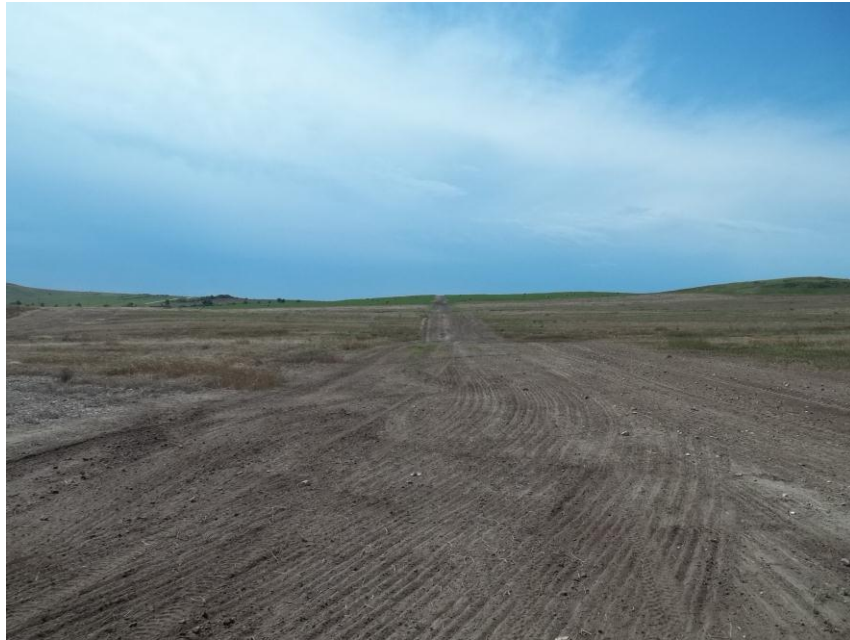
**Photo 25.** Direction: South. This photo shows the right-of-way for the Bridger Pipeline. At the time of our site visit the right-of-way needed final restoration.

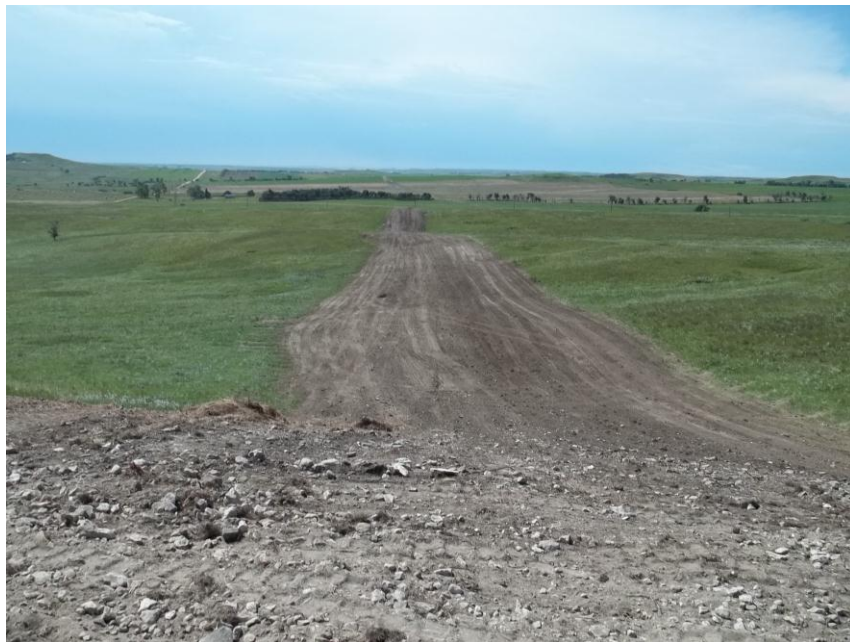
**Photo 26.** Direction: South. This photo shows the right-of-way for the Bridger Pipeline. At the time of our site visit the right-of-way needed final restoration.

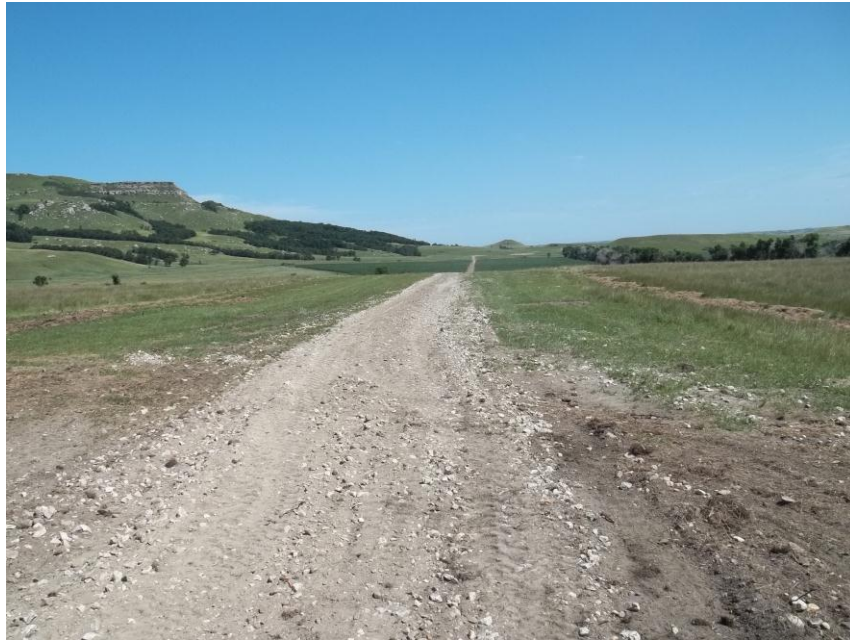
**Photo 27.** Direction: North. This photo shows the right-of-way for the Bridger Pipeline. At the time of our site visit the right-of-way needed final restoration.

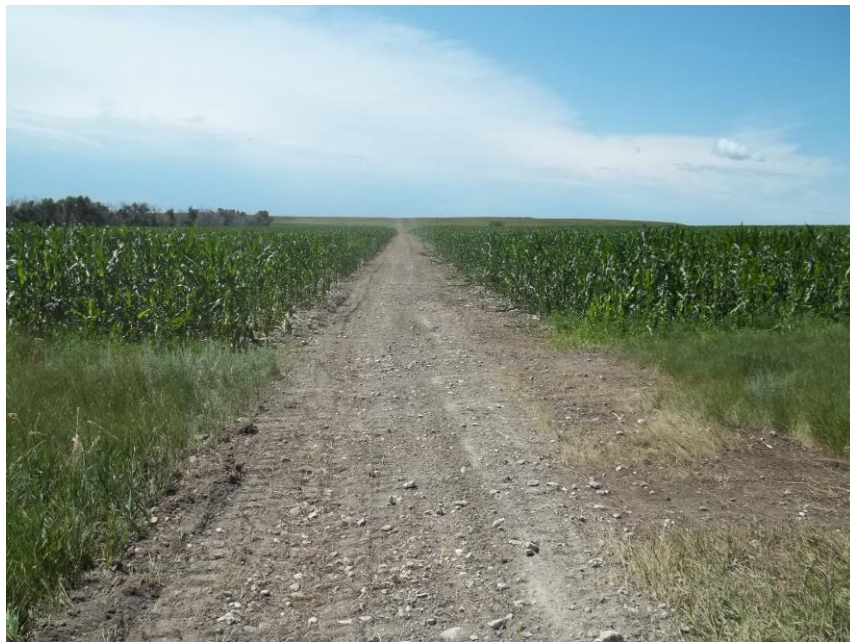
**Photo 28.** Direction: South. This photo shows the right-of-way for the Bridger Pipeline. At the time of our site visit the right-of-way needed final restoration.

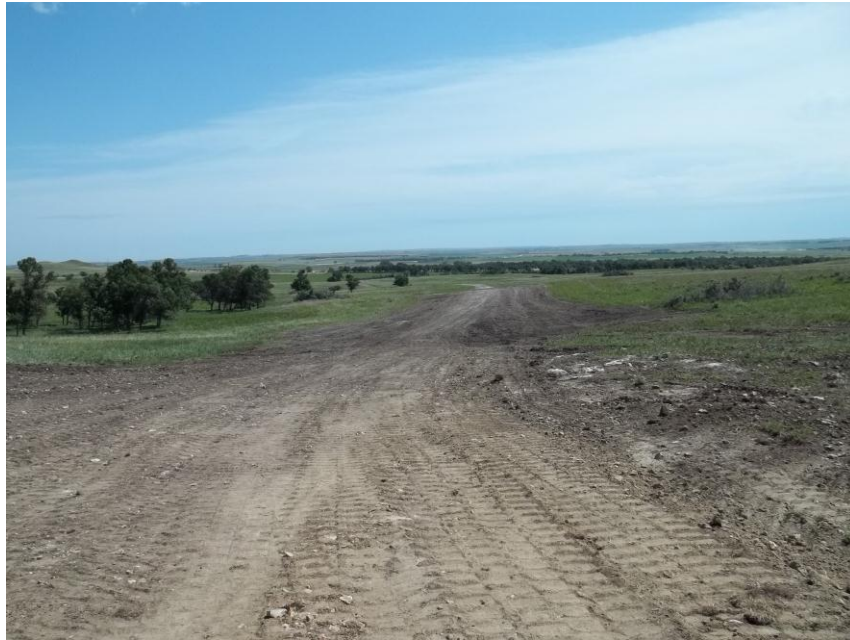
**Photo 29.** Direction: Northeast. This photo shows the right-of-way for the Bridger Pipeline. At the time of our site visit the right-of-way needed final restoration.

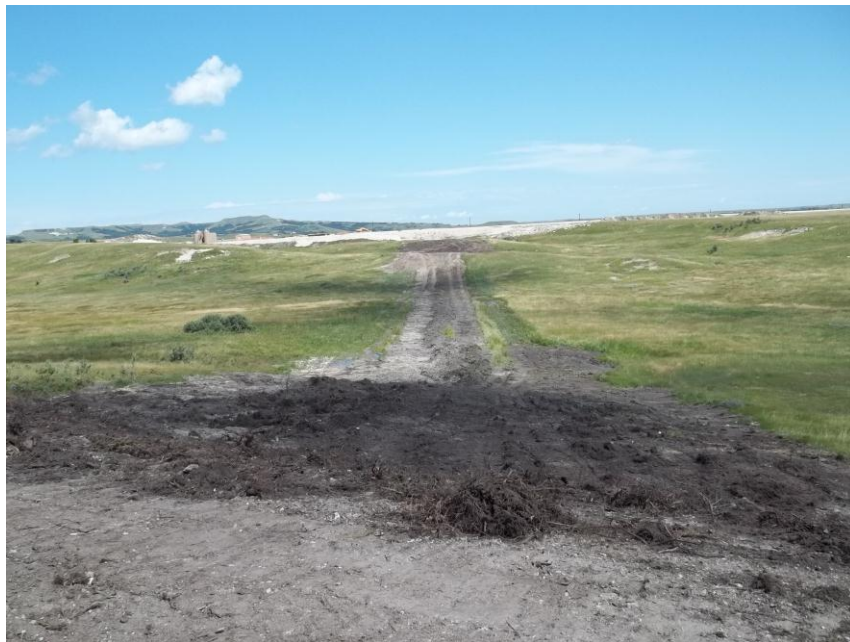
**Photo 30.** Direction: North. This photo shows the right-of-way for the Bridger Pipeline. At the time of our site visit the right-of-way needed final restoration.

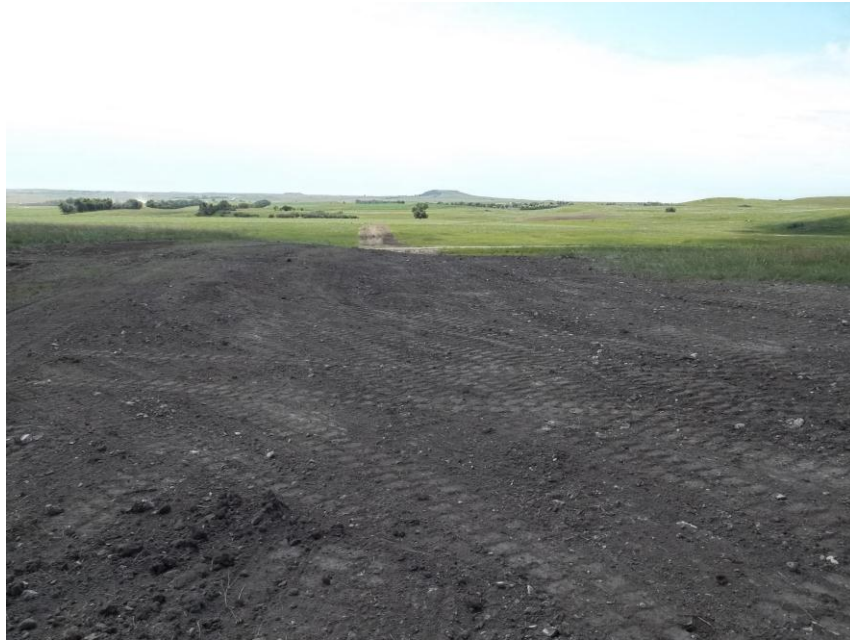
**Photo 31.** Direction: South. This photo shows the right-of-way for the Bridger Pipeline. At the time of our site visit the right-of-way needed final restoration.

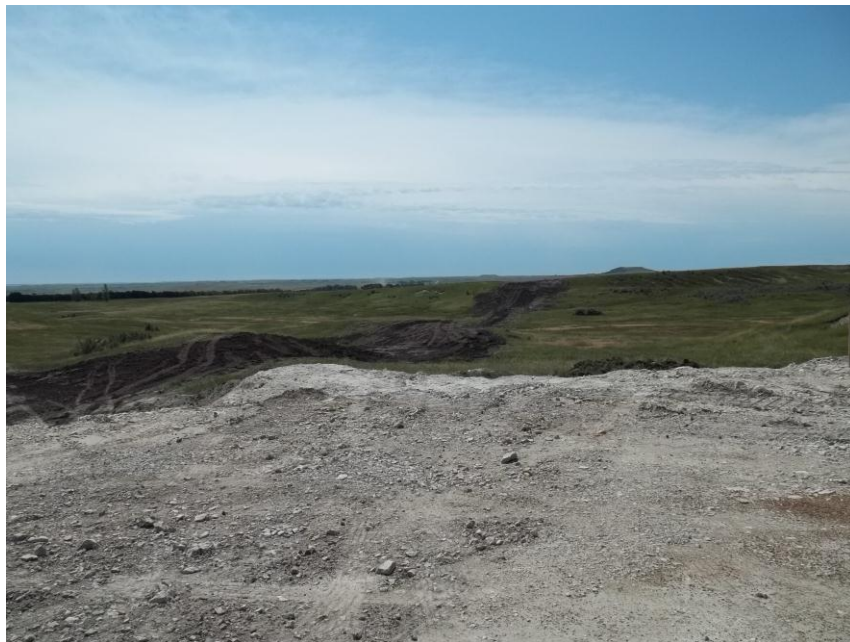
**Photo 32.** Direction: South. This photo shows the right-of-way for the Bridger Pipeline. At the time of our site visit the right-of-way needed final restoration.

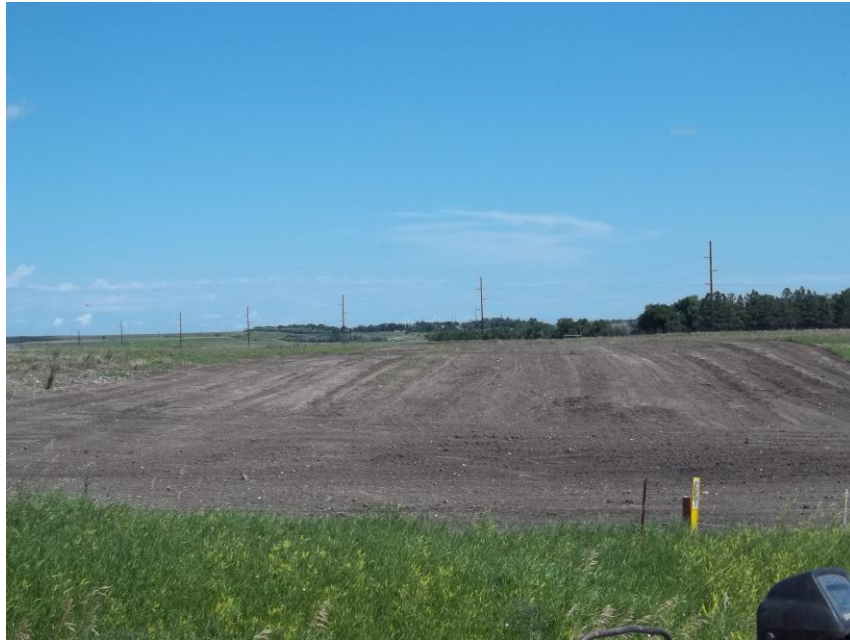
**Photo 33.** Direction: North. This photo shows the right-of-way for the Bridger Pipeline. At the time of our site visit the right-of-way needed final restoration.

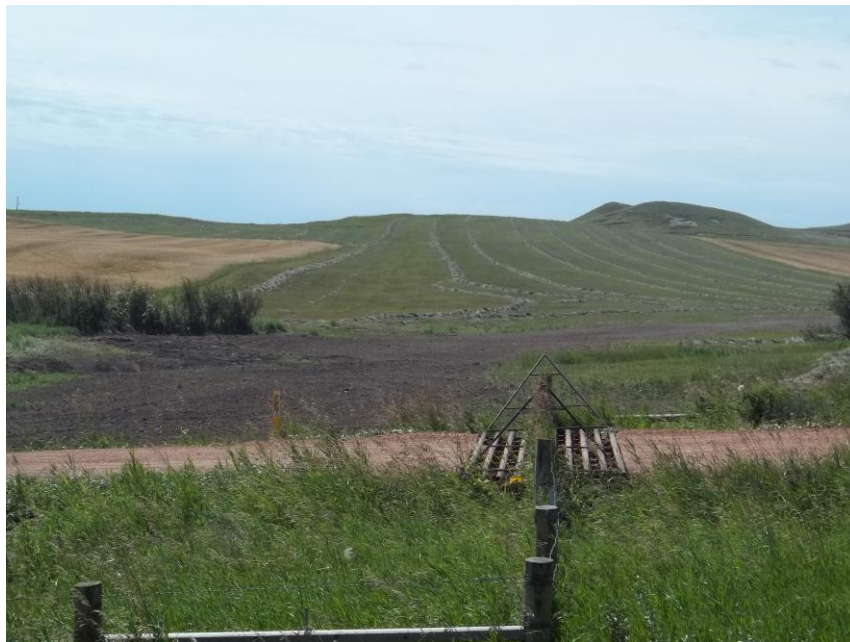
**Photo 34.** Direction: South. This photo shows the right-of-way for the Bridger Pipeline. At the time of our site visit the right-of-way needed final restoration.

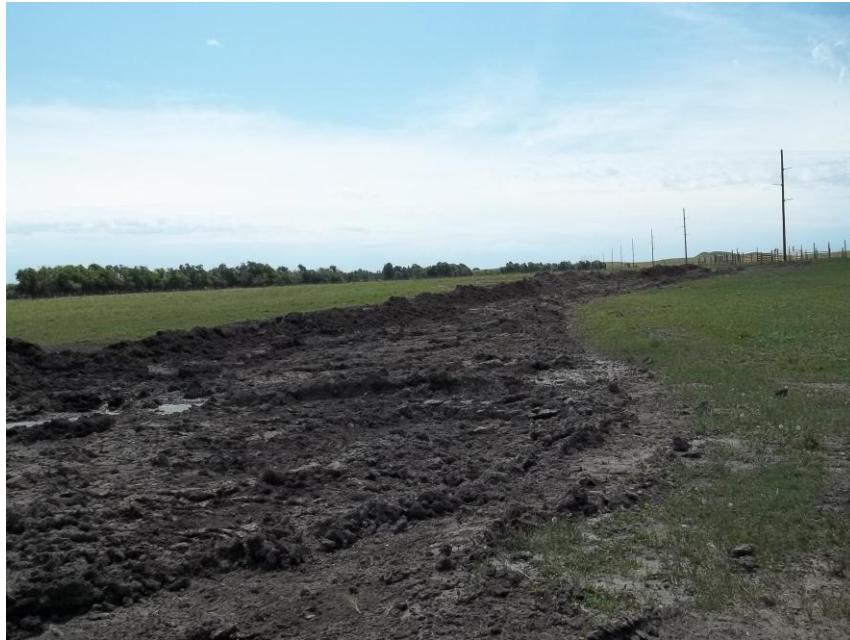
**Photo 35.** Direction: South. This photo shows the right-of-way for the Bridger Pipeline. At the time of our site visit the area shown needed topsoil spread for a total segment length of approximately 1,500 feet and final restoration.

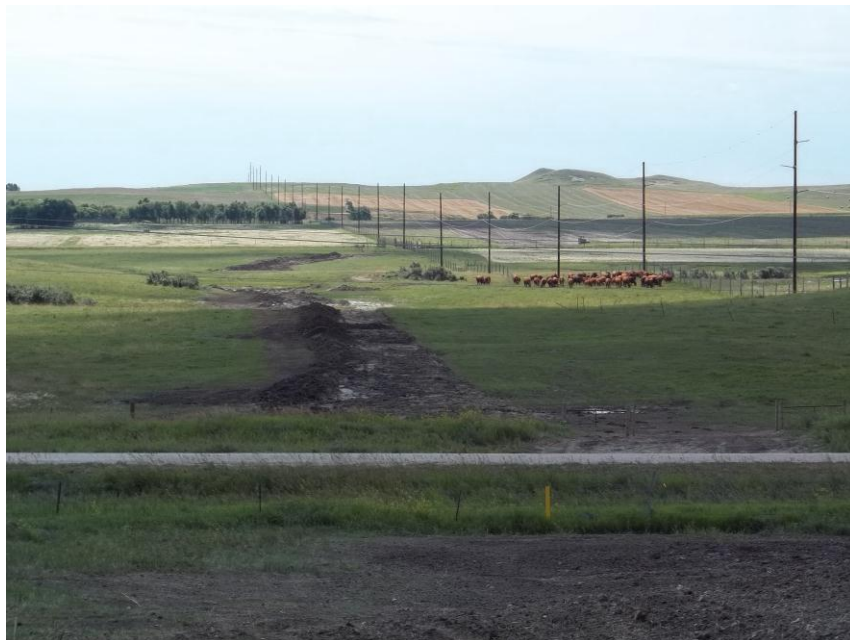
**Photo 36.** Direction: South. This photo shows the right-of-way for the Bridger Pipeline. At the time of our site visit the area shown needed topsoil spread and final restoration.

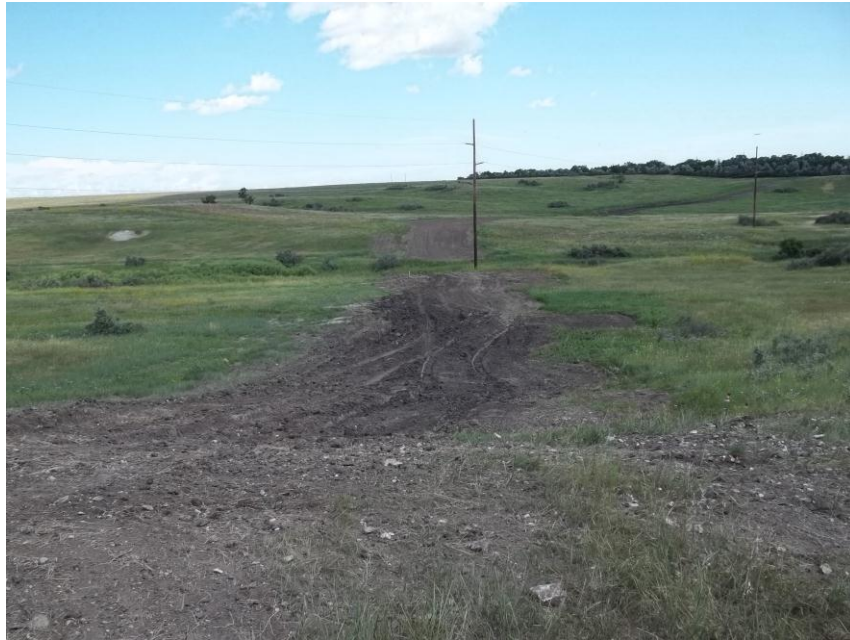
**Photo 37.** Direction: North. This photo shows the right-of-way for the Bridger Pipeline. At the time of our site visit the right-of-way needed final restoration.

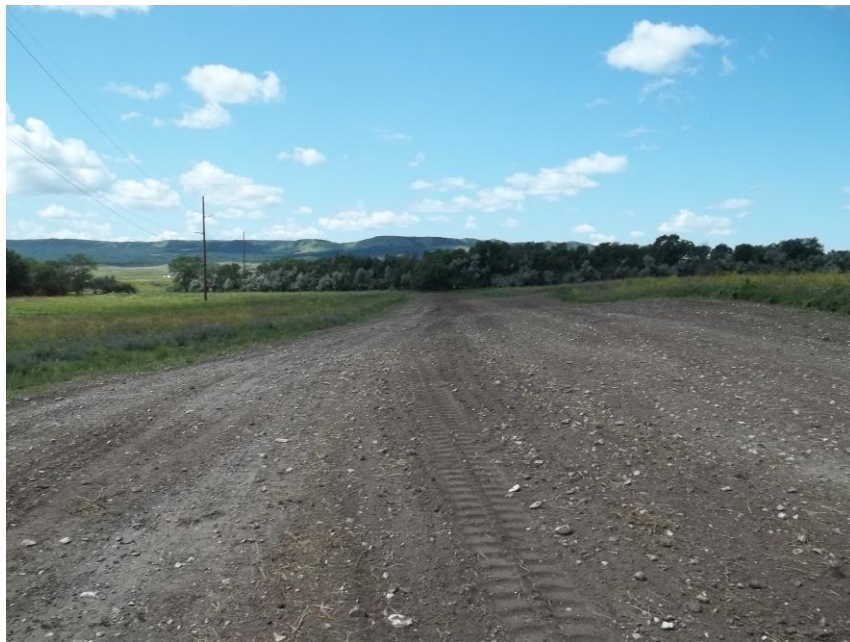
**Photo 38.** Direction: West. This photo shows the right-of-way for the Bridger Pipeline. At the time of our site visit the right-of-way needed final restoration.

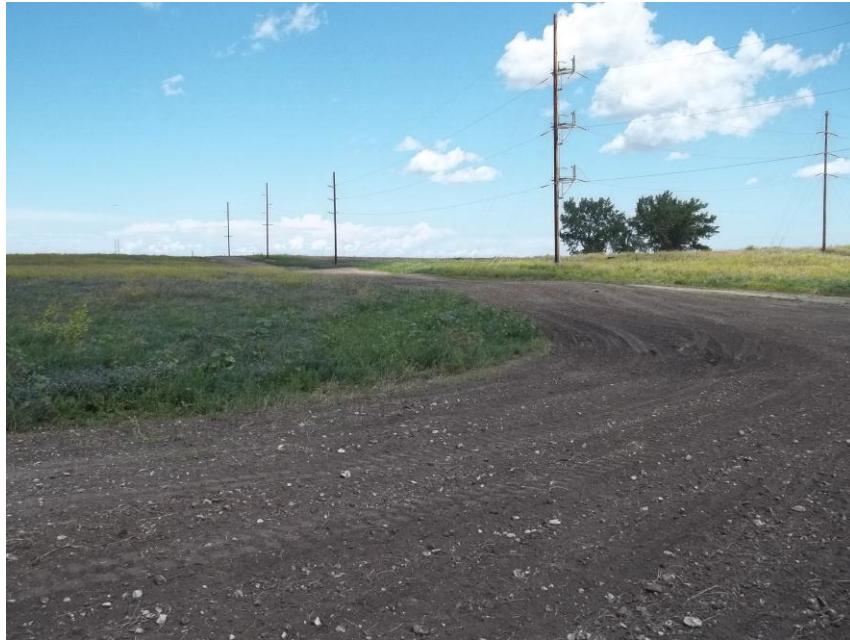
**Photo 39.** Direction: North. This photo shows the right-of-way for the Bridger Pipeline. At the time of our site visit the right-of-way needed final restoration.

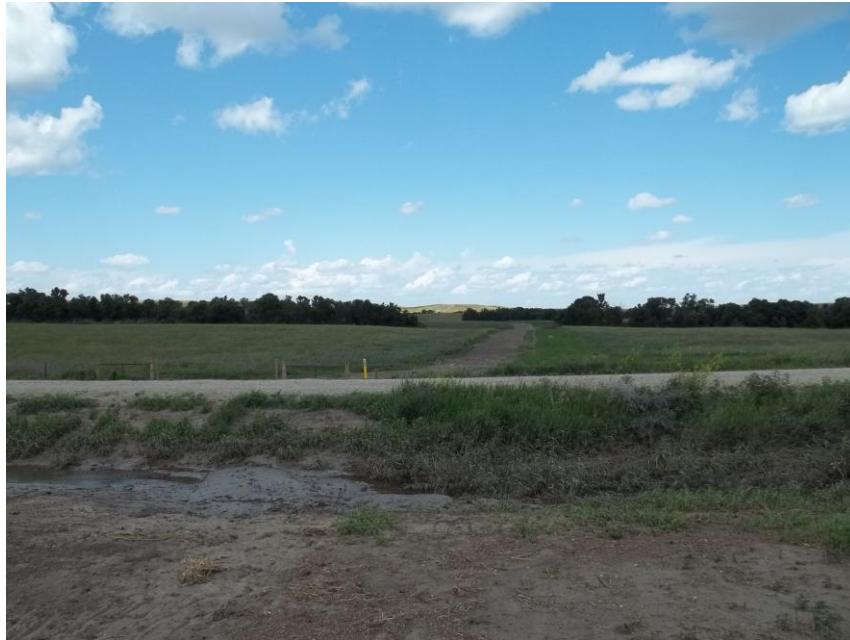
**Photo 41.** Direction: North. This photo shows the right-of-way for the Bridger Pipeline. At the time of our site visit the right-of-way needed final restoration.

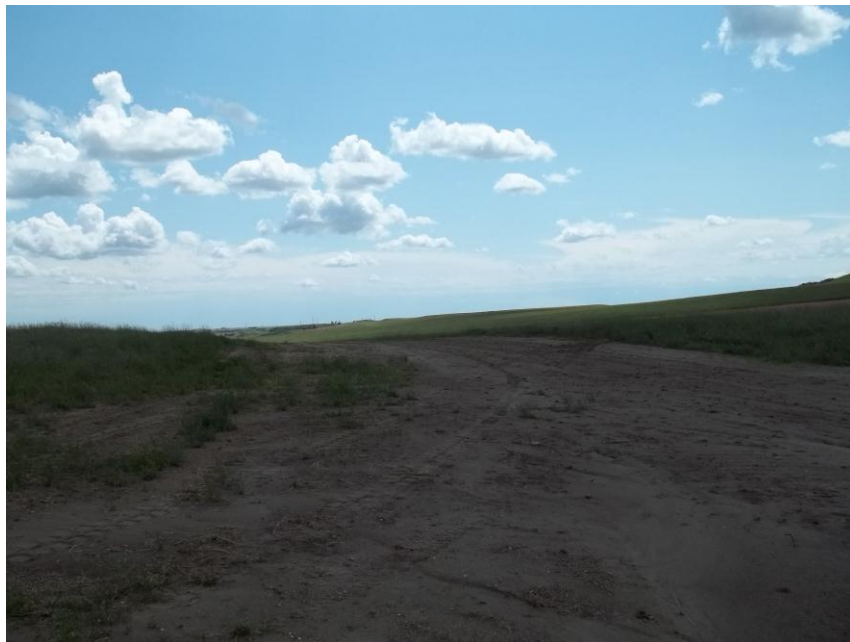
**Photo 42.** Direction: South. This photo shows the right-of-way for the Bridger Pipeline. At the time of our site visit the right-of-way needed final restoration.

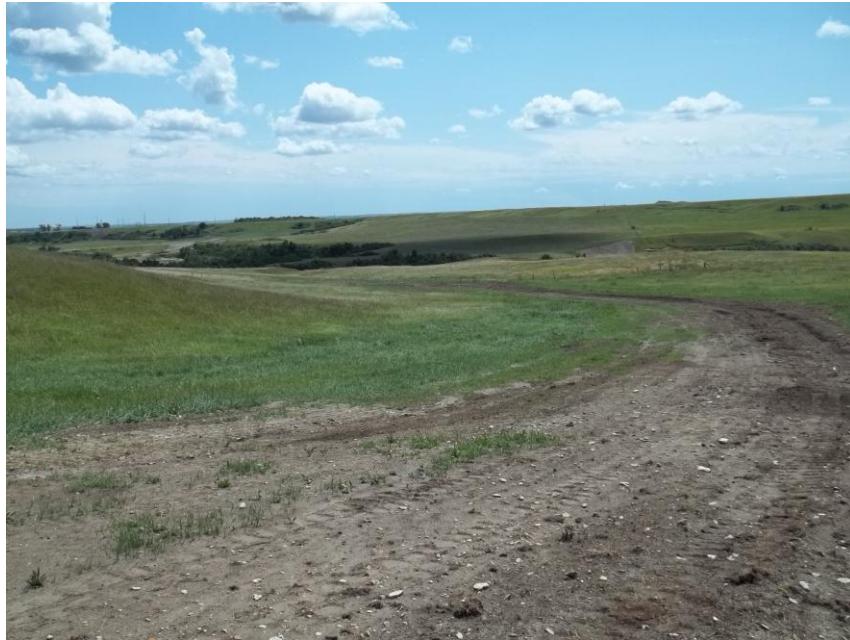
**Photo 43.** Direction: South. This photo shows the right-of-way for the Bridger Pipeline. At the time of our site visit the right-of-way needed final restoration.

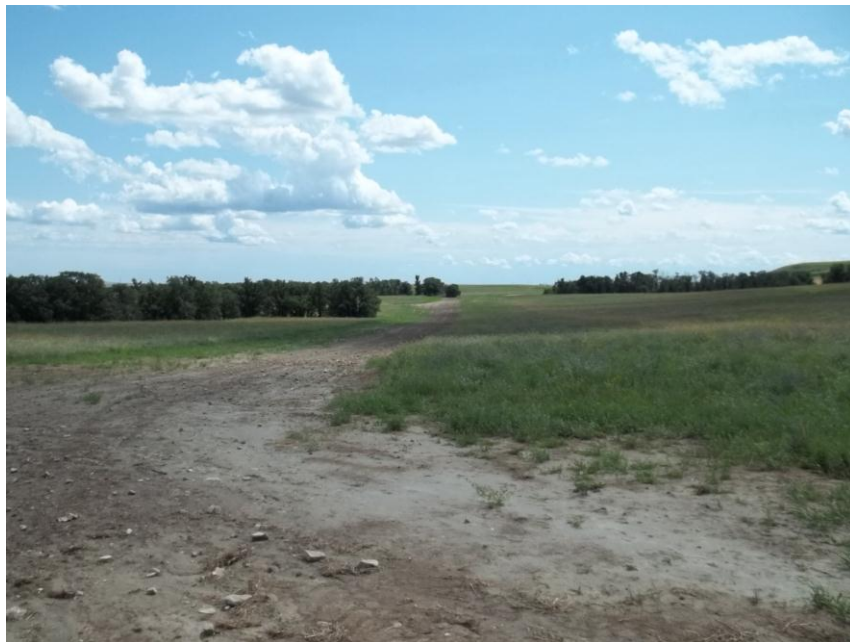
**Photo 44.** Direction: South. This photo shows the right-of-way for the Bridger Pipeline. At the time of our site visit the right-of-way needed final restoration.

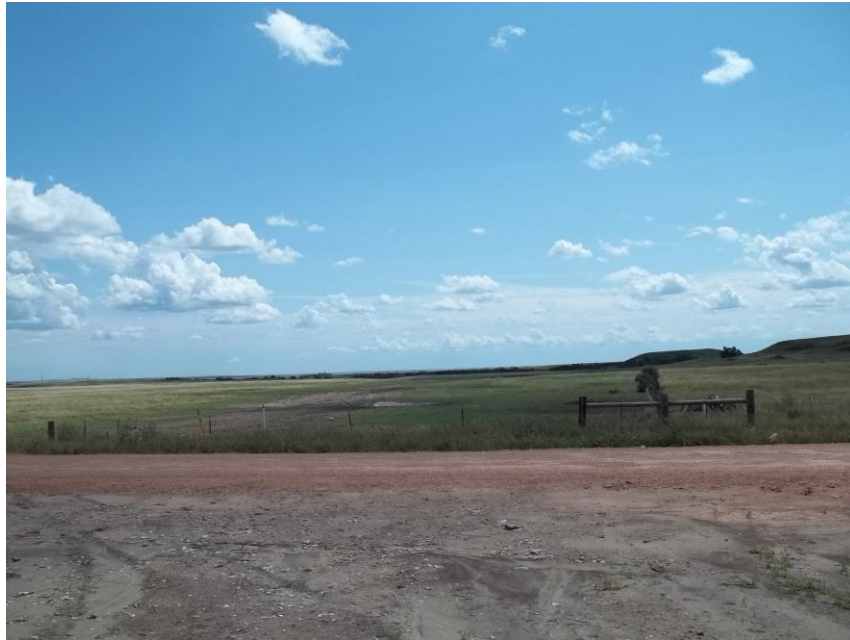
**Photo 45.** Direction: South. This photo shows the right-of-way for the Bridger Pipeline. At the time of our site visit the right-of-way needed final restoration.

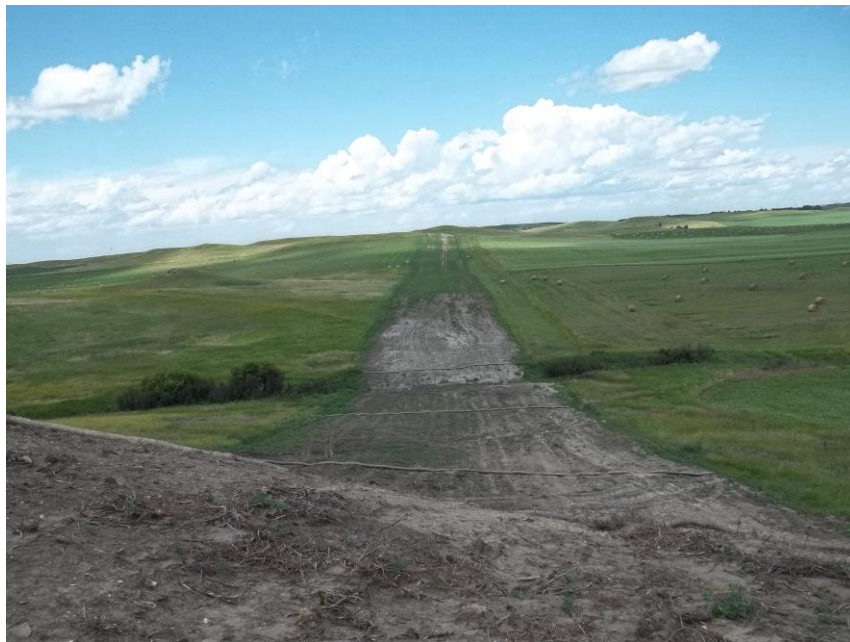
**Photo 46.** Direction: North. This photo shows the right-of-way for the Bridger Pipeline. At the time of our site visit the right-of-way needed final restoration.

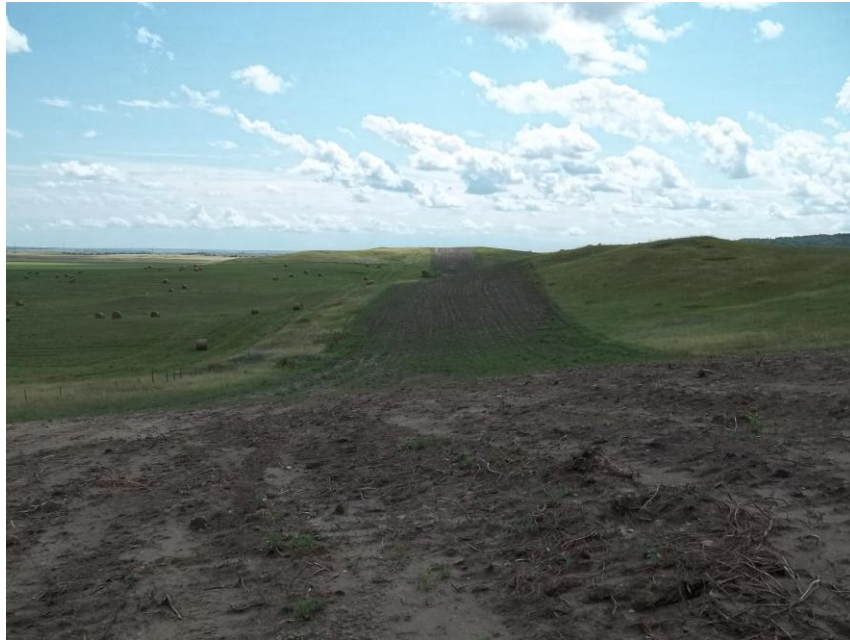
**Photo 47.** Direction: South. This photo shows the right-of-way for the Bridger Pipeline. At the time of our site visit the right-of-way needed final restoration.

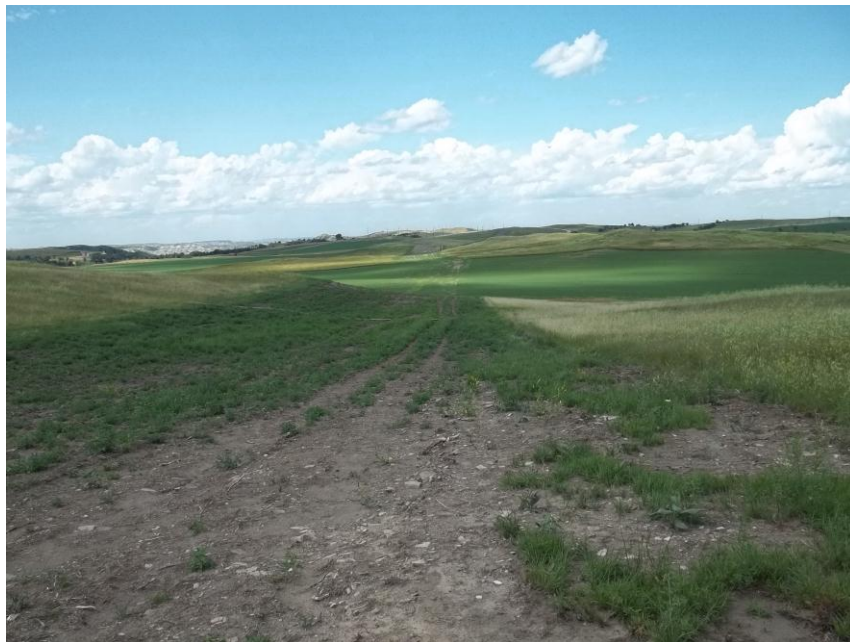
**Photo 48.** Direction: North. This photo shows the right-of-way for the Bridger Pipeline. At the time of our site visit the right-of-way needed final restoration.
