# **Bridger Pipeline, LLC Inspection Report**

## **Phase 1 – Construction Phase**

**NORTH DAKOTA  
PUBLIC SERVICE COMMISSION**  
600 E. Boulevard Avenue  
Bismarck, ND 58505-0480

August 2011

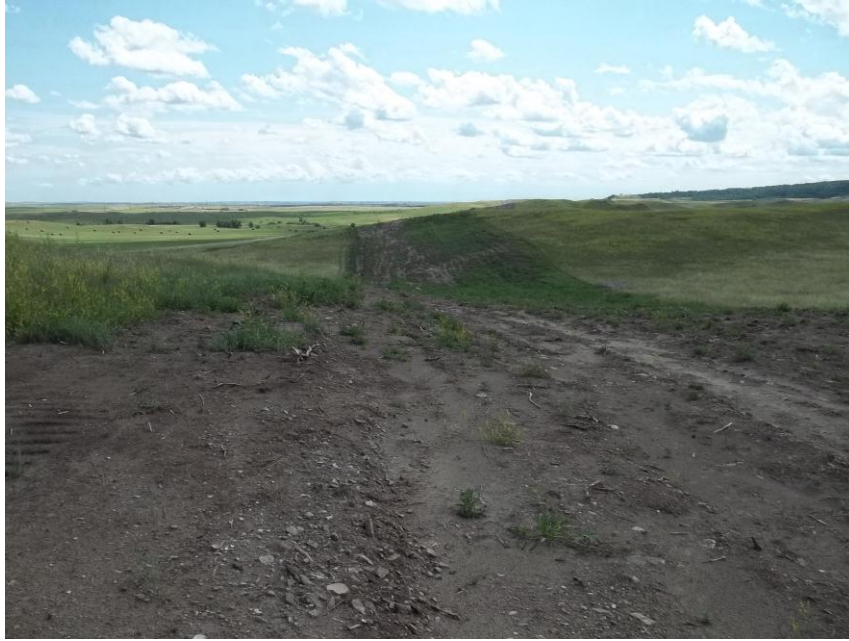
**Photo 49.** Direction: South. This photo shows the right-of-way for the Bridger Pipeline. At the time of our site visit the right-of-way needed final restoration.

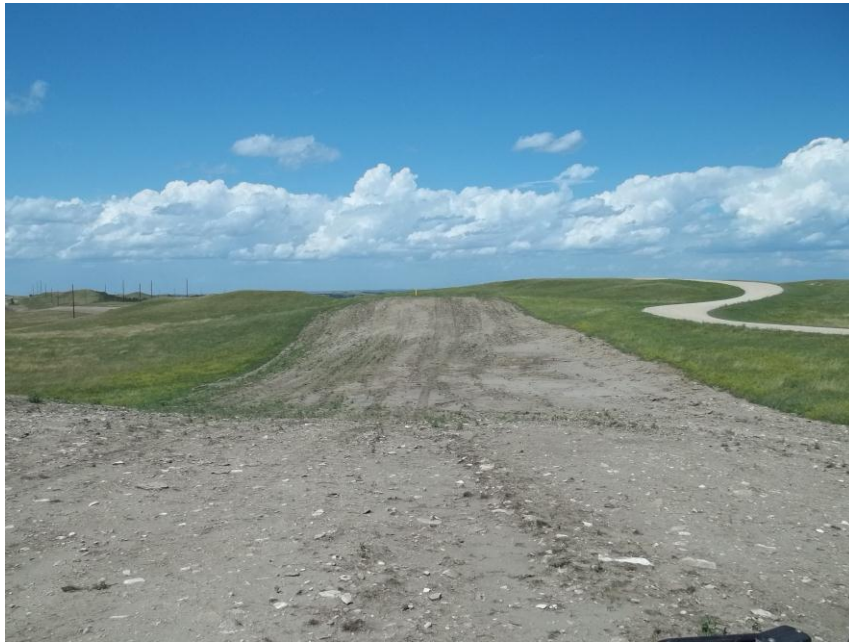
**Photo 50.** Direction: North. This photo shows the right-of-way for the Bridger Pipeline. At the time of our site visit the right-of-way needed final restoration.

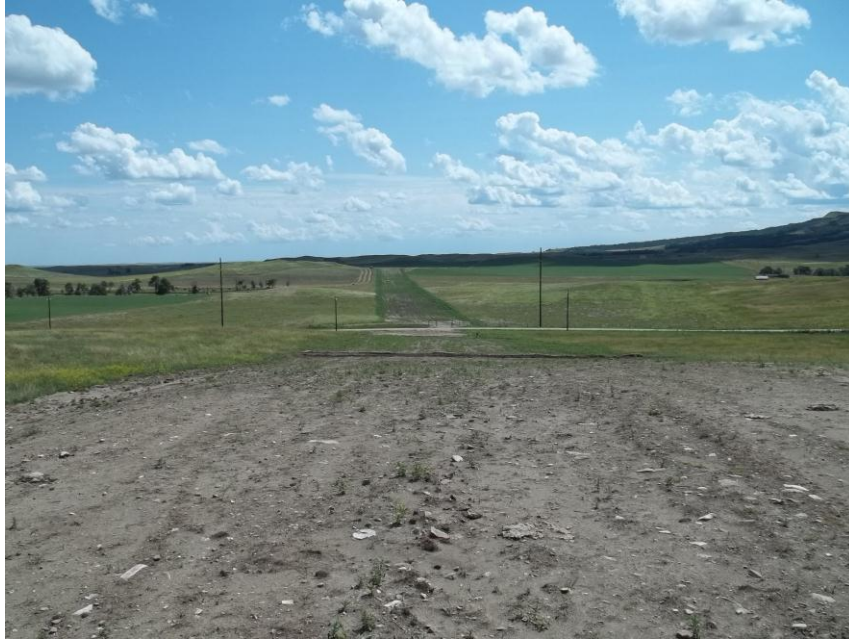
**Photo 51.** Direction: South. This photo shows the right-of-way for the Bridger Pipeline. At the time of our site visit the right-of-way needed final restoration.

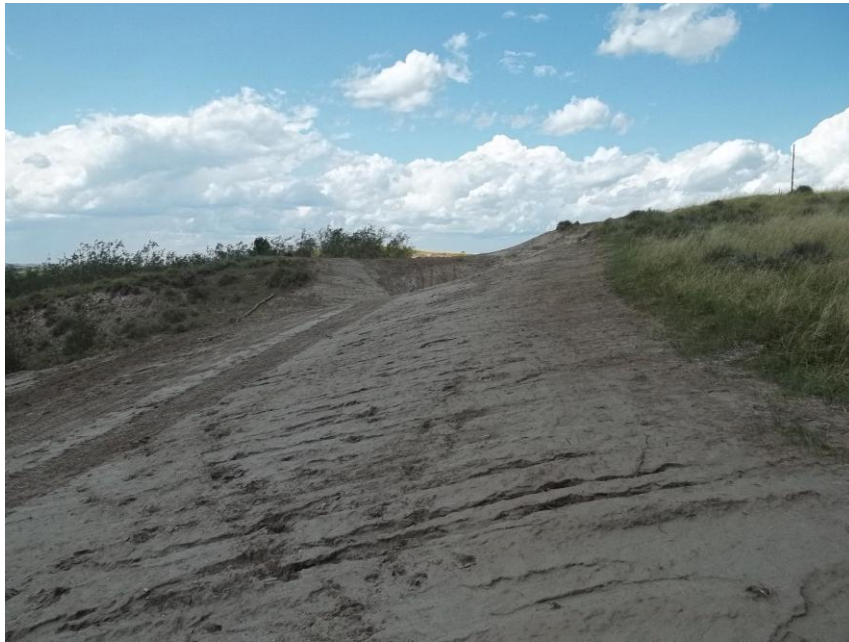
**Photo 52.** Direction: North. This photo shows the right-of-way for the Bridger Pipeline. At the time of our site visit the right-of-way needed final restoration.

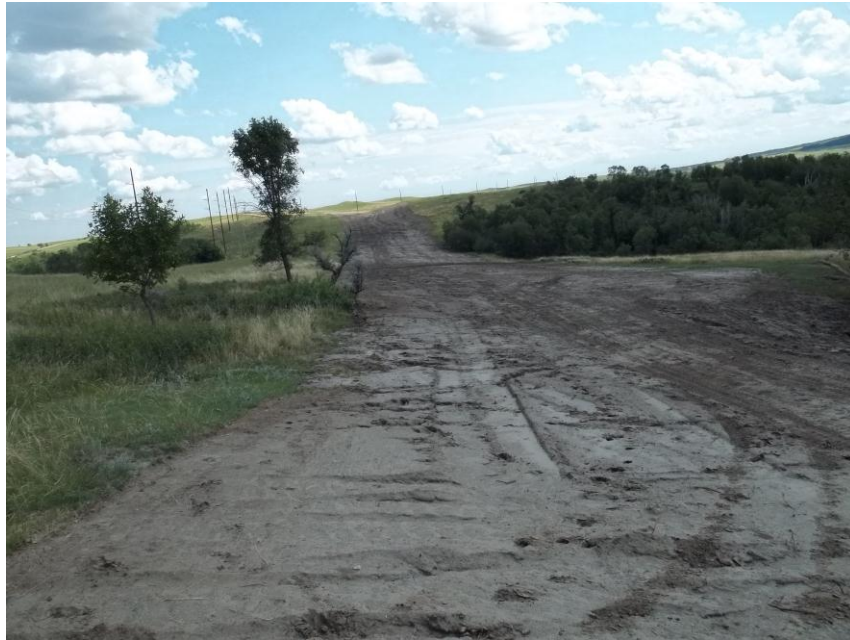
**Photo 53.** Direction: South. This photo shows the right-of-way for the Bridger Pipeline. At the time of our site visit the right-of-way needed final restoration.

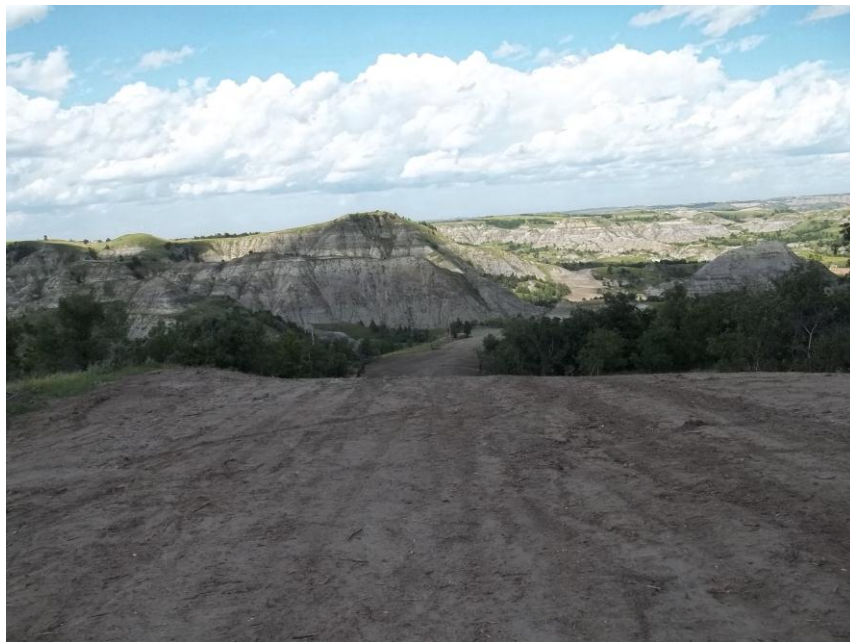
**Photo 54.** Direction: North. This photo shows the right-of-way for the Bridger Pipeline. At the time of our site visit the right-of-way needed final restoration.

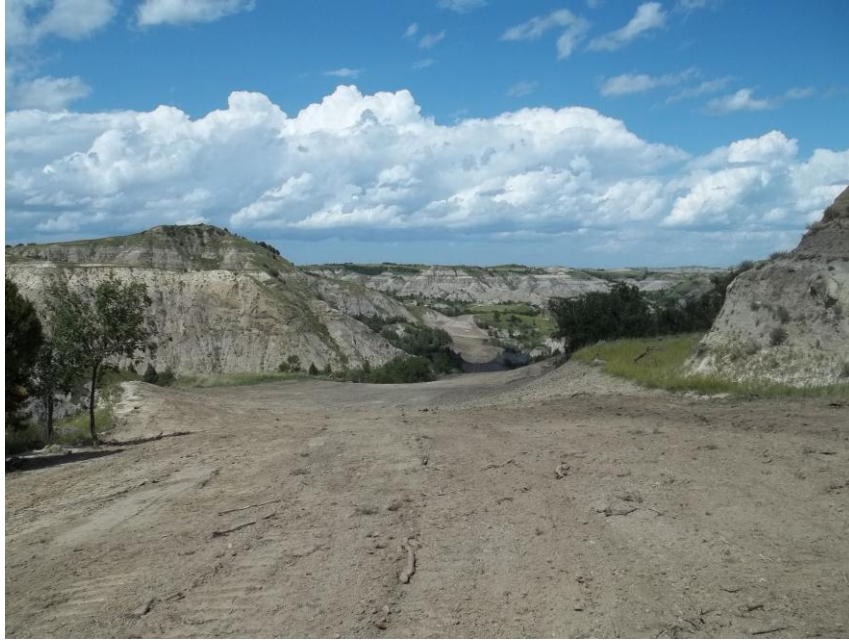
**Photo 55.** Direction: North. This photo shows the right-of-way for the Bridger Pipeline. At the time of our site visit the right-of-way needed final restoration.

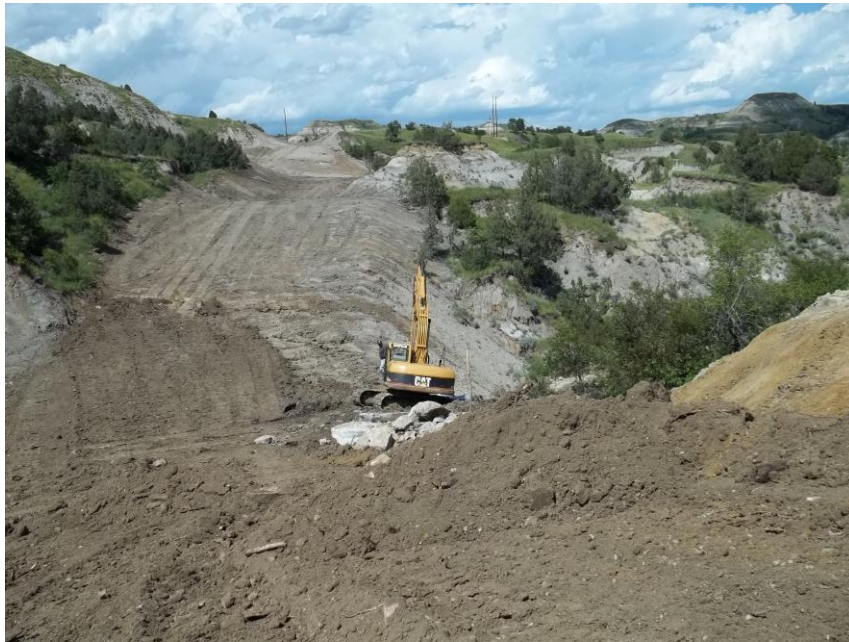
**Photo 56.** Direction: North. This photo shows the right-of-way for the Bridger Pipeline. At the time of our site visit the right-of-way needed final restoration.

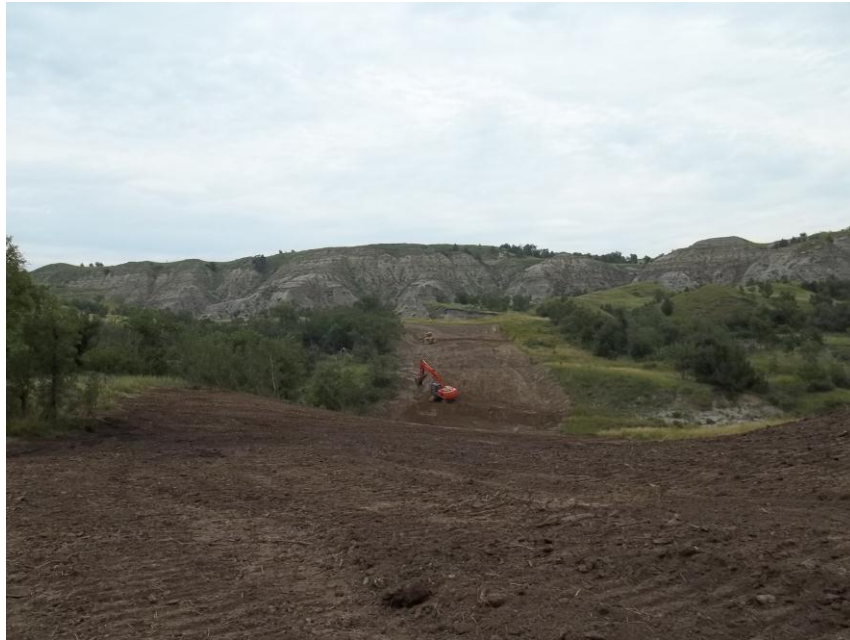
**Photo 57.** Direction: Northwest. This photo shows the right-of-way for the Bridger Pipeline. At the time of our site visit the right-of-way needed final restoration.

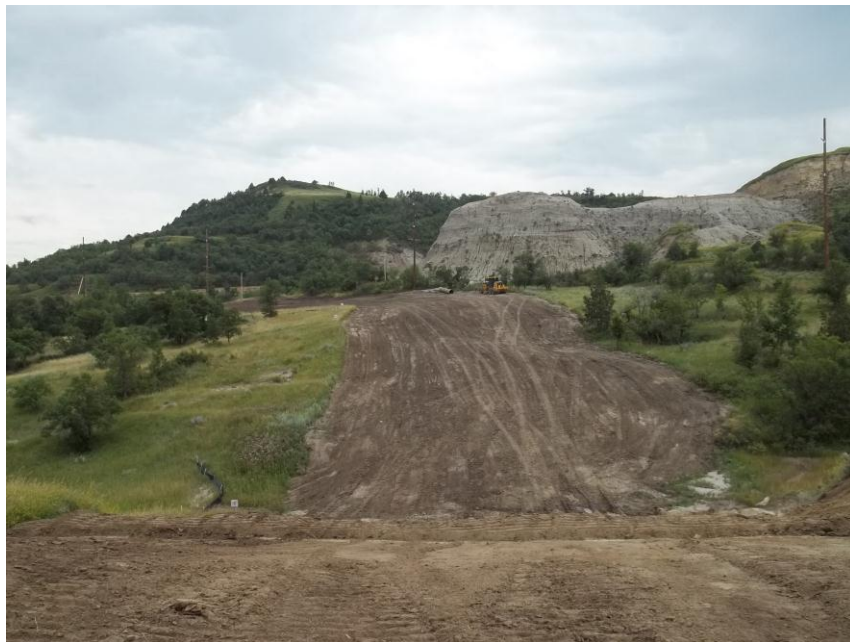
**Photo 58.** Direction: Southeast. This photo shows the right-of-way for the Bridger Pipeline. At the time of our site visit the right-of-way needed final restoration.

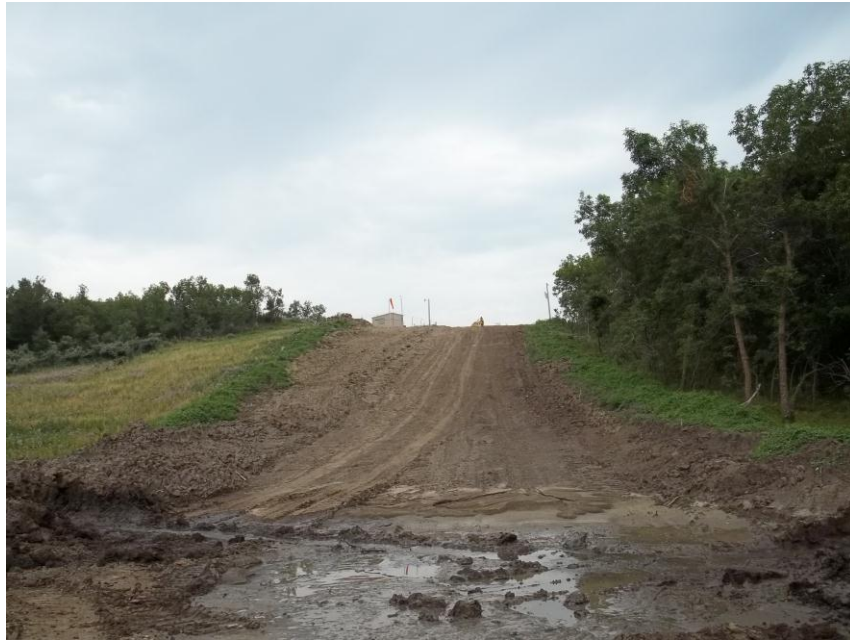
**Photo 59.** Direction: Southeast. This photo shows the right-of-way for the Bridger Pipeline. At the time of our site visit the area shown was wet and needed final restoration.

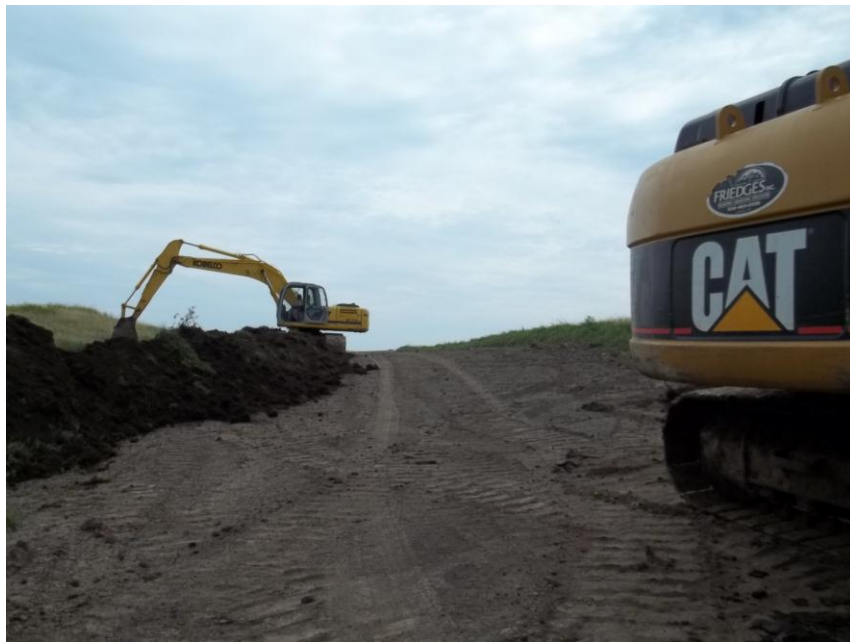
**Photo 60.** Direction: Northwest. This photo shows the right-of-way for the Bridger Pipeline. At the time of our site visit the right-of-way needed final restoration.

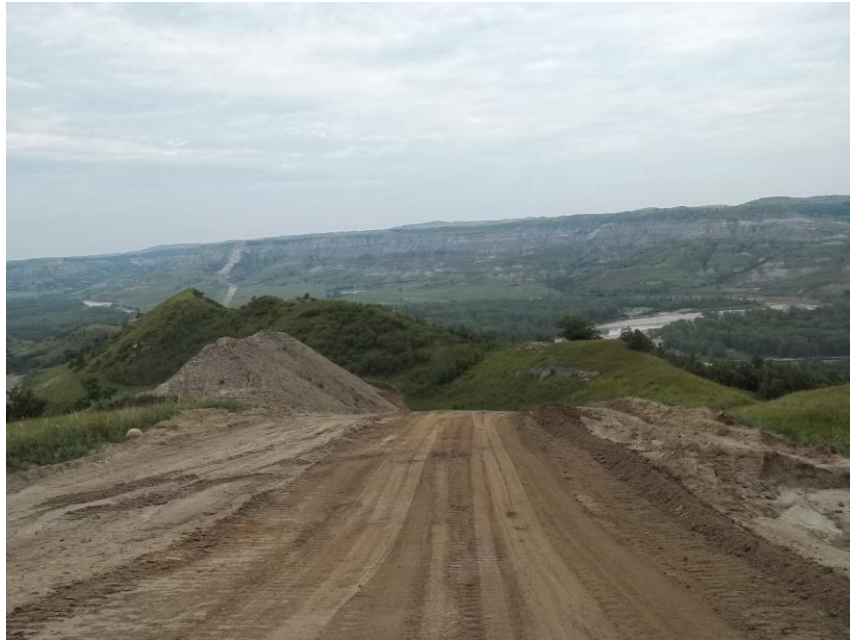
**Photo 61.** Direction: Northwest. This photo shows the right-of-way for the Bridger Pipeline. At the time of our site visit the right-of-way needed final restoration.

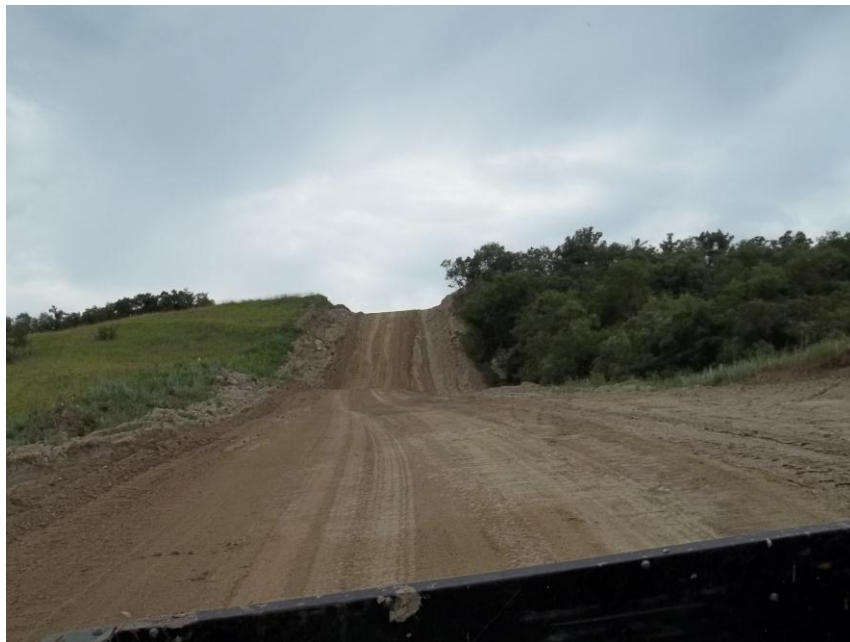
**Photo 62.** Direction: Southeast. This photo shows the right-of-way for the Bridger Pipeline. At the time of our site visit the right-of-way needed final restoration.

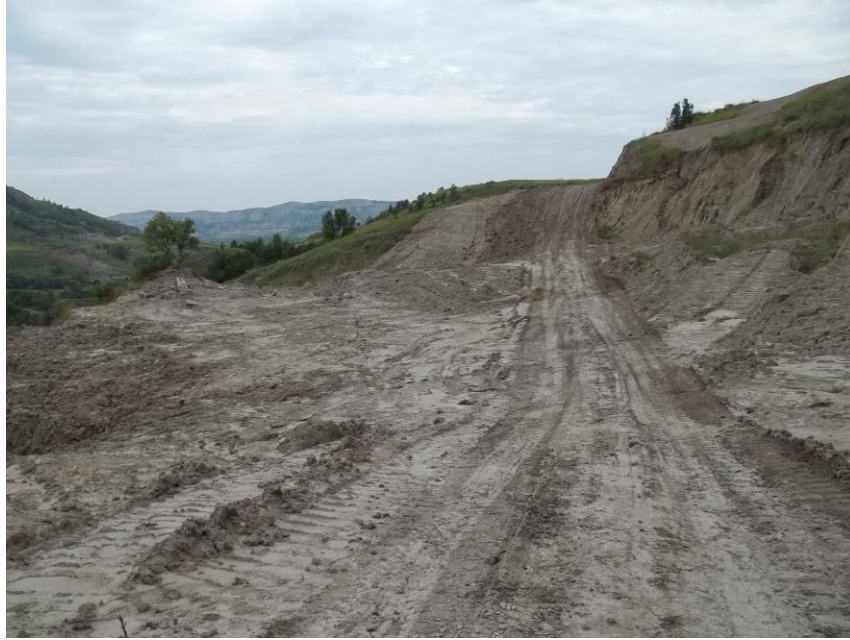
**Photo 63.** Direction: North. This photo shows the right-of-way for the Bridger Pipeline. At the time of our site visit the right-of-way needed final restoration.

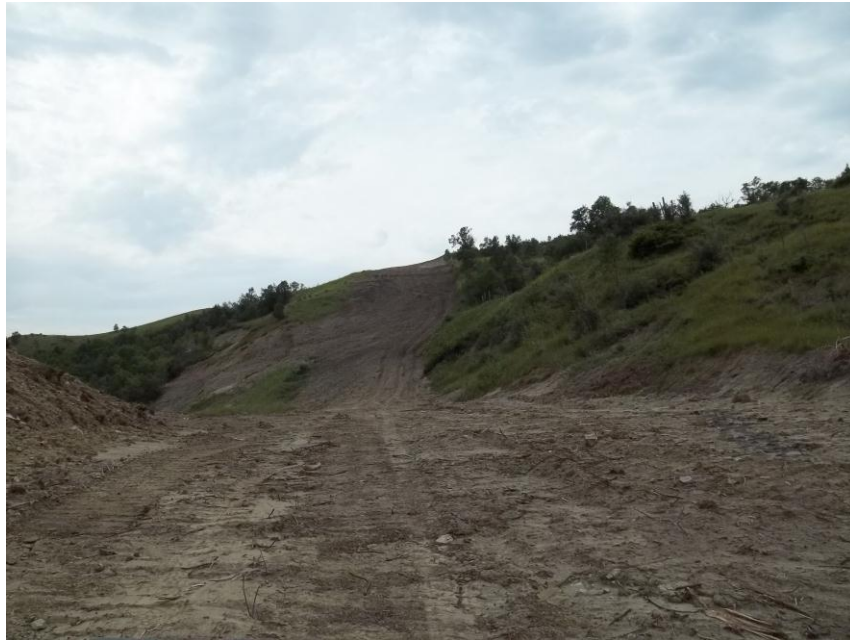
**Photo 65.** Direction: South. This photo shows the right-of-way for the Bridger Pipeline. At the time of our site visit the right-of-way needed final restoration.

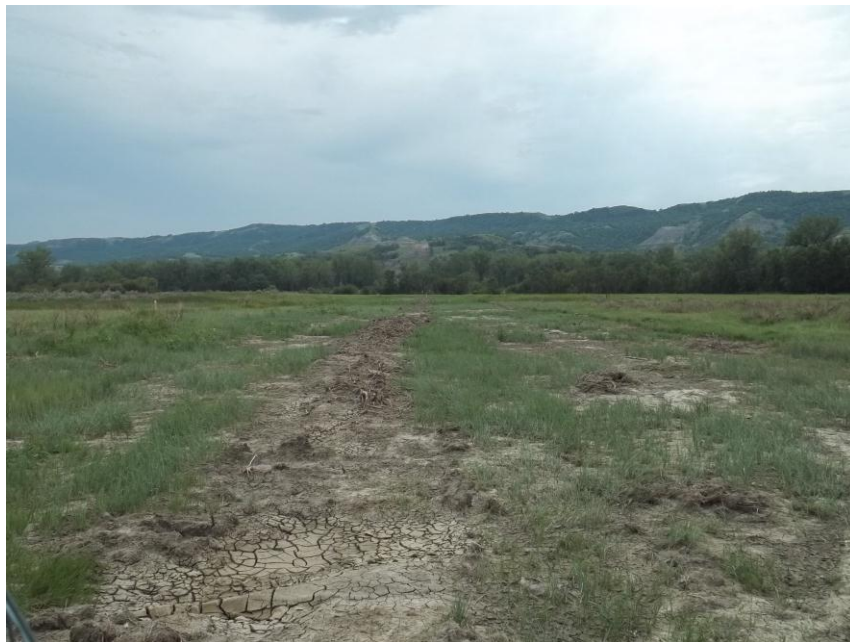
**Photo 66.** Direction: South. This photo shows the right-of-way for the Bridger Pipeline. At the time of our site visit the right-of-way needed final restoration.

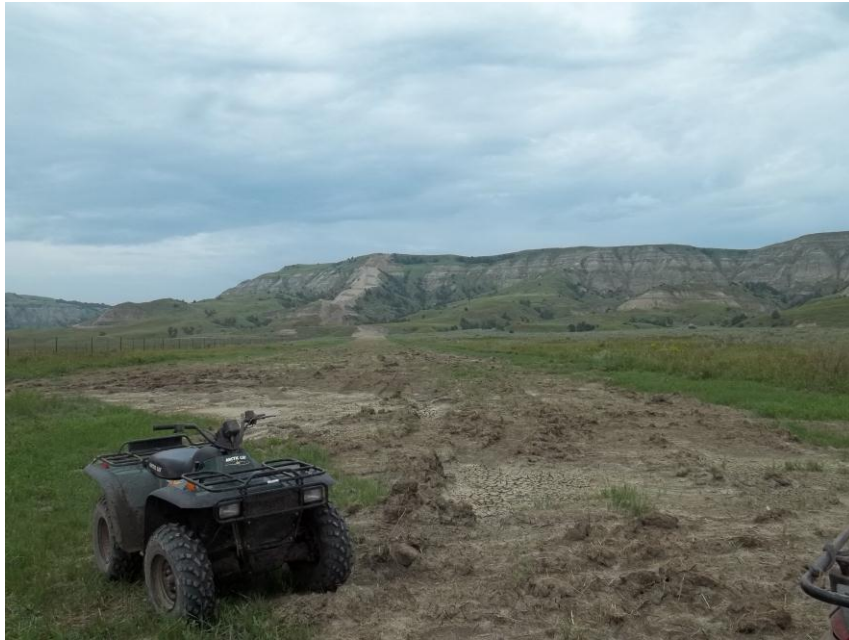
**Photo 67.** Direction: North. This photo shows the right-of-way for the Bridger Pipeline. At the time of our site visit the right-of-way needed final restoration.

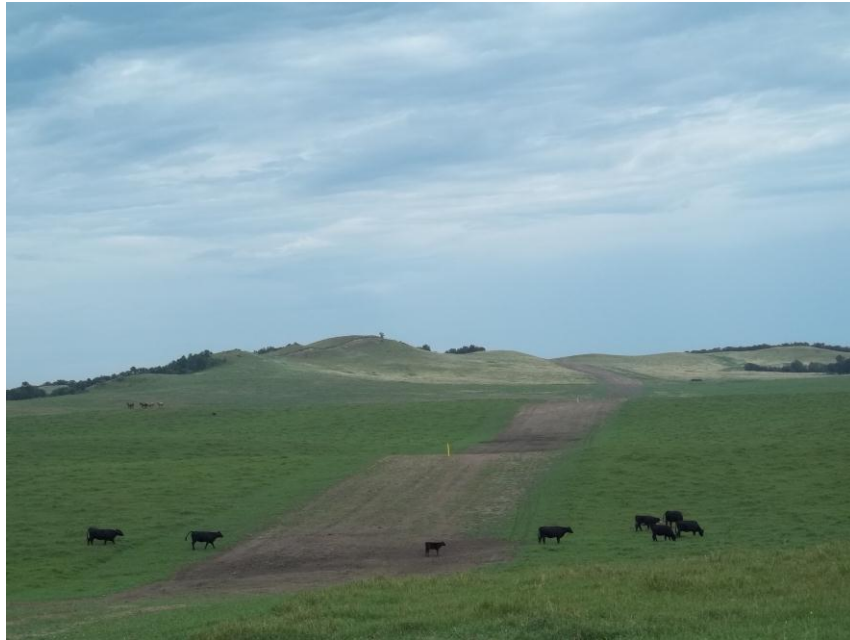
**Photo 69.** Direction: North. This photo shows the right-of-way for the Bridger Pipeline. At the time of our site visit the right-of-way needed final restoration.

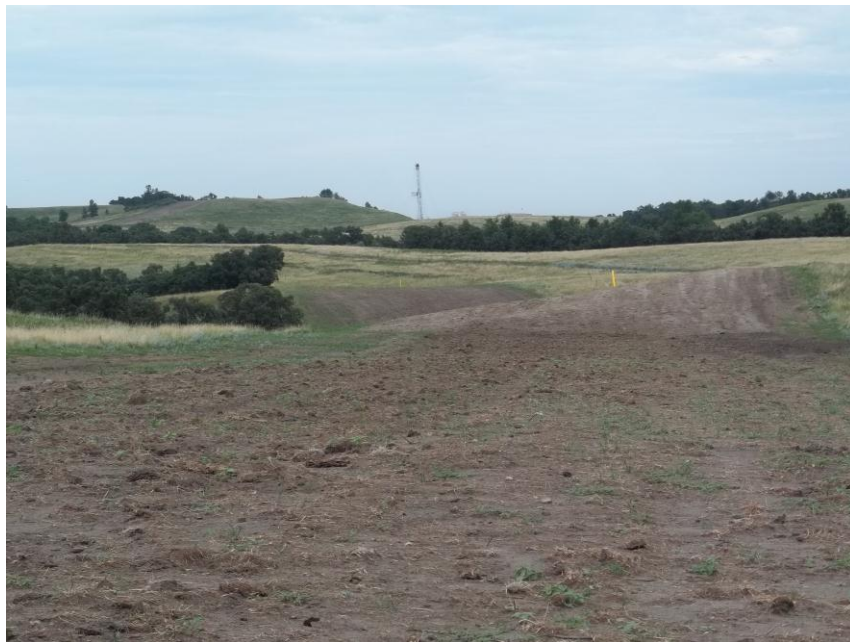
**Photo 70.** Direction: North. This photo shows the right-of-way for the Bridger Pipeline. At the time of our site visit the right-of-way needed final restoration.

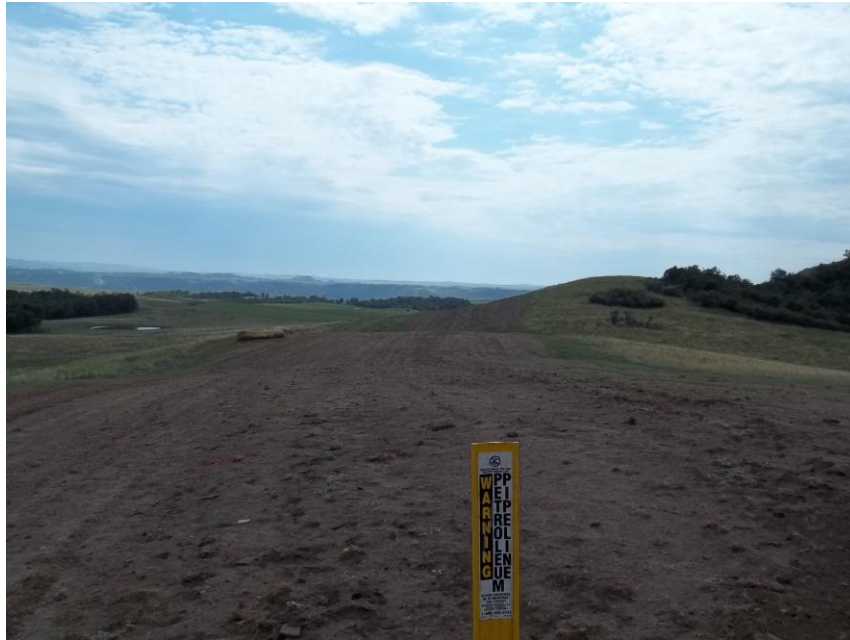
**Photo 71.** Direction: South. This photo shows the right-of-way for the Bridger Pipeline. At the time of our site visit the right-of-way needed final restoration.

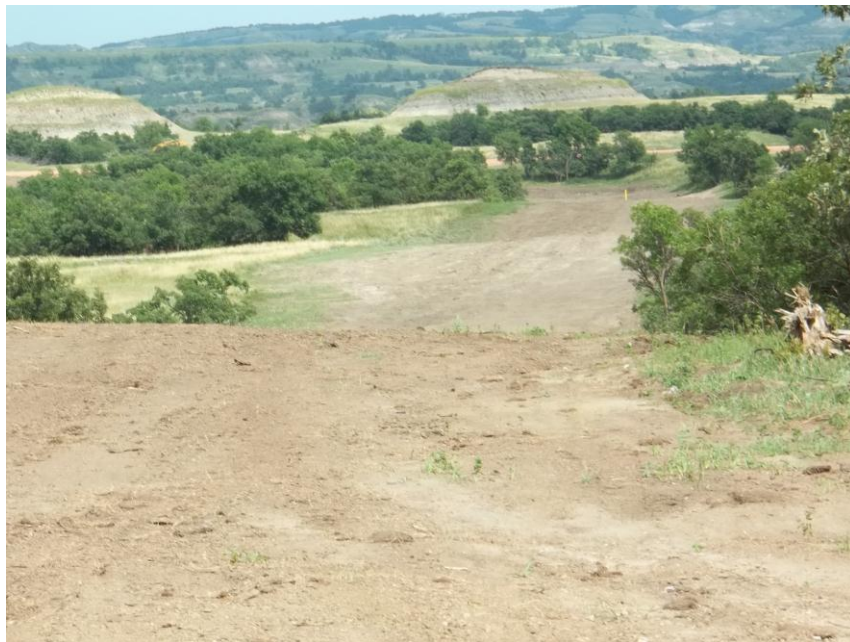
**Photo 72.** Direction: North. This photo shows the right-of-way for the Bridger Pipeline. At the time of our site visit the right-of-way needed final restoration.

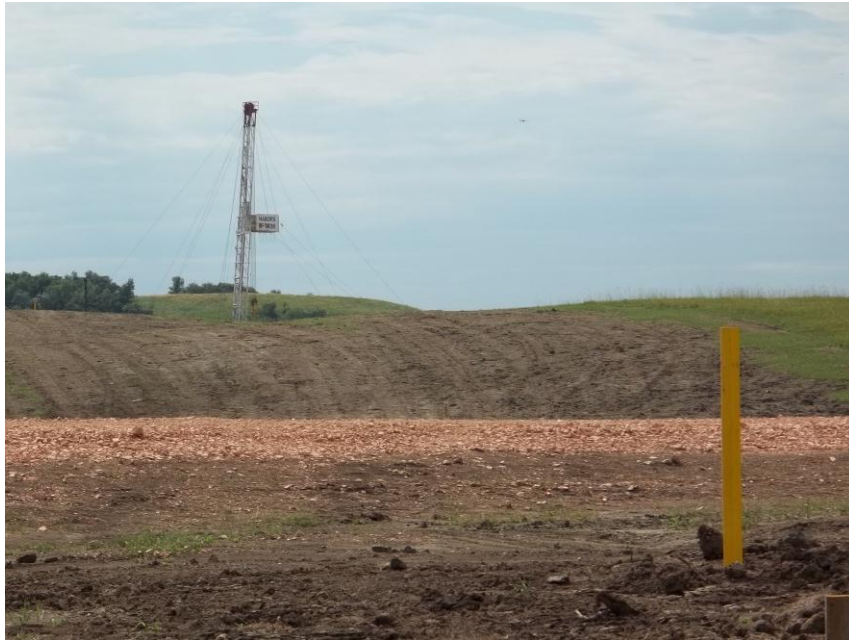
**Photo 73.** Direction: South. This photo shows the right-of-way for the Bridger Pipeline. At the time of our site visit the right-of-way needed final restoration.

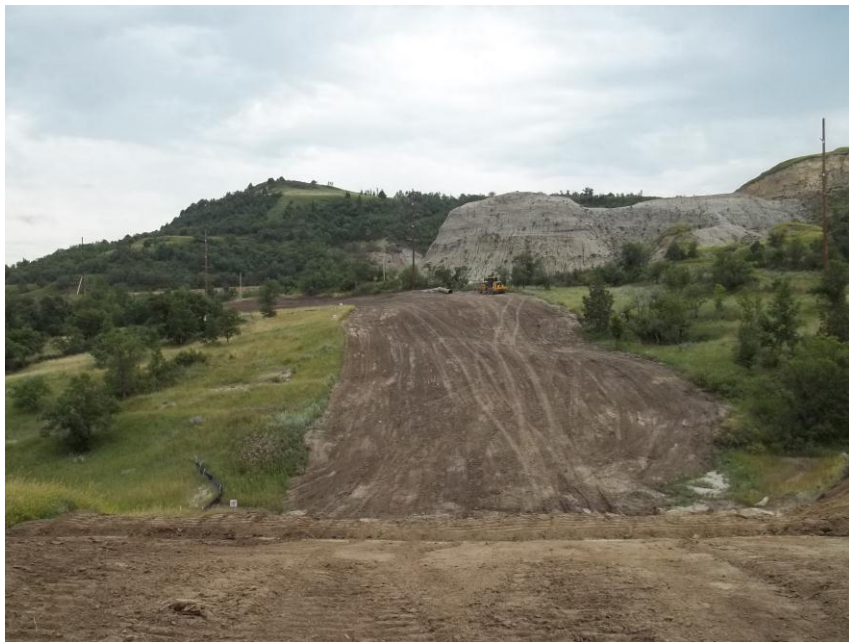
**Photo 74.** Direction: North. This photo shows the right-of-way for the Bridger Pipeline. At the time of our site visit the right-of-way needed final restoration.

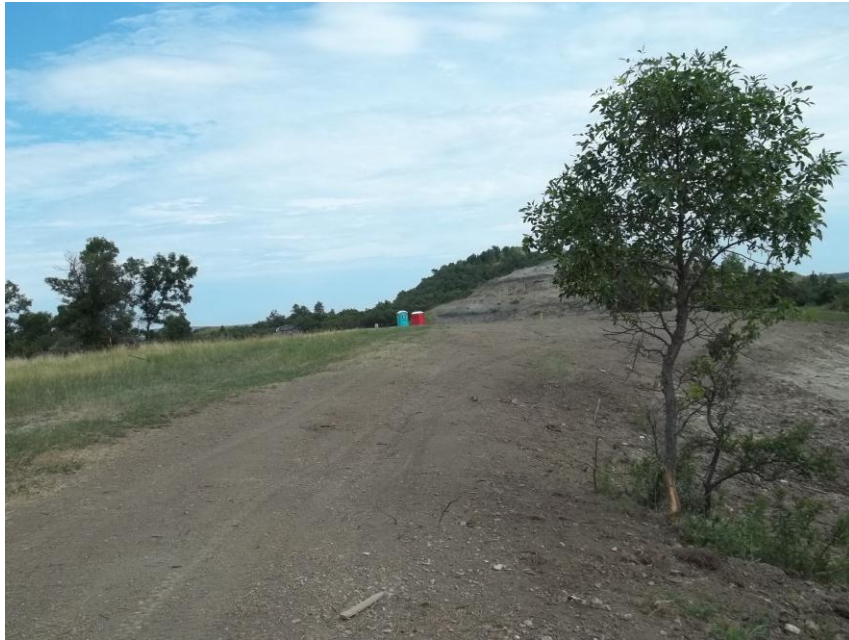
**Photo 75.** Direction: South. This photo shows the right-of-way for the Bridger Pipeline. At the time of our site visit the right-of-way needed final restoration.

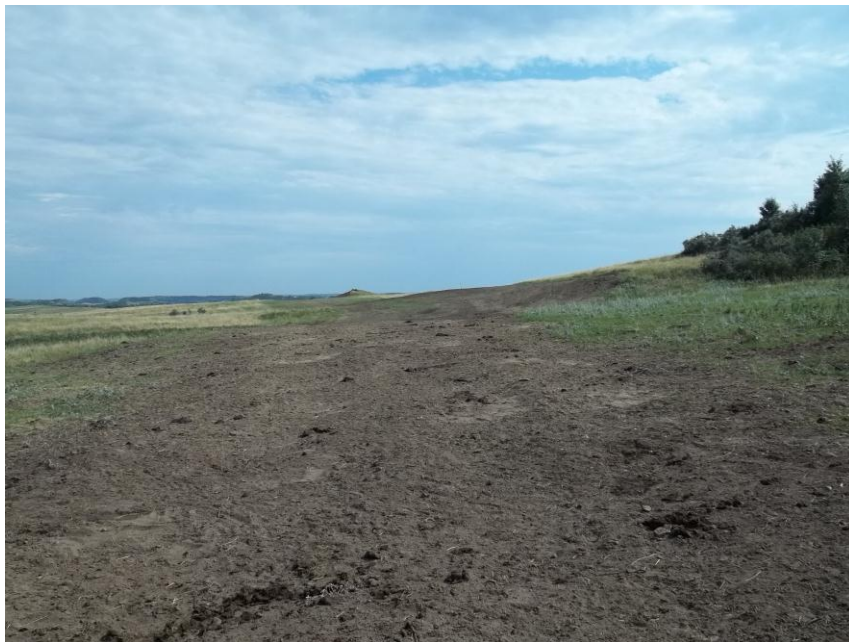
**Photo 76.** Direction: South. This photo shows the right-of-way for the Bridger Pipeline. At the time of our site visit the right-of-way needed final restoration.

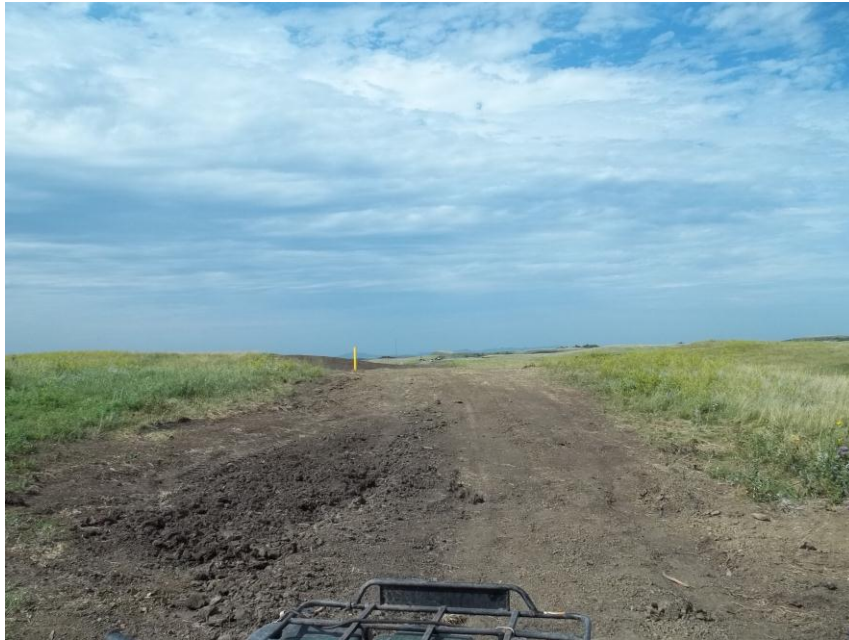
**Photo 77.** Direction: North. This photo shows the right-of-way for the Bridger Pipeline. At the time of our site visit the right-of-way needed final restoration.

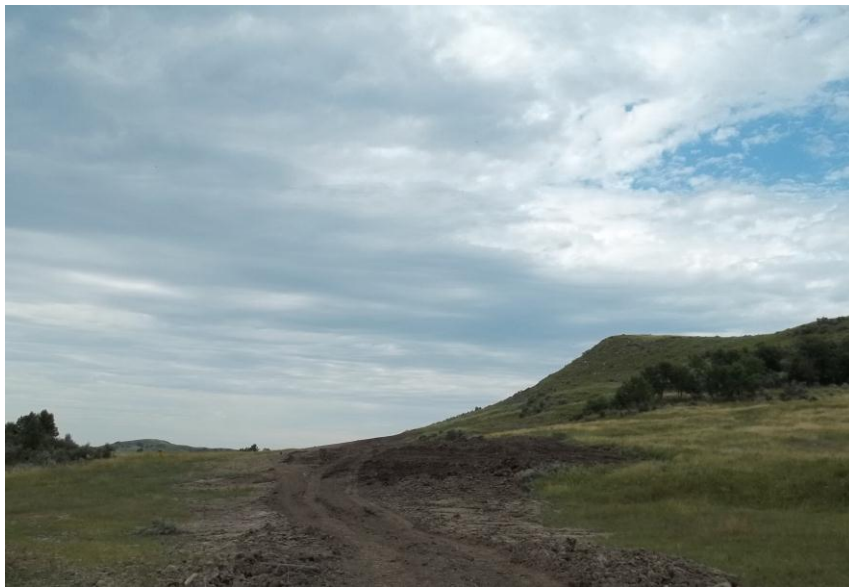
**Photo 78.** Direction: North. This photo shows the right-of-way for the Bridger Pipeline. At the time of our site visit the right-of-way needed final restoration.

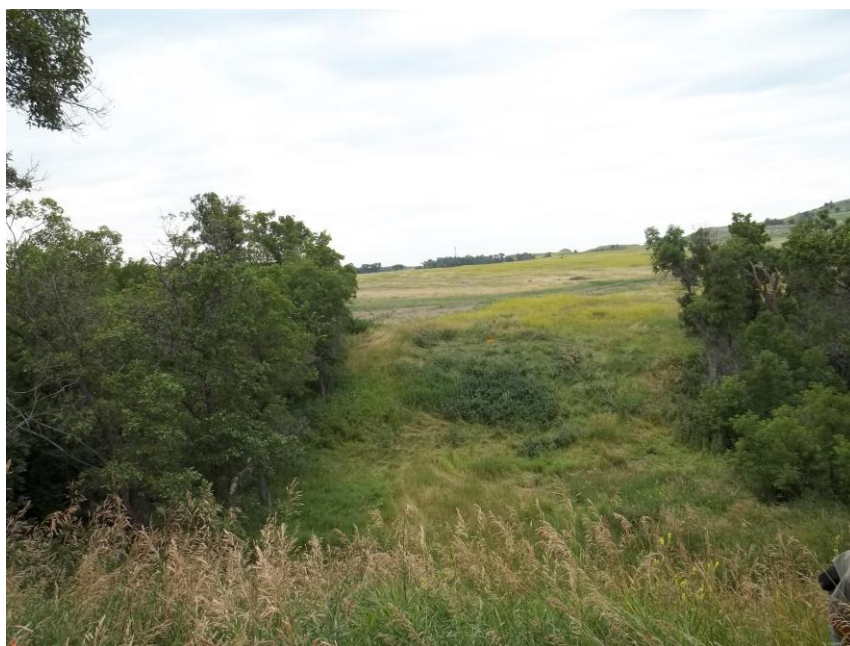
**Photo 80.** Direction: North. This photo shows the right-of-way for the Bridger Pipeline. At the time of our site visit the right-of-way needed final restoration.

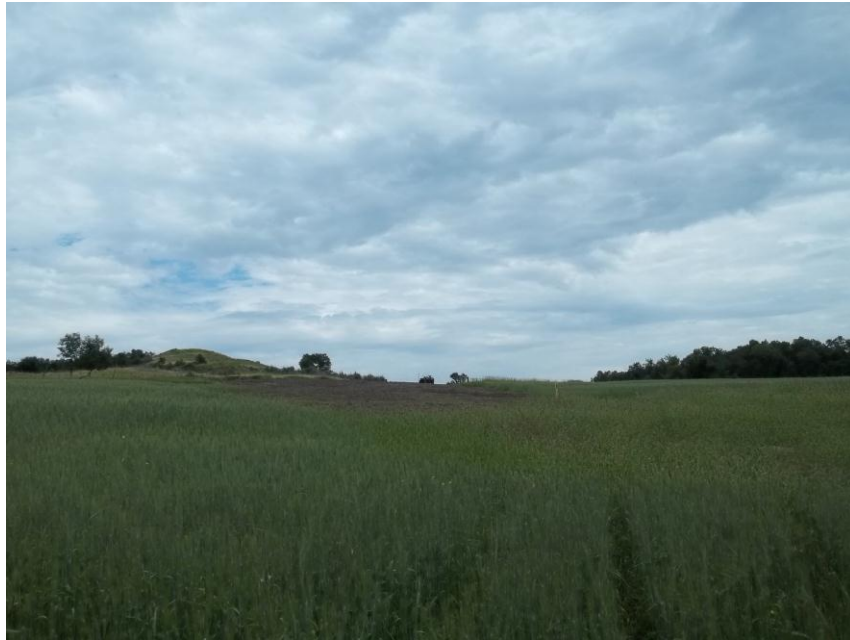
**Photo 81.** Direction: South. This photo shows the right-of-way for the Bridger Pipeline. At the time of our site visit the right-of-way needed final restoration.

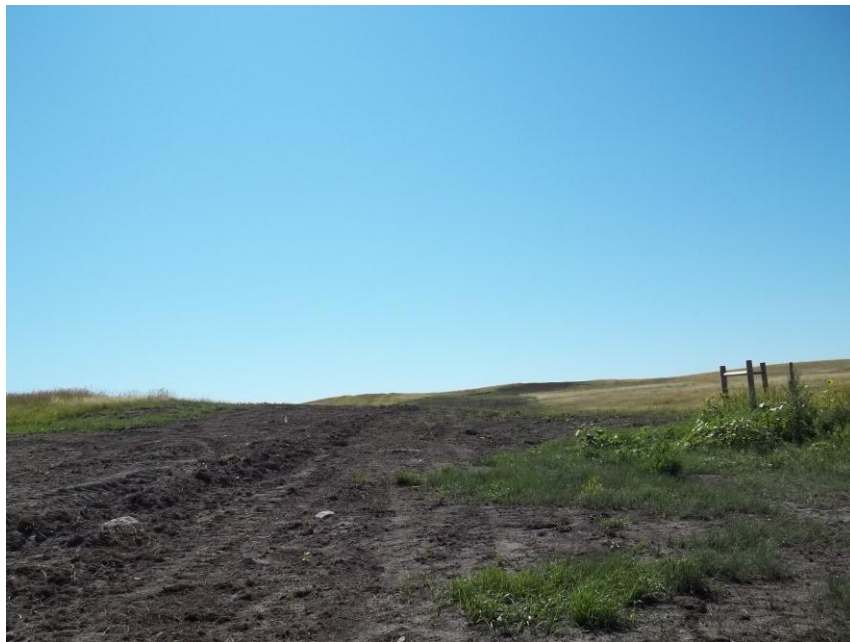
**Photo 82.** Direction: Southeast. This photo shows the right-of-way for the Bridger Pipeline. At the time of our site visit the right-of-way needed final restoration.

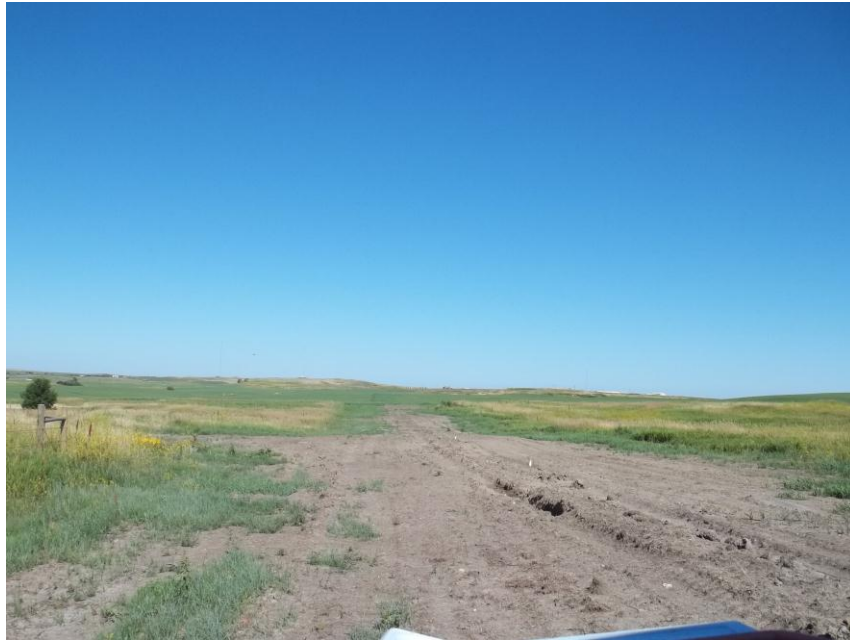
**Photo 83.** Direction: Northwest. This photo shows the right-of-way for the Bridger Pipeline. At the time of our site visit the right-of-way needed final restoration.

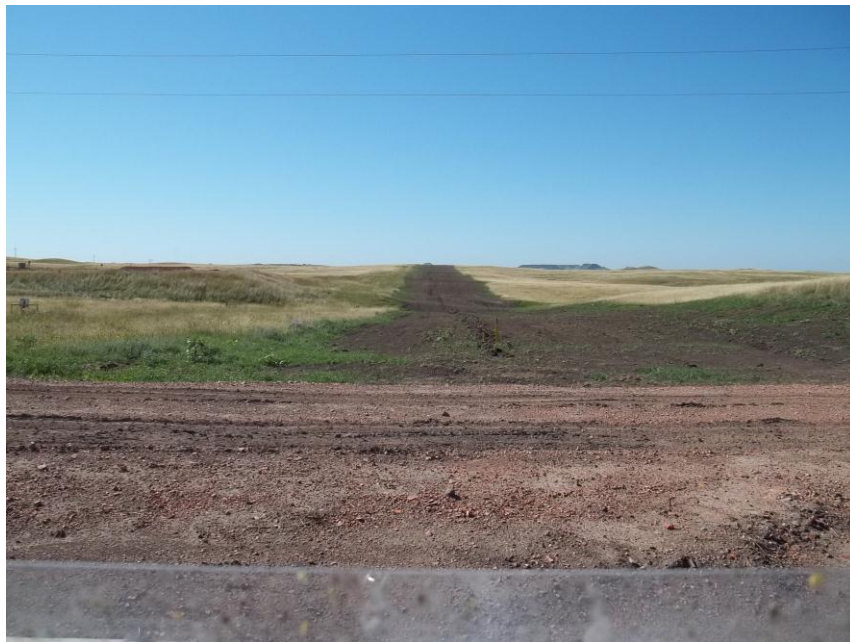
**Photo 84.** Direction: South. This photo shows the right-of-way for the Bridger Pipeline. At the time of our site visit the right-of-way needed final restoration.

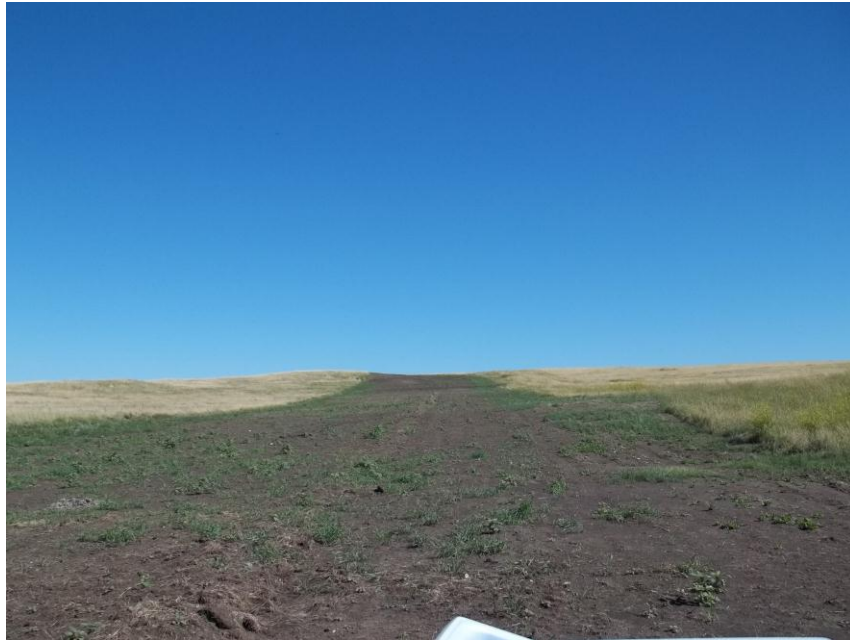
**Photo 85.** Direction: North. This photo shows the right-of-way for the Bridger Pipeline. At the time of our site visit the right-of-way needed final restoration.

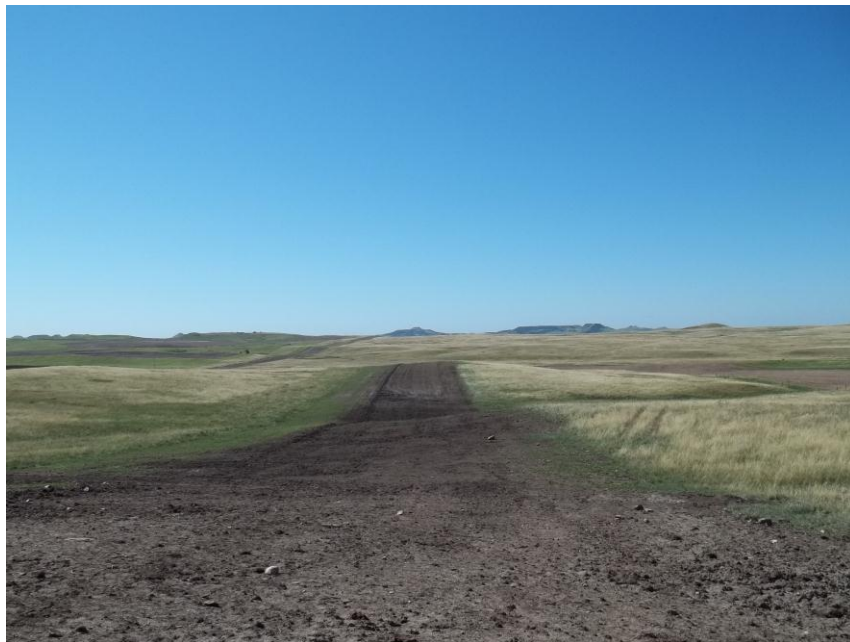
**Photo 86.** Direction: South. This photo shows the right-of-way for the Bridger Pipeline. At the time of our site visit the right-of-way needed final restoration.

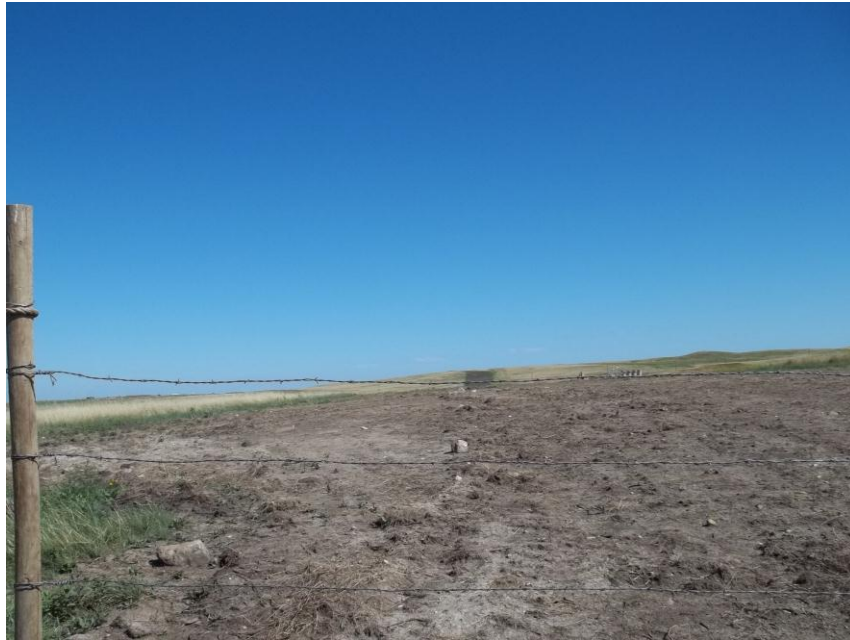
**Photo 87.** Direction: North. This photo shows the right-of-way for the Bridger Pipeline. At the time of our site visit the right-of-way needed final restoration.

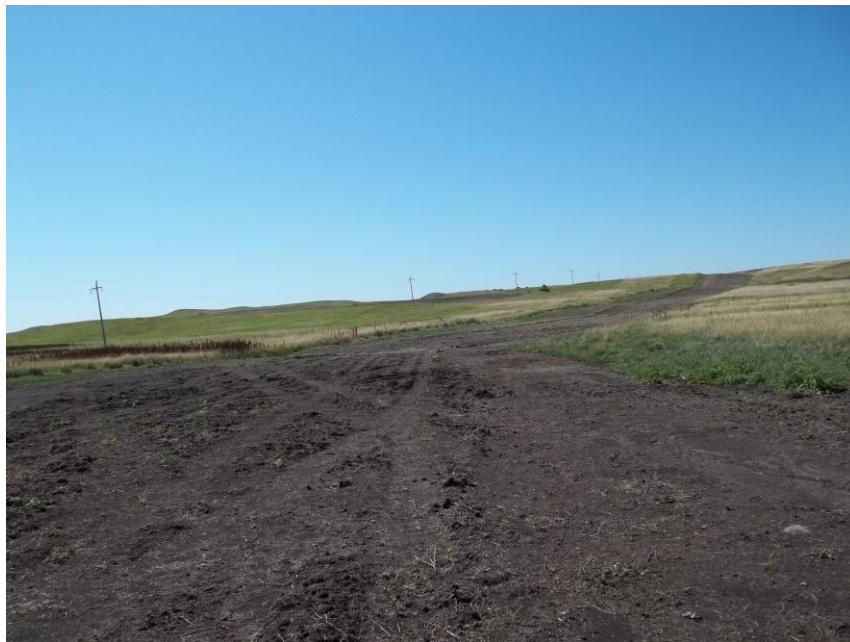
**Photo 88.** Direction: South. This photo shows the right-of-way for the Bridger Pipeline. At the time of our site visit the right-of-way needed final restoration.

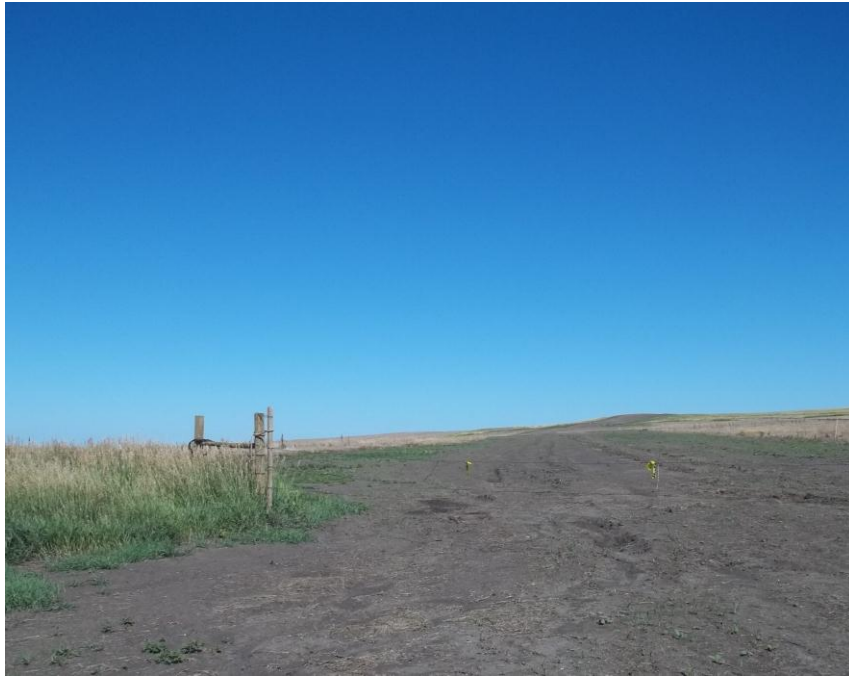
**Photo 89.** Direction: North. This photo shows the right-of-way for the Bridger Pipeline. At the time of our site visit the right-of-way needed final restoration.

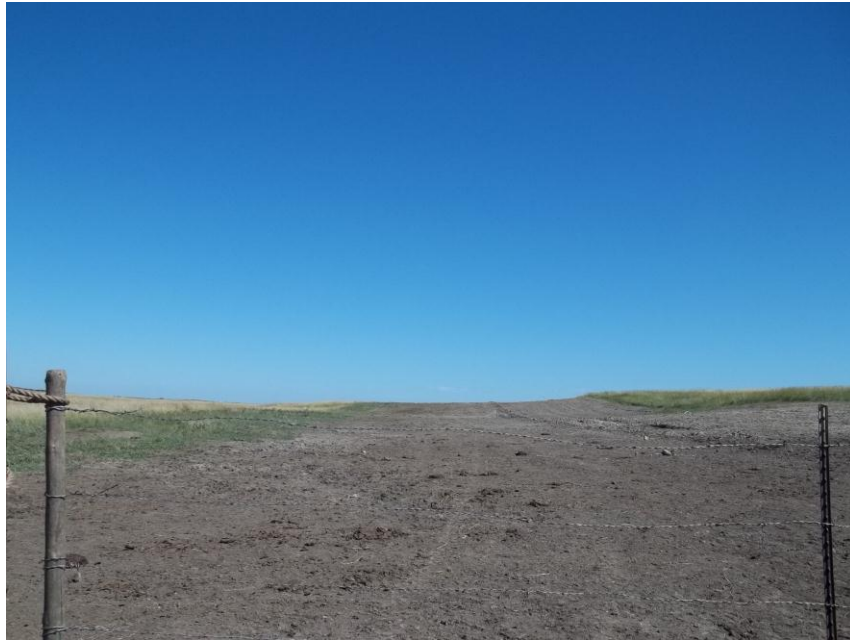
**Photo 90.** Direction: South. This photo shows the right-of-way for the Bridger Pipeline. At the time of our site visit the right-of-way needed final restoration.
