# **Bridger Pipeline, LLC Inspection Report**

## **Phase 1 – Construction Phase**

**NORTH DAKOTA  
PUBLIC SERVICE COMMISSION**  
600 E. Boulevard Avenue  
Bismarck, ND 58505-0480

August 2011

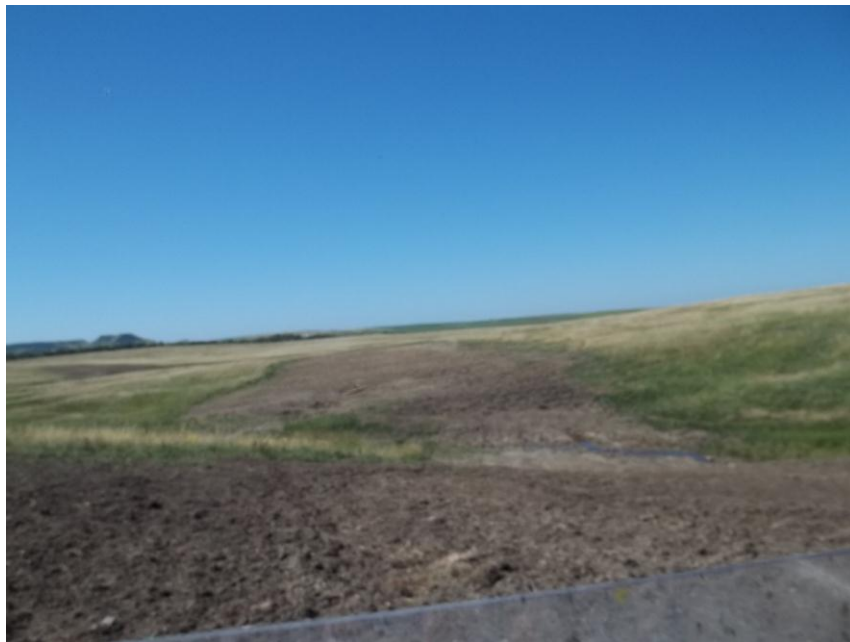
**Photo 91.** Direction: North. This photo shows the right-of-way for the Bridger Pipeline. At the time of our site visit the right-of-way needed final restoration.

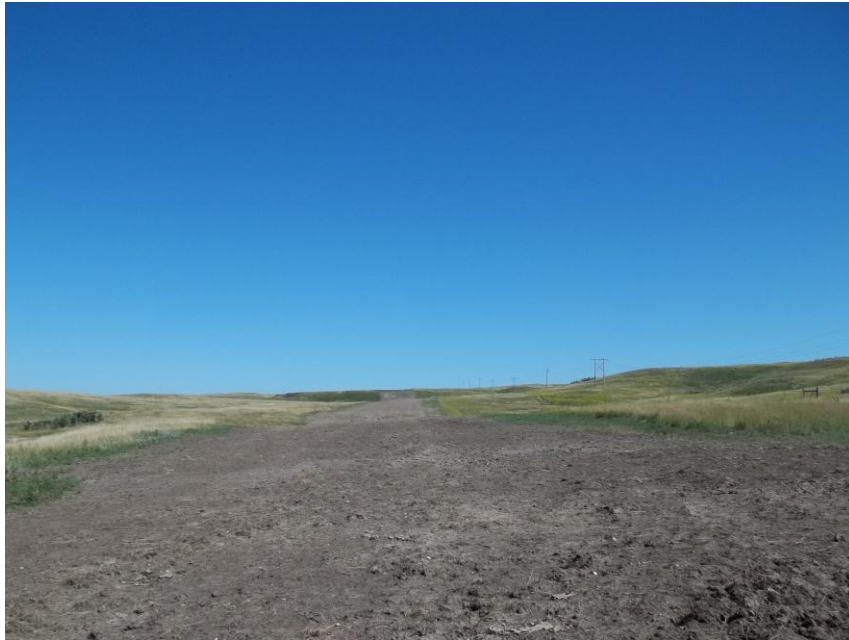
**Photo 92.** Direction: South. This photo shows the right-of-way for the Bridger Pipeline. At the time of our site visit the right-of-way needed final restoration.

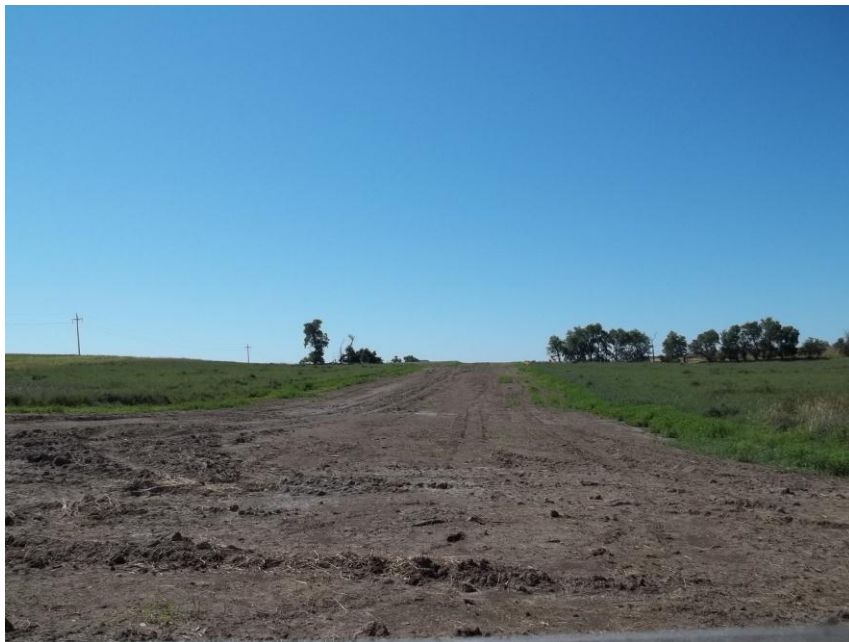
**Photo 93.** Direction: North. This photo shows the right-of-way for the Bridger Pipeline. At the time of our site visit the right-of-way needed final restoration.

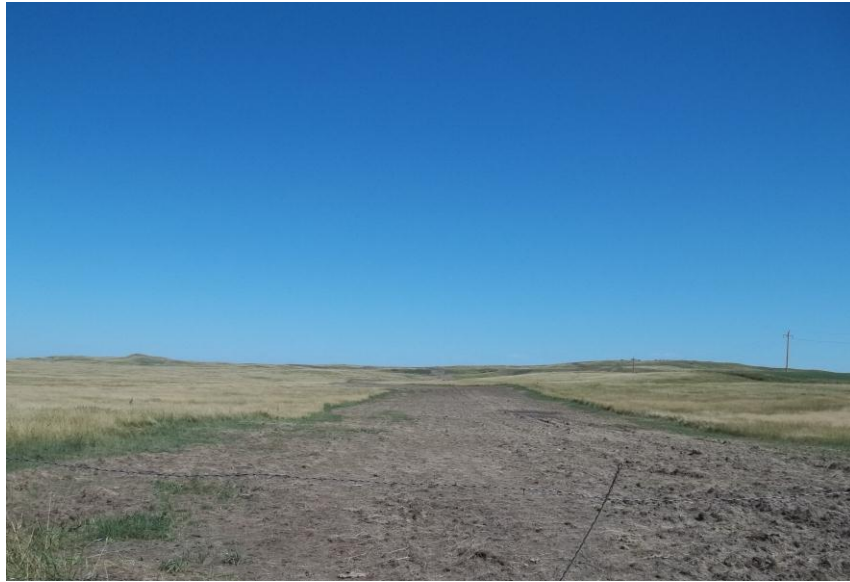
**Photo 94.** Direction: South. This photo shows the right-of-way for the Bridger Pipeline. At the time of our site visit the right-of-way needed final restoration.

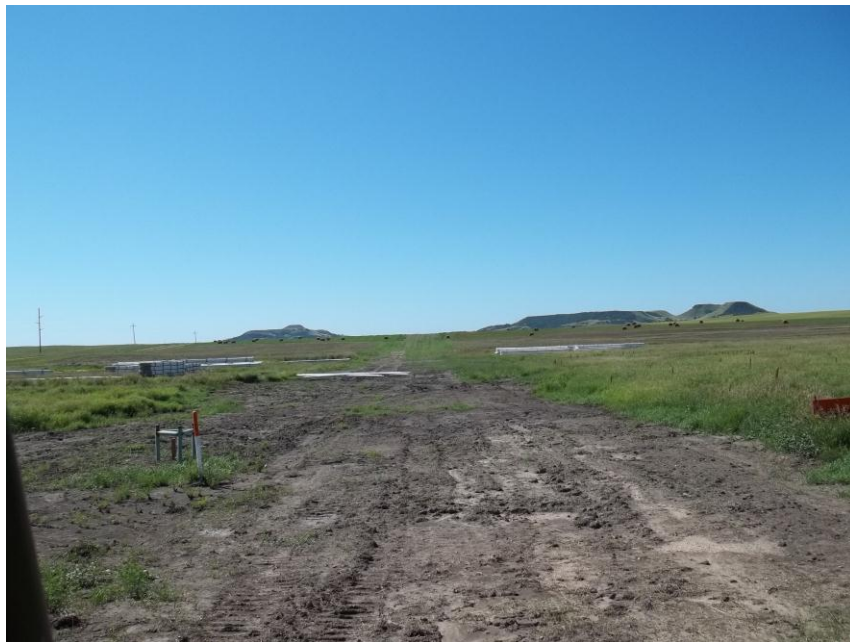
**Photo 95.** Direction: North. This photo shows the right-of-way for the Bridger Pipeline. At the time of our site visit the right-of-way needed final restoration.

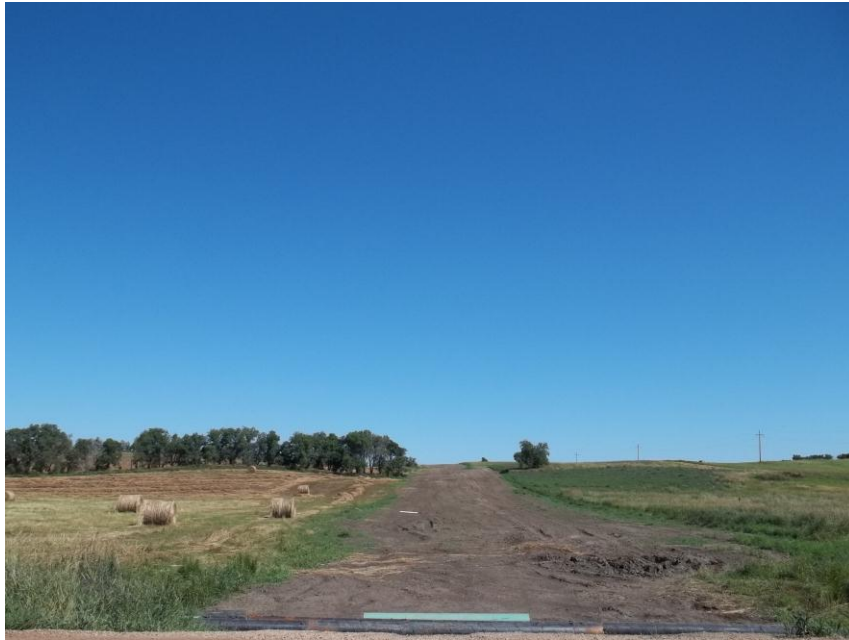
**Photo 96.** Direction: South. This photo shows the right-of-way for the Bridger Pipeline. At the time of our site visit the right-of-way needed final restoration.

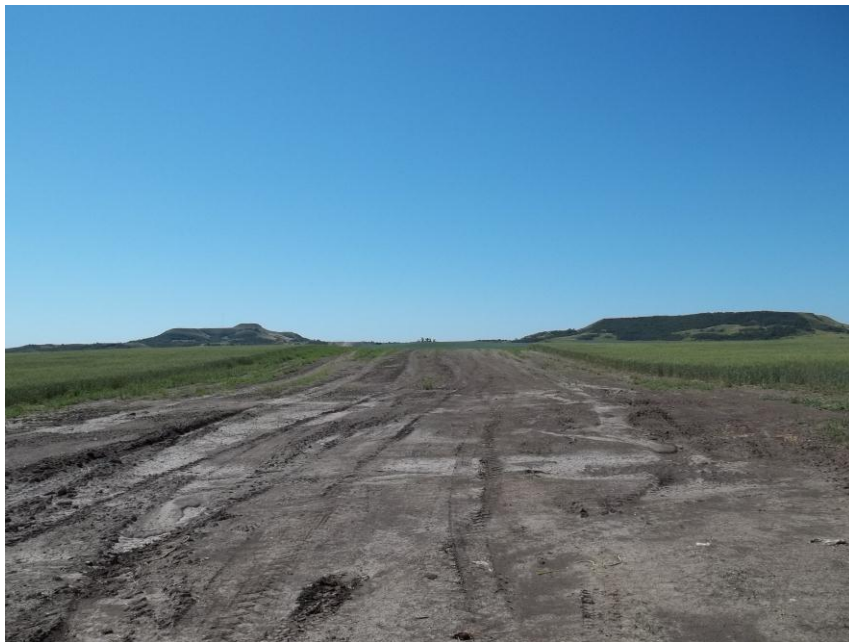
**Photo 97.** Direction: North. This photo shows the right-of-way for the Bridger Pipeline. At the time of our site visit the right-of-way needed final restoration.

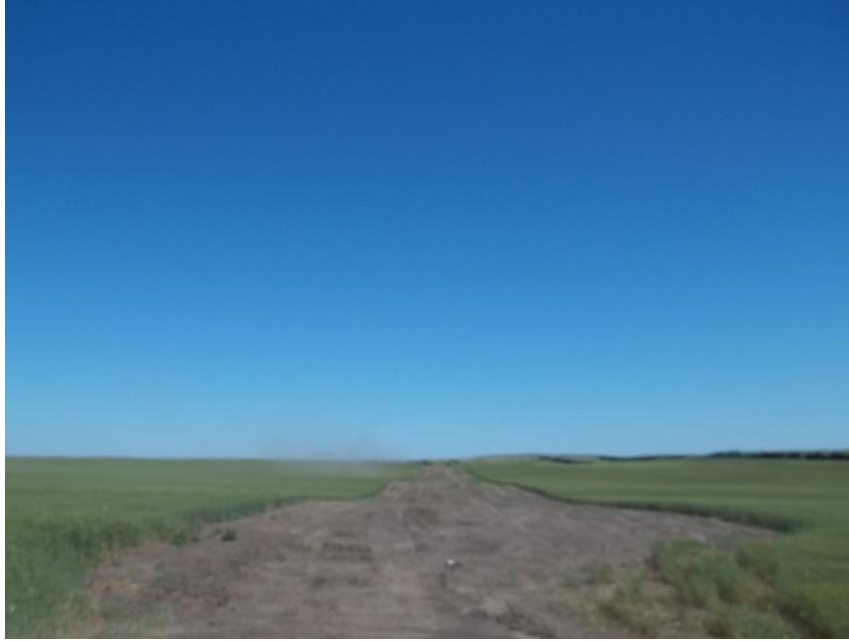
**Photo 98.** Direction: South. This photo shows the right-of-way for the Bridger Pipeline. At the time of our site visit the right-of-way needed final restoration.

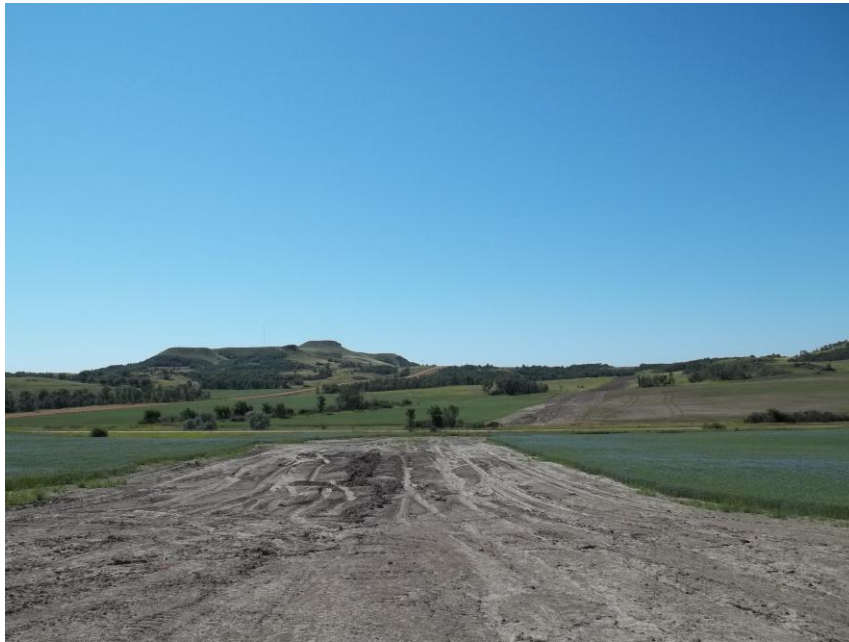
**Photo 99.** Direction: North. This photo shows the right-of-way for the Bridger Pipeline. At the time of our site visit the right-of-way needed final restoration.

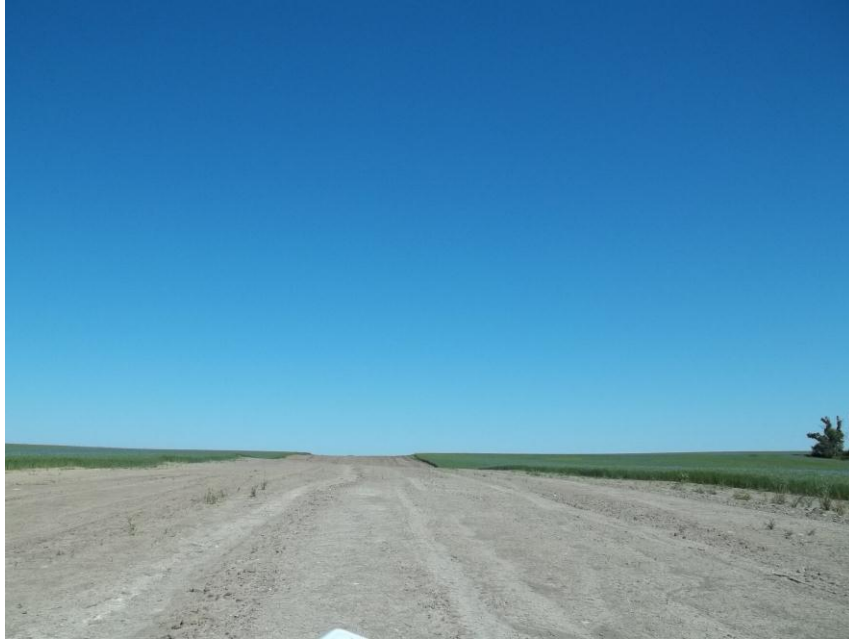
**Photo 100.** Direction: South. This photo shows the right-of-way for the Bridger Pipeline. At the time of our site visit the right-of-way needed final restoration.

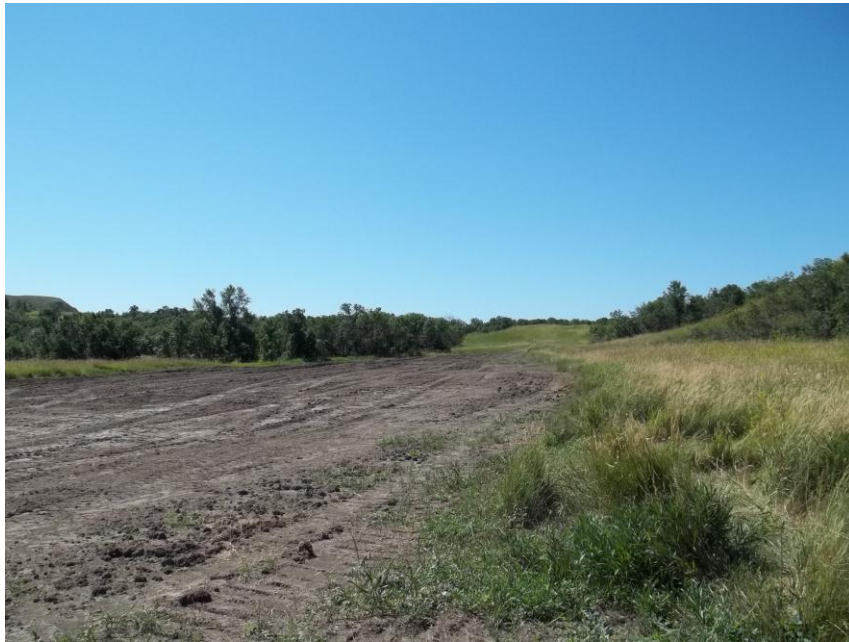
**Photo 101.** Direction: North. This photo shows the right-of-way for the Bridger Pipeline. At the time of our site visit the right-of-way needed final restoration.

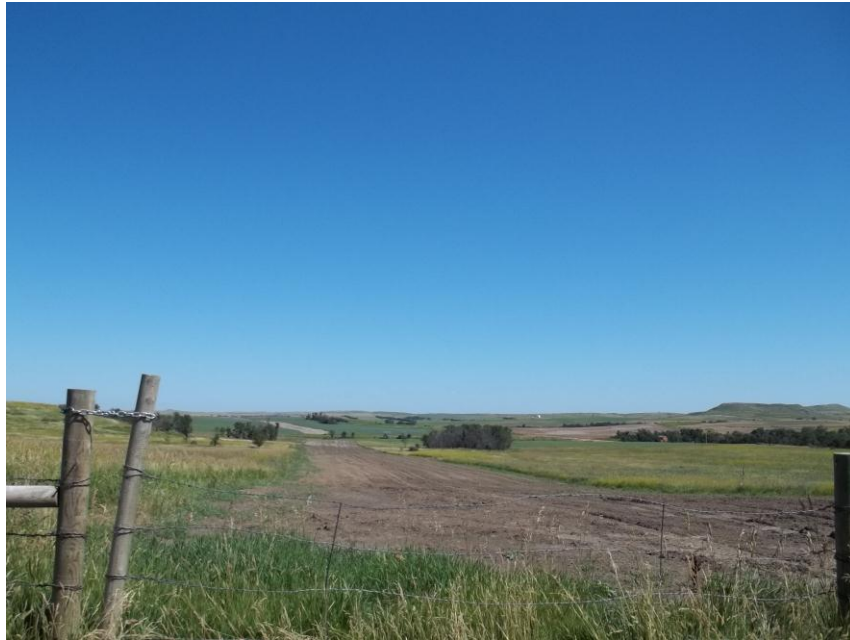
**Photo 102.** Direction: South. This photo shows the right-of-way for the Bridger Pipeline. At the time of our site visit the right-of-way needed final restoration.

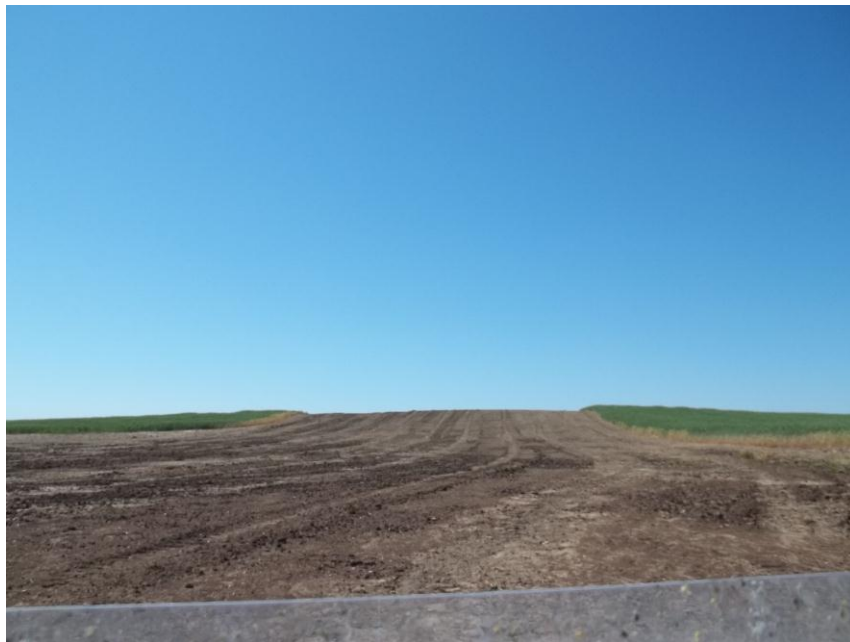
**Photo 103.** Direction: North. This photo shows the right-of-way for the Bridger Pipeline. At the time of our site visit the right-of-way needed final restoration.

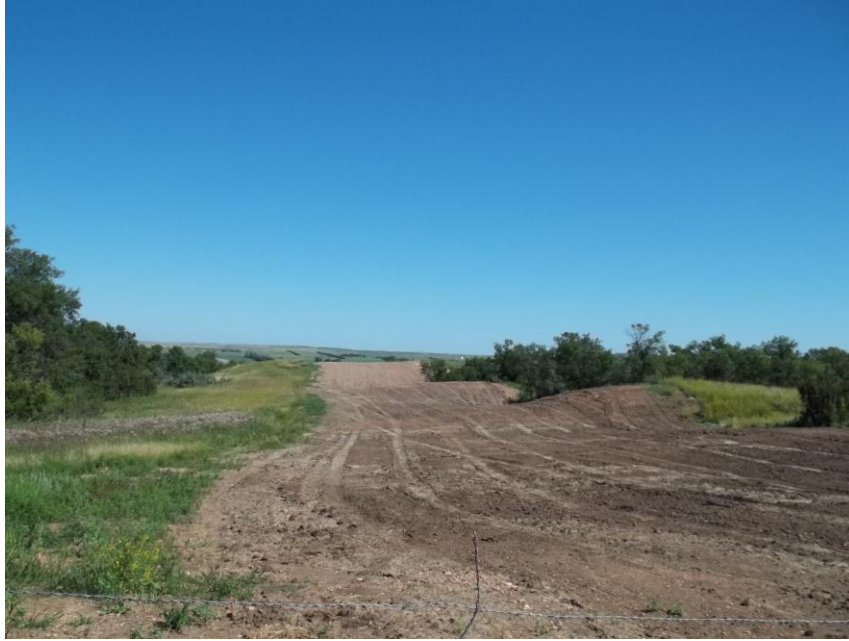
**Photo 104.** Direction: South. This photo shows the right-of-way for the Bridger Pipeline. At the time of our site visit the right-of-way needed final restoration.

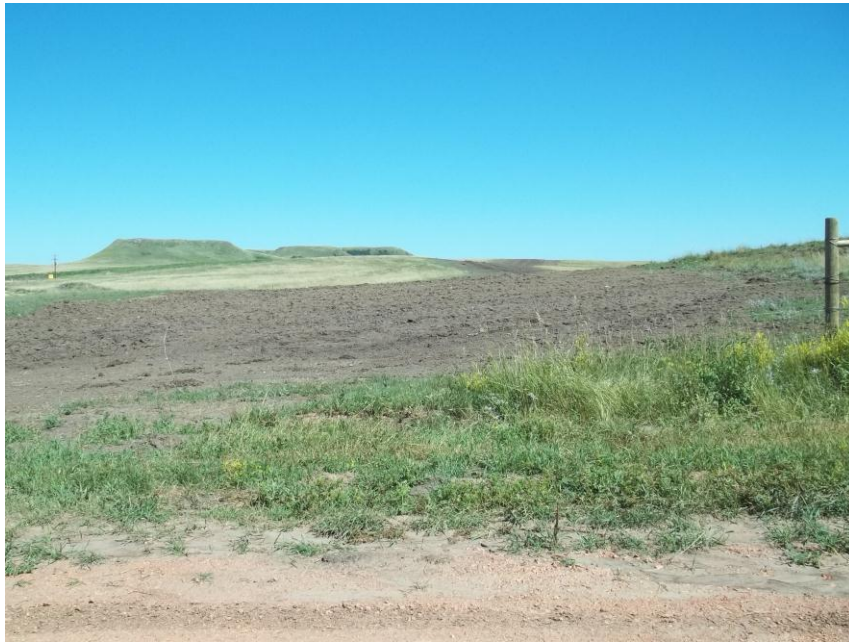
**Photo 105.** Direction: North. This photo shows the right-of-way for the Bridger Pipeline. At the time of our site visit the right-of-way needed final restoration.

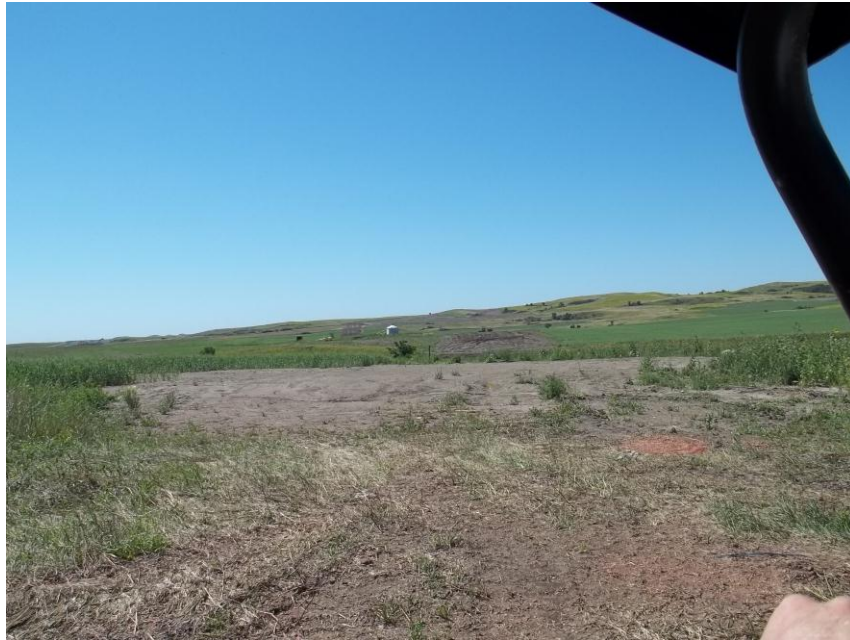
**Photo 106.** Direction: North. This photo shows the right-of-way for the Bridger Pipeline. At the time of our site visit the right-of-way needed final restoration.

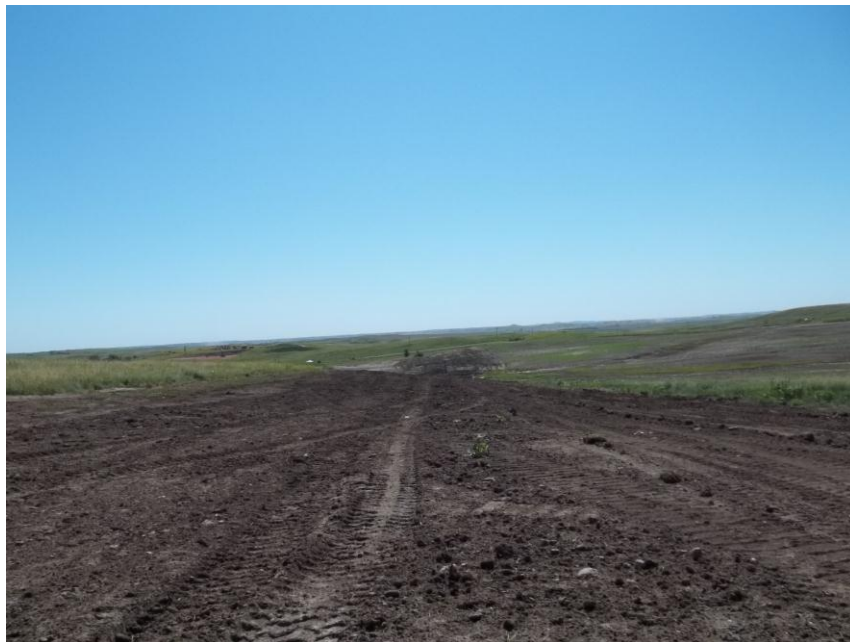
**Photo 107.** Direction: South. This photo shows the right-of-way for the Bridger Pipeline. At the time of our site visit the right-of-way needed final restoration.

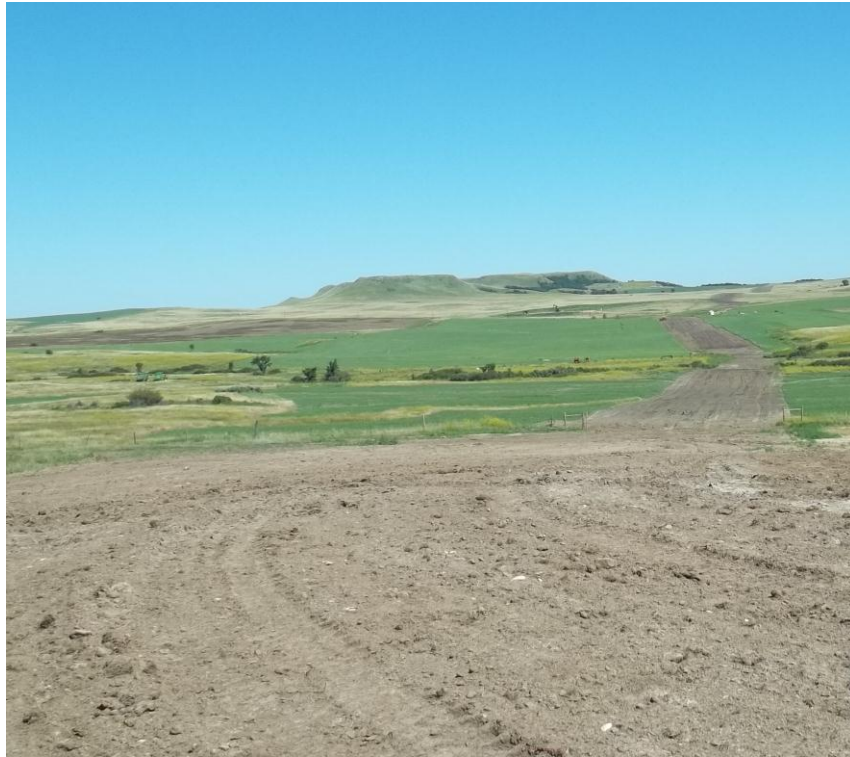
**Photo 108.** Direction: South. This photo shows the right-of-way for the Bridger Pipeline. At the time of our site visit the right-of-way needed final restoration.

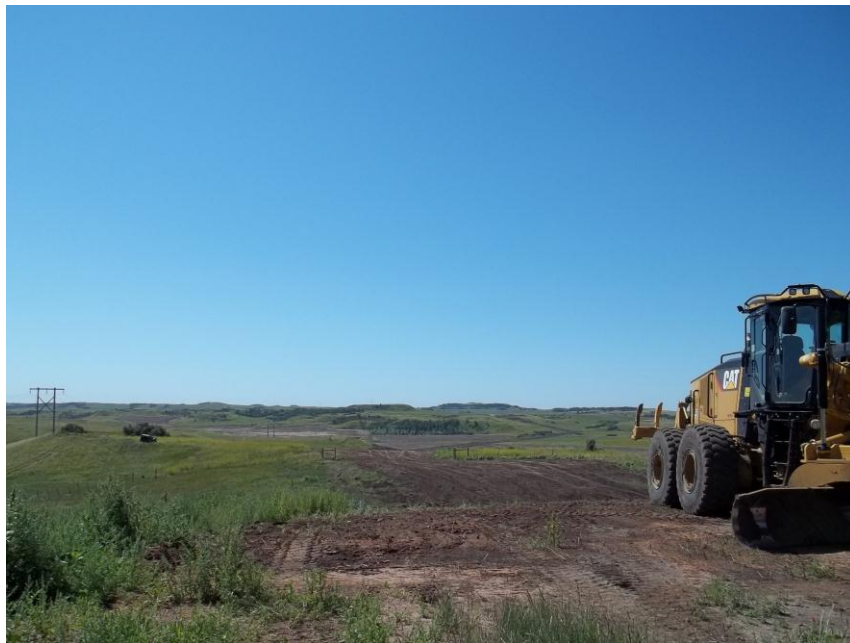
**Photo 109.** Direction: North. This photo shows the right-of-way for the Bridger Pipeline. At the time of our site visit the right-of-way needed final restoration.

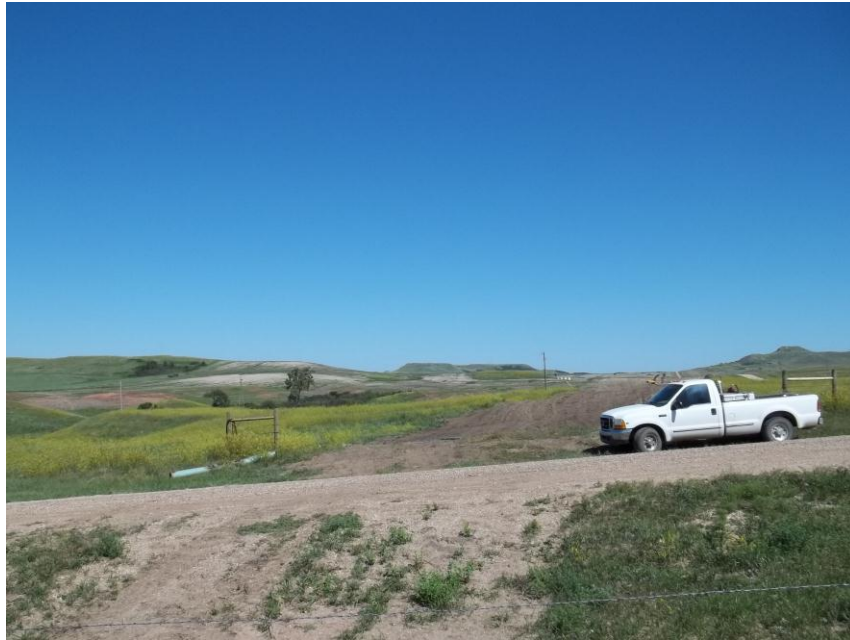
**Photo 110.** Direction: South. This photo shows the right-of-way for the Bridger Pipeline. At the time of our site visit the right-of-way needed final restoration

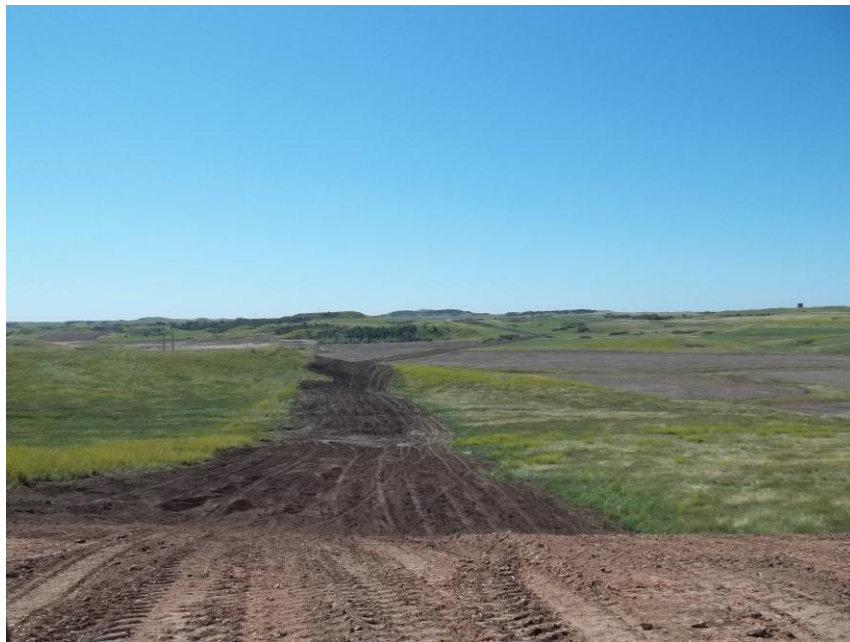
**Photo 111.** Direction: North. This photo shows the right-of-way for the Bridger Pipeline. At the time of our site visit the right-of-way needed final restoration.

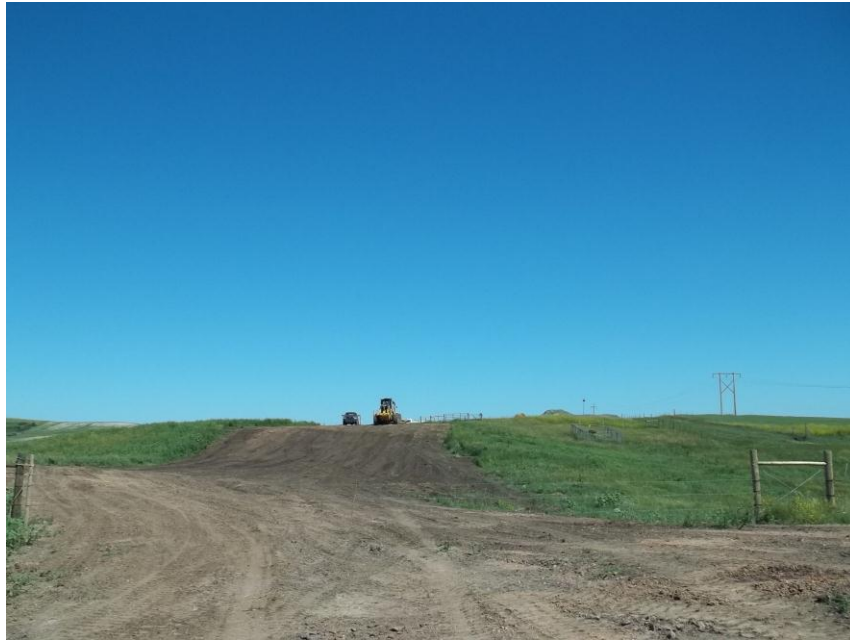
**Photo 112.** Direction: South. This photo shows the right-of-way for the Bridger Pipeline. At the time of our site visit the right-of-way needed final restoration.

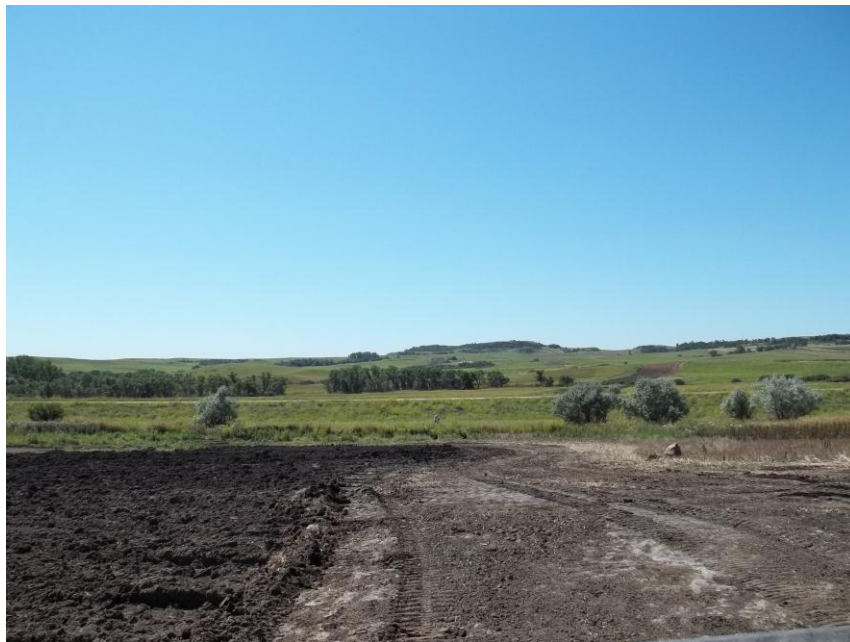
**Photo 113.** Direction: North. This photo shows the right-of-way for the Bridger Pipeline. At the time of our site visit the right-of-way needed final restoration.

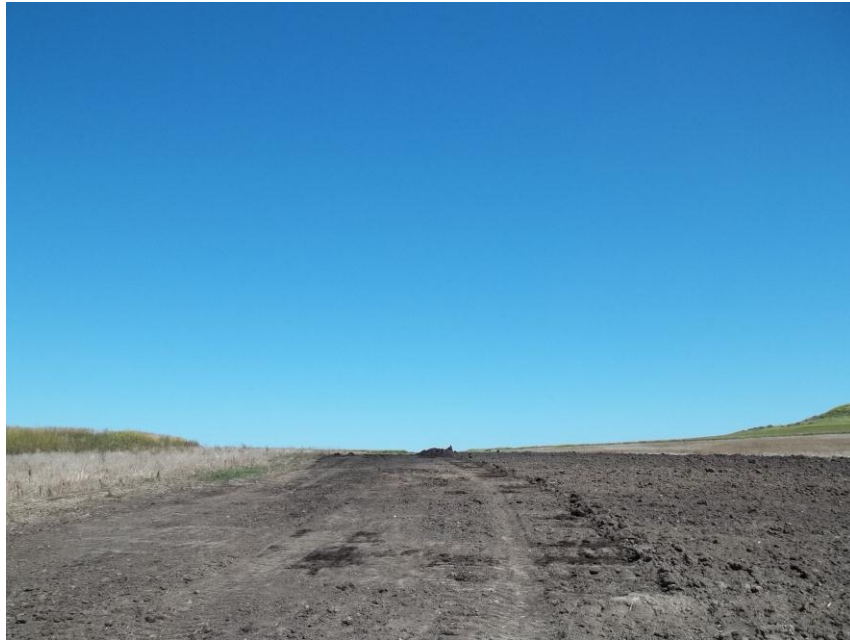
**Photo 114.** Direction: South. This photo shows the right-of-way for the Bridger Pipeline. At the time of our site visit the right-of-way needed final restoration.

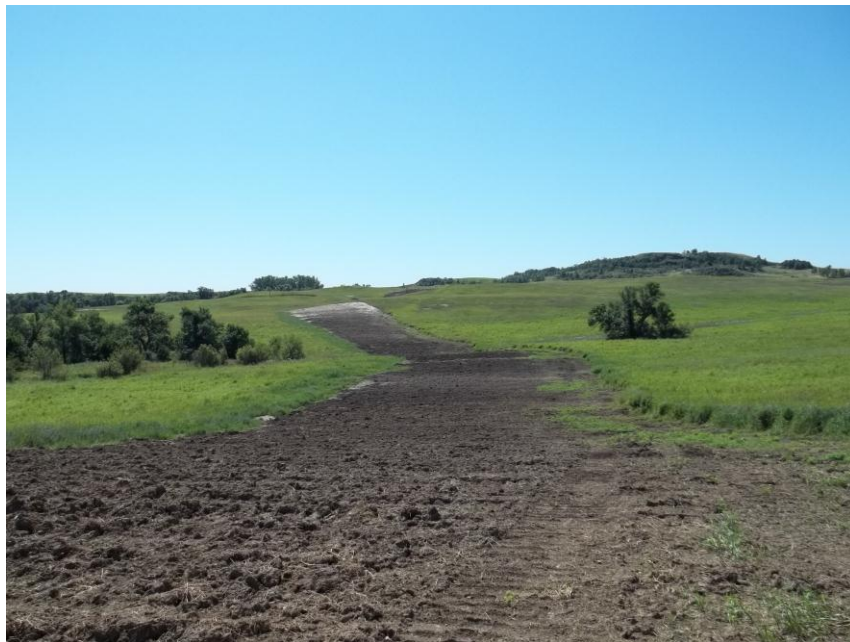
**Photo 115.** Direction: North. This photo shows the right-of-way for the Bridger Pipeline. At the time of our site visit the right-of-way needed final restoration.

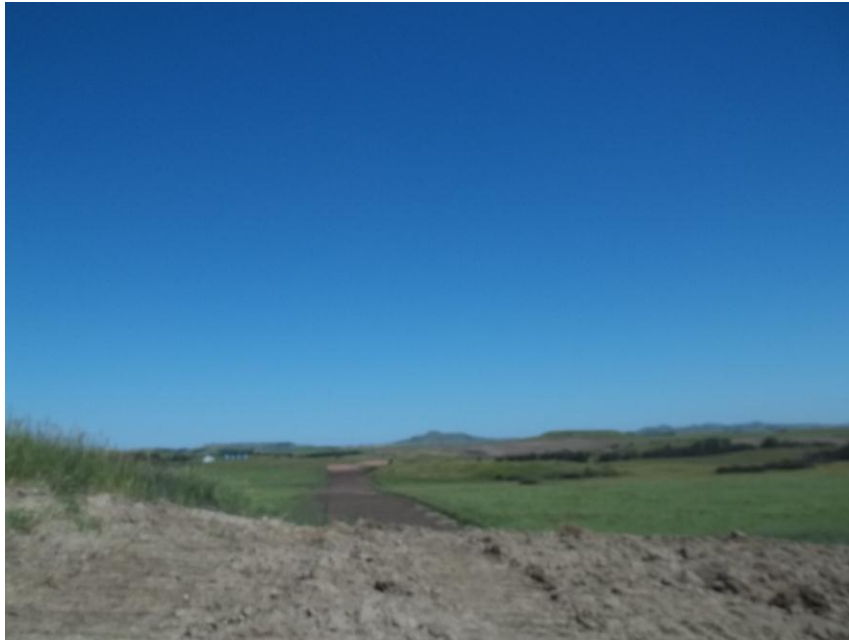
**Photo 116.** Direction: South. This photo shows the right-of-way for the Bridger Pipeline. At the time of our site visit the right-of-way needed final restoration.

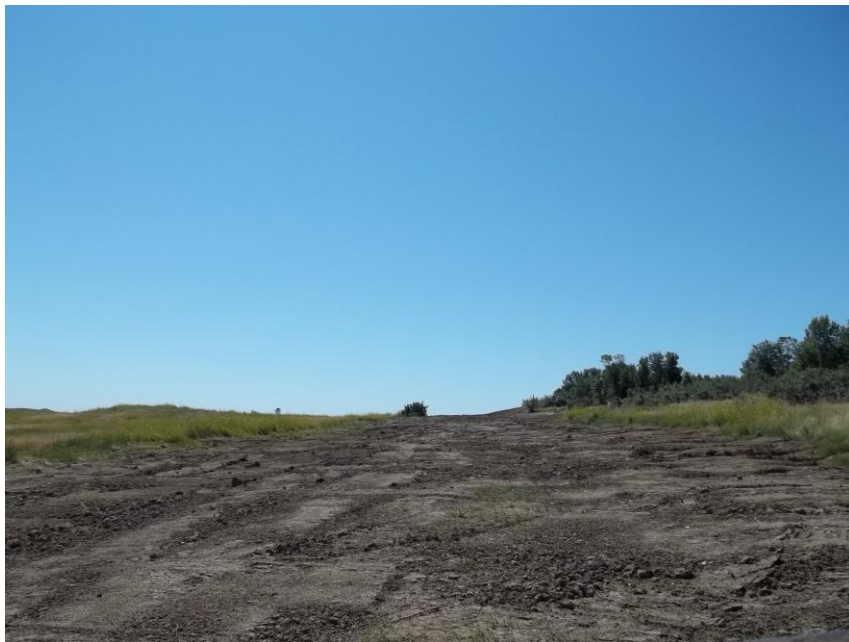
**Photo 117.** Direction: North. This photo shows the right-of-way for the Bridger Pipeline. At the time of our site visit the right-of-way needed final restoration.

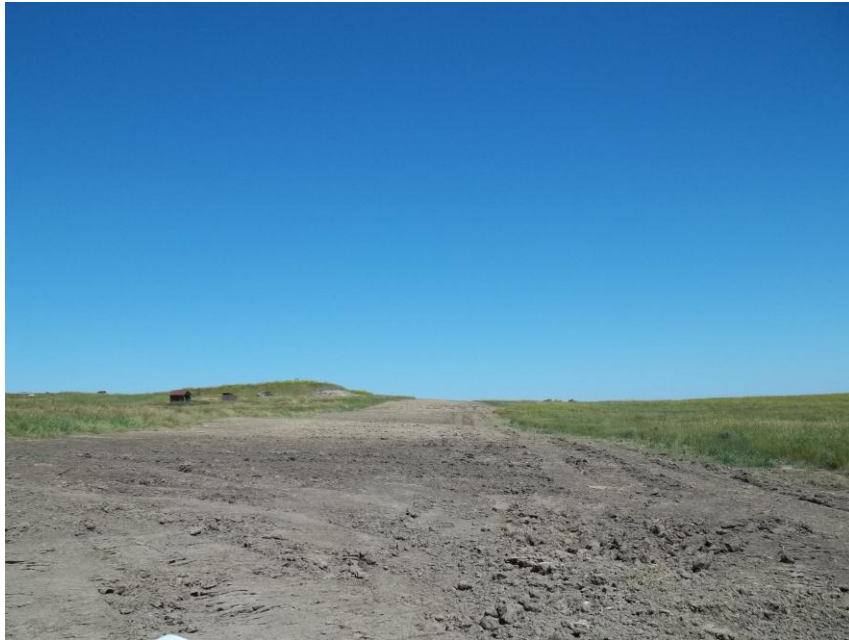
**Photo 118.** Direction: South. This photo shows the right-of-way for the Bridger Pipeline. At the time of our site visit the right-of-way needed final restoration.

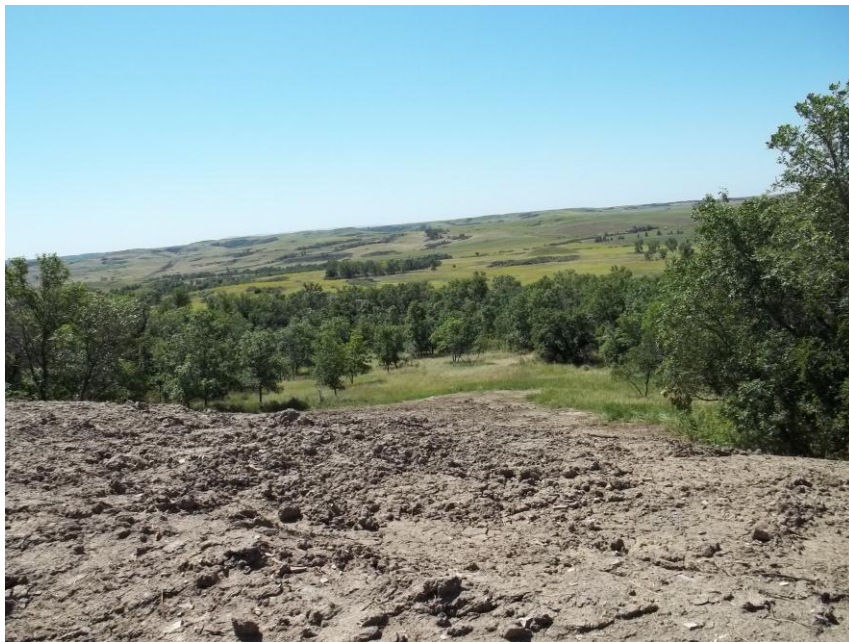
**Photo 119.** Direction: North. This photo shows the right-of-way for the Bridger Pipeline. At the time of our site visit the right-of-way needed final restoration.

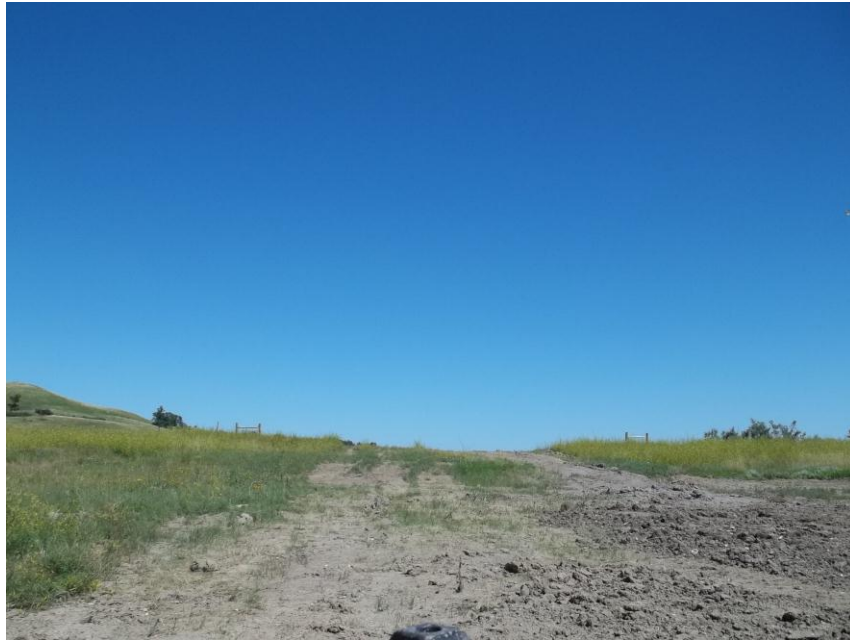
**Photo 120.** Direction: South. This photo shows the right-of-way for the Bridger Pipeline. At the time of our site visit the right-of-way needed final restoration.

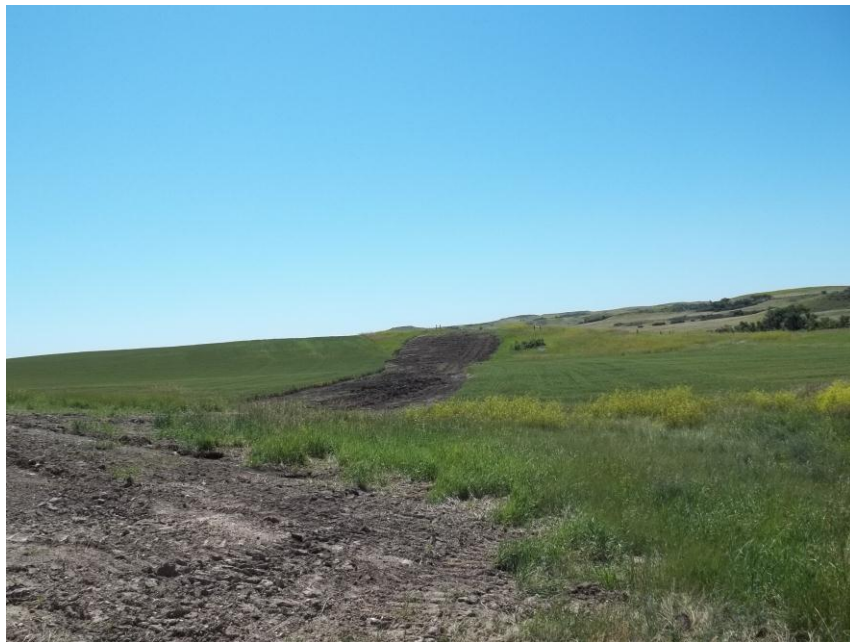
**Photo 121.** Direction: North. This photo shows the right-of-way for the Bridger Pipeline. At the time of our site visit the right-of-way needed final restoration.

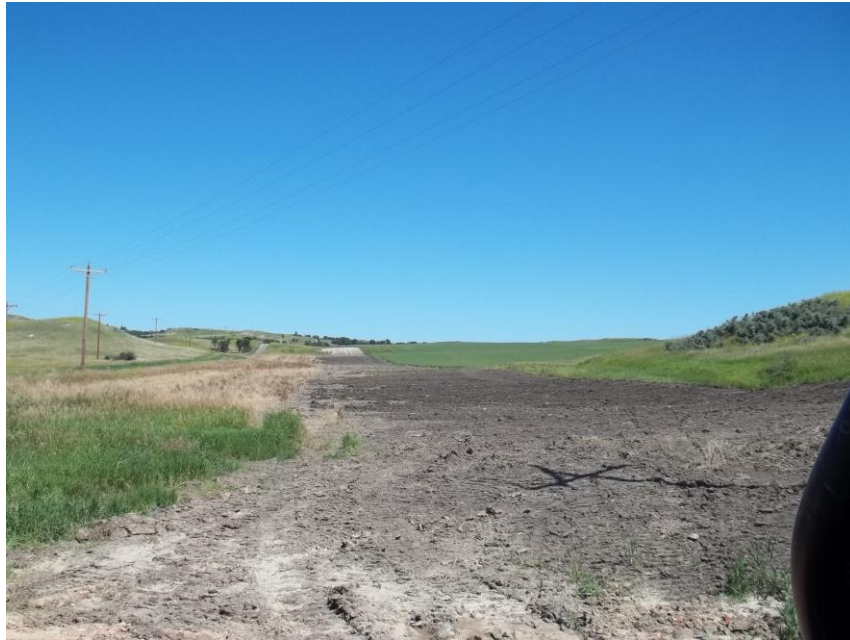
**Photo 122.** Direction: South. This photo shows the right-of-way for the Bridger Pipeline. At the time of our site visit the right-of-way needed final restoration.

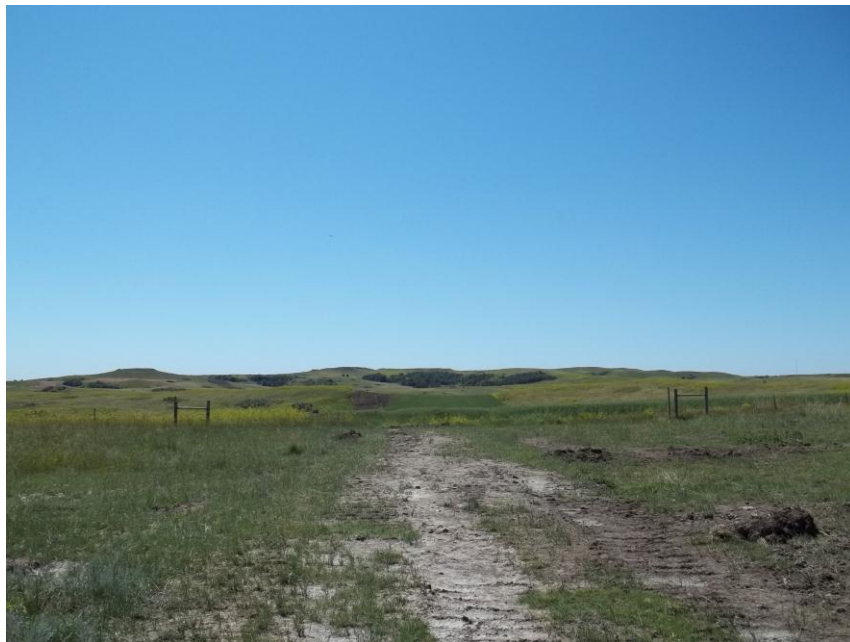
**Photo 123.** Direction: North. This photo shows the right-of-way for the Bridger Pipeline. At the time of our site visit the right-of-way needed final restoration.

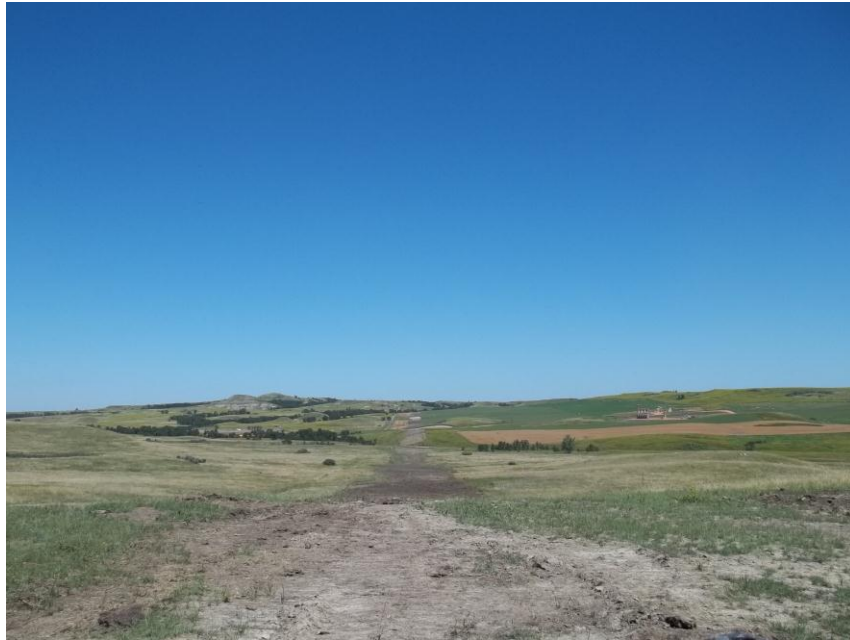
**Photo 124.** Direction: South. This photo shows the right-of-way for the Bridger Pipeline. At the time of our site visit the right-of-way needed final restoration.

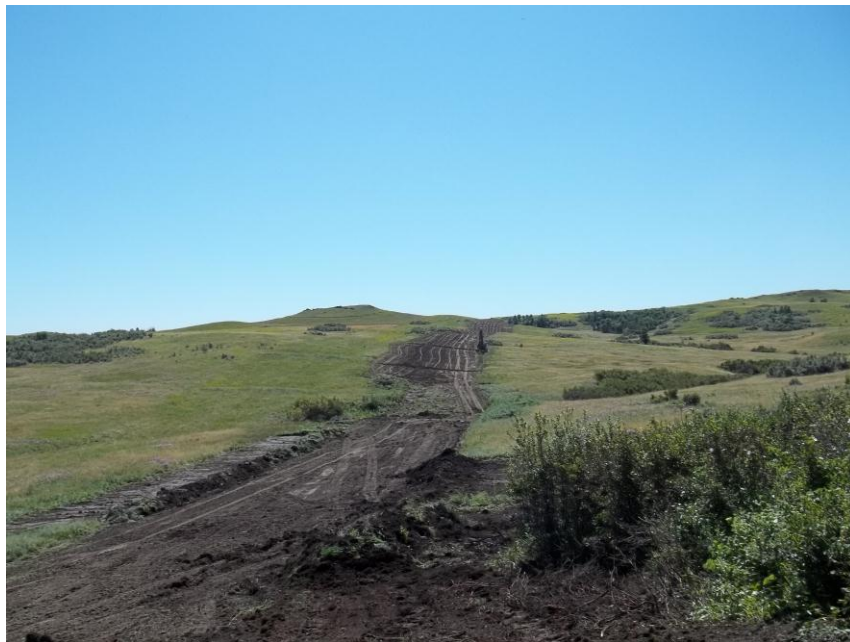
**Photo 125.** Direction: North. This photo shows the right-of-way for the Bridger Pipeline. At the time of our site visit the right-of-way needed final restoration.

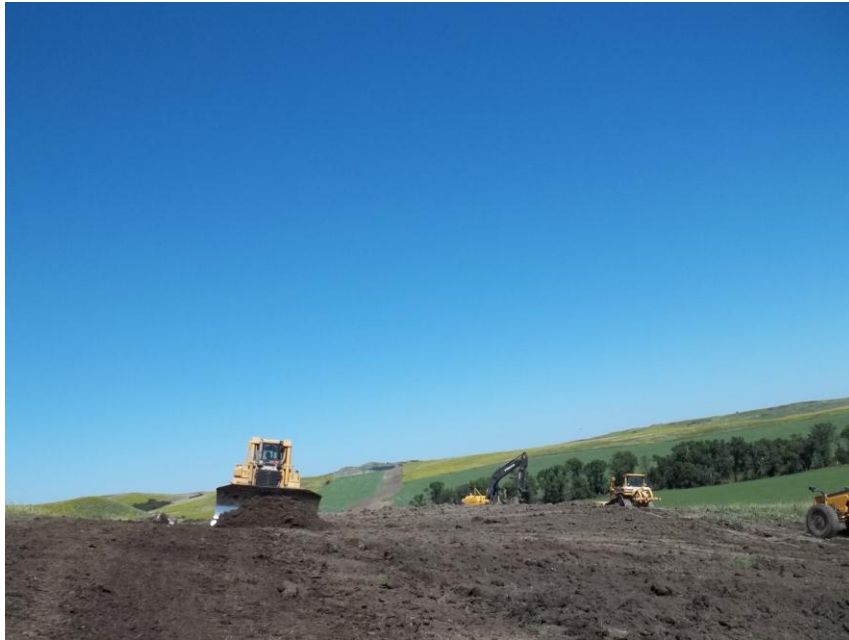
**Photo 126.** Direction: South. This photo shows the right-of-way for the Bridger Pipeline. At the time of our site visit the right-of-way needed final restoration.

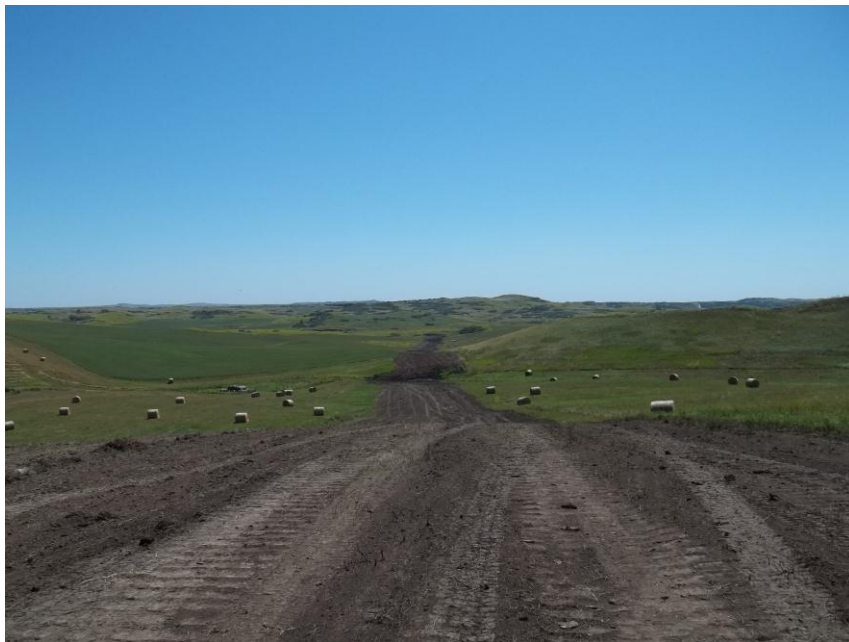
**Photo 127.** Direction: North. This photo shows the right-of-way for the Bridger Pipeline. At the time of our site visit the right-of-way needed final restoration.

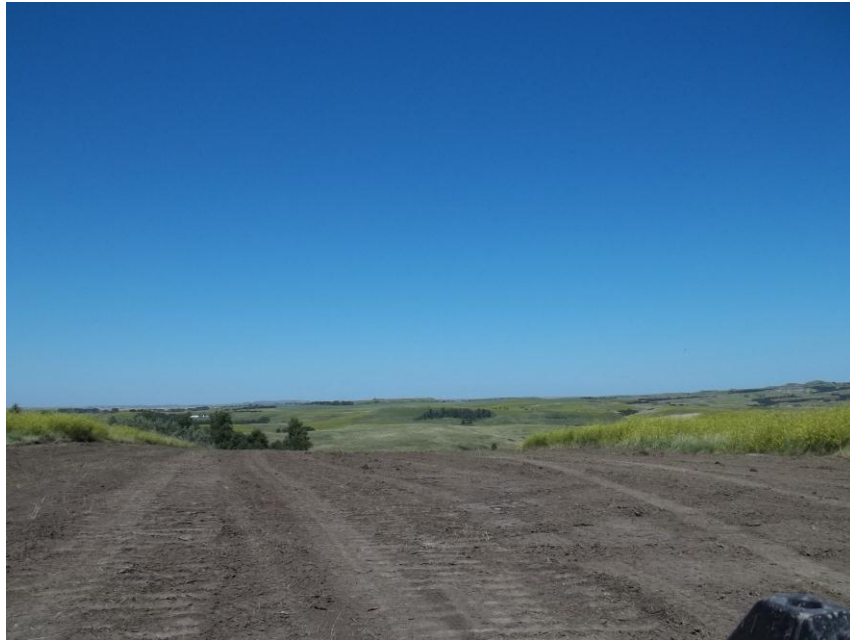
**Photo 128.** Direction: South. This photo shows the right-of-way for the Bridger Pipeline. At the time of our site visit the right-of-way needed final restoration.

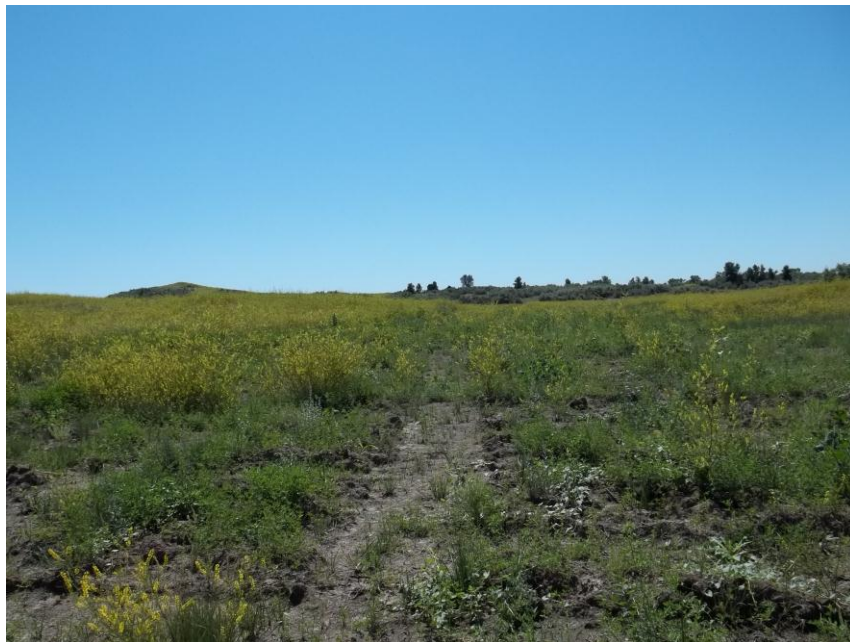
**Photo 129.** Direction: North. This photo shows the right-of-way for the Bridger Pipeline. At the time of our site visit the right-of-way needed final restoration.
