# **Bridger Pipeline, LLC Inspection Report**

## **Phase 1 – Construction Phase**

**NORTH DAKOTA  
PUBLIC SERVICE COMMISSION**  
600 E. Boulevard Avenue  
Bismarck, ND 58505-0480

August 2011

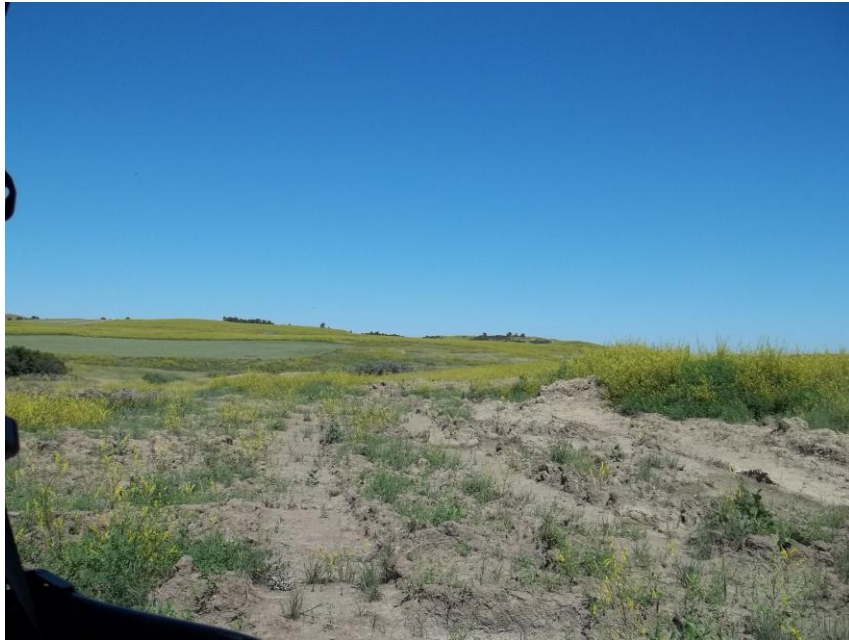
**Photo 130.** Direction: Southwest. This photo shows the right-of-way for the Bridger Pipeline. At the time of our site visit the right-of-way needed final restoration.

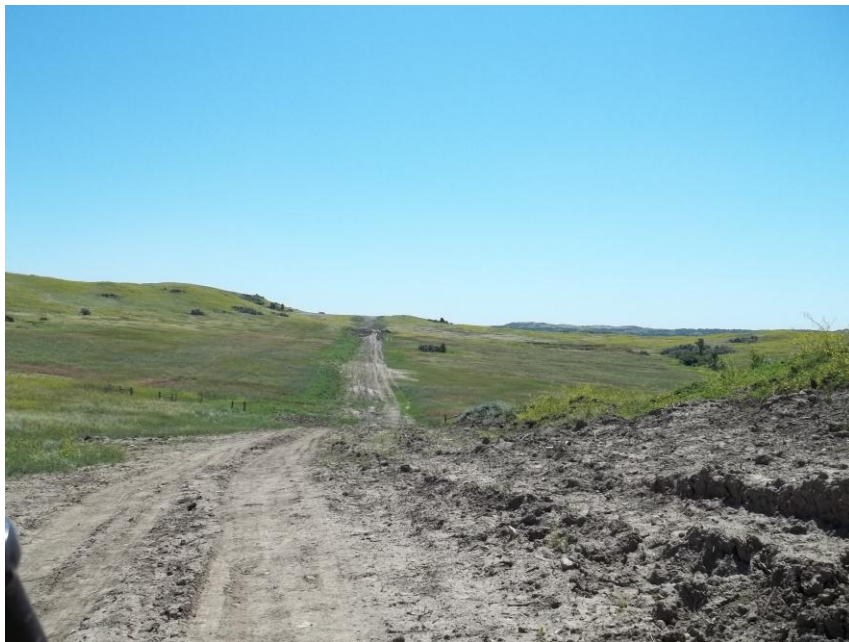
**Photo 131.** Direction: Northeast. This photo shows the right-of-way for the Bridger Pipeline. At the time of our site visit the right-of-way needed final restoration.

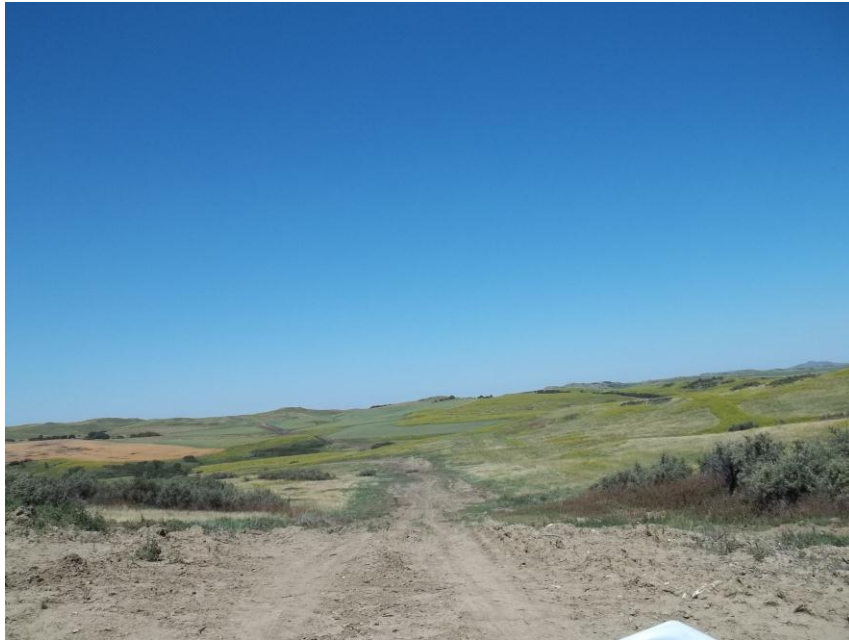
**Photo 132.** Direction: South. This photo shows the right-of-way for the Bridger Pipeline. At the time of our site visit the right-of-way needed final restoration.

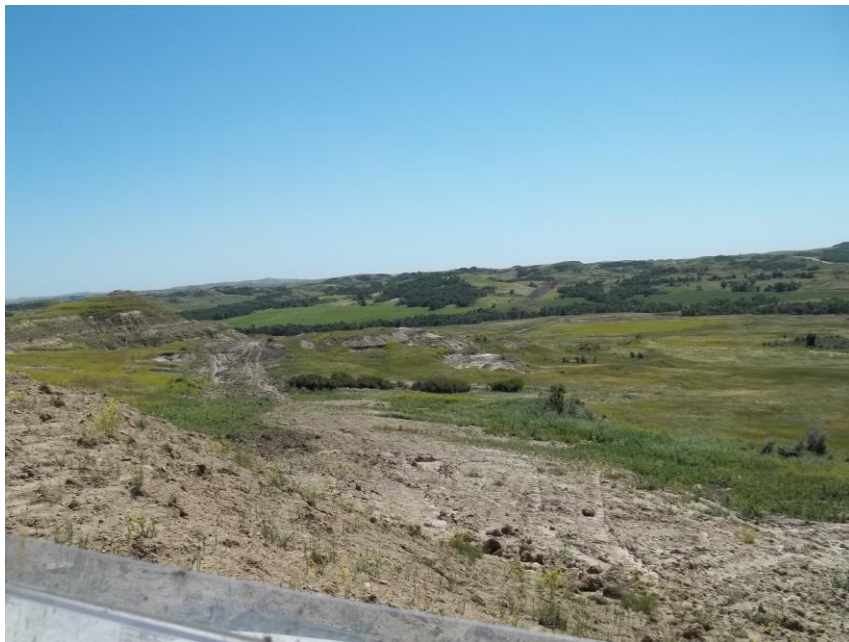
**Photo 133.** Direction: North. This photo shows the right-of-way for the Bridger Pipeline. At the time of our site visit the right-of-way needed final restoration.

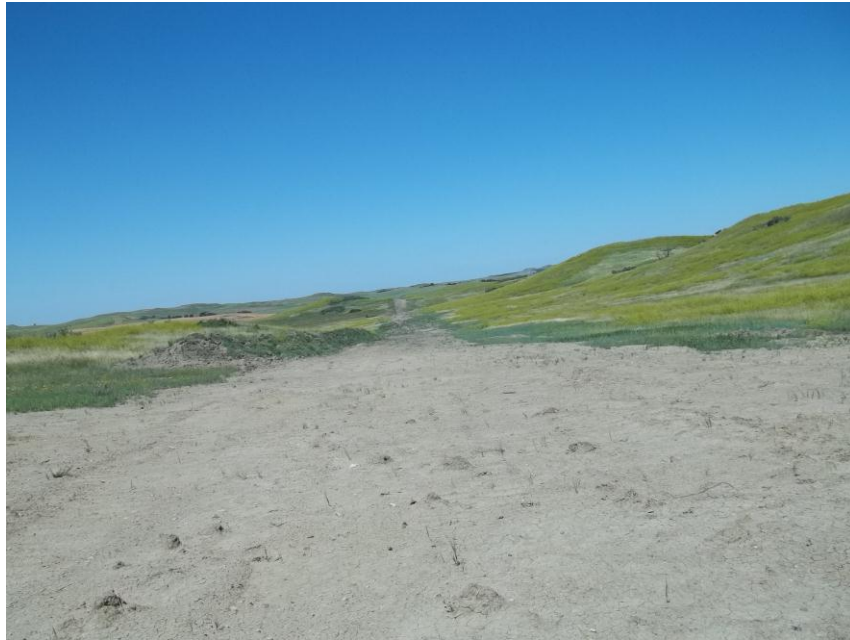
**Photo 134.** Direction: South. This photo shows the right-of-way for the Bridger Pipeline. At the time of our site visit the right-of-way needed final restoration.

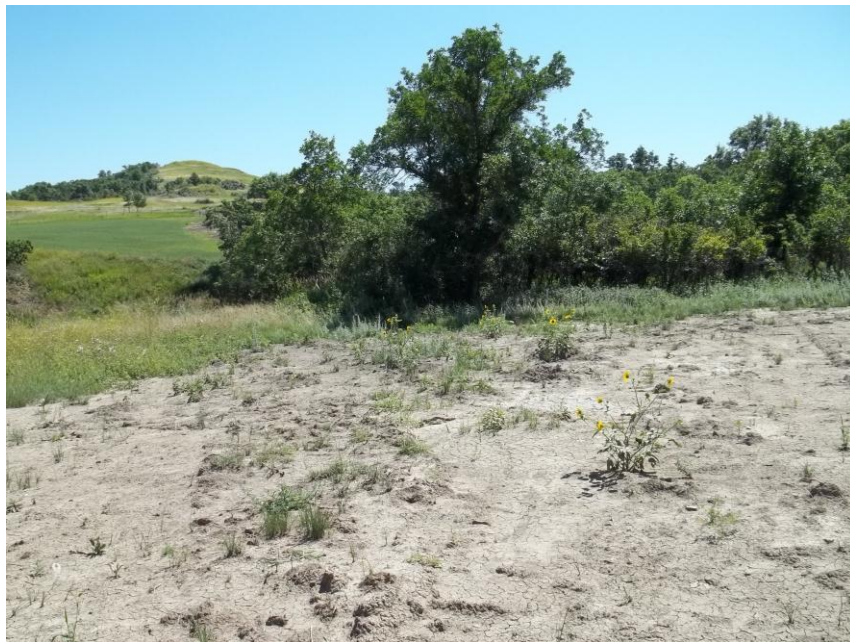
**Photo 135.** Direction: North. This photo shows the right-of-way for the Bridger Pipeline. At the time of our site visit the right-of-way needed final restoration.

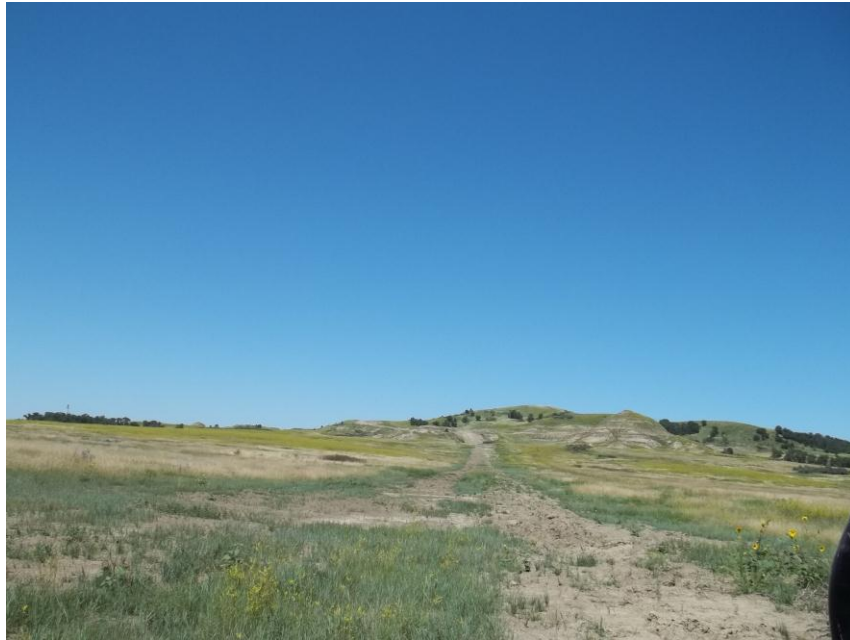
**Photo 136.** Direction: South. This photo shows the right-of-way for the Bridger Pipeline. At the time of our site visit the right-of-way needed final restoration.

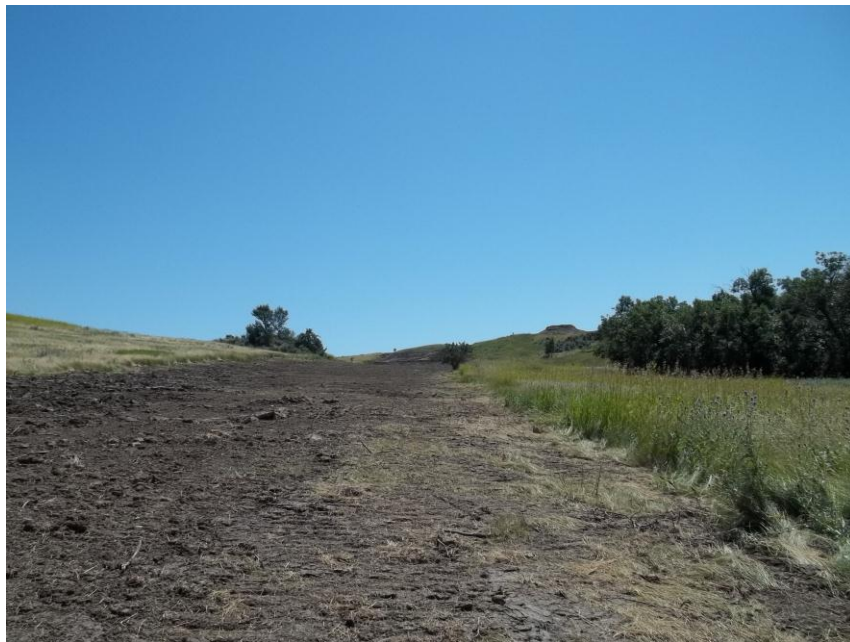
**Photo 137.** Direction: North. This photo shows the right-of-way for the Bridger Pipeline. At the time of our site visit the right-of-way needed final restoration.

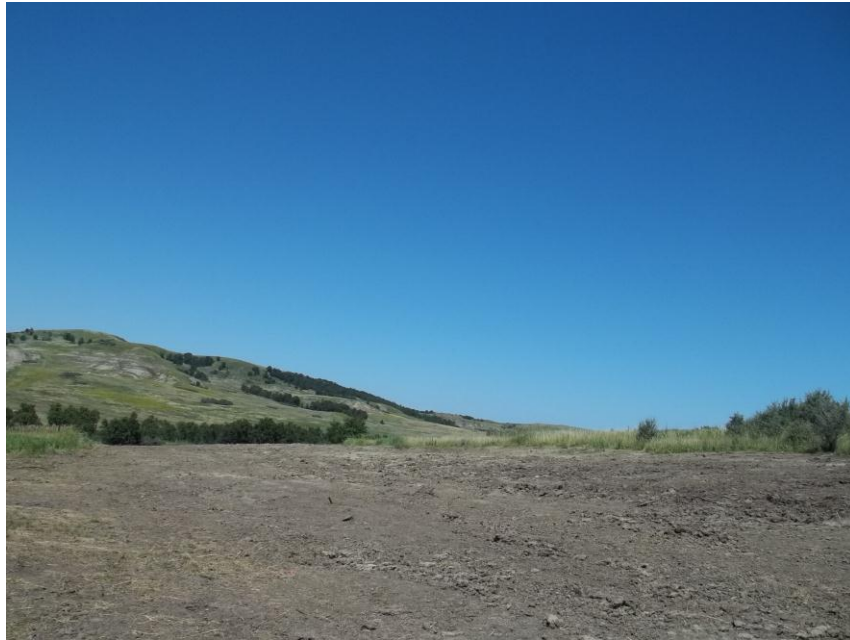
**Photo 138.** Direction: South. This photo shows the right-of-way for the Bridger Pipeline. At the time of our site visit the right-of-way needed final restoration.

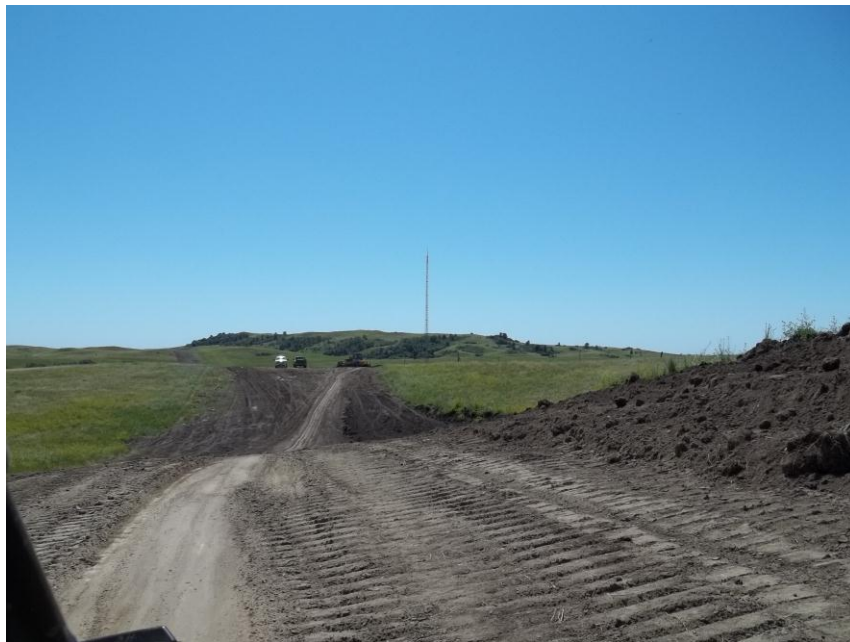
**Photo 139.** Direction: North. This photo shows the right-of-way for the Bridger Pipeline. At the time of our site visit the right-of-way needed final restoration.

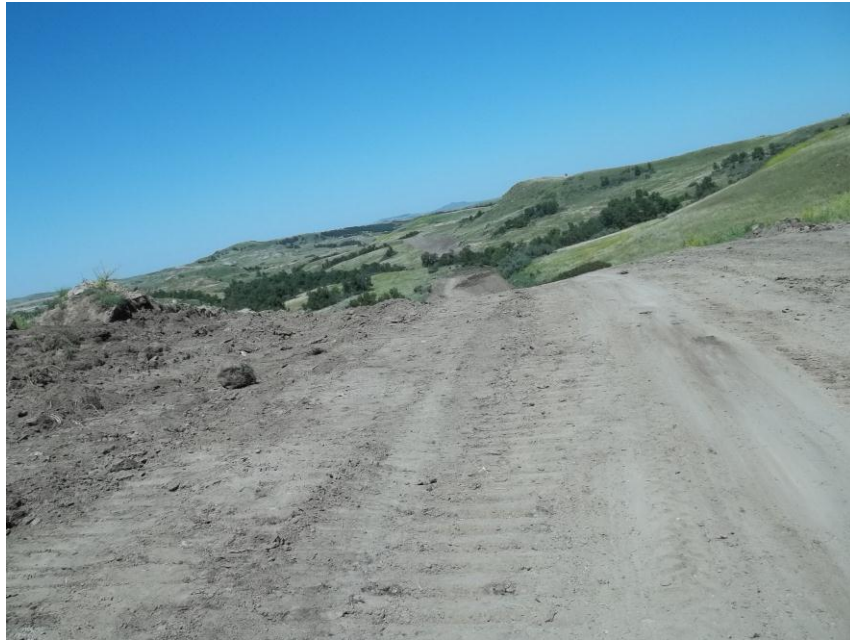
**Photo 140.** Direction: Southwest. This photo shows the right-of-way for the Bridger Pipeline. At the time of our site visit the right-of-way needed final restoration.
