***Bridger Four
Bears Pipeline
Phase 2
Construction
Inspection Report***

***Bridger Pipeline,
L.L.C.***

PU-09-750

June 2012

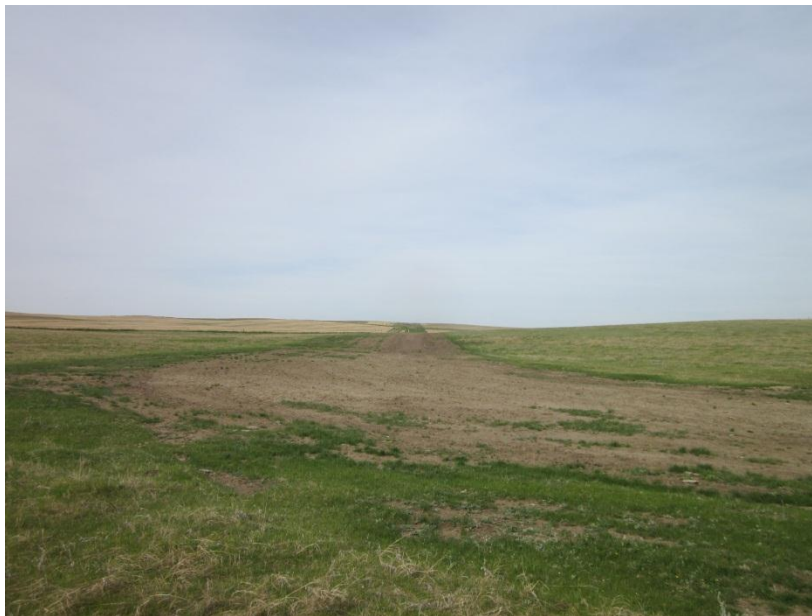
was evident and soil was bare (**Appendix B, Photos 2, 3, 4, 8, 10, 11, 14, 17, 18, 19, 20, 22, 33, 35, 37, 38, 39, 41, 45, 46, 48-61, 63-70, 77**). Other areas were partially reclaimed by vegetation (**Appendix B, Photos 15, 16, 25, 47, 62, 71, 72, 74**), or nearly completely revegetated (**Appendix B, Photos 7, 12, 26, 27, 31, 32, 43, 75, 76**). Even where landowners had planted over the pipeline, revegetation varied from being non-existent to nearly completely reclaiming the route (**Appendix B, Photos 1, 5, 22, 23, 28, 40, 73**). Revegetation is of paramount concern to prevent erosion, especially around waterways and steep slopes (**Appendix B, Photos 13, 14, 53, 54, 56, 58-60**). Wenck recommends that reseeded be done immediately in areas with a high potential for erosion, like on steep slopes near the Little Missouri. Bridger has the obligation per PSC stipulations to monitor revegetation and restoration by October 1st for 3 years following the completion of construction. In other areas, if reseeded is still unsuccessful after 3 years, additional topsoil may be necessary for vegetation to colonize the area. The degree or lack of revegetation along the pipeline route is the most outstanding issue observed during the inspection, one that the PSC should monitor or enforce before Bridger is considered in full compliance.

Photo 2. Direction: Southwest. Pipeline right-of-way. Reseeding had occurred, but vegetation had yet to reclaim the disturbance.

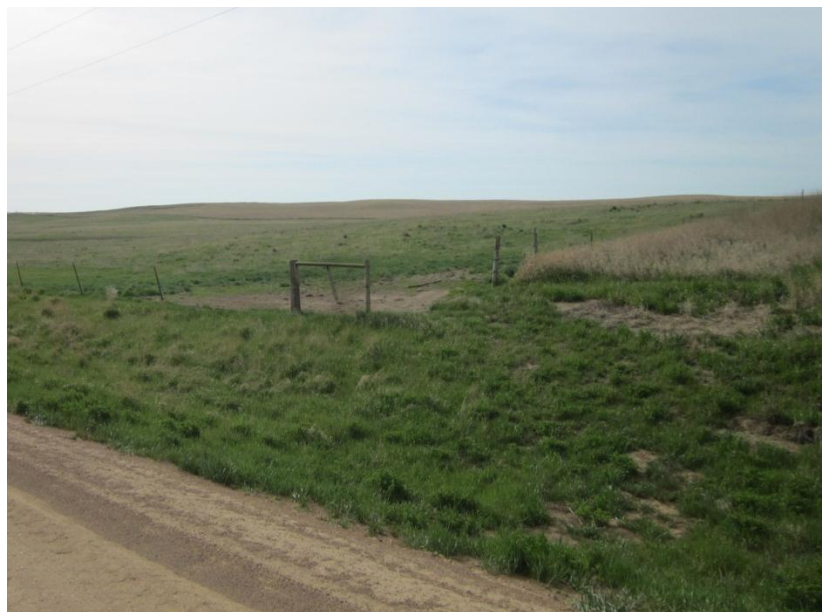
- *Roads Restored to Previous Use.* The Application stated that several temporary access roads would be constructed for the Project. These roads were well maintained and in good condition at the time of the inspection (**Appendix B, Photos 6, 9, 24**). One access road was constructed for pipeline access, but built according to landowner stipulations for use after the pipeline was complete (**Appendix B, Photo 9**). Wenck confirmed that minimum maintenance roads, county roads, and highways within the Project area appeared to be in good condition and properly maintained (**Appendix B, Photos 16, 47**). In addition, Wenck observed that appropriate signage was in place at all road, fence, and section line intersections with the pipeline ROW (**Appendix B, Photos 1, 4, 5, 7, 8, 22, 23, 29, 30, 33, 43, 44, 63, 69, 73, and 77**).

Photo 6. Direction: Southeast. An access road for Bridger's pipeline routed through the fenceline just below the dense grass in the upper right hand corner of the photo. Disturbance had been restored and almost completely reclaimed.

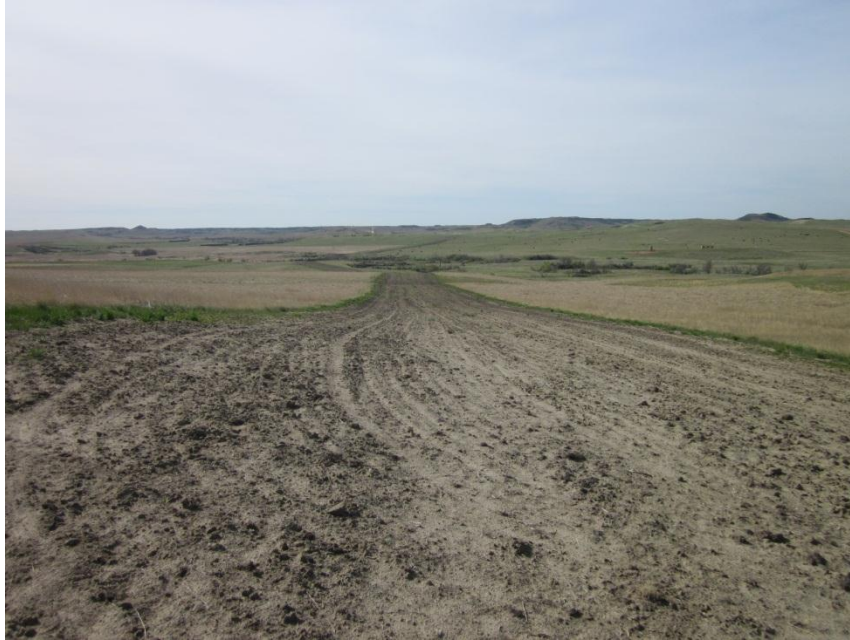
Photo 11. Direction: South. Pipeline right-of-way. Reseeding had occurred, but vegetation had yet to reclaim the disturbance.

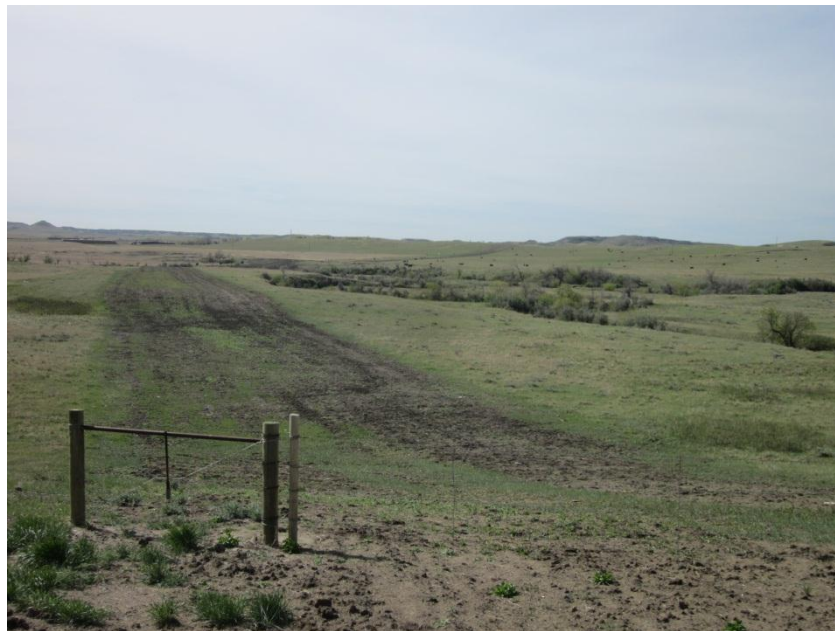
Photo 12. Direction: South. Pipeline right-of-way. Plants were beginning to reclaim the disturbance.

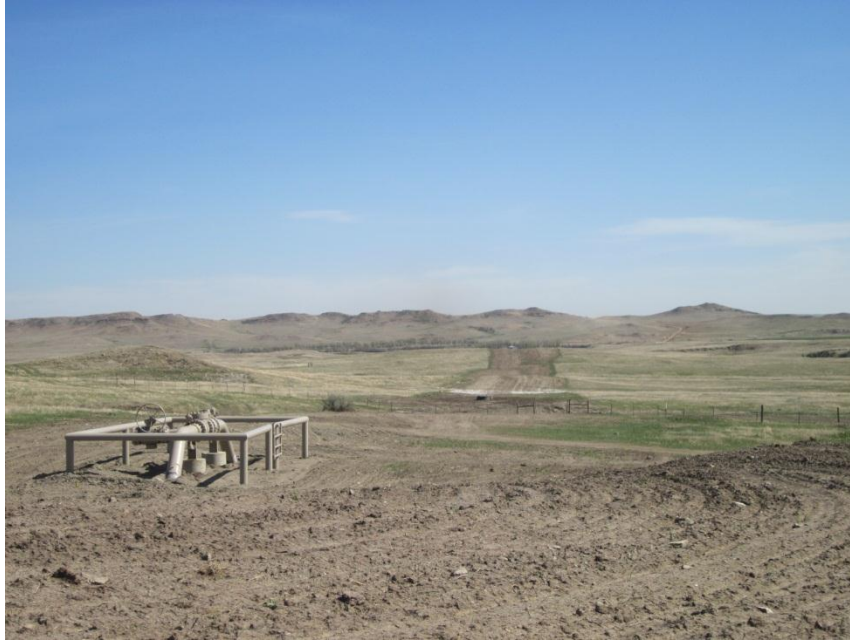
Photo 21. Direction: Southeast. Pipeline right-of-way at the 12th St. valve setting. Reseeding had occurred, but vegetation had yet to reclaim the disturbance.

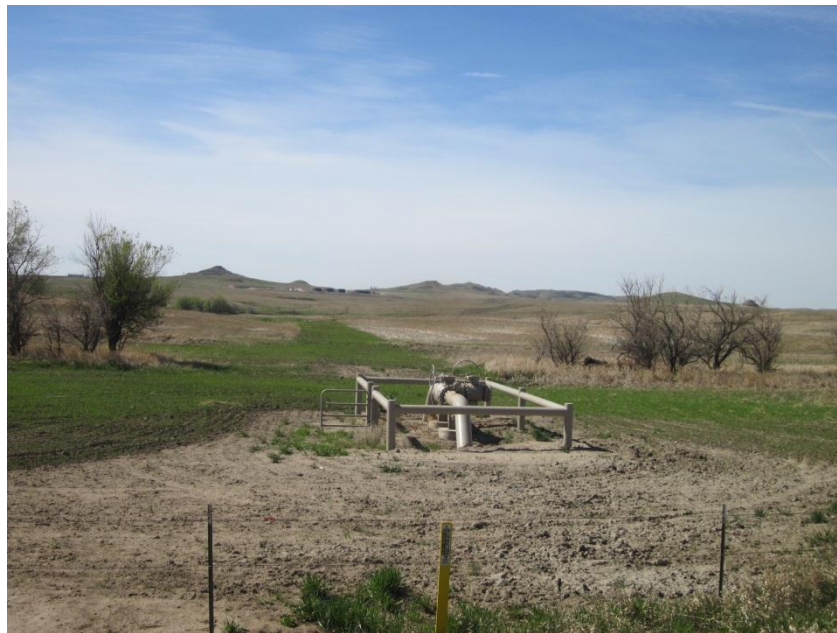
Photo 22. Direction: South. Pipeline right-of-way at the 10th St. valve setting. Agricultural field in the background had been planted by landowner.

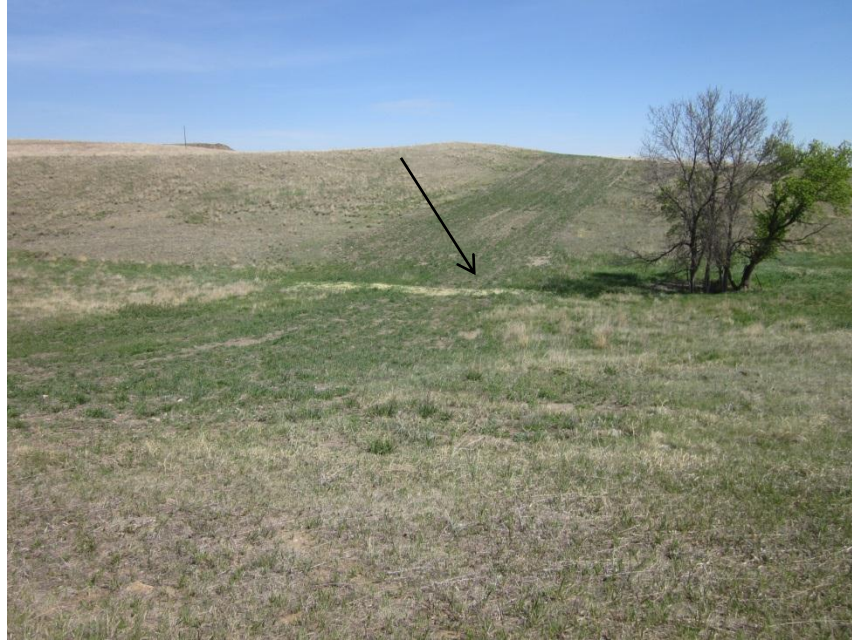
Photo 31. Direction: Northwest. Pipeline right-of-way. Grass mats (indicated by arrow) had been placed for erosion control at the request of landowner. This area was nearly completely reclaimed by vegetation.

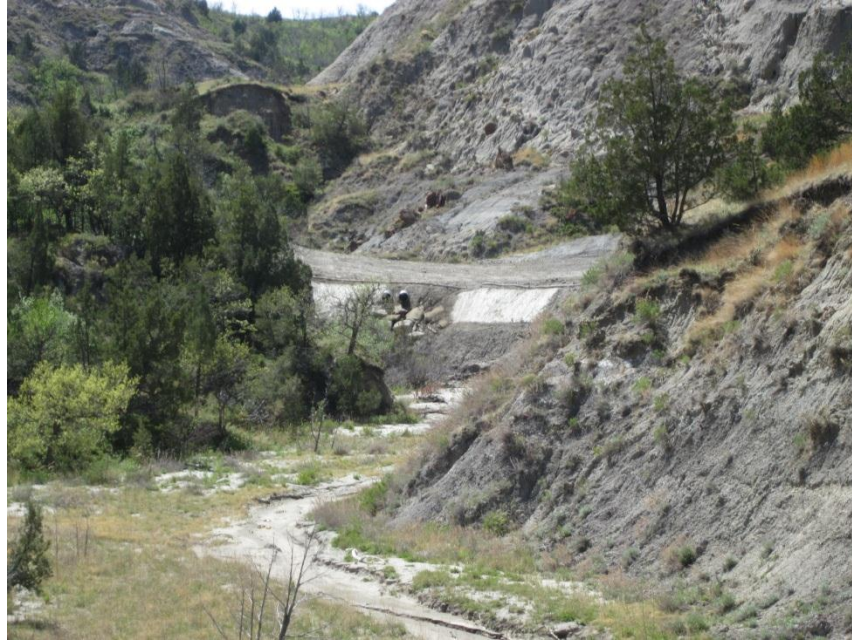
Photo 55. Direction: West. Photo shows an area where erosion had been a problem. Erosion was controlled by diverting water through culverts and laying down grass mats. It appeared these methods have been successful.

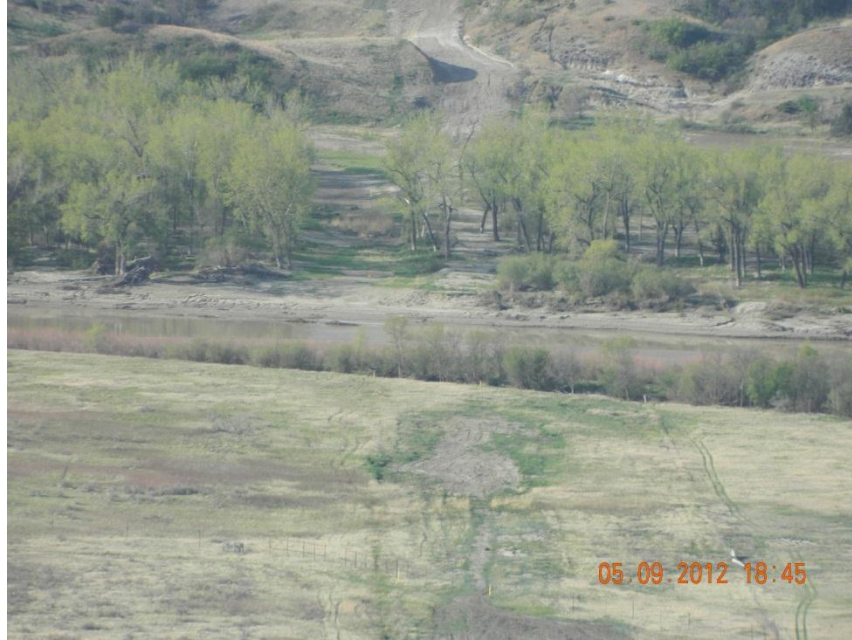
Photo 61. Direction: South. Photo shows where the right-of-way of Bridger’s pipeline bores under the Little Missouri River. No erosion or sedimentation was evident to the water body.

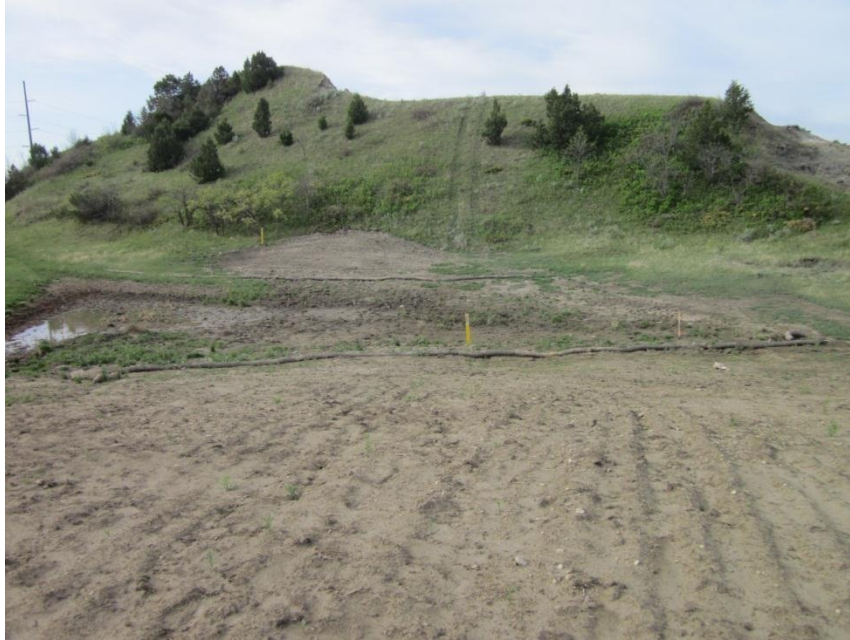
Photo 67. Direction: South. North of where Bridger’s pipeline bores under a badland butte. Note erosion control structures in place around wetland.

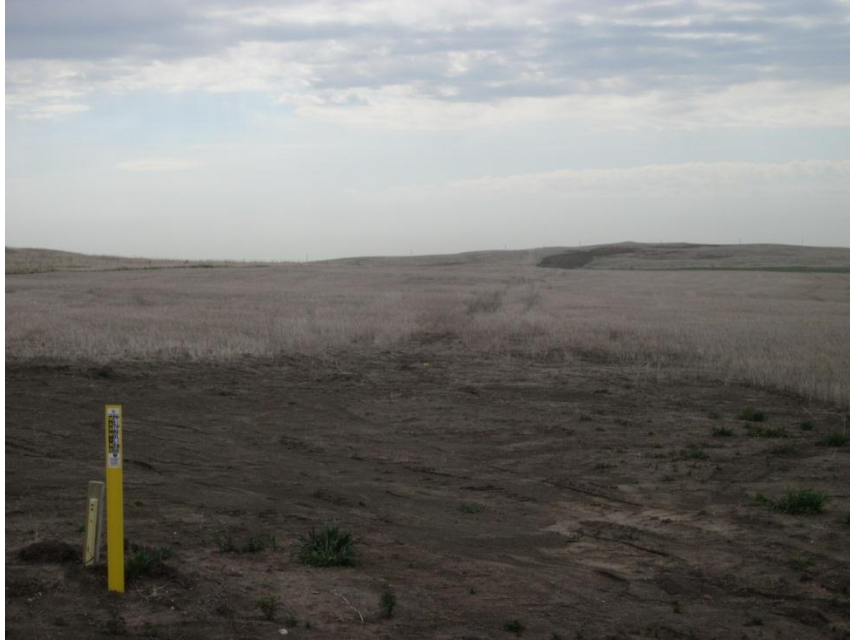
- *Cathodic Protection System in Place.* Bridger asserted that cathodic testers were located at every mile throughout the route (Tommy Massengale, pers. comm. 2012). Wenck observed several of these testers; only one tester was photographed (**Appendix B, Photo 77**).

Photo 77. Direction: Southeast. Pipeline right-of-way. Note cathodic tester located in bottom left of photo.
