# Memorandum

Subject: Basin Electric Power Cooperative, Minot Wind & PrairieWinds ND1, Decommissioning Plan & Cost (Case No. PU-10-078)

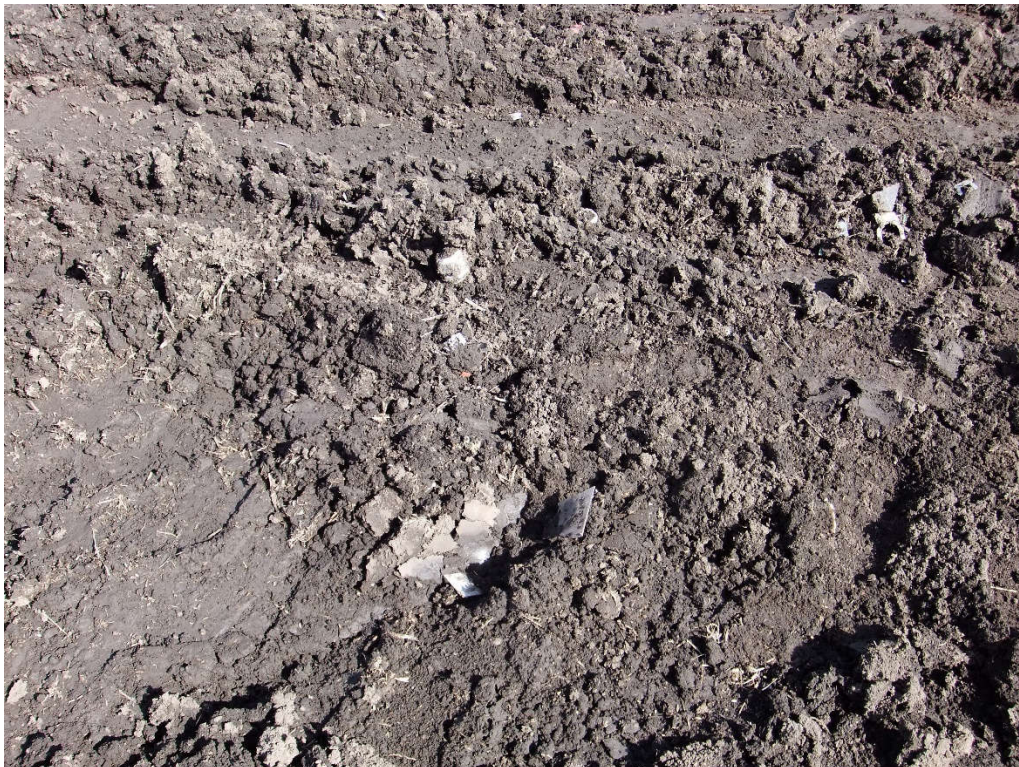
Picture 6:

Site 1 (picture 4) had completed decommissioning the entire turbine with only the foundation and underground cables remaining. The site was disturbed by heavy equipment traversing the area and disturbing the soil (picture 5). This was because in the middle of decommissioning, the area experienced its first warm days of the season, and according to the contractor, the frost came down approximately four inches. The mud made it difficult to determine the amount of fiberglass which remained to be cleaned up. A few locations had pieces of fiberglass that remained lodged in the mud (picture 6). Overall, the site appeared relatively clean from fiberglass debris based on visual inspection (pictures 7 and 8).
