## Project Inspection Report

**Project Name:** Basin Transload Lignite Pipeline Project 10" Crude Line, Burke County ND

**PSC Case Number:** PU-12-775

**Inspector:** Tony Ross, E3 Environmental, LLC    **Date:** November 13, 2013

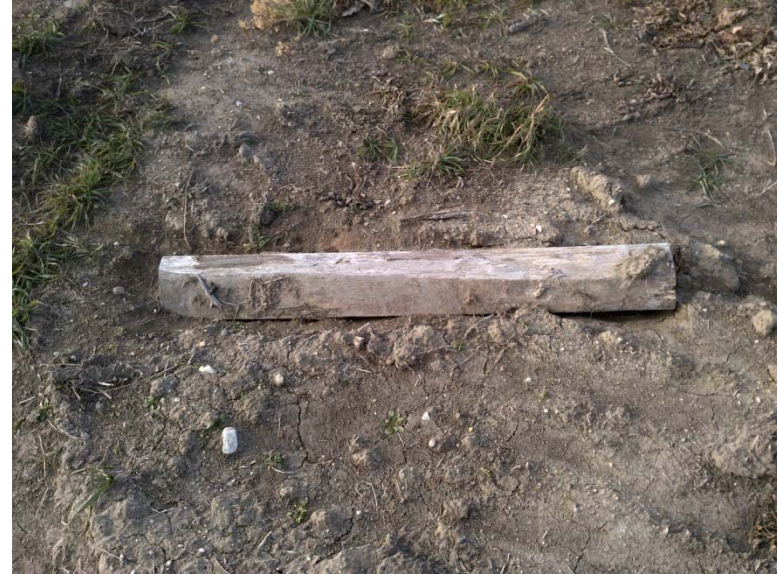
Image 38:

11/13/2013	32	Partially buried railroad tie	N48 53 19.11 W102 36 6.12	Properly dispose of	Yes	No
11/13/2013	33	Partially buried railroad tie	N48 53 18.12 W102 36 7.22	Properly dispose of	Yes	No
11/13/2013	38	Partially buried railroad tie	N48 53 15.27 W102 37 2.38	Properly dispose of	Yes	No
<b>SECTION C: NOTED ANOMOLIES</b>						
11/13/2013	1	Rough ROW	N48 53 18.90 W102 44 10.35	Regrade	Yes	No
11/13/2013	4	Rough ROW	N48 53 19.12 W102 44 2.58	Regrade	Yes	No
11/13/2013	6	Rough ROW	N48 53 19.06 W102 43 52.49	Regrade	Yes	No
11/13/2013	7	Rough ROW	N48 53 18.83 W102 43 37.87	Regrade	Yes	No
11/13/2013	8	Rough ROW	N48 53 15.53 W102 43 9.97	Regrade	Yes	No
11/13/2013	15	Rough ROW	N48 53 15.50 W102 41 37.96	Regrade	Yes	No
11/13/2013	17	Contractor drove through a perennial creek and there is no evidence of matting boards being used; rutted	N48 53 15.16 W102 41 36.20			No
11/13/2013	20	Rough ROW	N48 53 15.83 W102 39 8.30	Regrade	Yes	No
