Technical Memo

From: Luke Toso, Wenck Associates, Inc.

Date: June 14, 2018

Subject: Bison IV Reclamation Investigation, Case PU-13-127 & I-15-0195

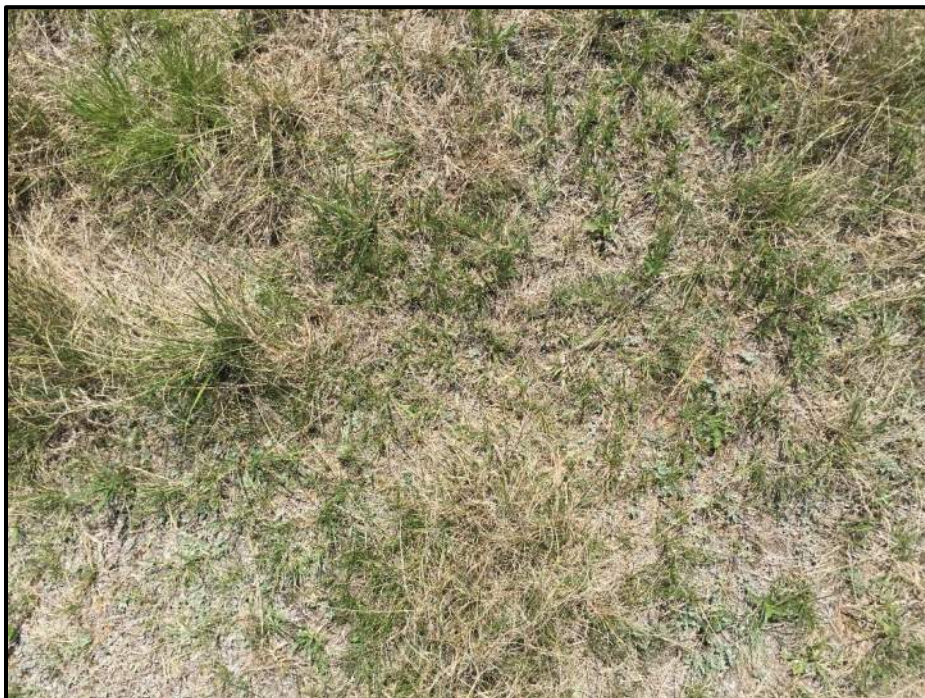
Photo 14. Location: 47.026522, -101.703414
View of the vegetation cover outside of the crane walk path.

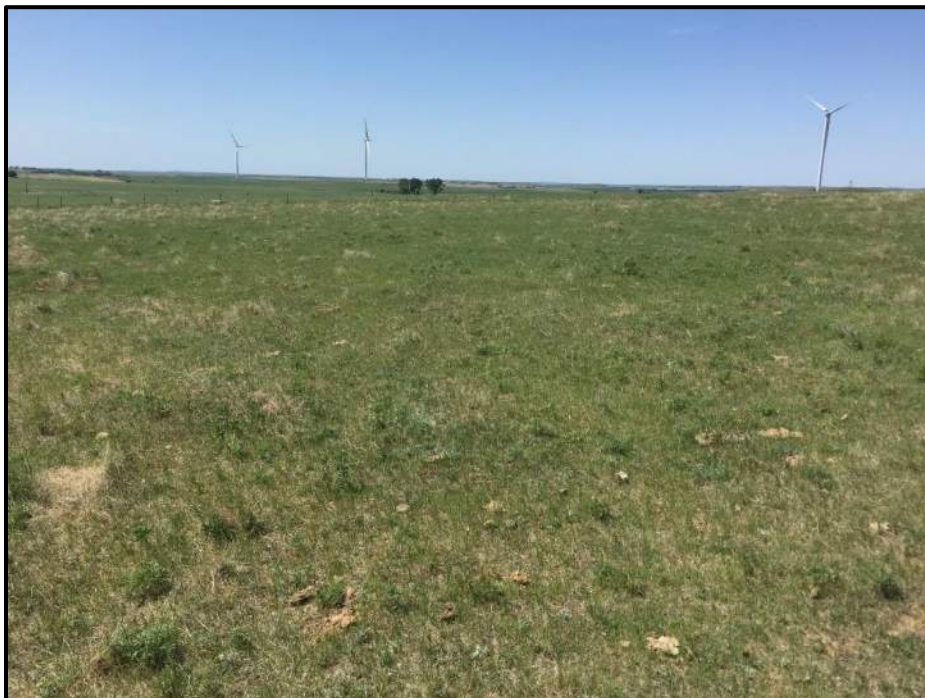
Decompaction and re-seeding along the crane walk path were specifically noted in the NDPSC Reclamation Memo. The crane walk path crosses through rolling native pasture. Based on the site visit, the entire crane walk path had excellent vegetative cover (70-90% absolute cover), with an abundance of the native species western wheatgrass, sun sedge (*Carex inops*), little bluestem (*Schizachyrium scoparium*), field sagewort (*Artemisia ludoviciana*), and green needlegrass (**Photo 11-18**). There was no evidence of extensive or problematic soil compaction along the route, which would have been evident with a lower abundance of native vegetation. One location along the route had a subtle ridge approximately 5 feet long and 2-3 inches high that was formed by the crane compacting the soil (**Photo 15**). The short length and low height of the ridge should not pose a hazard or impediment to livestock or vehicles and is similar to natural features throughout the pasture. In comparison to the surrounding site, the crane walk path appears to have been restored to as near as is practicable to the condition as it existed prior to the beginning of construction. No further action is recommended.

Photo 18. Facing: Southeast. Location: 47.036189, -101.708947
View of the northernmost extent of the crane walk path.
