As-Built Inspection Report

Desktop Trees & Shrubs Review

Dakota Access Pipeline

ND PSC Case No. PU-14-842

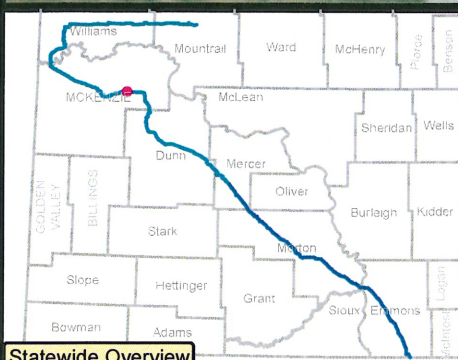
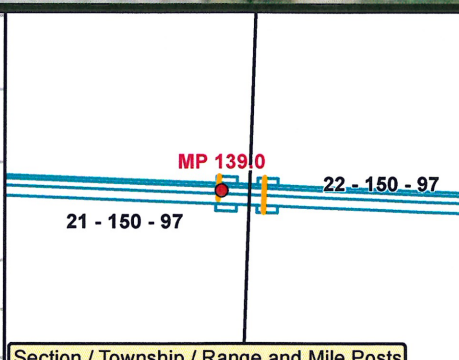
Appendix A contains examples of three of the 83 sites identified. These maps explain the methodology employed to use aerial photography for this study to determine potential violations.
