STATE OF NORTH DAKOTA
PUBLIC SERVICE COMMISSION

Dakota Access, LLC
Dakota Access Pipeline Project
Siting Application

Case No. PU-14-842

STAFF MEMORANDUM IN RESPONSE TO OPENED INVESTIGATION

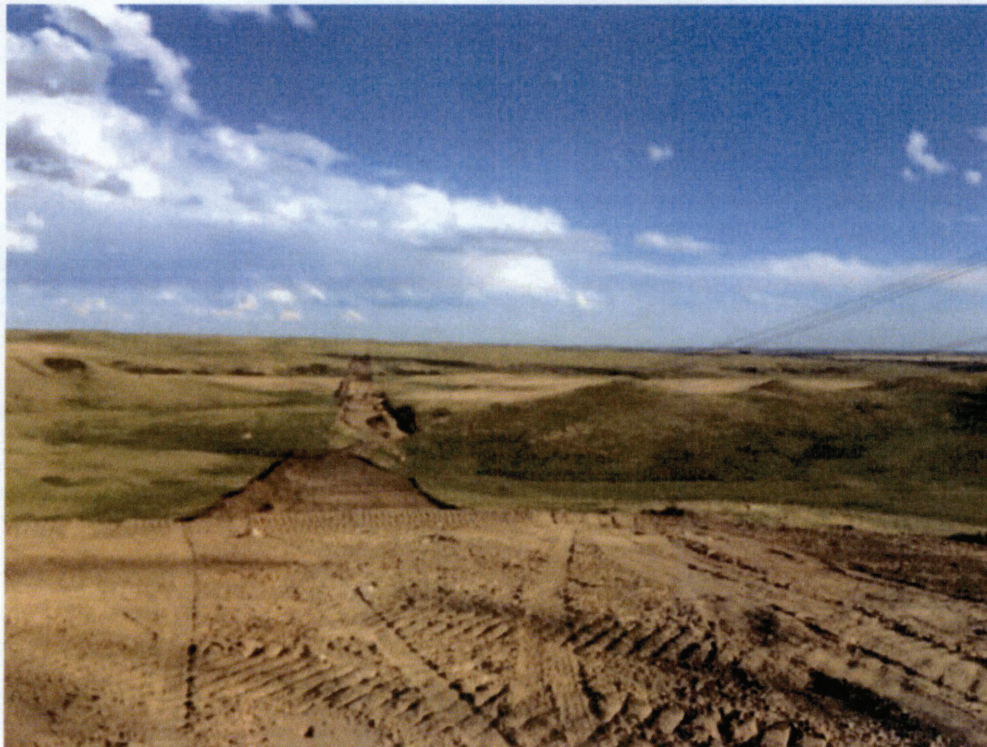
¹⁷ Docket No. 282, pg. 21. T.134N, R. 78W, Sec. 16,21, and 22. An email after reviewing the information from Keitu confirmed that the reroute occurred outside of the location of the route provided to Keitu in January of 2016, but corresponded to the location associated with later reroutes submitted to the Commission after the field inspection.

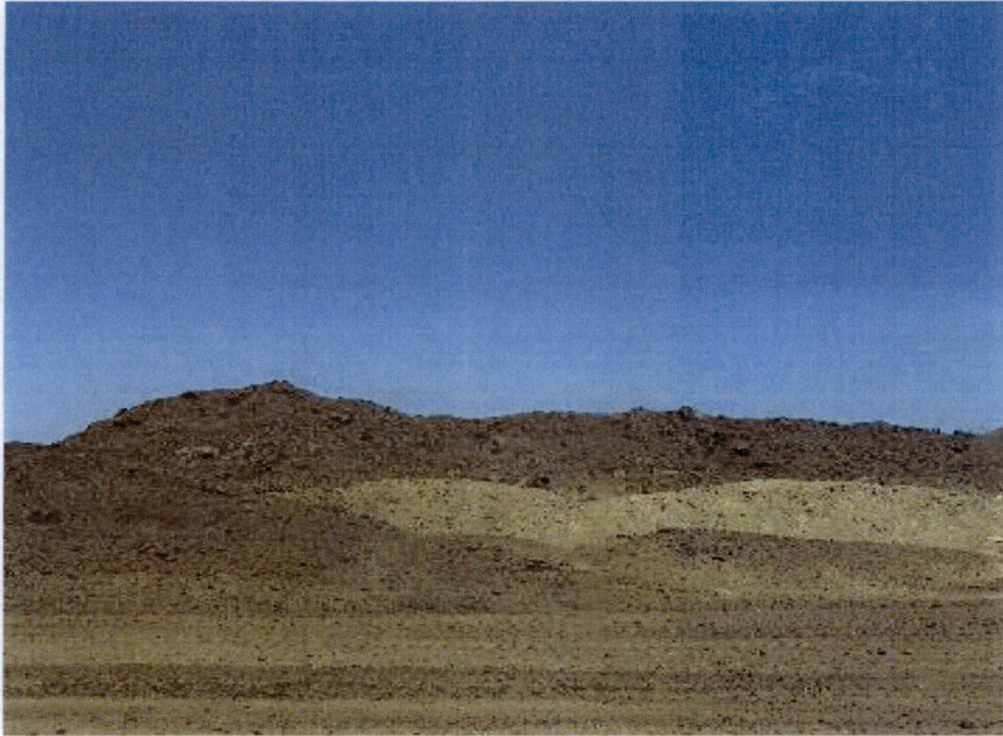
- 5. May 20, 2016 – MP 167-170 in Emmons County near Cannonball –** An inspection showed many areas of excessive subsoil mixed with topsoil and subsoil piles touching topsoil piles.⁴² Topsoil segregation was found to be not adequate. Keitu inspector advised the third party coordinator to notify construction crews that there was insufficient segregation of topsoil and subsoil. Due to the inspection being from the same MP area in follow-up of the May 19, 2016 inspection, there is a redundant use of a documented picture.
