**RE: Hess Corporation Depth of Cover River Crossing North Shore
Tree and Shrub Installation & Survival Rate Report**

2023 HESS DEPTH OF COVER RIVER CROSSING NORTH SHORE TREE AND SHRUB INSTALLATION & SURVIVAL RATE REPORT

Field Verification: Week of July 24, 2023

Report Issuance: September 8, 2023

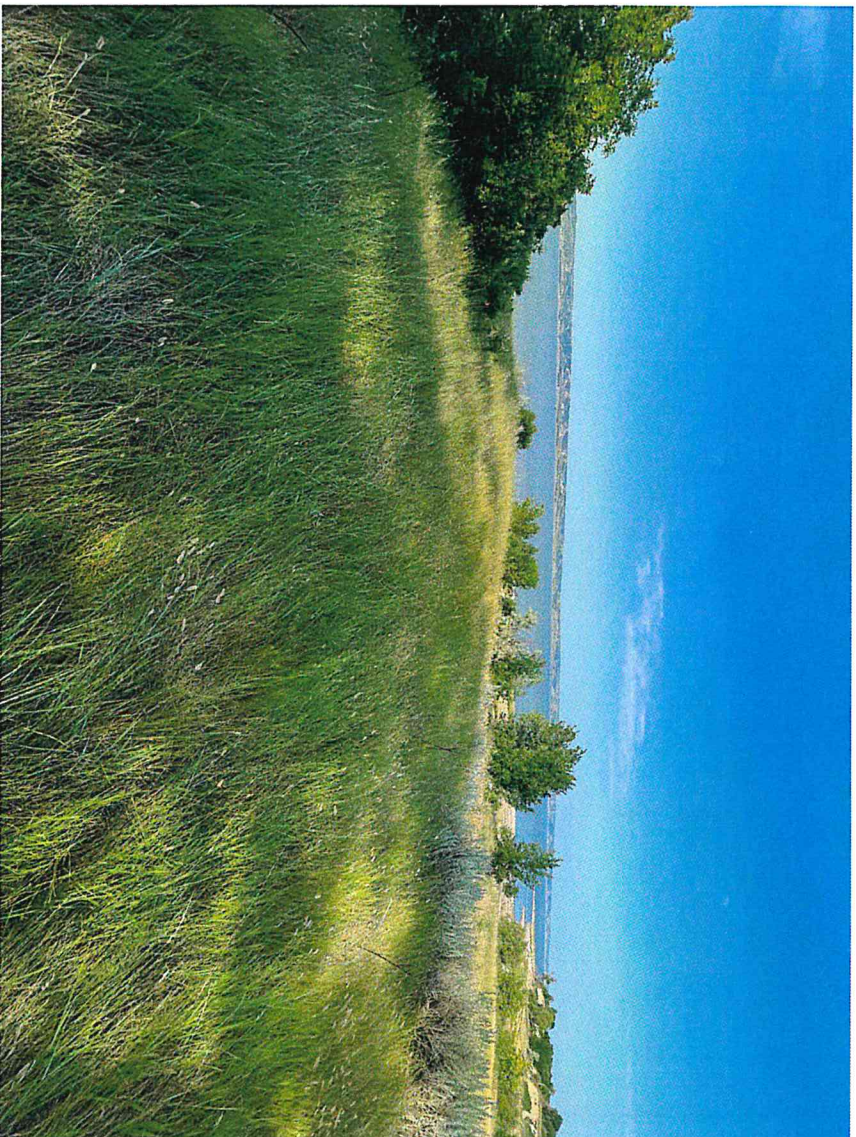
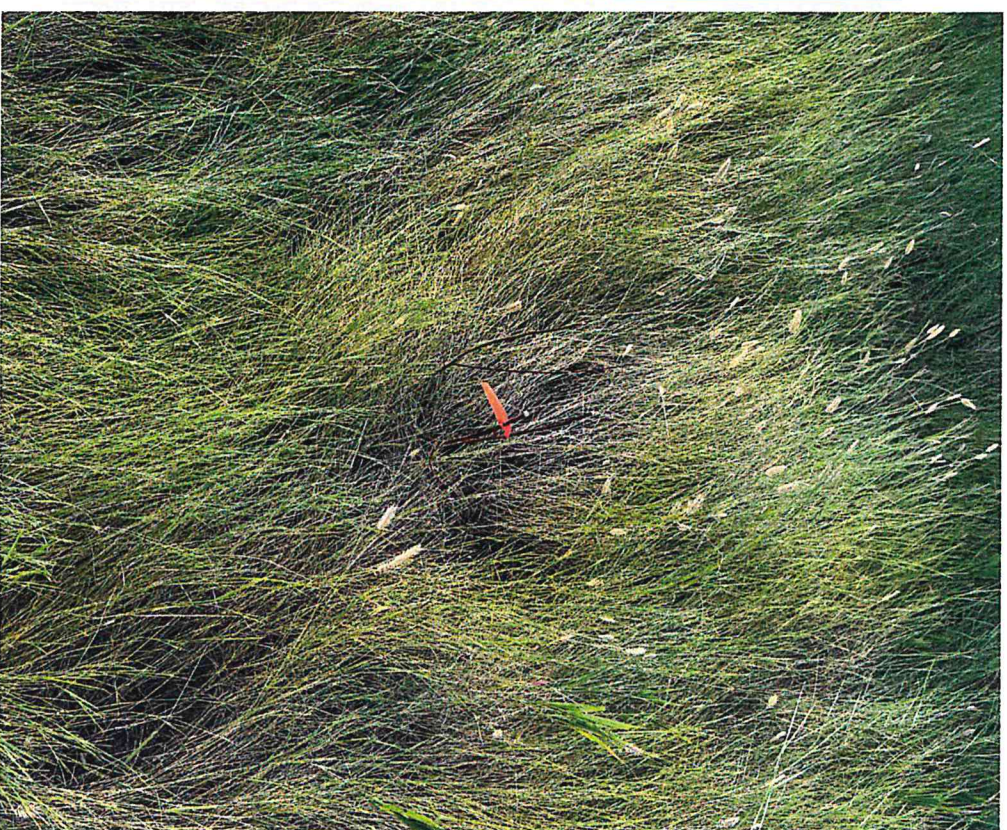
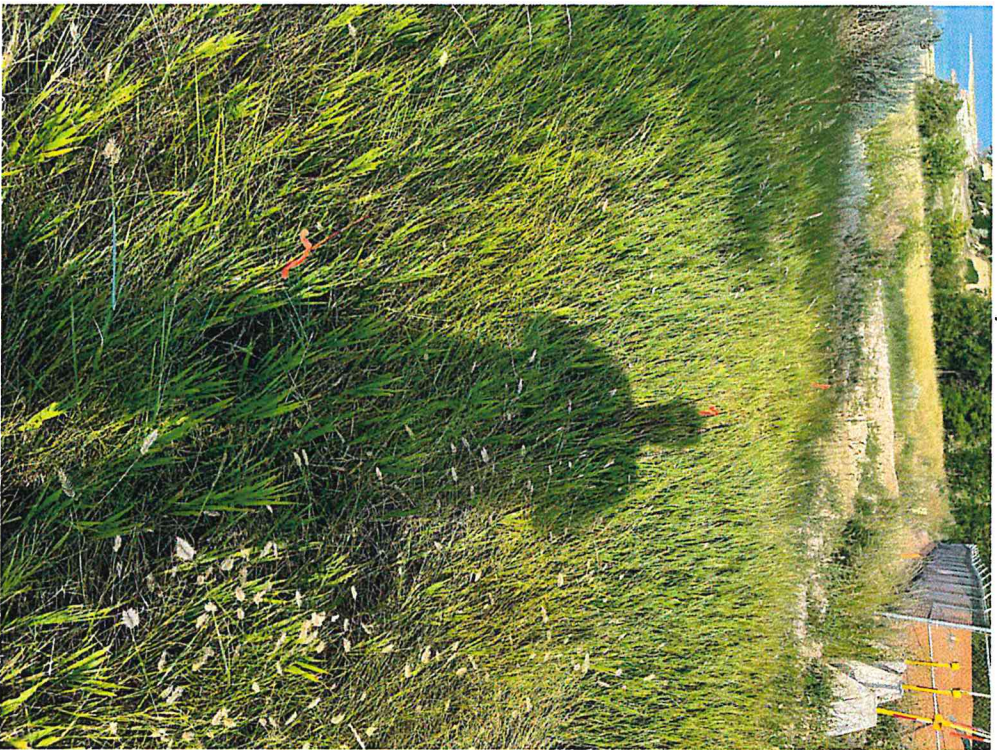
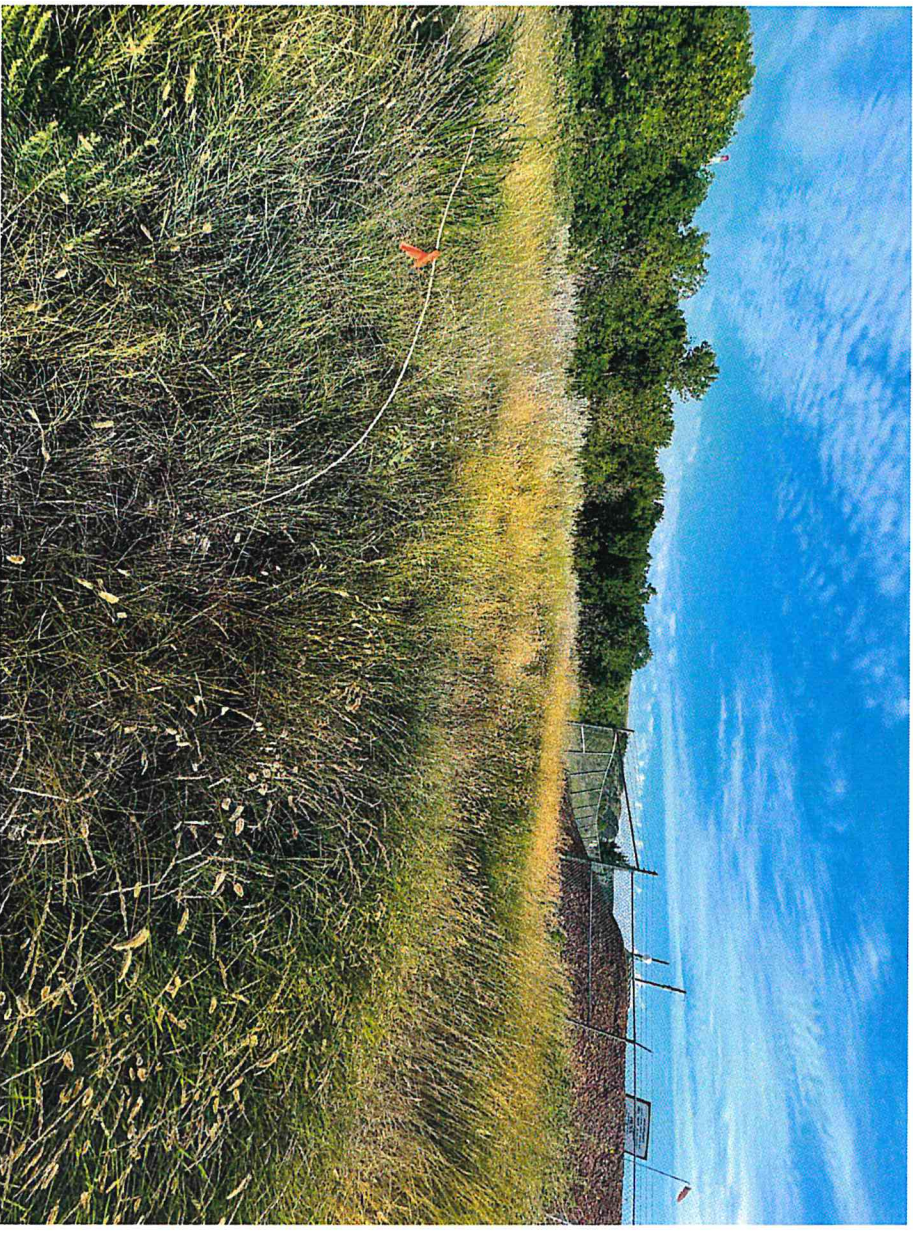
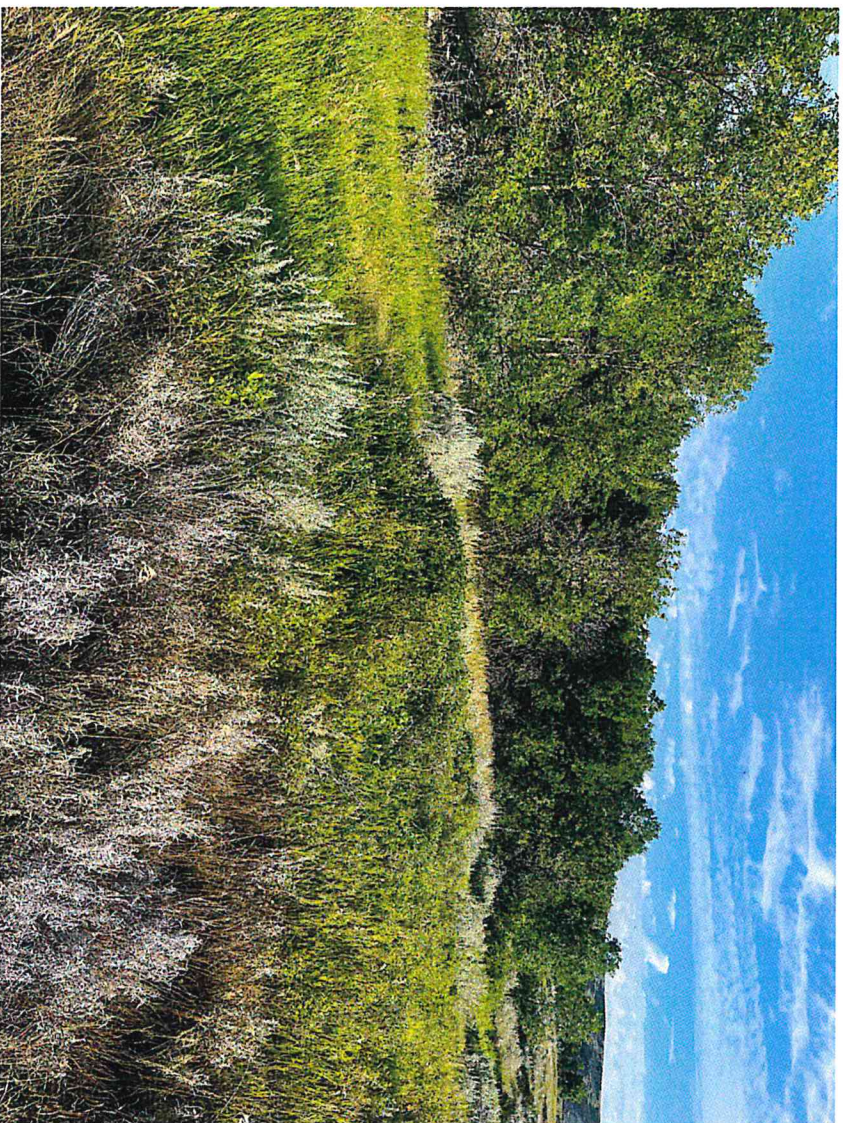
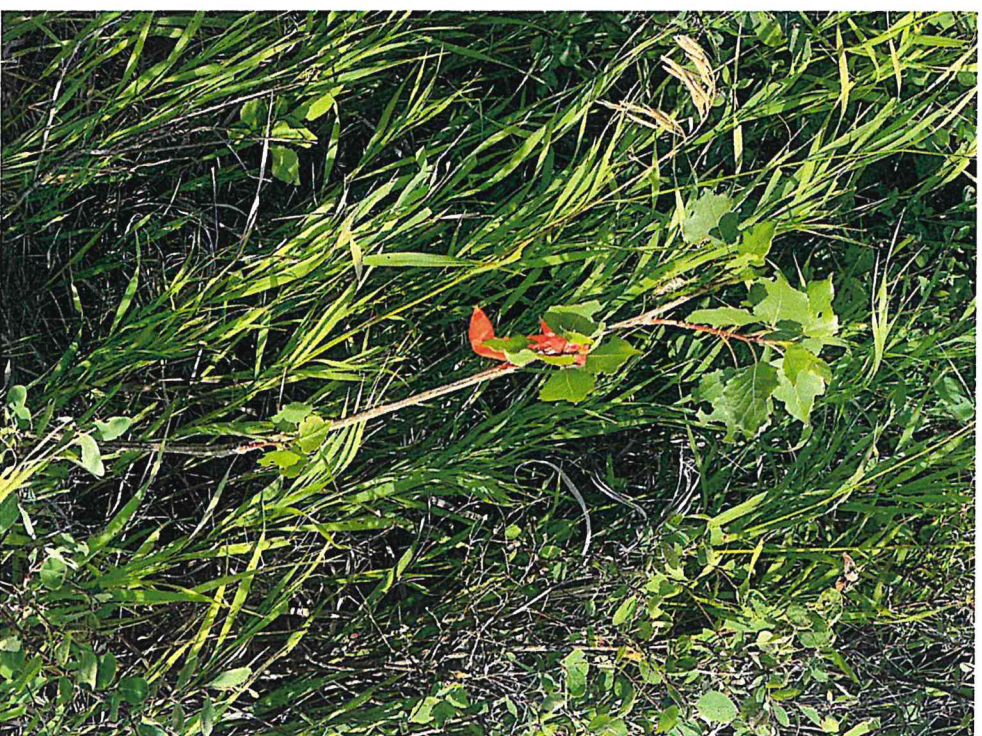
After Tree/Shrub Installation Pictures (2022)

During the week of July 24, 2023, an inventory of trees and shrubs was conducted to determine the health of the June 2022 replacement process and to ensure a greater than 75% survival rate. It was determined that there was an 82% survival rate. Unfortunately, shortly after initial plantings, some of the species in rows 10-18 succumbed to animal predation. During year 2 (Summer 2024) of the inventory process of said plantings, trees/shrubs will be reevaluated. Table 2 lists the tree/shrub planting survival rate. Appendix D presents the pictures post construction (2021), after installation (2022) and after survival rate assessment (2023).
