Bridger Crude Oil Loop Pipeline Project Topsoil Inspection Report PU-15-097

Prepared for:
**North Dakota
Public Service Commission**

Prepared by:

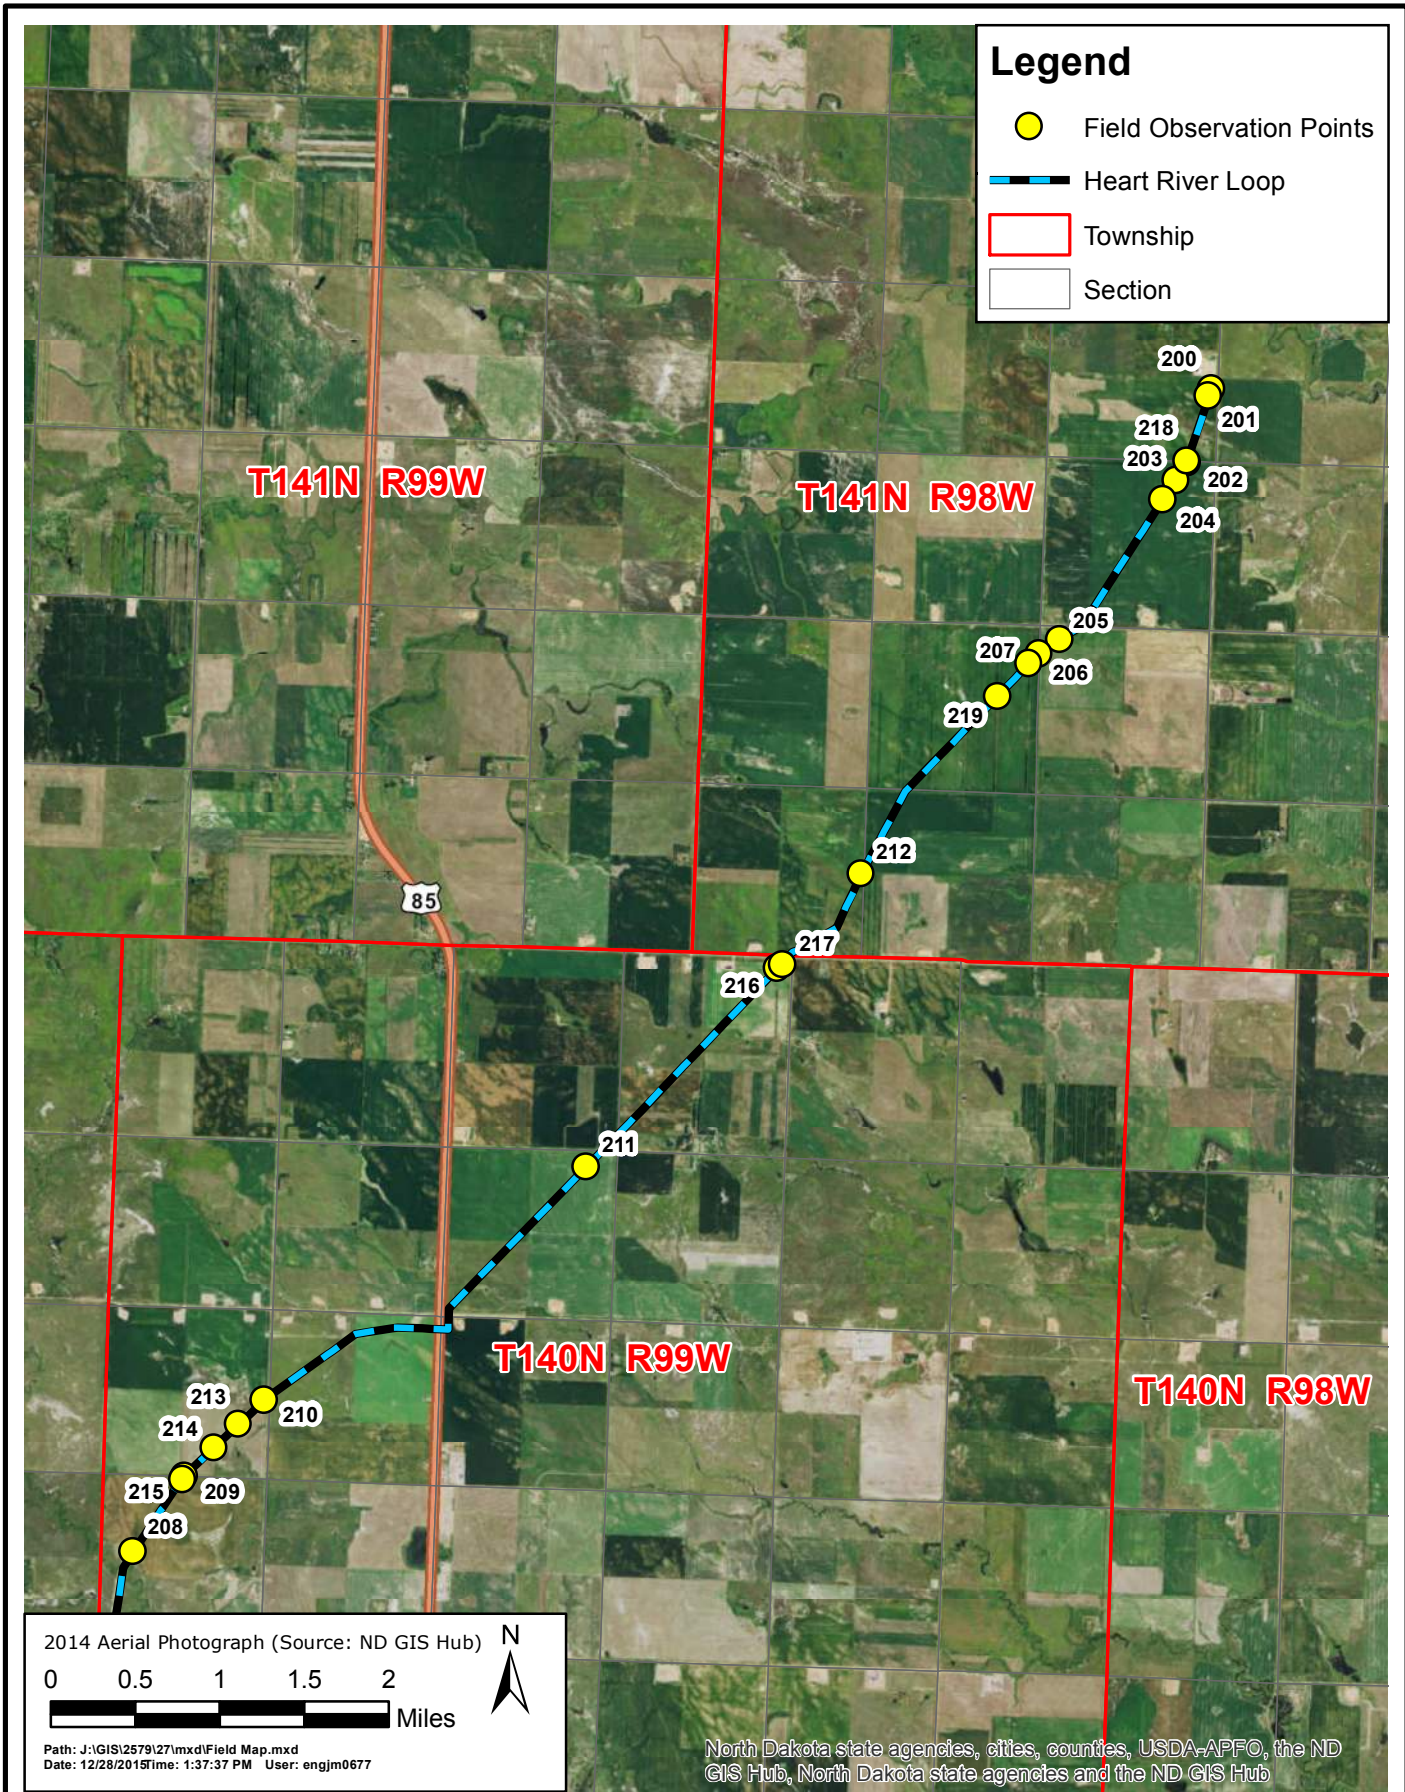
Map of Project and Observation Points

When the topsoil inspection of the project was conducted, there was one location where the subsoil pile was observed touching the topsoil pile at a bell hole location (Observation Point 217, **Appendix A, Figure 1 and Appendix C**). Contractors/equipment operators need to take special care in this area not to mix the topsoil and subsoil. Wenck recommends monitoring and documentation of this area to ensure vegetation becomes established after reclamation.

White crusts on the soil were observed on some areas (Observation Point 210, **Appendix A, Figure 1 and Appendix C**) of the pipeline. During reclamation and revegetation of these areas, a seed mix using species of the undisturbed surrounding alkaline areas should be considered or perhaps a saline-alkaline seed mix. Along with soil amendments and irrigation management, such as frequent irrigation that provides drainage to avoid build up of salinity. Wenck recommends monitoring and documentation of this area to ensure the vegetation becomes established after reclamation.

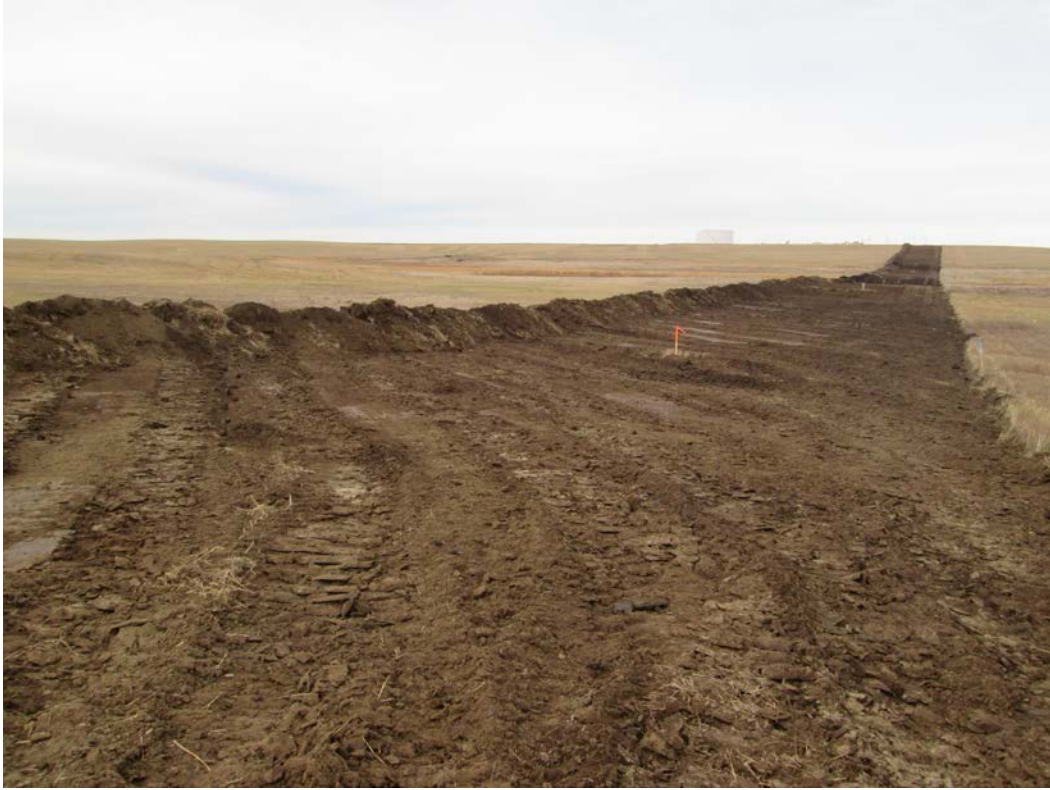
Above: Photo 5 (pt. 202) – Direction looking north towards Skunk Hill. Topsoil stripped.

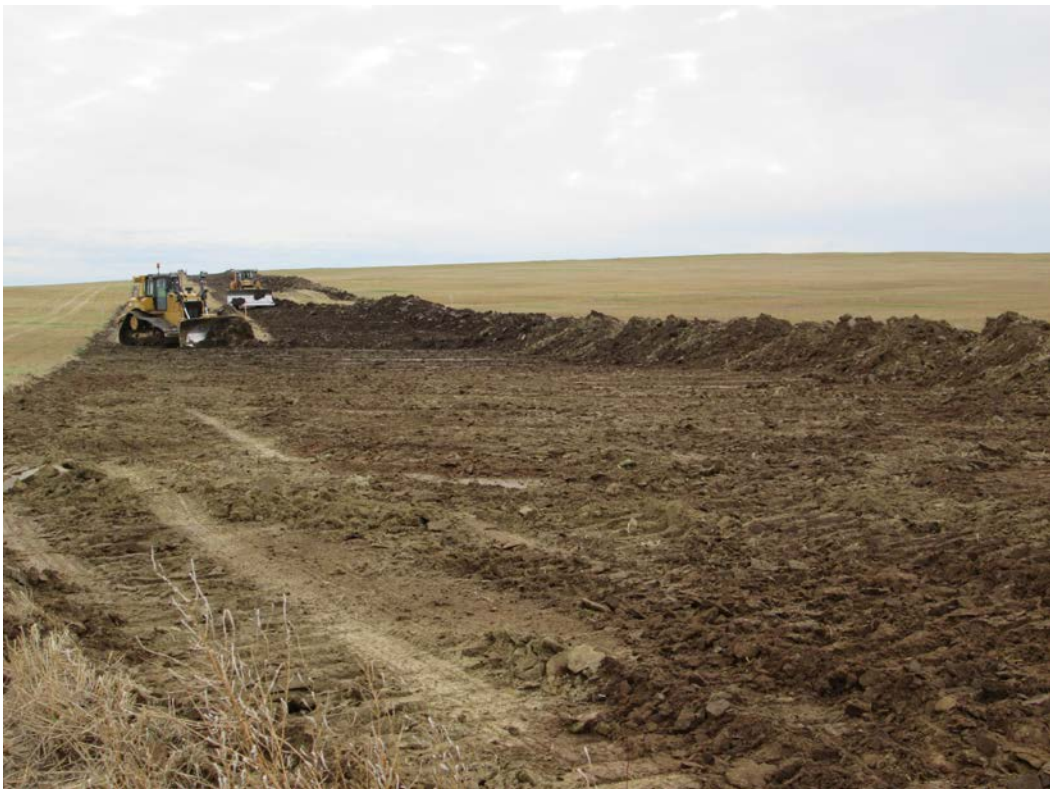
Below: Photo 6 (pt. 202) – Direction looking south. Topsoil being stripped.

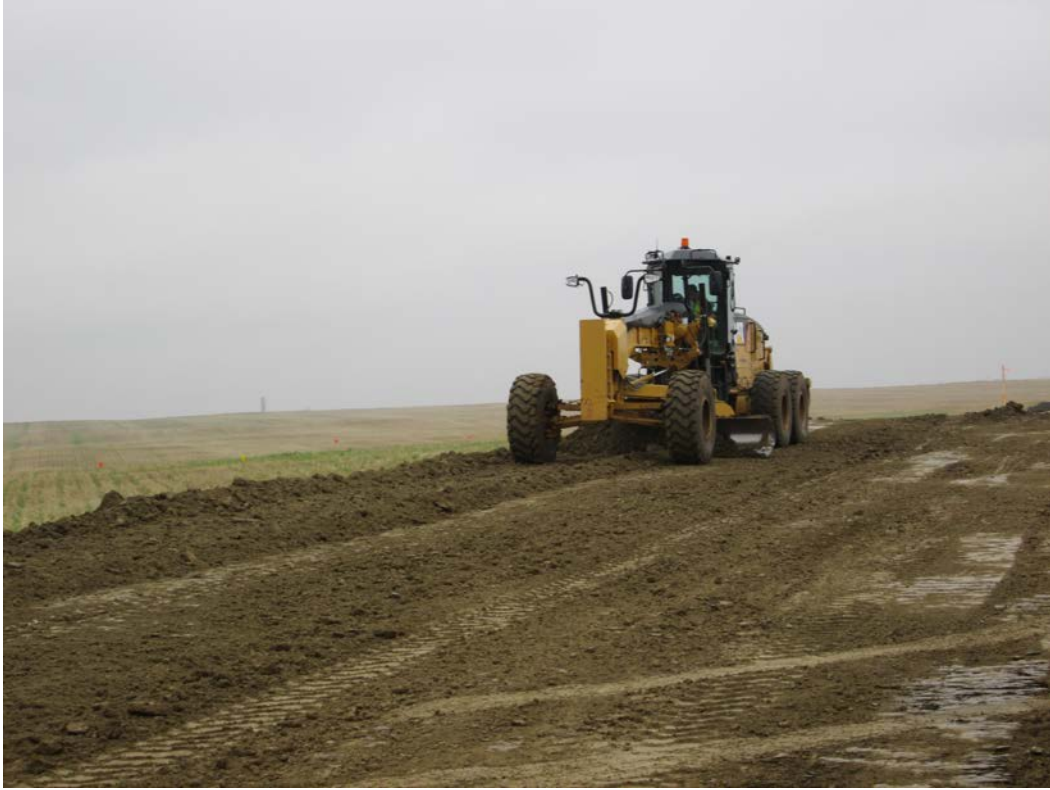
Above: Photo 7 (pt. 204) – Direction looking south. Topsoil stripped, area being finished (leveled off, smoothed and flattened).

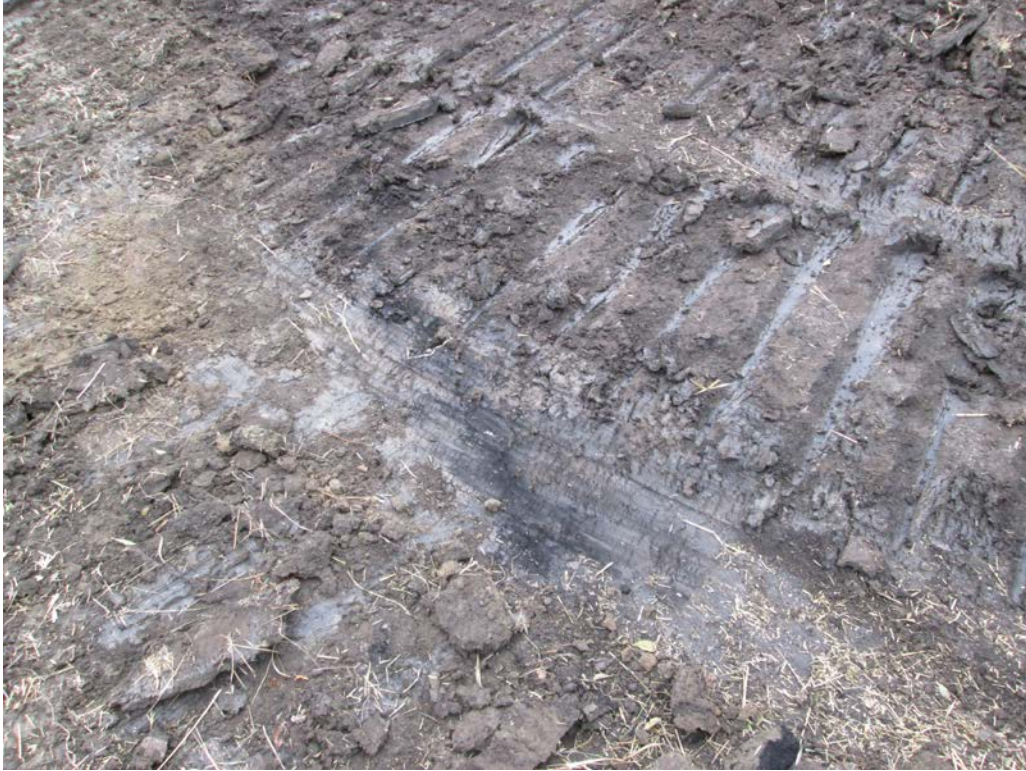
Equipment operators noticed a coal vein running through the ROW; this was found within the top approximate 4 inches of the soil profile (**Appendix A, Photo 9**). Operators took less topsoil from this area, so as not to mix coal with topsoil.

Above: Photo 9 (pt. 207) – Coal vein observed approximately 4 inches deep. Less topsoil was stripped in this small area, as to not mix coal with soil.

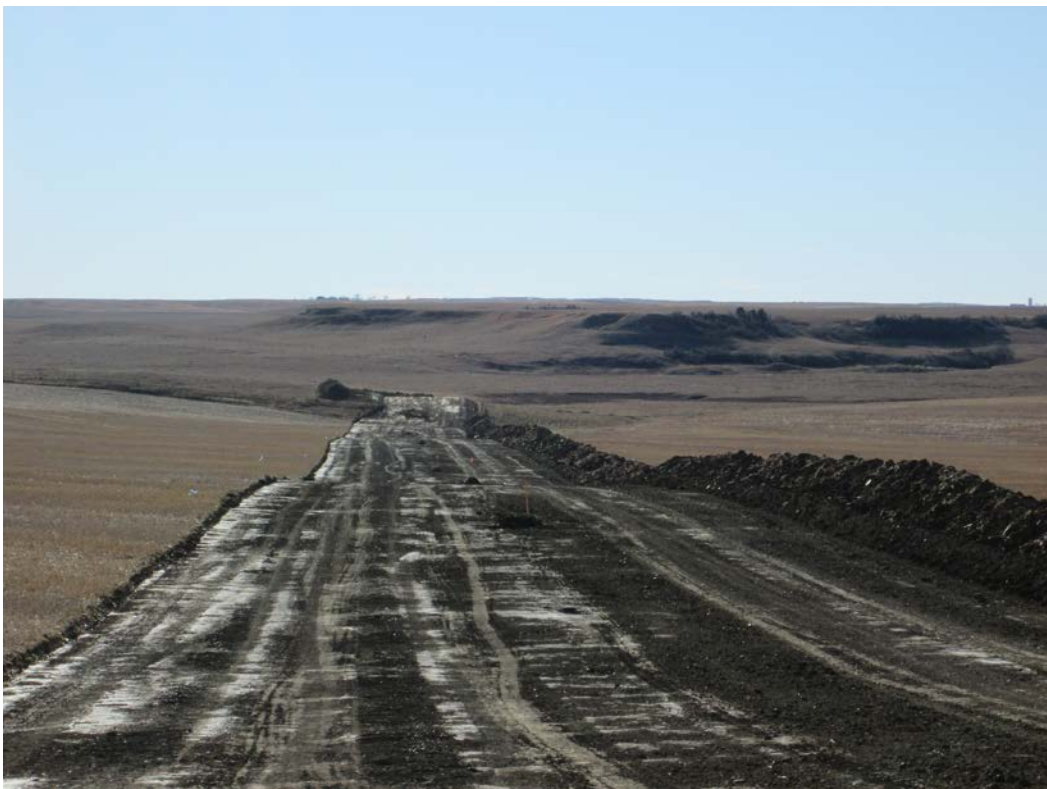
Below: Photo 10 (pt. 208) – Topsoil stripped; can see area that was side-sloped/two-toned in the distance. Topsoil was moved to opposite side; ROW area was leveled. Looking southwest.

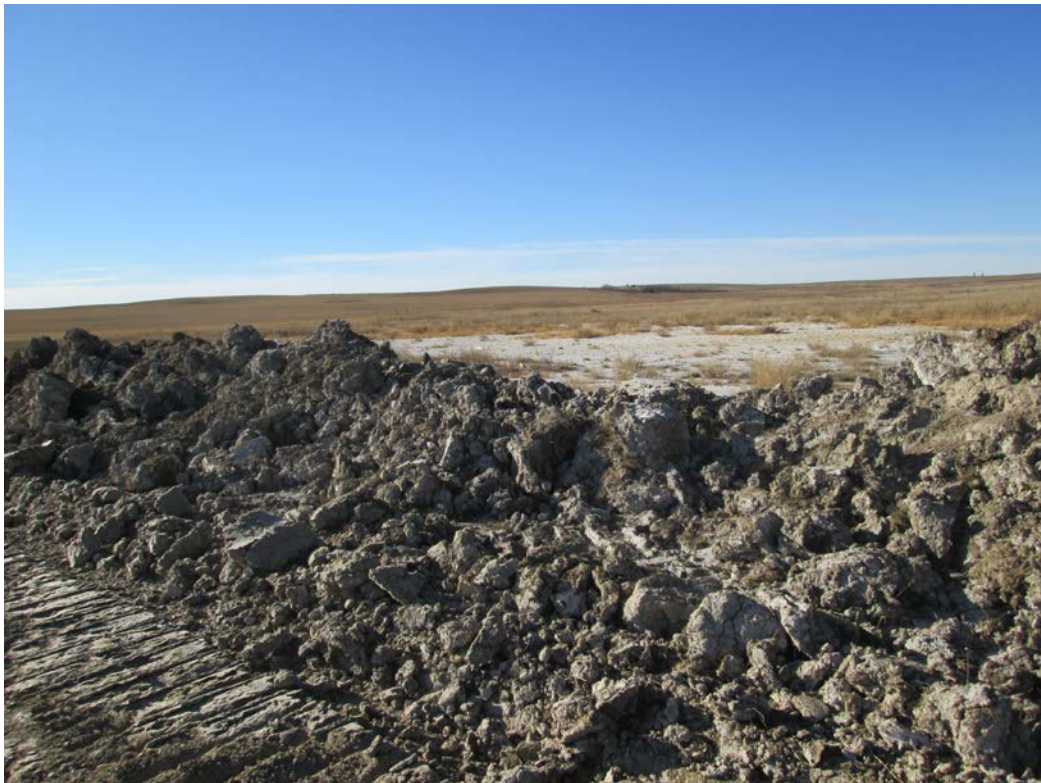
Above: Photo 15 (near pt. 210) – ROW topsoil has been removed. Topsoil piles were moved away from low area of landscape, in case of drainage. Looking northwest.

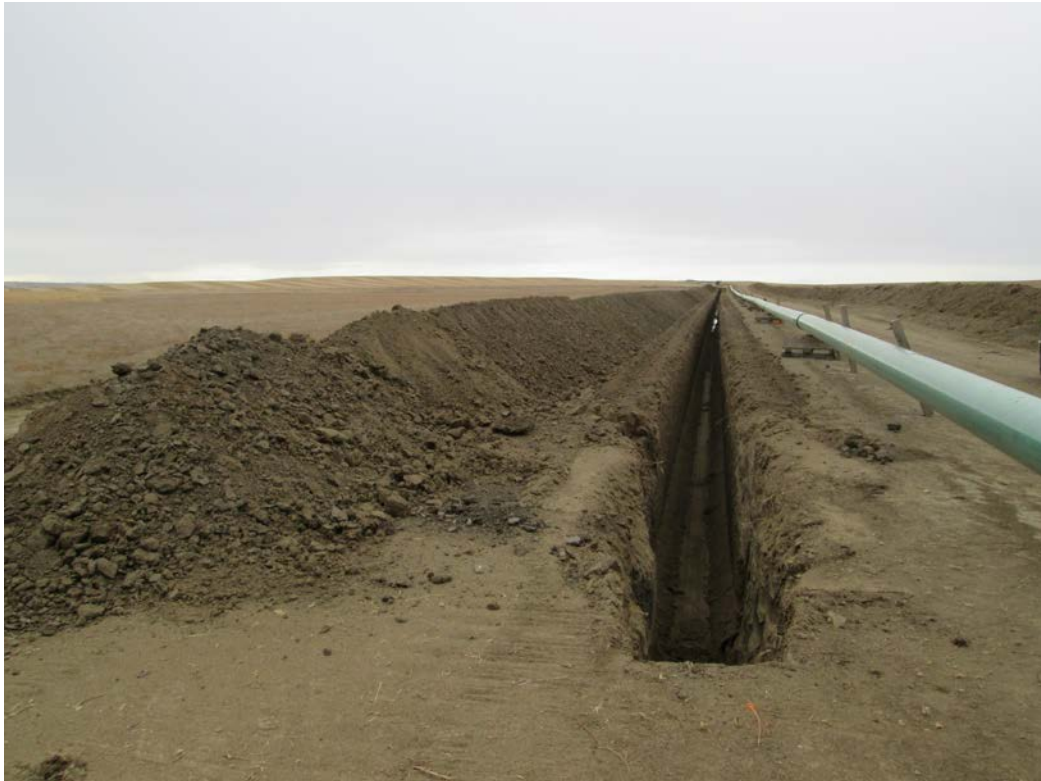
Above: Photo 19 (pt. 213) – Trench. Subsoil pile to the left.

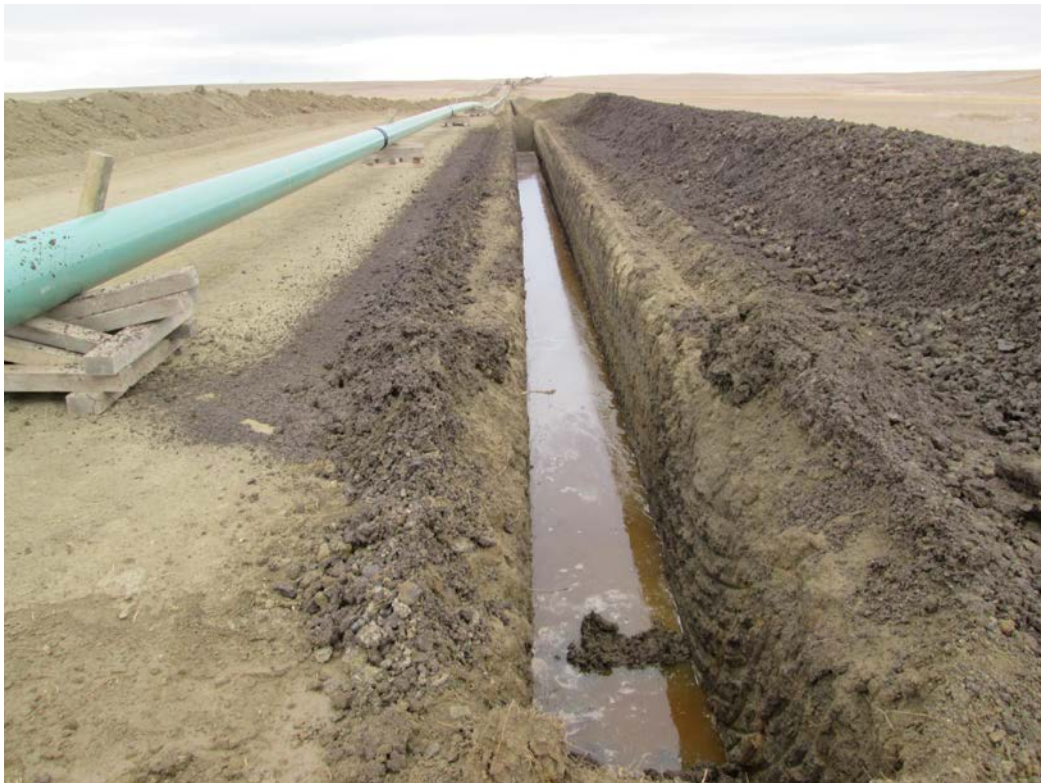
Above: Photo 21 (pt. 215) – Trenching machine removing subsoil. Subsoil pile to the left. Looking south.

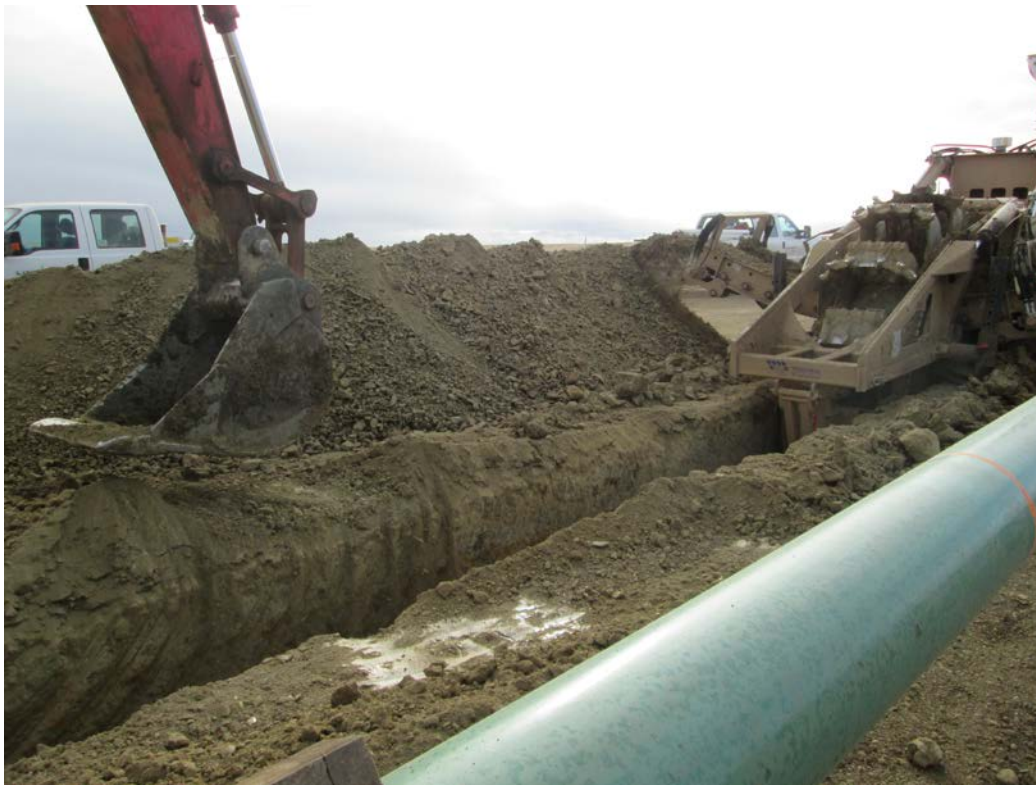
Below: Photo 22 (pt. 215) – Trenching machine removing subsoil. Subsoil pile to the left. Looking south.

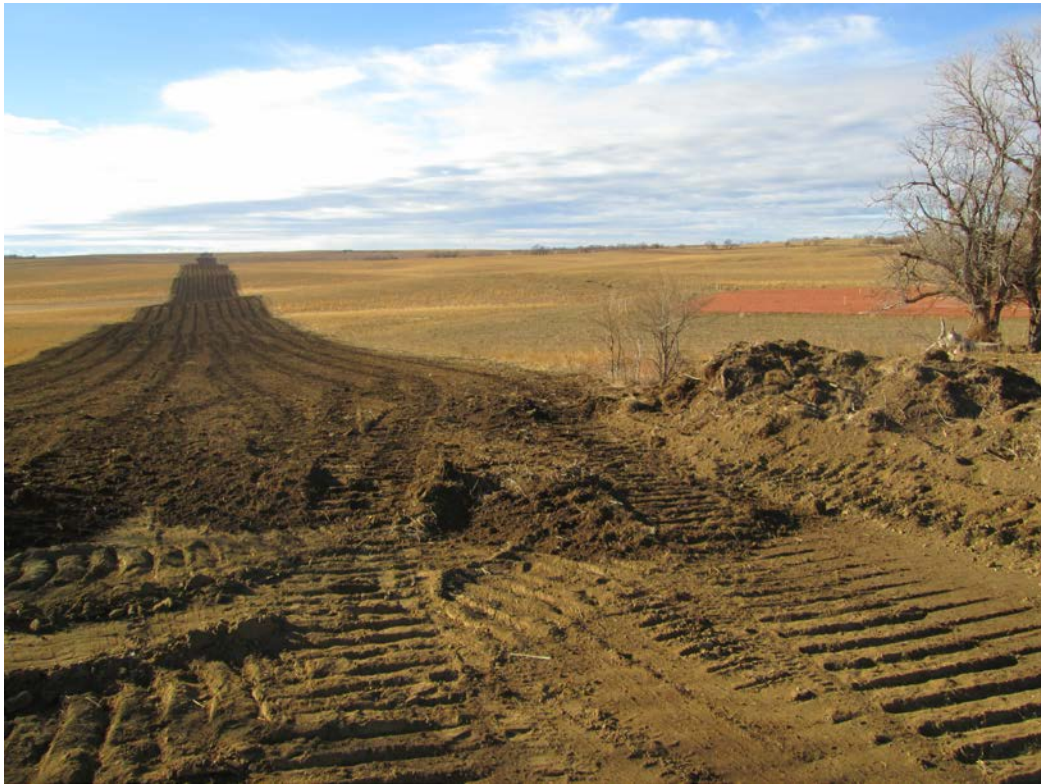
Above: Photo 25 (pt. 216) – Topsoil replaced. Lighter colored subsoil at very bottom of photo where topsoil has not been replaced yet. Looking southwest.

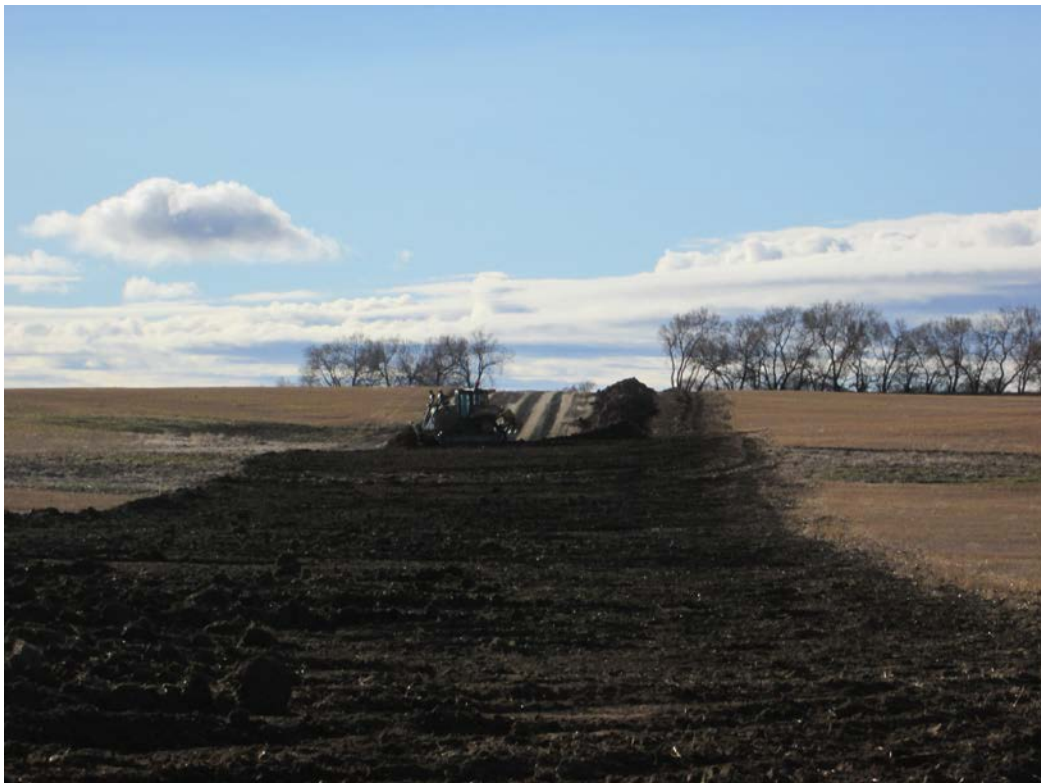
Below: Photo 26 (pt. 219) – Dozer replacing topsoil back over ROW ground. Looking southwest.
