Sacagawea 16-inch Pipeline Project Revegetation Inspection Report PU-15-114

Prepared for:
**North Dakota
Public Service Commission**

WENCK Associates, Inc.
301 1st Street NE, Suite 202
Mandan, ND 58554
Phone: 701-751-3370
Fax: 763-479-4242

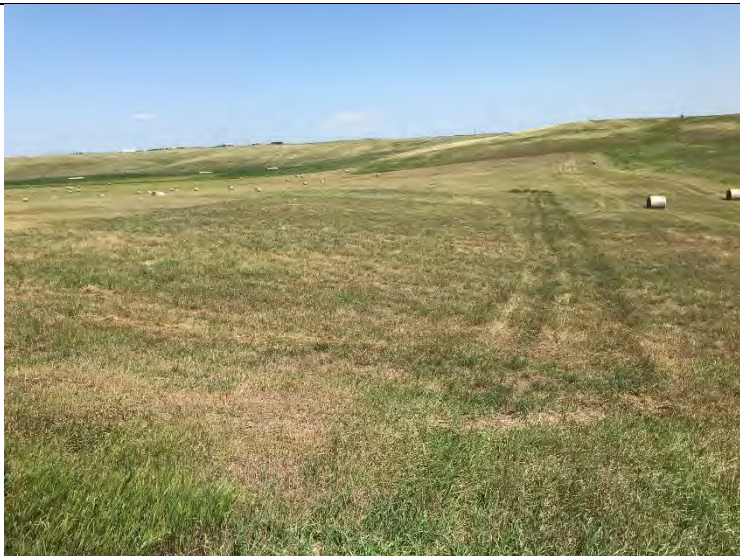
Observation Point: 687

Photo Description: Hayland of alfalfa and grass at 50-75% cover. Grasses included sideoats grama, western wheatgrass, and green needlegrass.
