Appendix A

Aerial View Station 0+00 thru Station 31+82

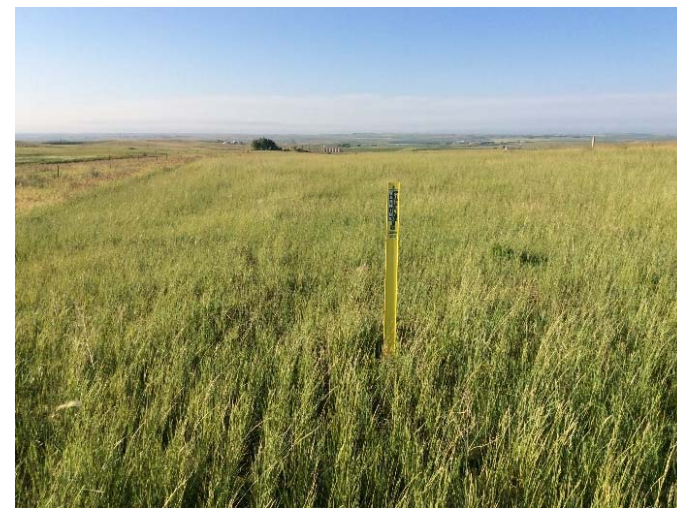
Below is an example of the rehabilitation efforts south of station 204+38 through Mr. Larry Novak first section of property.
