**Re: Citizen Complaint of Casey Voigt**

### INSPECTION REPORT

PERMITTEE - MINE: Coyote Creek Mining Company, L.L.C. - Coyote Creek Mine

PERMITS INSPECTED: NACC-1301 and NACC-1302

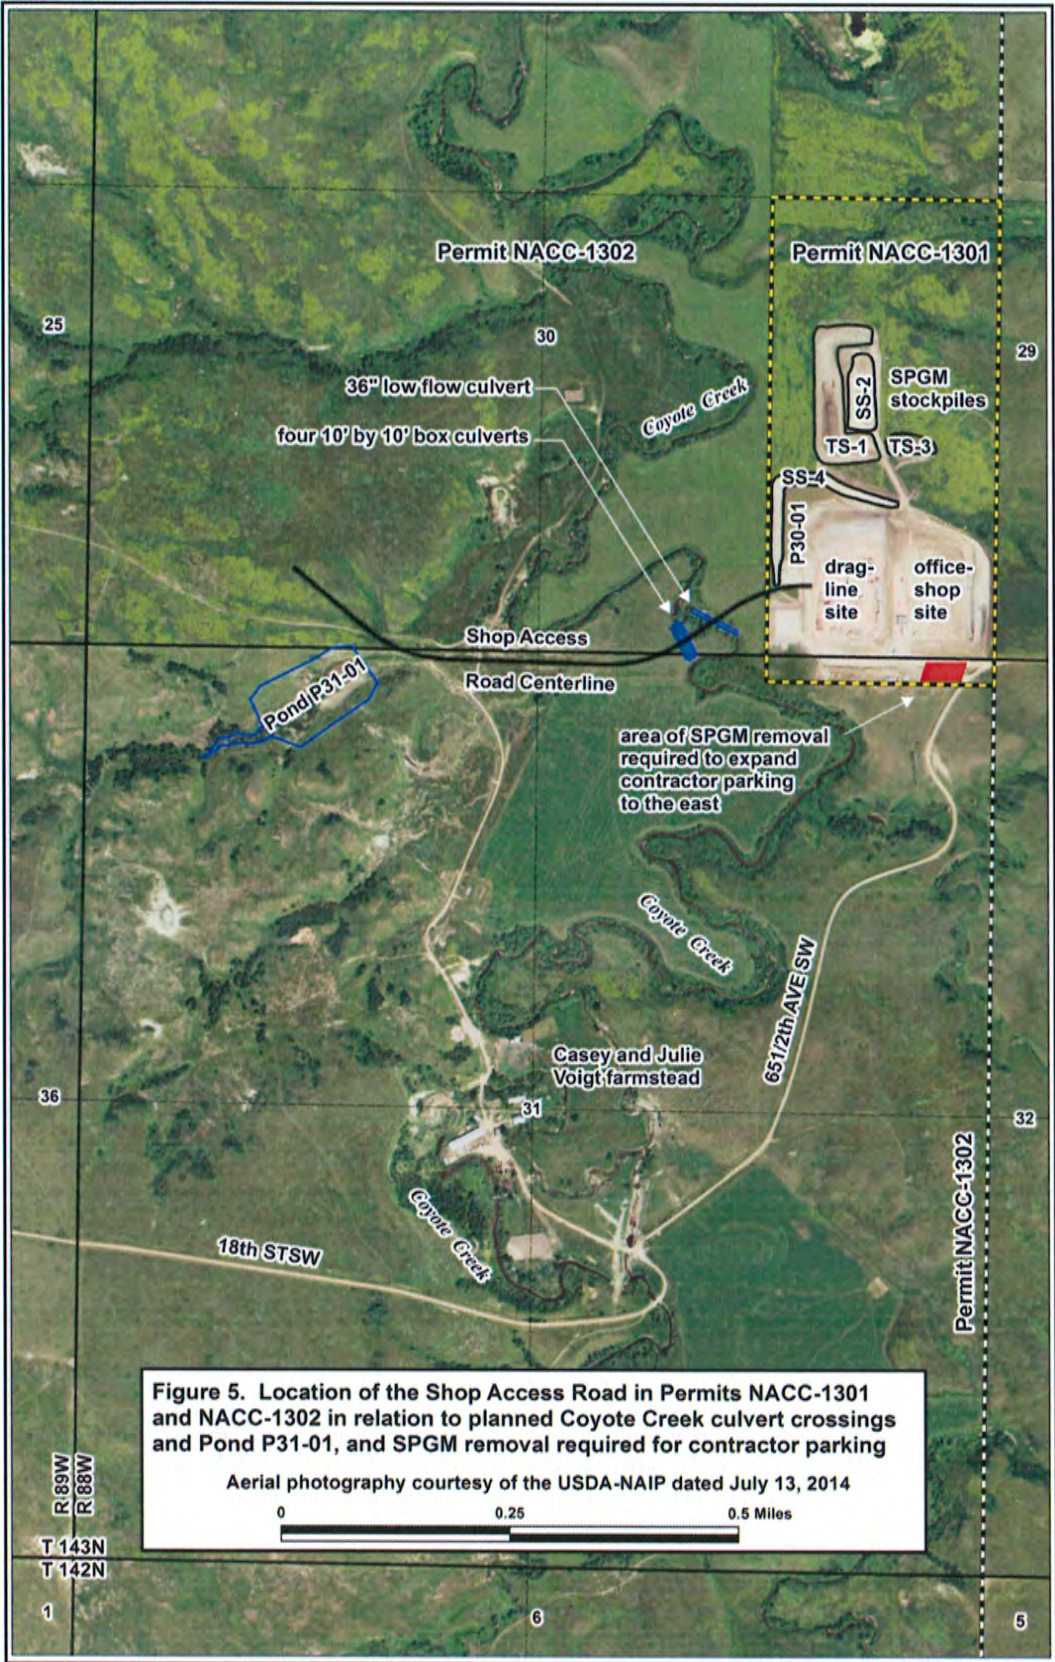
Culvert installation for the Shop Access Road Coyote Creek crossings was also viewed while viewing SPGM removal for a four acre segment of the Shop Access Road on both sides of Coyote Creek as previously described. At the time of inspection, the 36 inch low flow steel culvert was being installed as pictured in Figure 4. It should be noted that the approved design for the 36 inch culvert depicts a slight angle near the culvert's midpoint. The design was revised to depict a straight culvert with the application of Revision No. 1 to Permit NACC-1302 that is under review. The proposed design change was approved by the commission via email correspondence on March 19, 2015 and it received U.S. Army Corps of Engineers concurrence on March 20, 2015. Please refer to Figure 5 for the culvert types and locations for the Shop Access Road Coyote Creek crossings. Installation of the 36 inch low flow steel culvert would need to be completed no later than April 14<sup>th</sup> because CCMC's Regional General Permit from the U.S. Army Corps of Engineers does not allow regulated activity in Coyote Creek from April 15<sup>th</sup> to June 1<sup>st</sup>. Installation of the four 10 foot by 10 foot box culverts will follow but it appears that they will not be installed to divert Coyote Creek flow until after June 1<sup>st</sup>. Mr. Steffen indicated SPGM removal will proceed westward along the Shop Access Road corridor toward the location for pond P31-01 after the 36 inch low flow steel culvert installation is complete. Overburden from pond P31-01 excavation will provide the fill necessary to achieve grade for the Shop Access Road.

Figure 4. Panorama of 36 inch low flow steel culvert installation in Coyote Creek for the Shop Access Road Coyote Creek crossing - facing west on left and rotating to face north on right with temporary culvert in place on center-right for equipment crossing – refer to Figure 5 for culvert location – note temporary topsoil stockpile in left background and a temporary subsoil stockpile in middle background – also note that dozer was in motion when photographs were taken
