PSC April 13, 2015 Inspection Report

INSPECTION REPORT

PERMITTEE - MINE: Coyote Creek Mining Company, L.L.C. - Coyote Creek Mine

PERMITS INSPECTED: NACC-1301 and NACC-1302

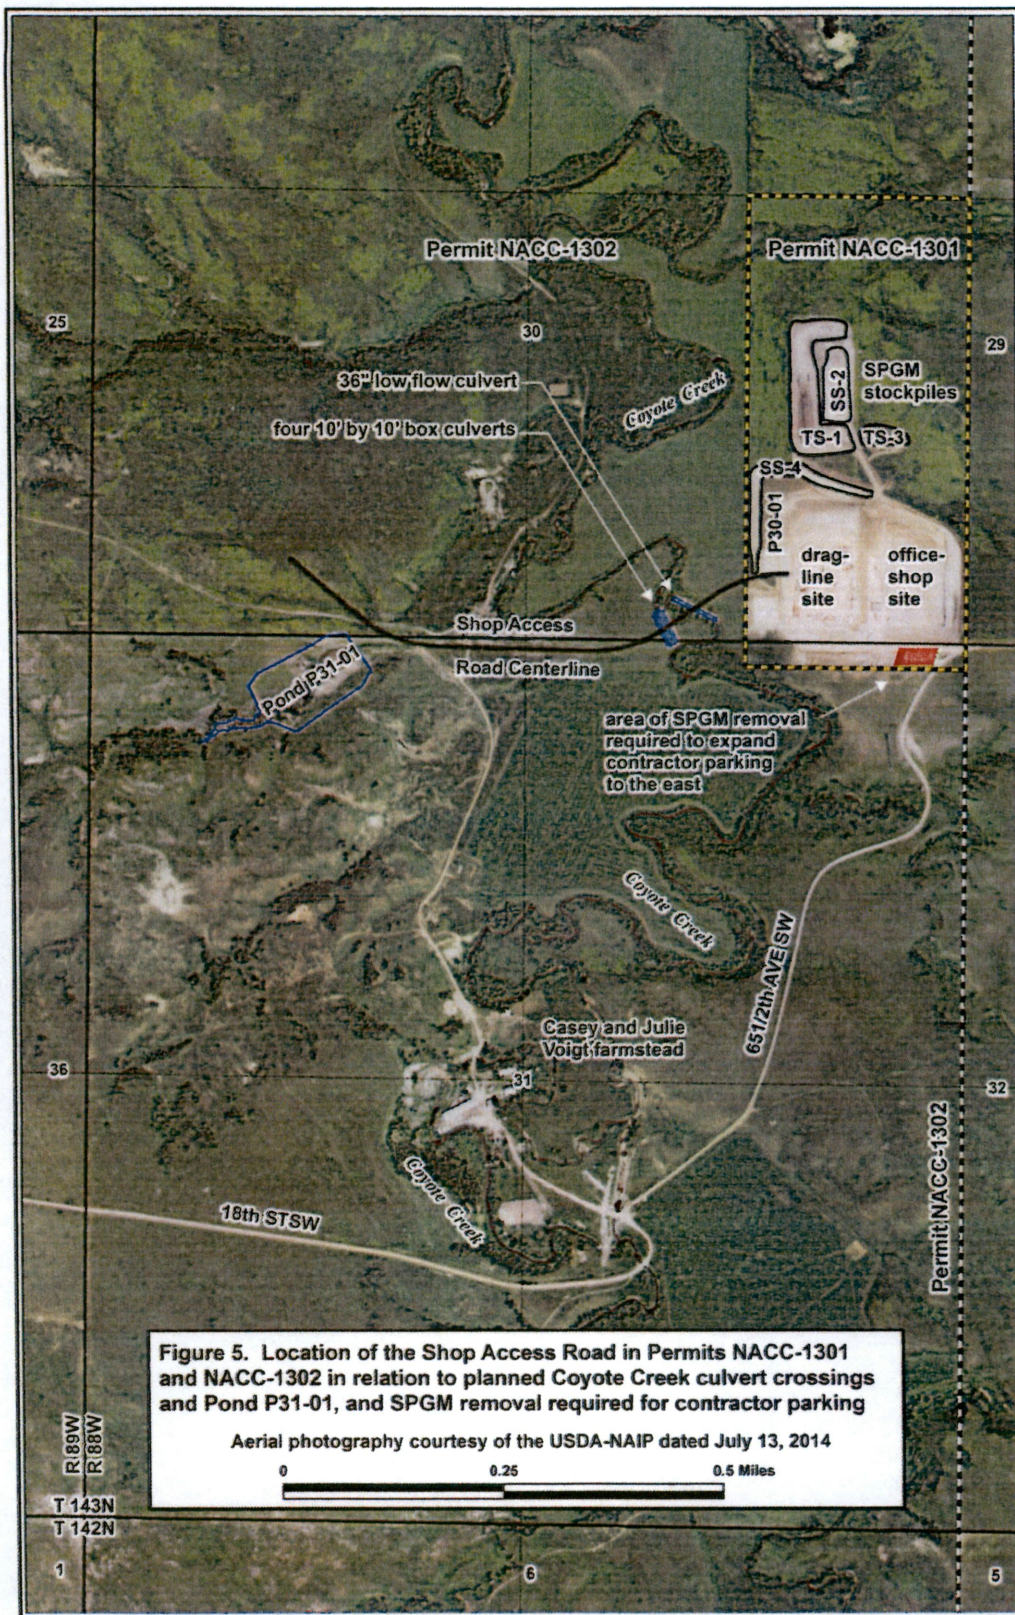
Culvert installation for the Shop Access Road Coyote Creek crossings was also viewed while viewing SPGM removal for a four acre segment of the Shop Access Road on both sides of Coyote Creek as previously described. At the time of inspection, the 36 inch low flow steel culvert was being installed as pictured in Figure 4. It should be noted that the approved design for the 36 inch culvert depicts a slight angle near the culvert's midpoint. The design was revised to depict a straight culvert with the application of Revision No. 1 to Permit NACC-1302 that is under review. The proposed design change was approved by the commission via email correspondence on March 19, 2015 and it received U.S. Army Corps of Engineers concurrence on March 20, 2015. Please refer to Figure 5 for the culvert types and locations for the Shop Access Road Coyote Creek crossings. Installation of the 36 inch low flow steel culvert would need to be completed no later than April 14th because CCMC's Regional General Permit from the U.S. Army Corps of Engineers does not allow regulated activity in Coyote Creek from April 15th to June 1st. Installation of the four 10 foot by 10 foot box culverts will follow but it appears that they will not be installed to divert Coyote Creek flow until after June 1st. Mr. Steffen indicated SPGM removal will proceed westward along the Shop Access Road corridor toward the location for pond P31-01 after the 36 inch low flow steel culvert installation is complete. Overburden from pond P31-01 excavation will provide the fill necessary to achieve grade for the Shop Access Road.

Figure 4. Panorama of 36 inch low flow steel culvert installation in Coyote Creek for the Shop Access Road Coyote Creek crossing - facing west on left and rotating to face north on right with temporary culvert in place on center-right for equipment crossing – refer to Figure 5 for culvert location – note temporary topsoil stockpile in left background and a temporary subsoil stockpile in middle background – also note that dozer was in motion when photographs were taken
