# Sacagawea Pipeline Co.

## Reclamation and Revegetation Inspection Report Palermo to Enbridge Crude Oil Pipeline

Case No. PU-15-670

*December 17, 2018*

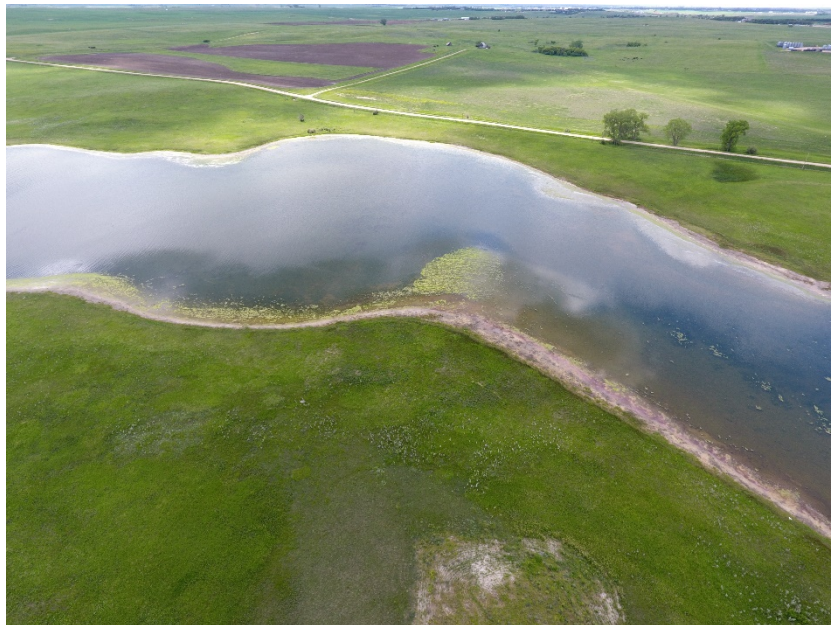
Location 18 (48.319378, -102.284782)  
Bore location

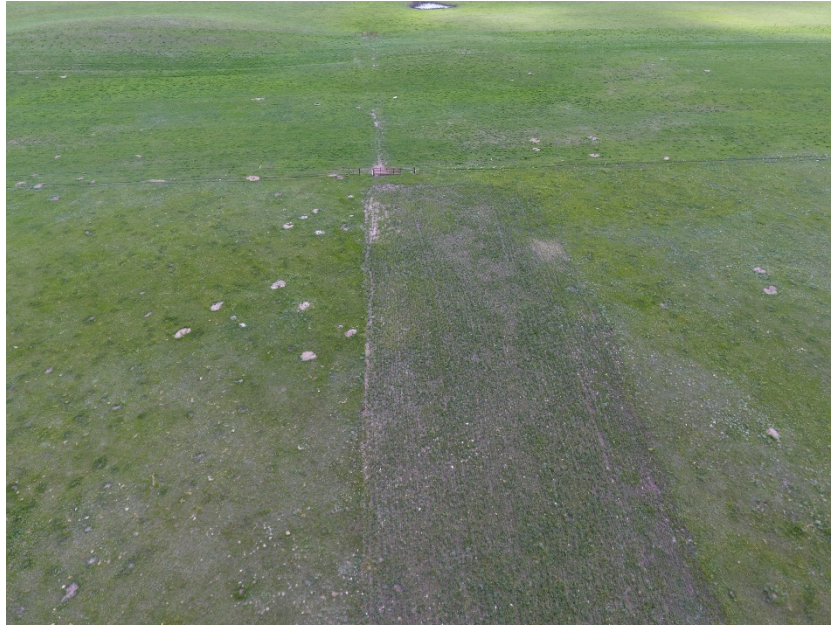
Location 22 (48.312489, -102.294922)

Location 22, page 20: Areas of thin growth and vegetation not closely matching the surrounding conditions. Near the middle of the picture, evidence can be seen of the existing vegetation growing into the reclaimed area. This is another area of concern that would be expected to improve with time.

Believed to be more recent reclamation work here than other areas
