ONEOK Bakken Pipeline Project Topsoil Inspection Report PU-15-801

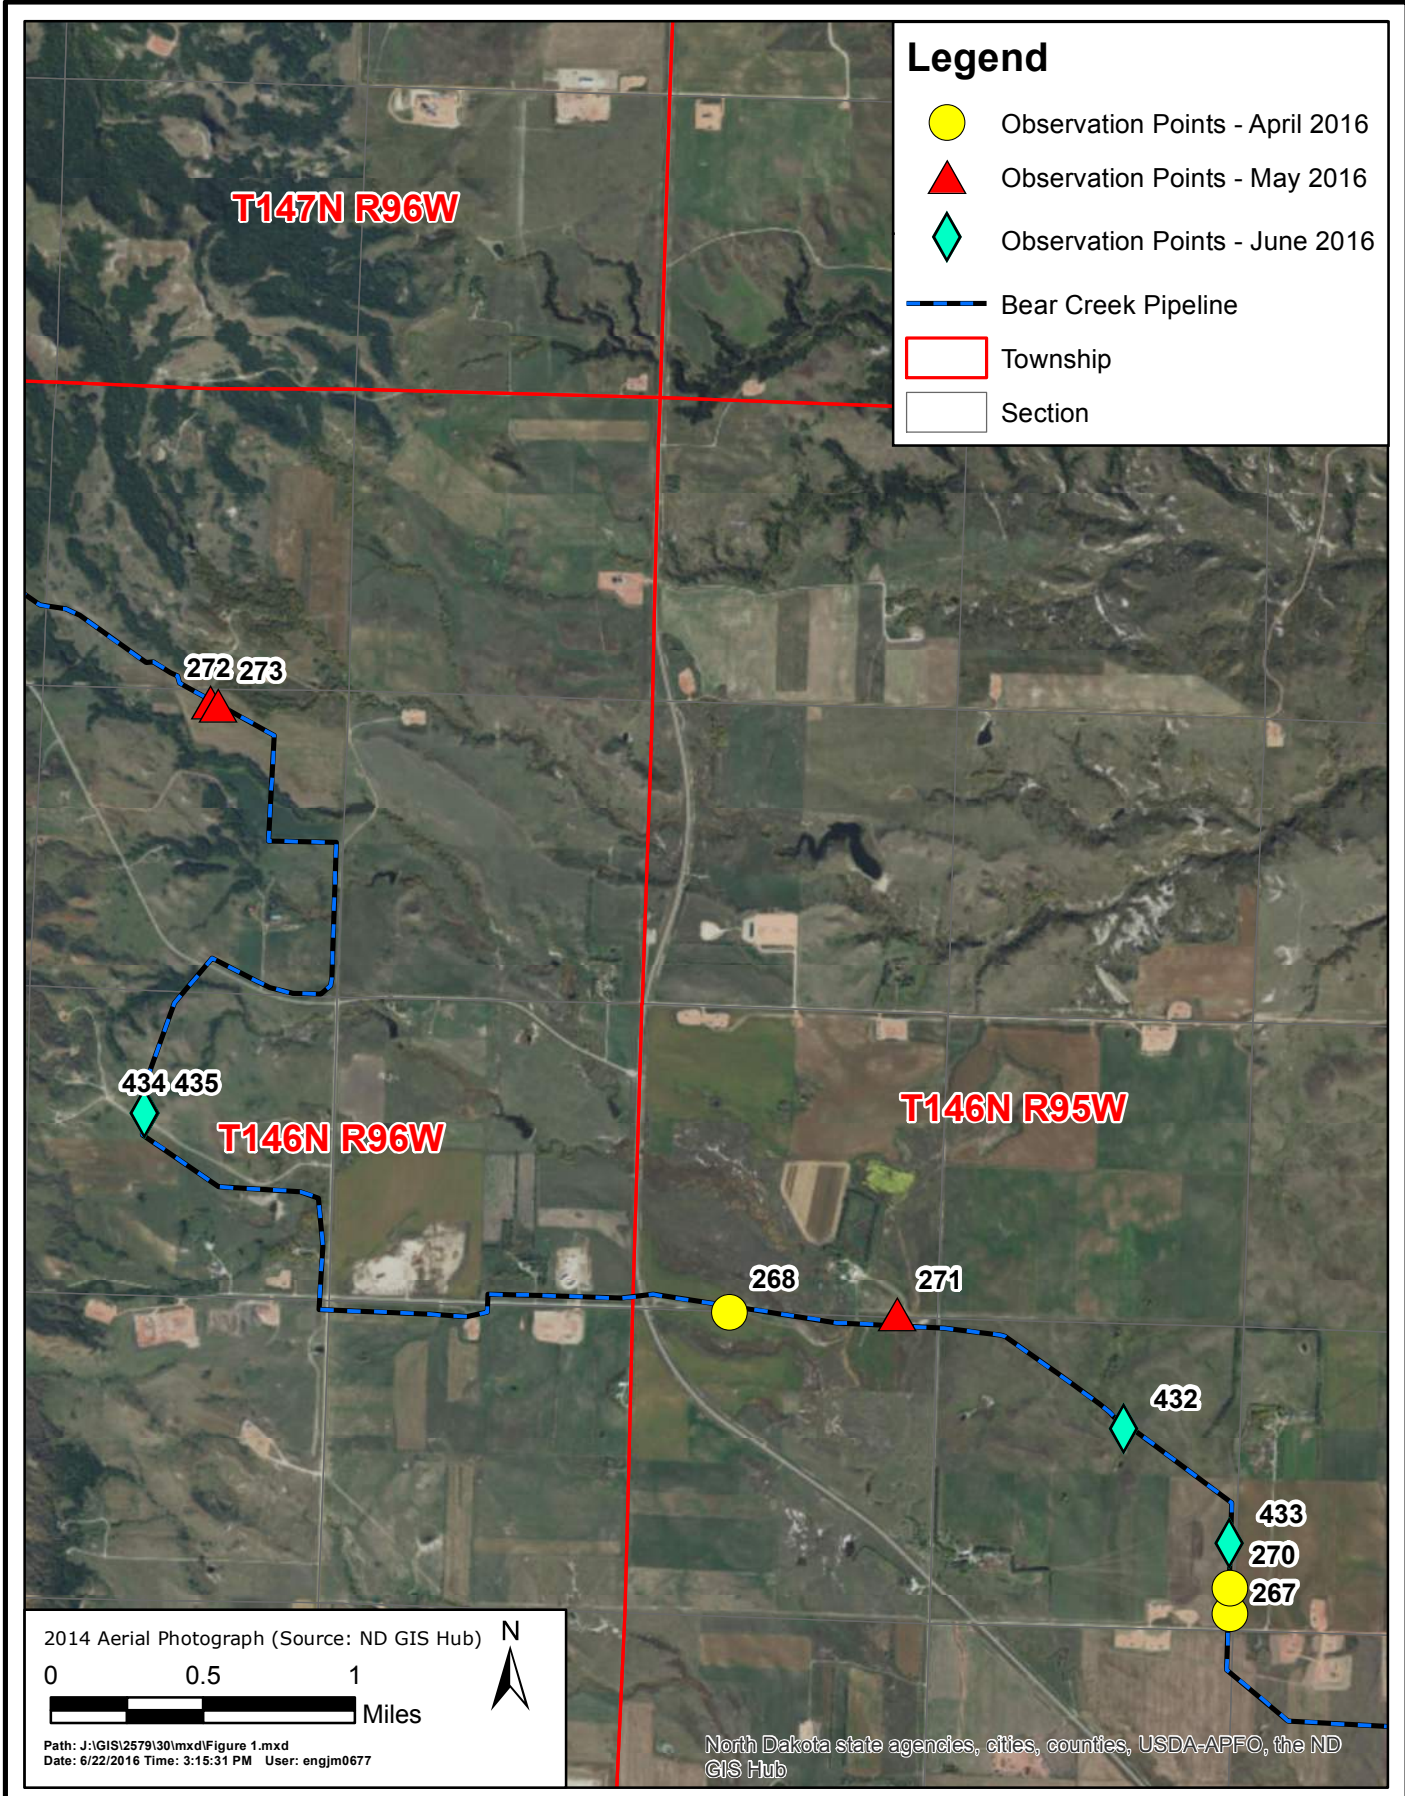
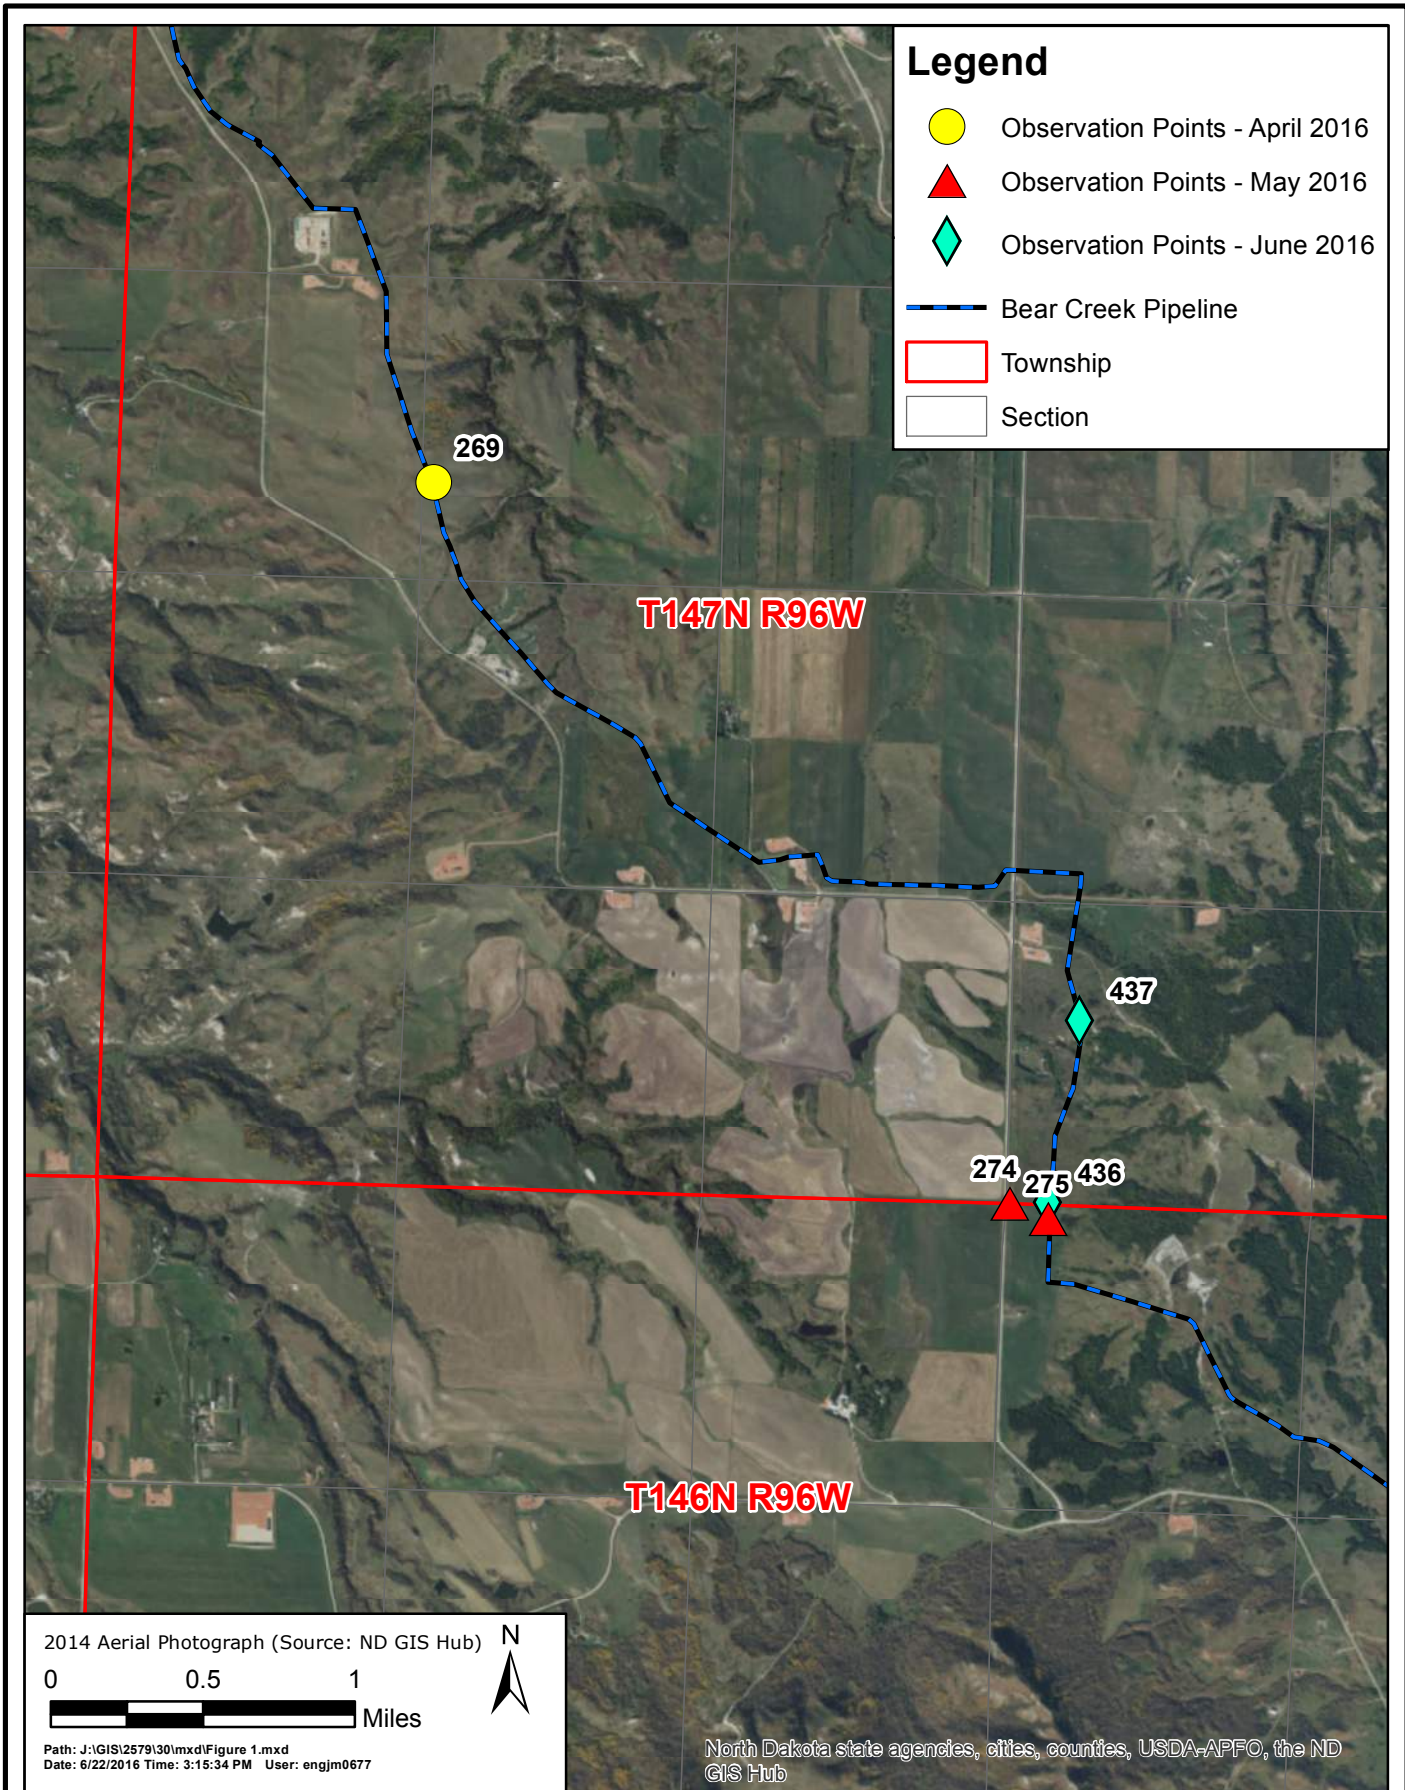
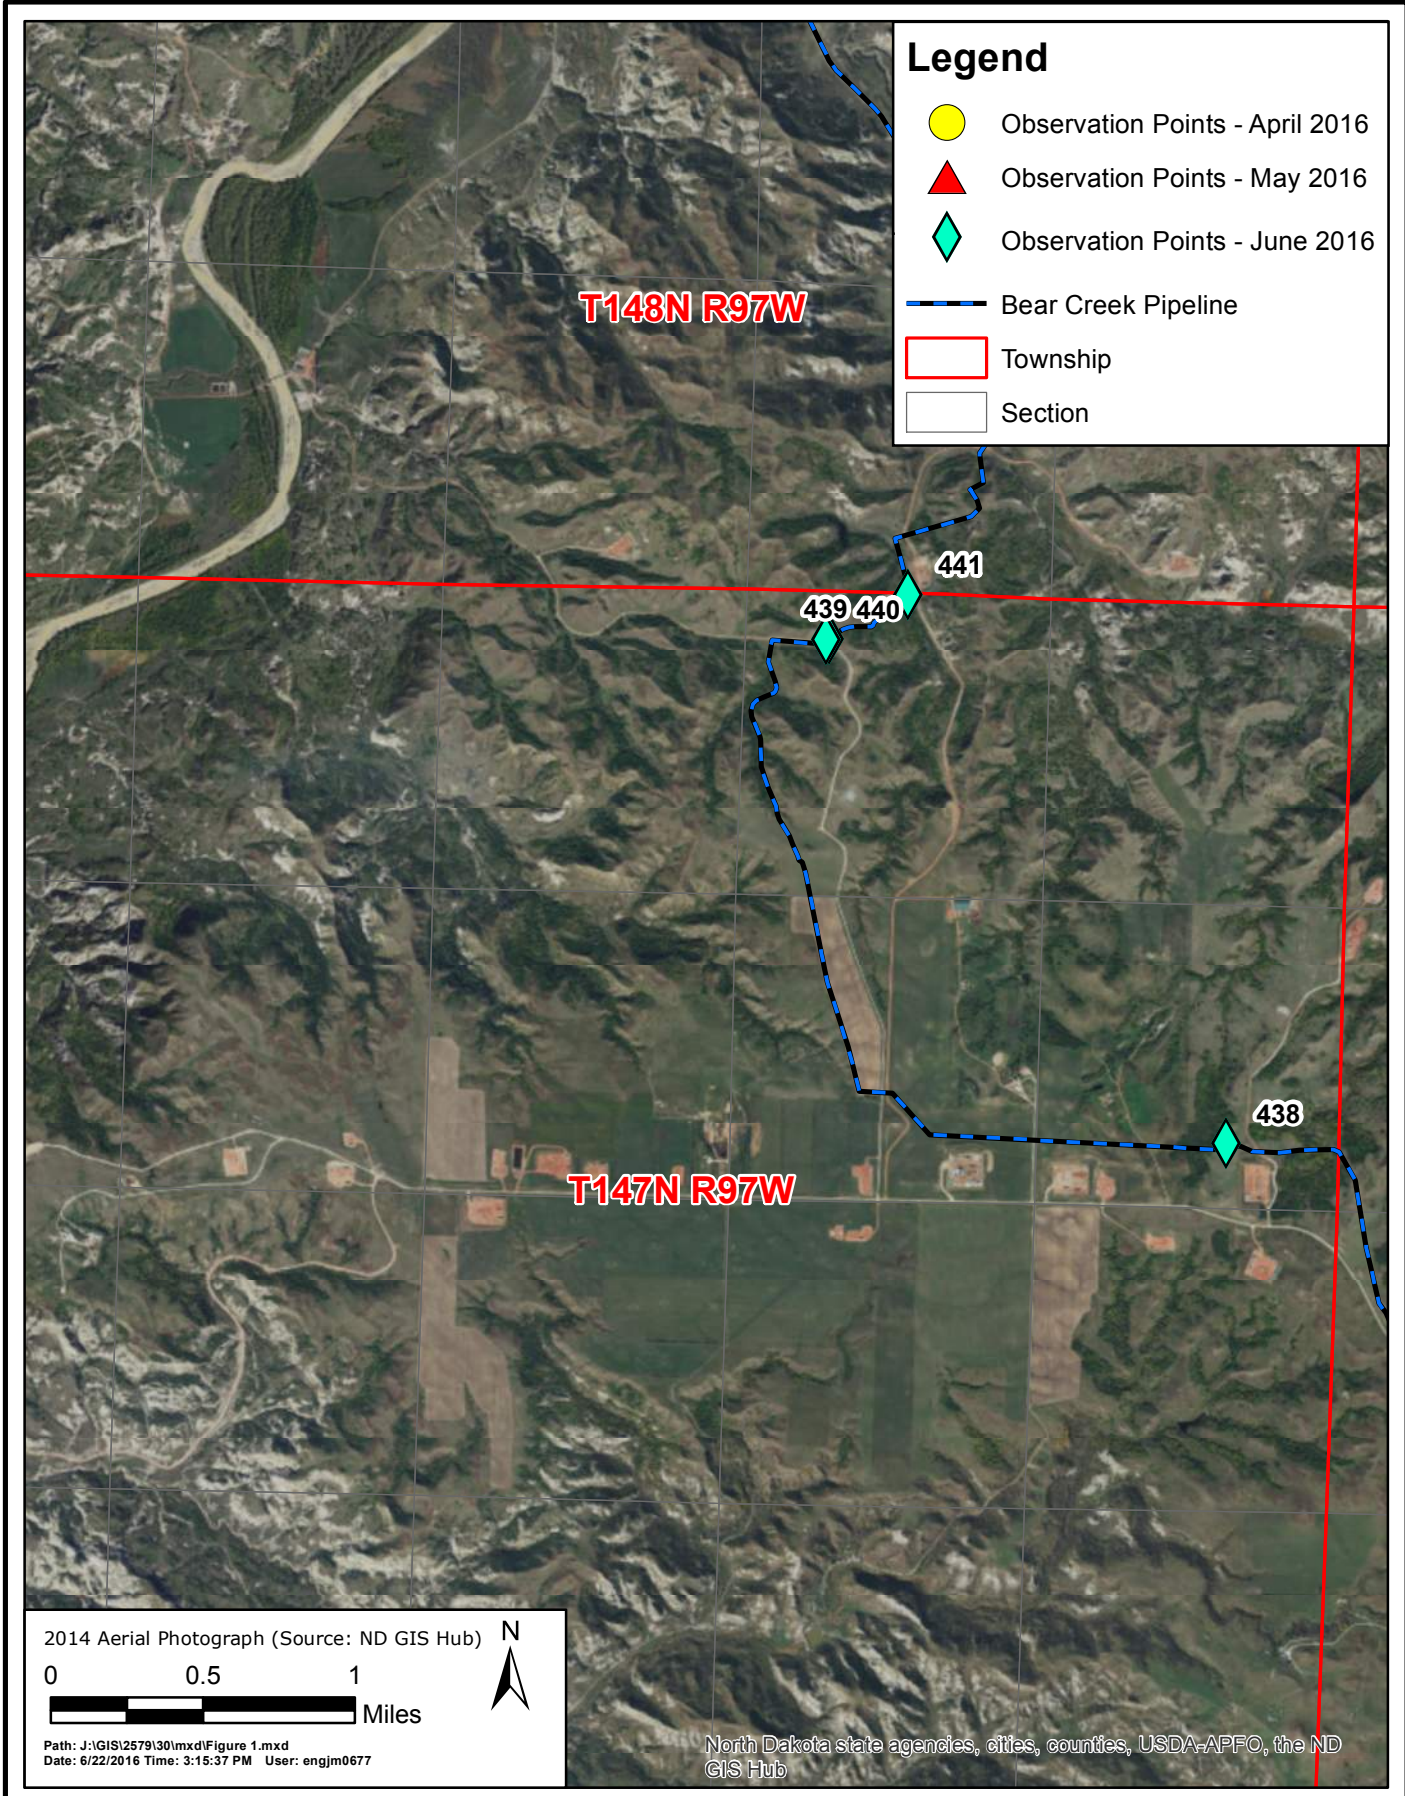
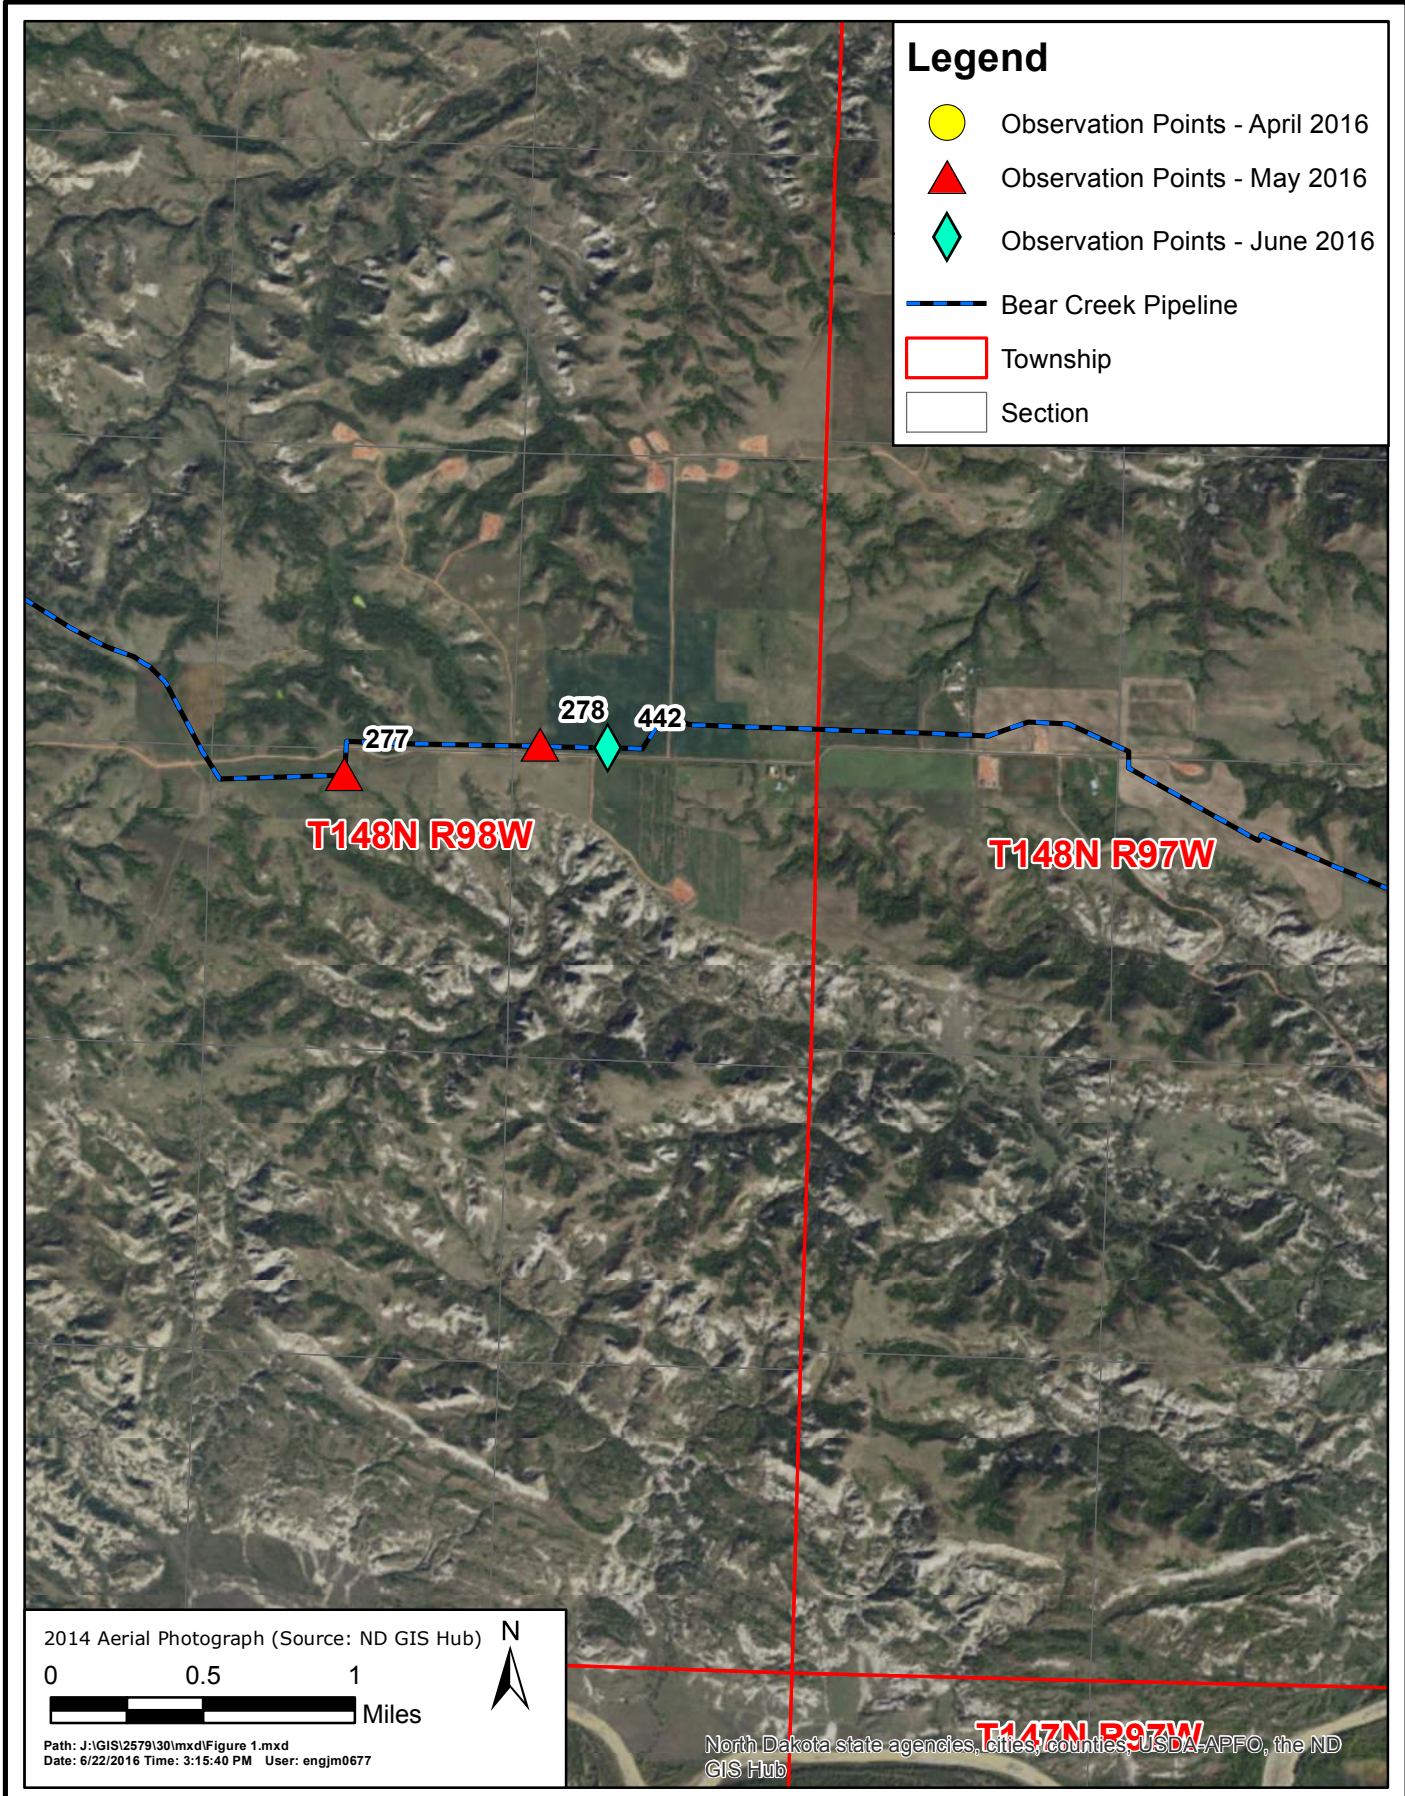
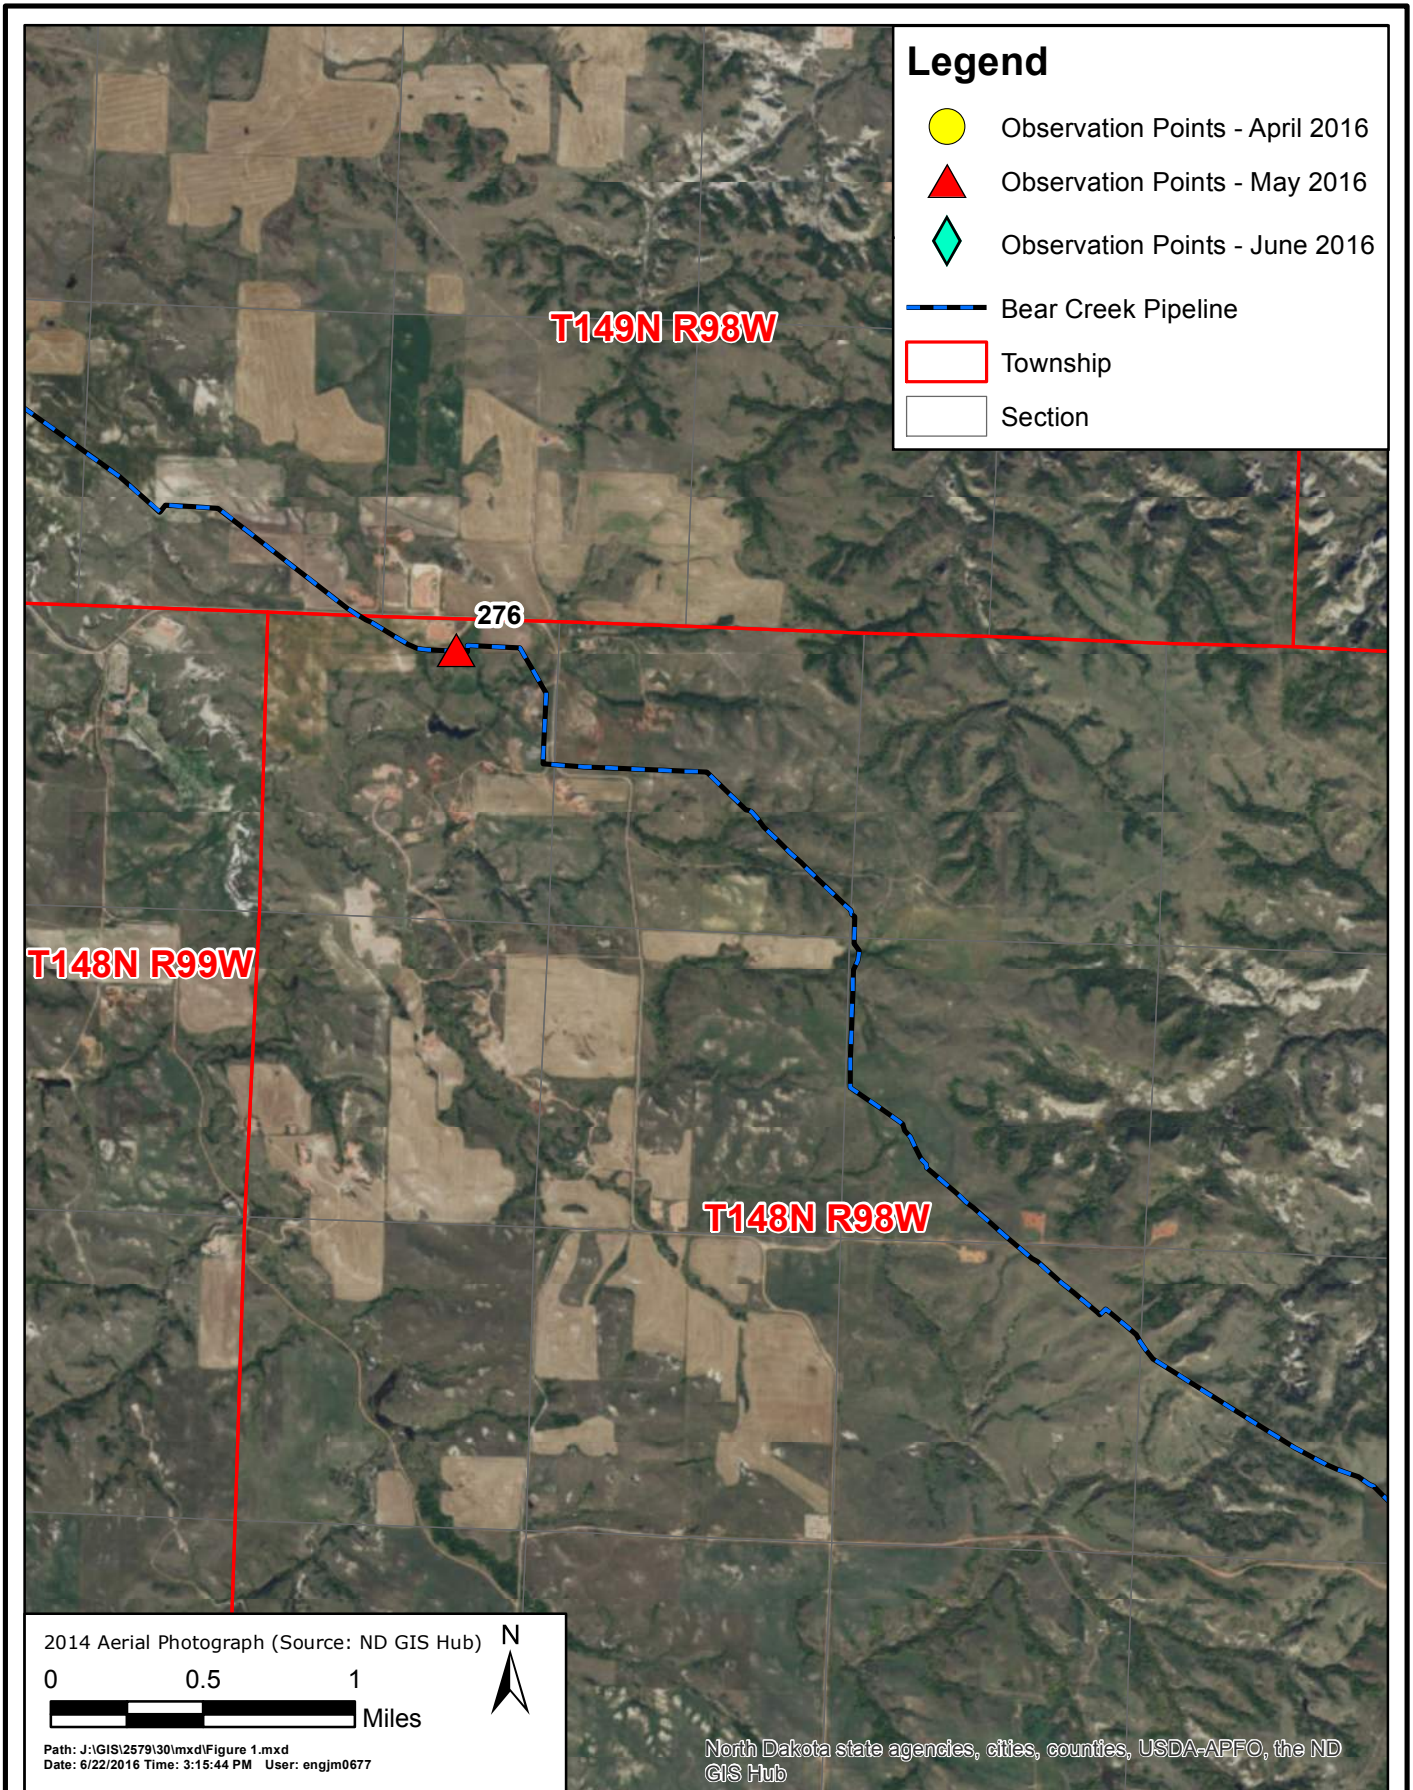
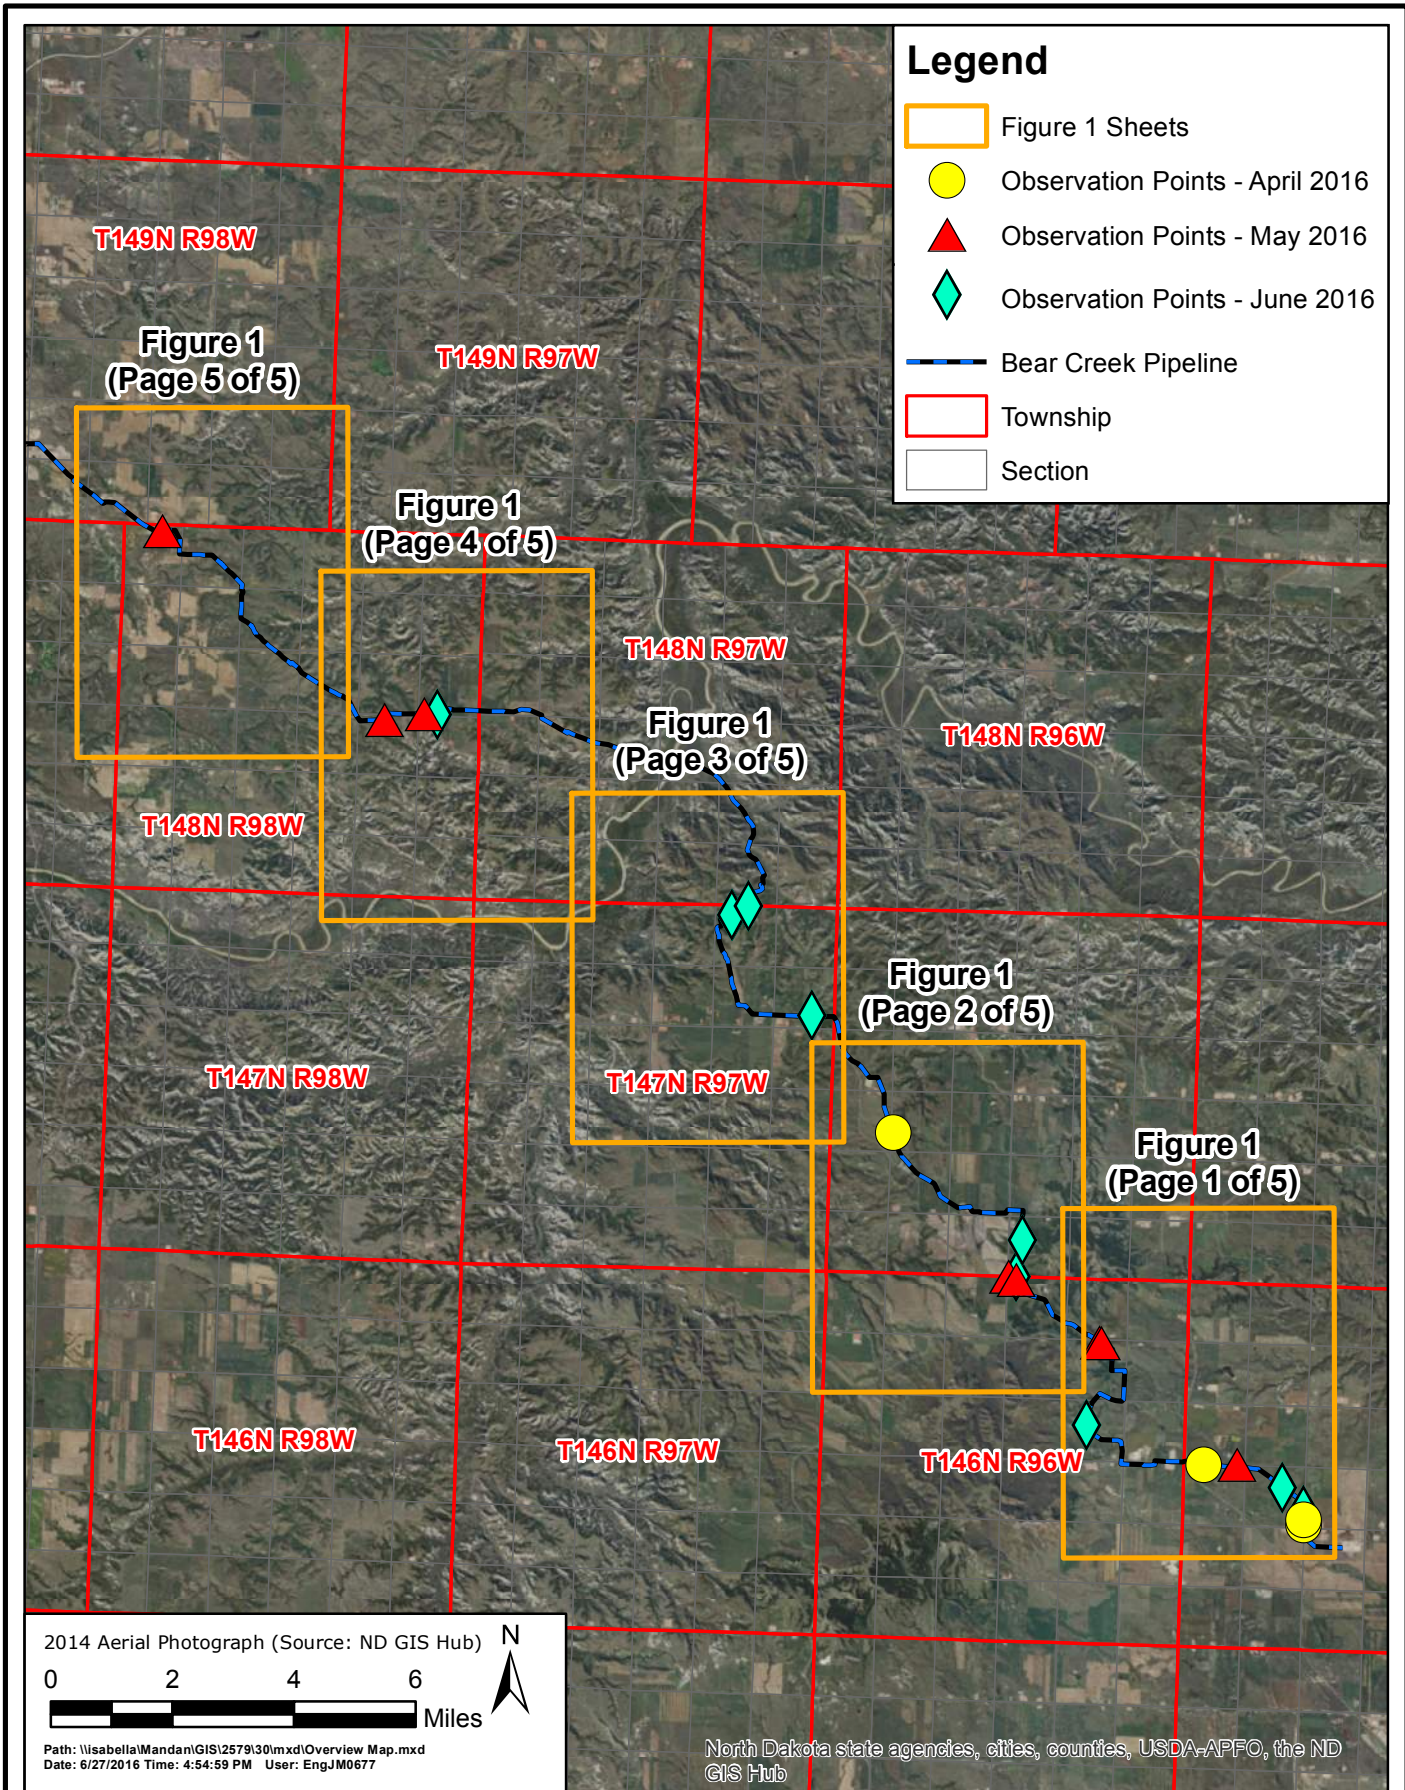
Map of Project and Observation Points

When the topsoil inspection of the project was conducted, there were portions of the project that went through steep slopes (Observation Point 441 and 439, **Appendix A, Figure 1 and Appendix C**). Areas of steep terrain often have shallow topsoil depths. These steep areas require additional grading down to a gentler slope to accommodate pipeline work. In steep terrain, best management practices (BMPs) are needed such as silt fences, slope breakers, certified weed-free mulch, seed, and erosion-control fabric; these are a few options to maintain the ROW until permanent vegetation is established. Silt fences, straw wattles and slope breakers were observed on site. Contractors/equipment operators need to take special care in this area to prevent movement of disturbed soil off the ROW. Wenck recommends monitoring and documentation of this area to ensure vegetation becomes established after reclamation.
