Plains Terminal 24-Inch Crude Oil Pipeline Johnson's Corner to Dakota Access Pipeline

Reclamation and Revegetation Inspection Report

Case No. PU-16-140

November 20, 2019

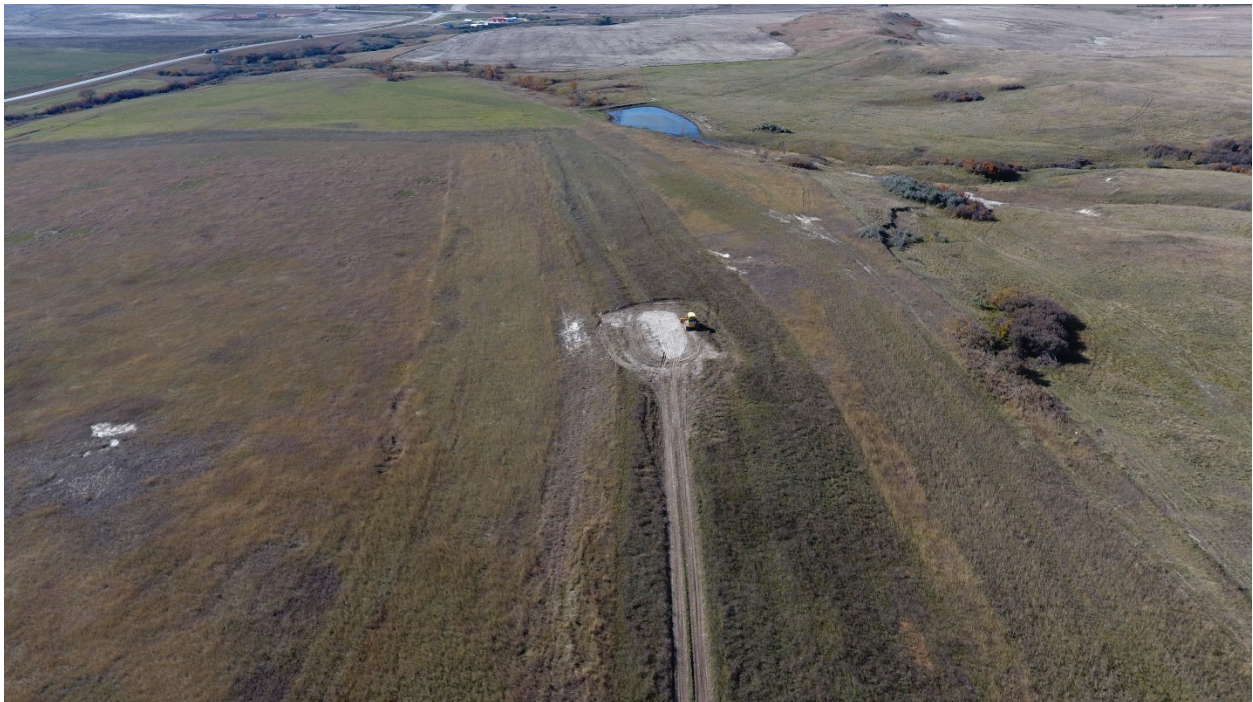
Location 24 - Looking west

Locations 32-24: Vegetation well established. Reclaimed areas nearly undetectable among its surroundings.
