Enclosed are copies of two complaints recently filed with the North Dakota Public Service Commission concerning the Sacagawea Pipeline, a crude oil transmission pipeline being constructed by Sacagawea Pipeline Company, LLC in McKenzie and Mountrail Counties, North Dakota. Siting of this pipeline was approved by the Commission's January 5, 2016 Order (Case No. PU-15-114).

**Re: Notice of Potential Violation
Sacagawea Pipeline Company, LLC
16-inch Crude Oil Pipeline – McKenzie & Mountrail
Case No. PU-15-114**

RE: Construction Inspection Report for the Sacagawea 16-inch Pipeline Project

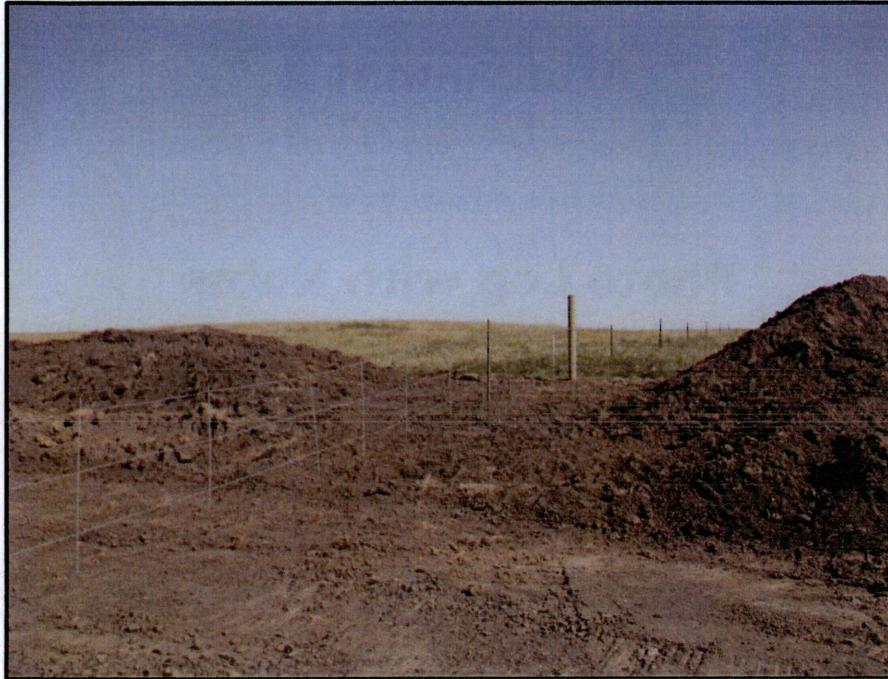
- Temporary gate for fence put up across the ROW (Photo #1, Point #443);
- Drainage area intersected by ROW. No erosion control devices were in place and the corridor had not been necked down in this area to reduce disturbance (Photo #2, Point #446);

Photo 1. (GPS Point #443) – Temporary gate for fence put up across the ROW. Site visit 7/21/2016.

Photo 1 of the Report notes that a temporary gate was erected across a ROW. SPC's agreement with landowners requires the installation of gates in any fence gaps to facilitate construction.

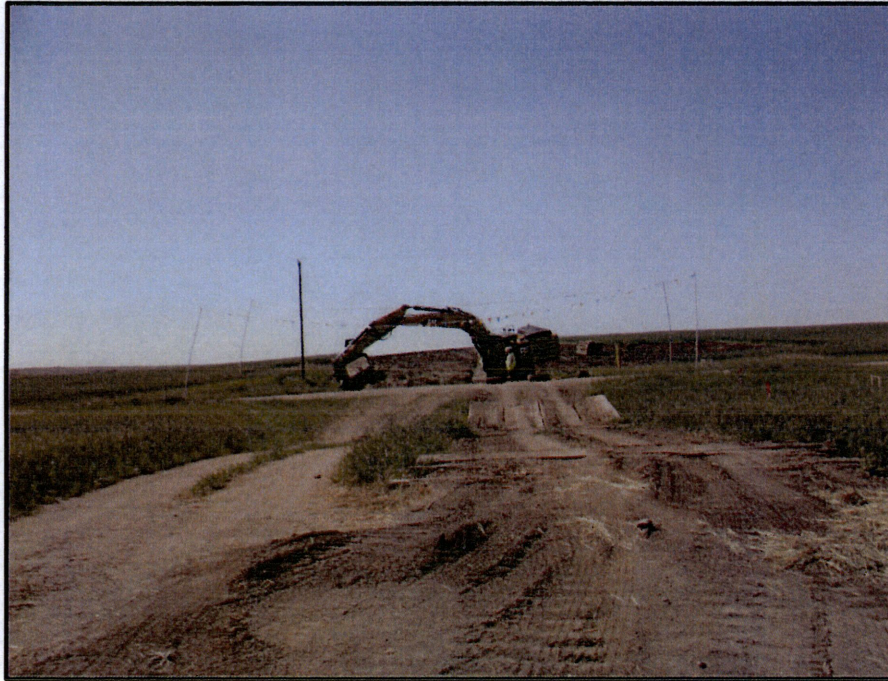
- Excavator removing mats from road ditch (far side of the road), which was used for access to the ROW. Most of the topsoil had been replaced in this area (Photo #5, Point #447);

Photo 5. (GPS Point #447) – Excavator removing mats from road ditch (far side of the road), which was used for access to the ROW. Most of the topsoil had been replaced in this area. Direction: South

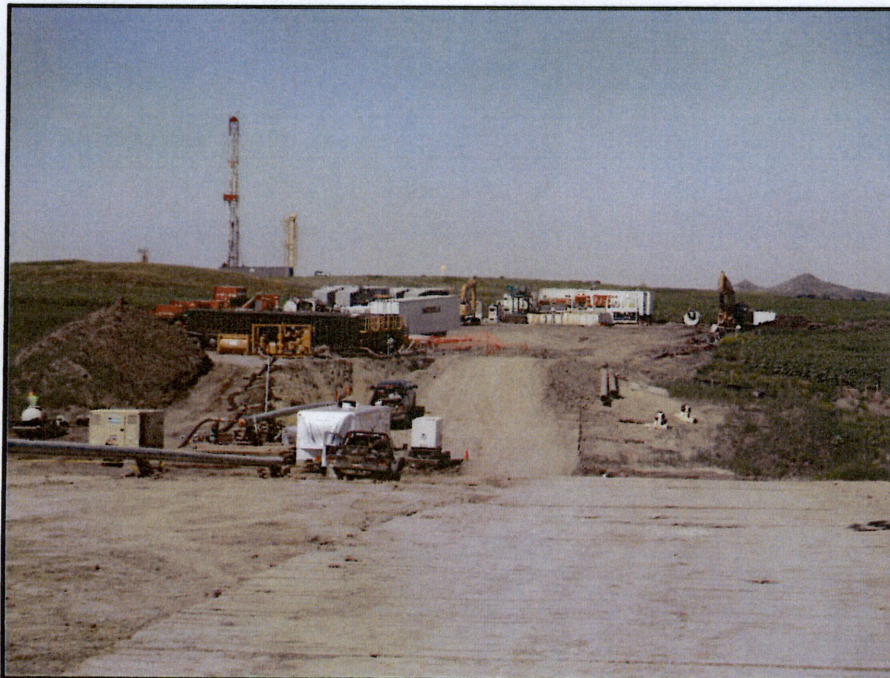
- Lake Sakakawea bore area (Photo #8, Point #449);
- ROW going up to Lake Sakakawea bore area. The bore contractor wanted mats placed on ROW up to bore area. Mats are observed on the left side of the ROW (Photo #9, Point #449);

Photo 8. (GPS Point #449) - Lake Sakakawea bore area. Direction: West

The Report indicates photos 8 through 12 were taken at the east side of the Lake Sakakawea HDD bore location on July 21, 2016. *See Report 2.* The accompanying photos imply an inadequate safety marking of the excavation hazard. *See Report 15-17.* Note that it is atypical for open pipeline trenches to be marked in their entirety.

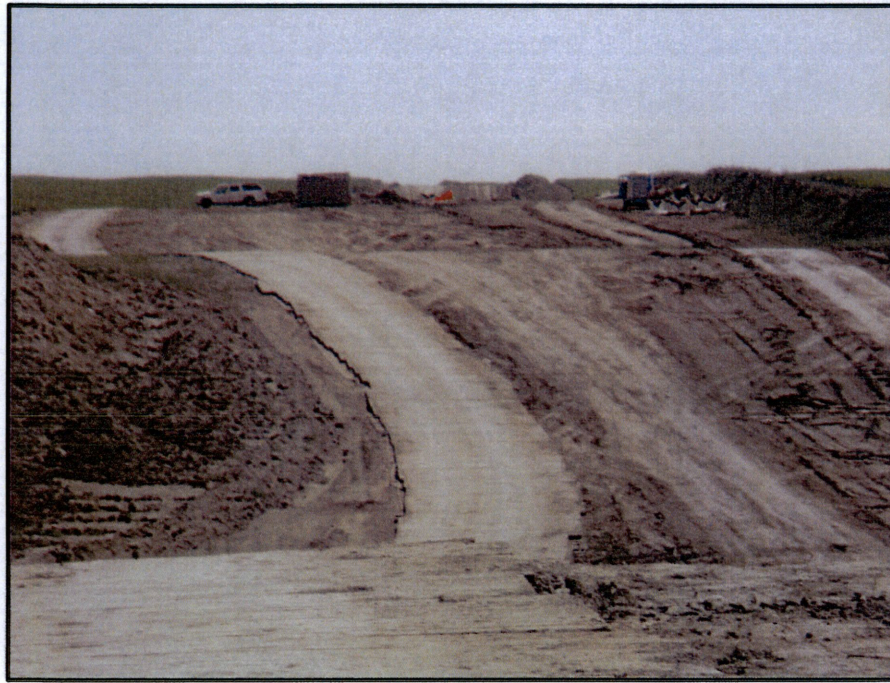
Photo 9. (GPS Point #449) – ROW going up to Lake Sakakawea bore area. The bore contractor wanted mats placed on ROW up to bore area. Mats are observed on the left side of the ROW. Direction: East

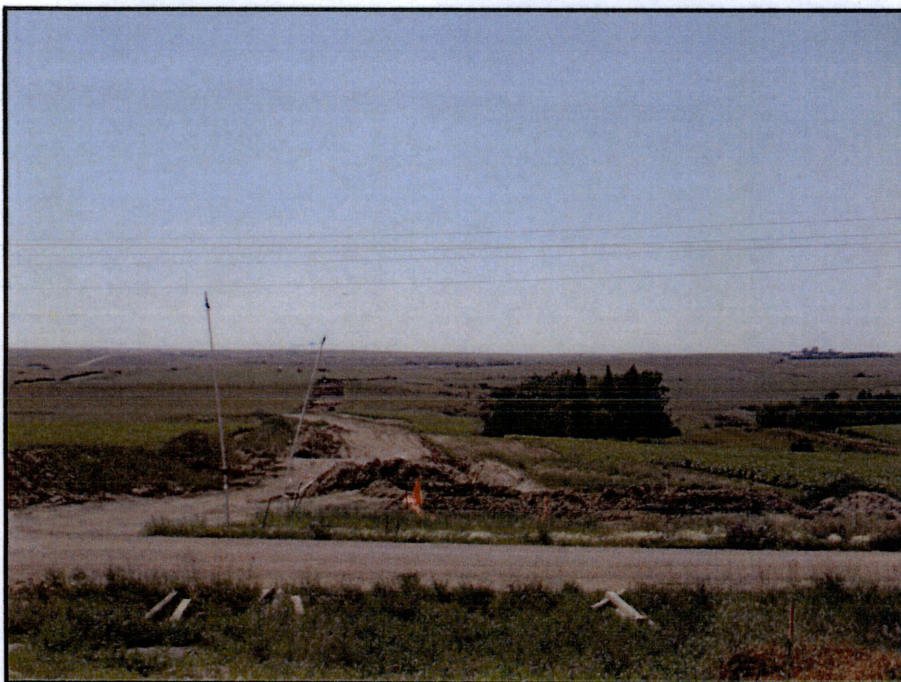
- Area near rural water line break. Extended ROW for bore area. Topsoil pile to the left of photo on left side of ROW with vegetation growing on it (Photo #14, Point #444);

Photo 14. (GPS Point #444) - Area near rural water line break. Extended ROW for bore area. Topsoil pile to the left of photo on left side of ROW with vegetation growing on it. Direction: South
