Interim Topsoil Inspection Report Cenex 10" Refined Fuels Pipeline PU-17-97

Prepared for:
**North Dakota
Public Service Commission**

PU-17-97 CONSTRUCTION INSPECTION

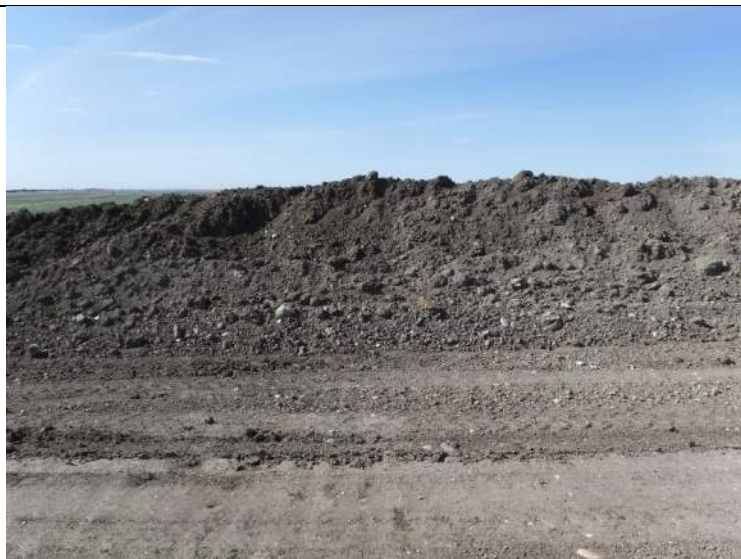
**Observation Point: 600b**

Photo Description: Topsoil stockpile.

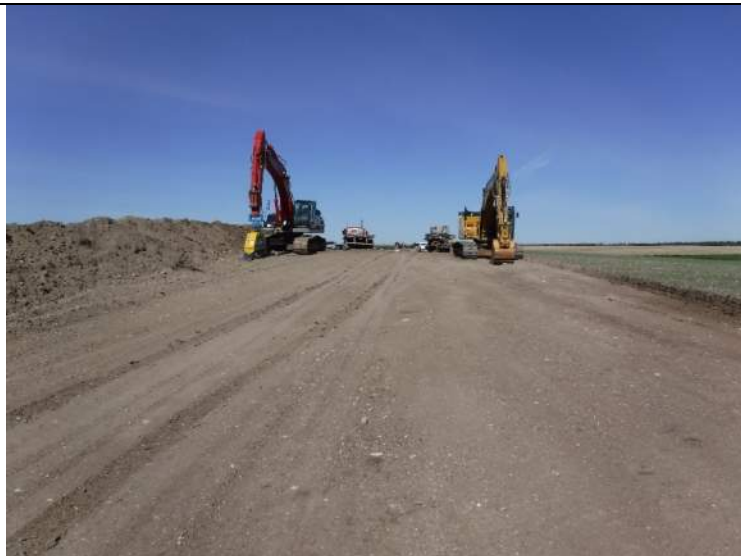
**Observation Point: 600c**

Photo Description: ROW stripped and graded.

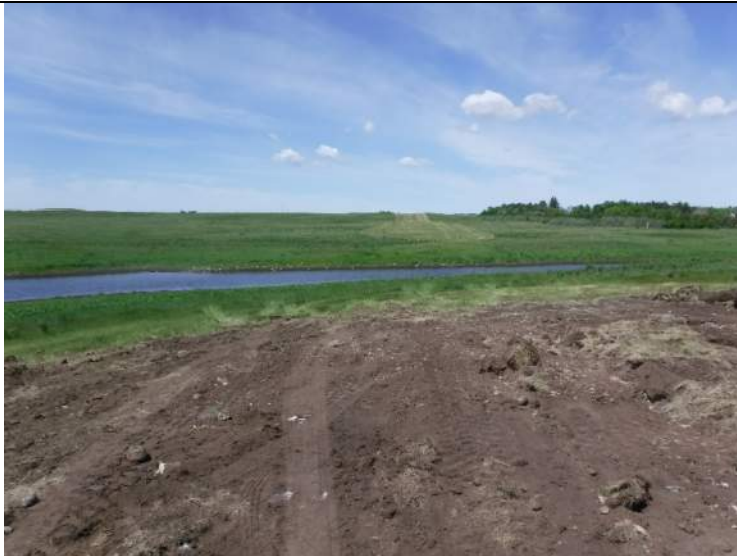
Observation Point: 615a

Photo Description: View of water feature that crosses pipeline ROW. Crews will install the pipe by boring under this feature.

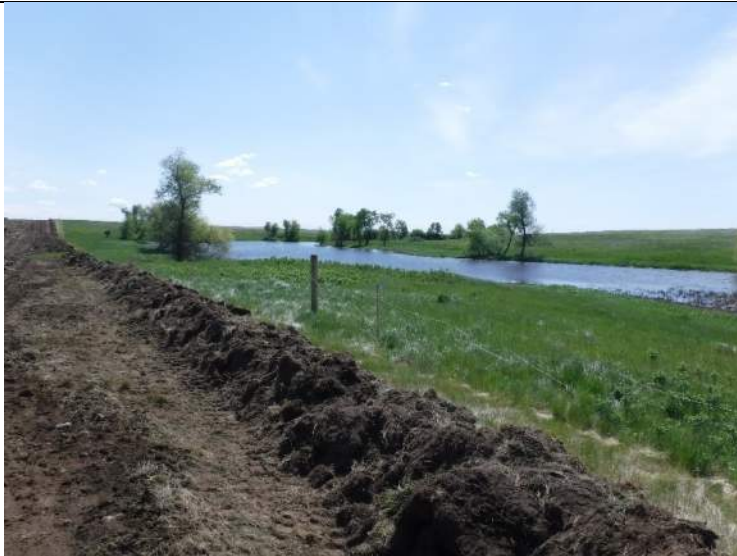
Observation Point: 615b

Photo Description: View of pond/wetland to the South of ROW.

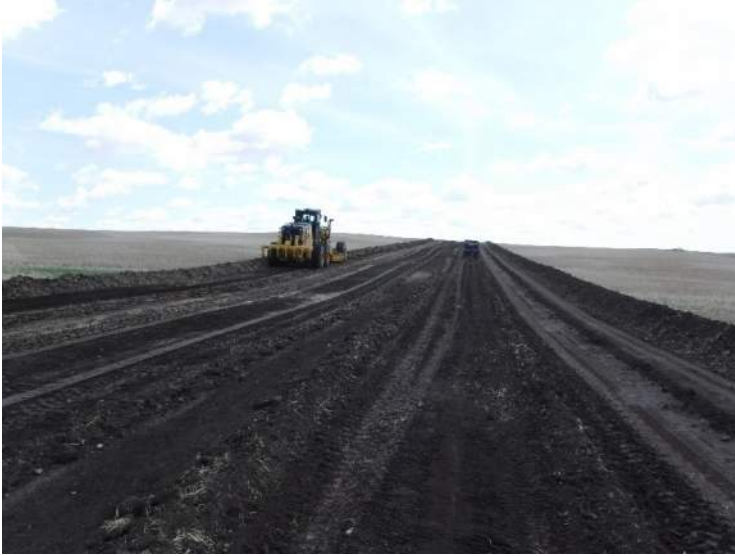
Observation Point: 617

Photo Description: View of grader stripping topsoil.

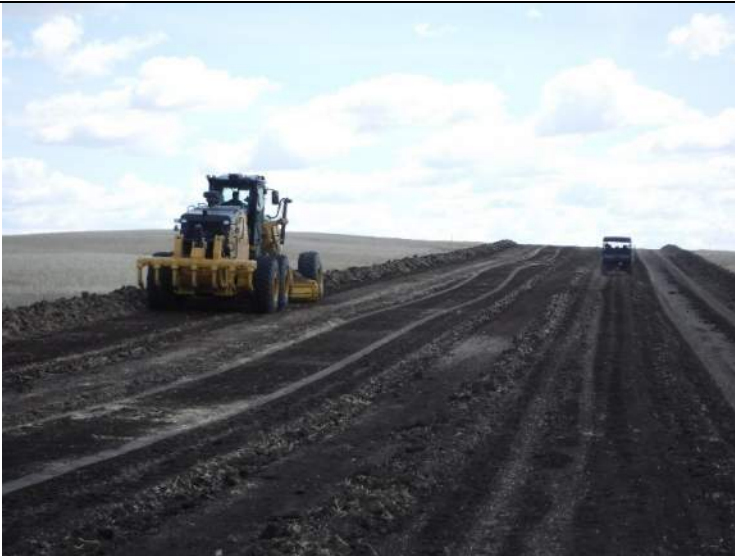
Observation Point: 618

Photo Description: View of grader stripping topsoil.

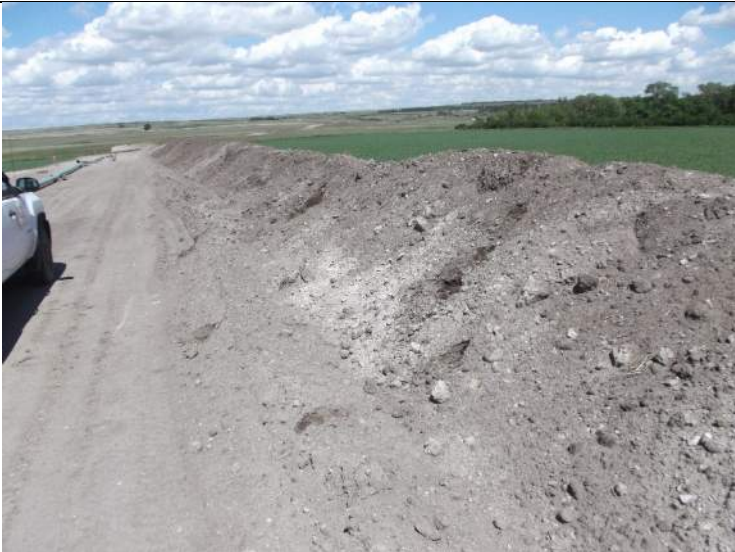
Observation Point: 65a

Photo Description: Calcareous topsoil. Summit of hill stripped to approximately 2-3 inches. Naturally poor quality soil.

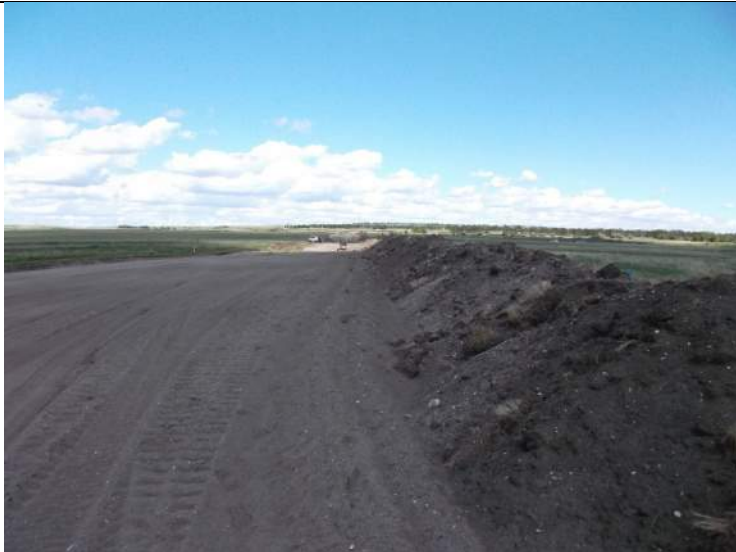
Observation Point: 67

Photo Description: Subsoil stockpile touching topsoil stockpile. Issue will resolve with motor grader activities after filling trench.

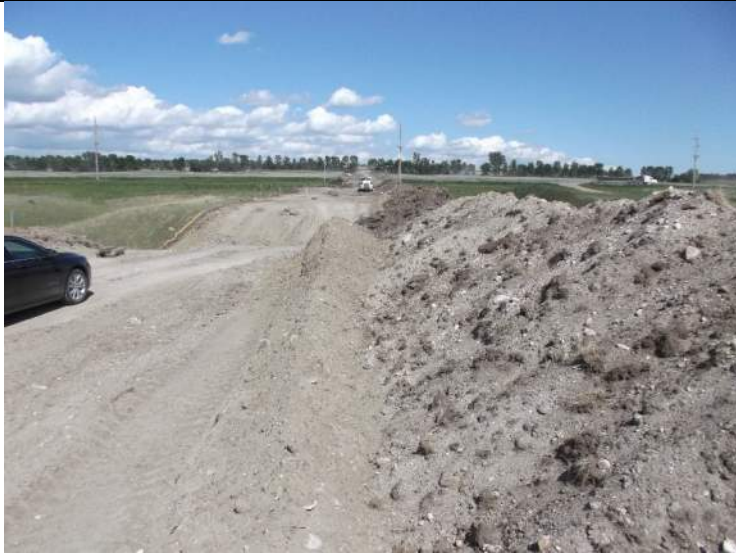
Observation Point: 68

Photo Description: Subsoil and topsoil touching. Mr. Stark aware of these issues. Resolutions to these issues will be made with motor grader activities. Topsoil naturally calcareous. Poor quality soil on hill summit.

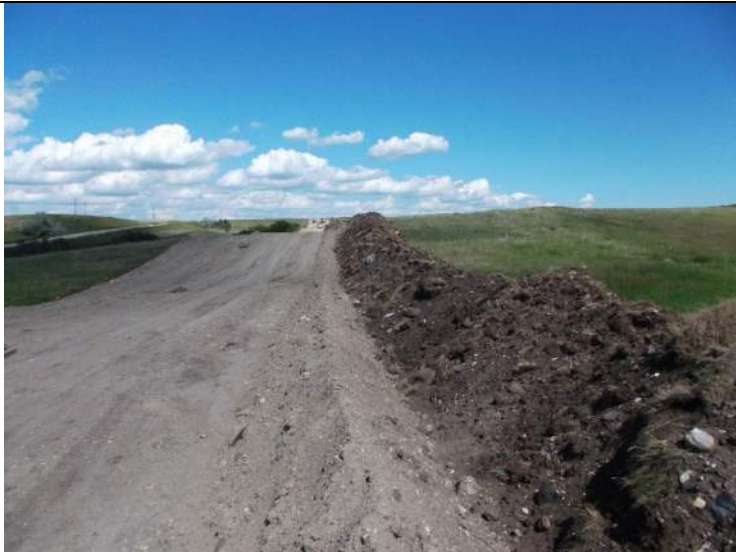
Observation Point: 69

Photo Description: Topsoil and subsoil segregated. In background subsoil piled on topsoil. Discussed the issues of segregation and subsoil on top of topsoil with Thomas Stark, Chief Inspector, WCI. He will work to resolve the issues as ROW stripping and grading continue.

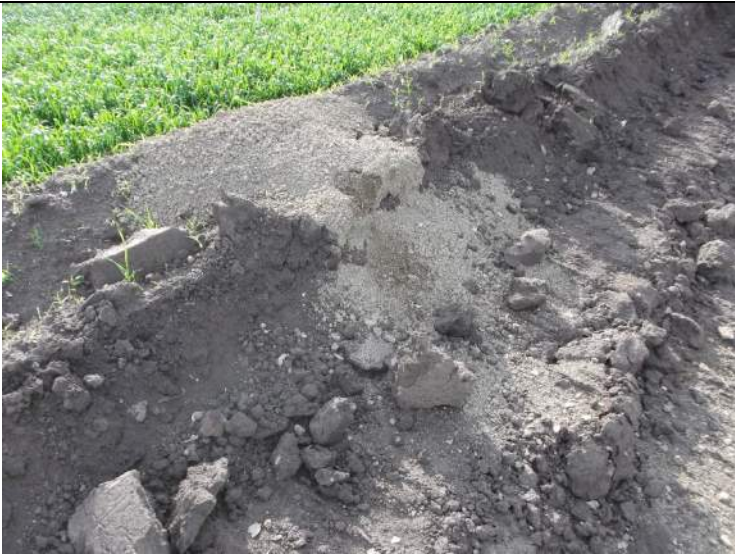
Observation Point: 94

Photo Description: Small area of subsoil spilled on topsoil stockpile.

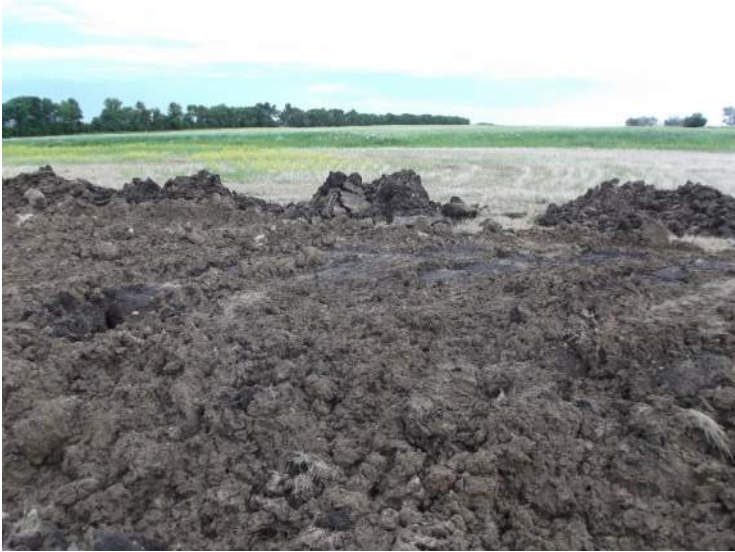
Observation Point: 98a

Photo Description: ROW not stripped. Excavated subsoil placed on in-situ topsoil. Subsoil raked back to fill trench. Only small topsoil stockpiles presumably stripped from trench area.

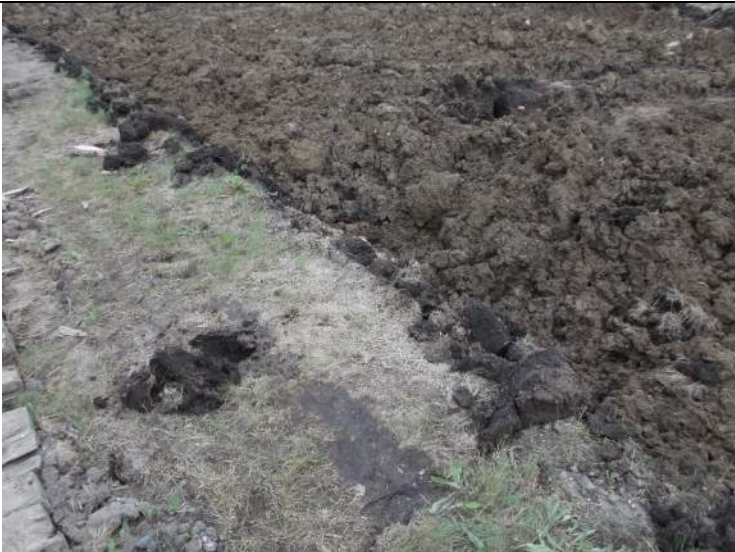
Observation Point: 98b

Photo Description: No topsoil stripped on northside of ROW.

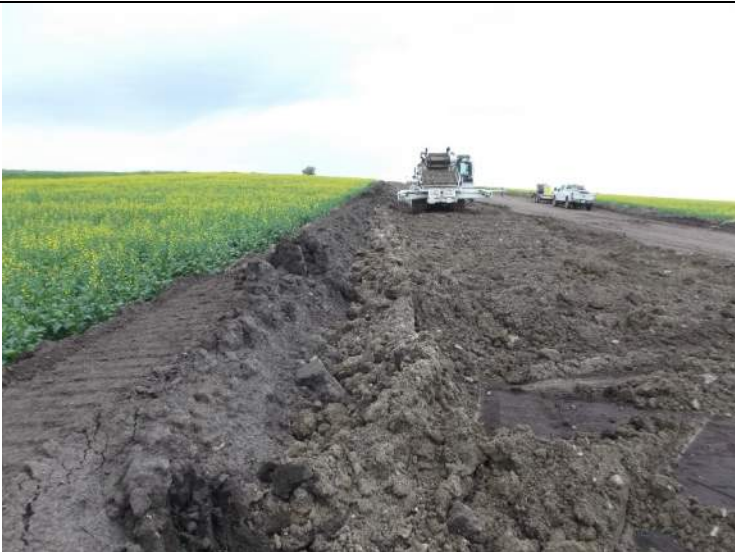
Observation Point: 100b

wetland and that their alignment sheets did not specify either way. Mr. Rowland further explained that due to wet conditions, topsoil stripping was only attempted above the trench area, and the excavated subsoil was placed adjacent to the trench. This direct trenching process occurred along the length of the timber mats. Mr. Oliver (Frontier) was notified of this issue. At the time of this report, resolutions to this issue are being considered. Visual inspection of the topsoil removal continued intermittently along the ROW heading west to T156N, R99W, Section 35 with no other issues observed. (**Appendix A, Observation Points 96-100**).
