# Topsoil Removal Inspection Report Cenex 10" Refined Fuels Pipeline PU-17-97

*Prepared for:*  
**North Dakota  
Public Service Commission**

**WENCK Associates, Inc.**  
301 1st Street NE, Suite 202  
Mandan, ND 58554  
Phone: 701-751-3370  
Fax: 763-479-4242

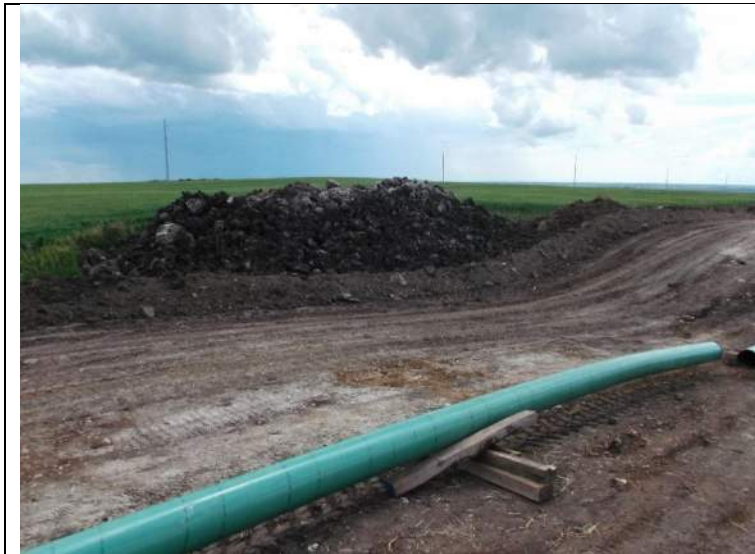
**Observation Point: 136**

Direction Photo is Taken: Southwest  
Station 3869+00 Spread 1Photo Description: Rock pile moved off ROW.  
Subsoil stockpile segregated in front of rockpile.  
Timber mats in place.

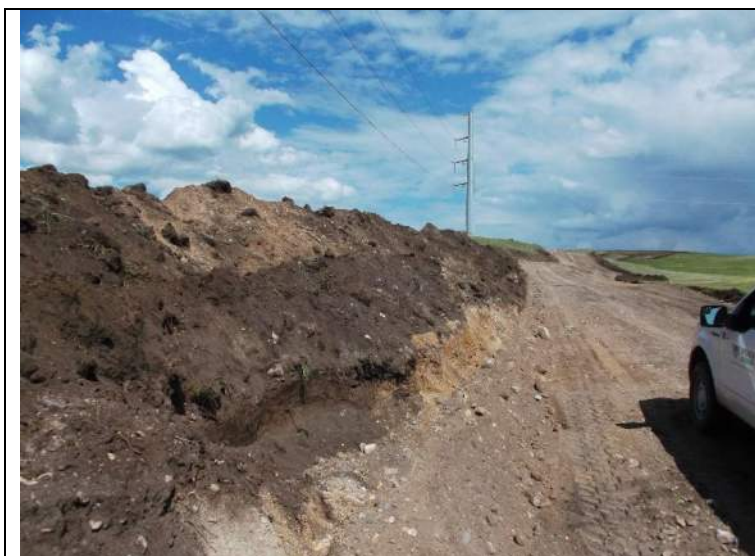
**Observation Point: 140**

Direction Photo is Taken: Southeast  
Station 3786+00 Spread 1Photo Description: Subsoil spill on top of topsoil  
stockpile. Discussed with Mr. Bishop and issue  
resolved on site.

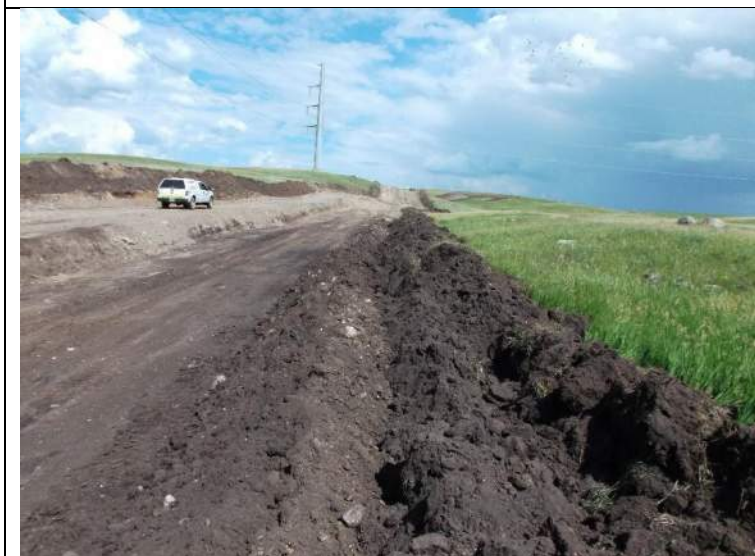
**Observation Point: 141**

Direction Photo is Taken: South  
Station 3785+00 Spread 1Photo Description: Topsoil and subsoil  
segregated although touching. Discussed with  
Mr. Bishop and how grader would manipulate  
stockpiles to achieve little to no mixing. Tiered  
ROW due to surrounding topography.

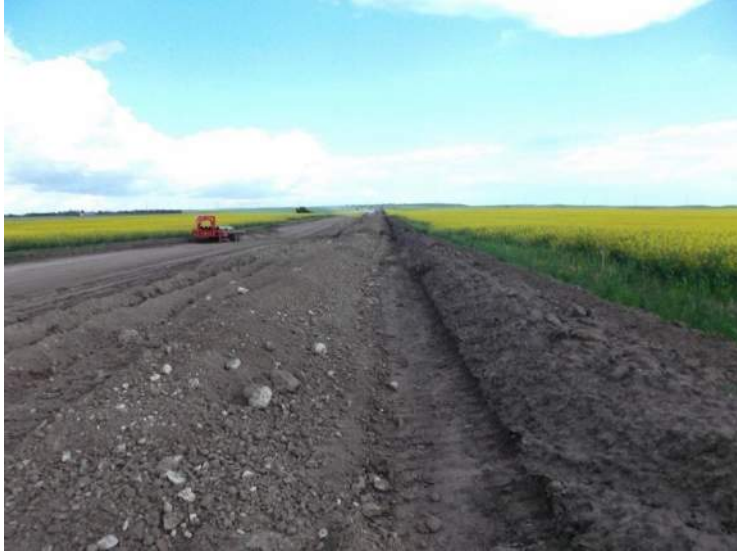
**Observation Point: 144a**

Photo Description: Topsoil and subsoil segregated properly.

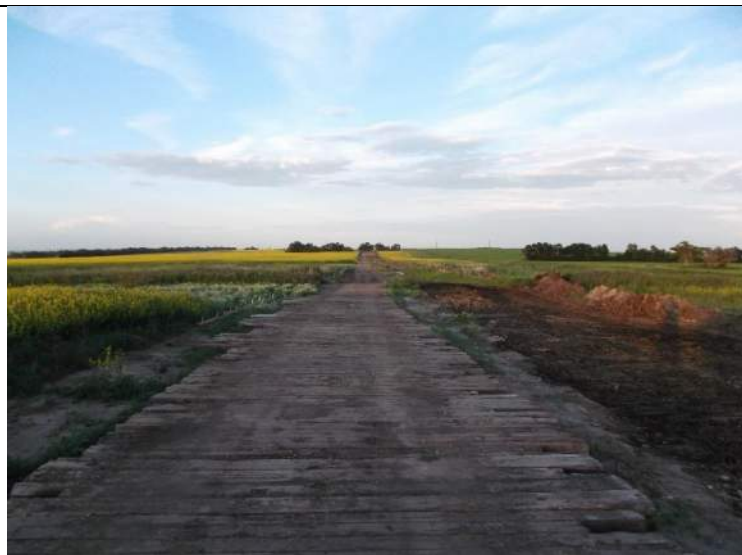
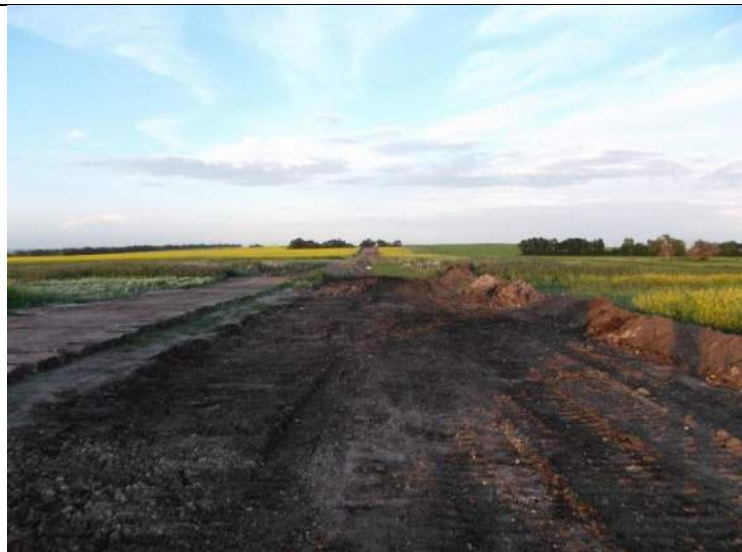
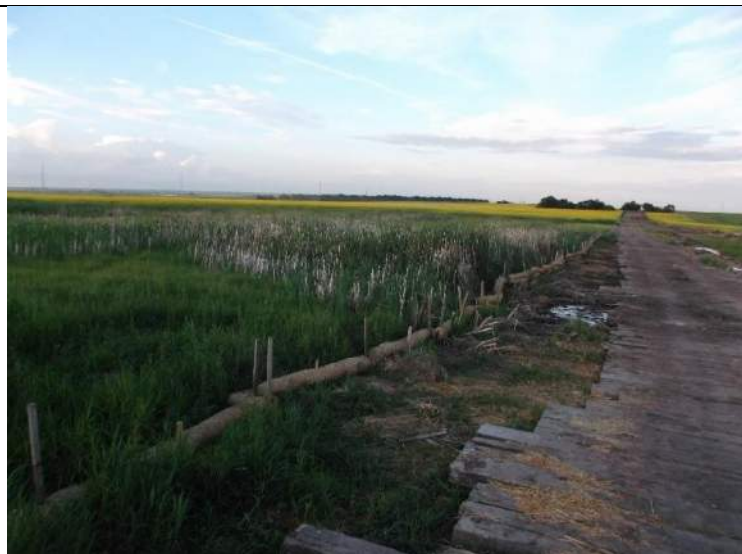
On 17 July 2019, Mr. Hackley visited Spread 1 of the Project. Frontier staff were observed stripping topsoil and installing pipe. Topsoil removal was being done south of U.S. Highway 2 at the northeast corner of the intersection of Williams County roads 8 and 9. An isolated observation of subsoil mixing was discussed with Mr. Bishop. This incident took place in an area with very steep topography where manipulation with a dozer would be difficult (**Appendix A, Observation Point 140**). Observations within agriculture fields found that crops had begun to grow on topsoil stockpiles during the time of removal and prior to re-distribution within the ROW (**Appendix A, Observation Point 155**). Topsoil and subsoil stockpile segregation was appropriate. In wetland areas, the “double-ditch” method of trenching was used in which only the width of the trench is excavated. Topsoil appeared to have been removed in isolated piles, with the subsoils removed in a linear stockpile. It’s not clear if a full 12 inches of topsoil was removed. Topsoil was replaced in the trench appropriately within these wetland areas (**Appendix A, Observation Points 158-167**).

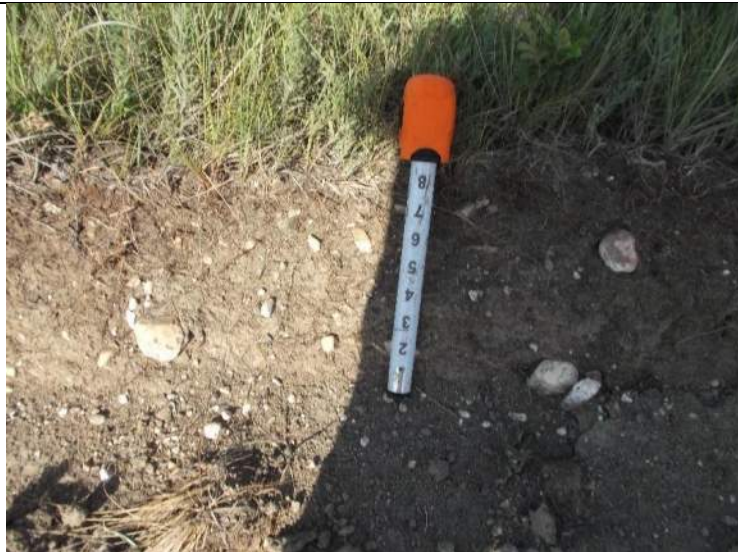
**Observation Point: 146**

On 17 July 2019, Mr. Hackley visited Spread 2 of the Project. Measurements of stripping depth were made at different topographical locations along the ROW. Those locations were appropriately stripped to depth. An isolated issue of topsoil and subsoil stockpiles touching was observed. A discussion with Mr. Moss concluded that a grader would manipulate stockpiles to achieve little to no mixing (**Appendix A, Observation Points 146, 147, 151, and 152**).

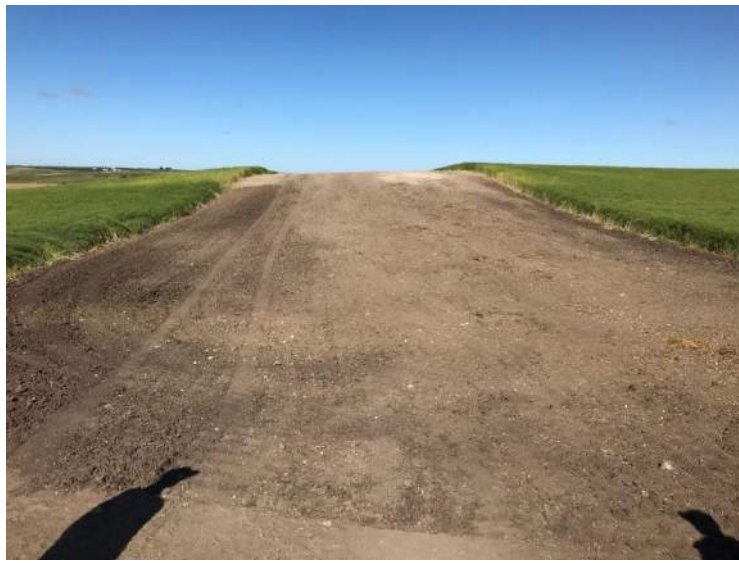
**Observation Point: 646a**

On 29 July 2019, Ms. Simmers and Mr. Leitner visited Spread 1 of the Project. Reclamation within the wetland area where the “double ditch” process was conducted looked according to standards (**Appendix A, Observation Point 646**). Observations were made of ROW reclamation with subsoil mixing due to deep ripping. Further subsoil mixing was observed as a result of removing large rocks (**Appendix A, Observation Points 648, 651**). Topsoil removal was observed in progress and appropriately stripped to color change on the trenching side of the ROW. On the traffic side of the ROW, approximately 4-inches of in situ

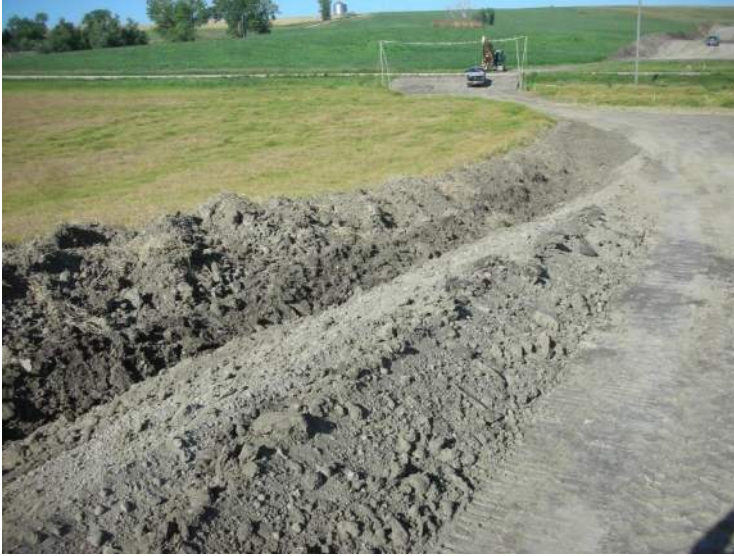
**Observation Point: 2724**

Photo Description: Appropriately stripping of Zahl-like soil.

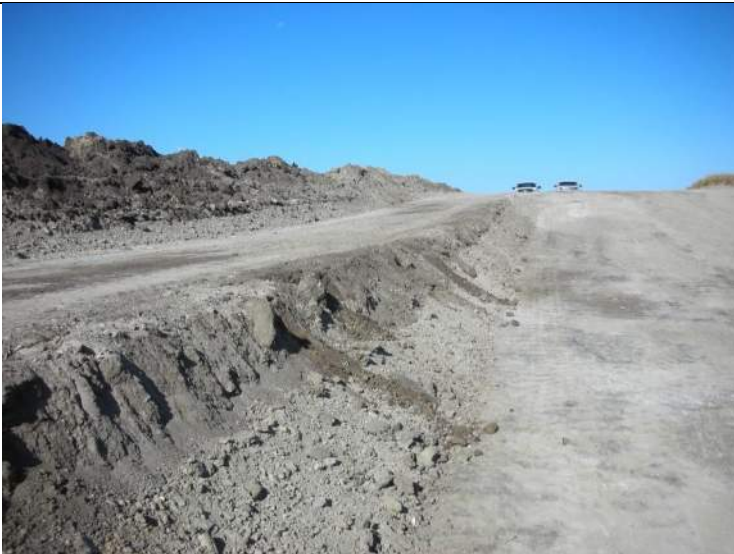
**Observation Point: 2725**

Photo Description: Tiered ROW due to surrounding topography.

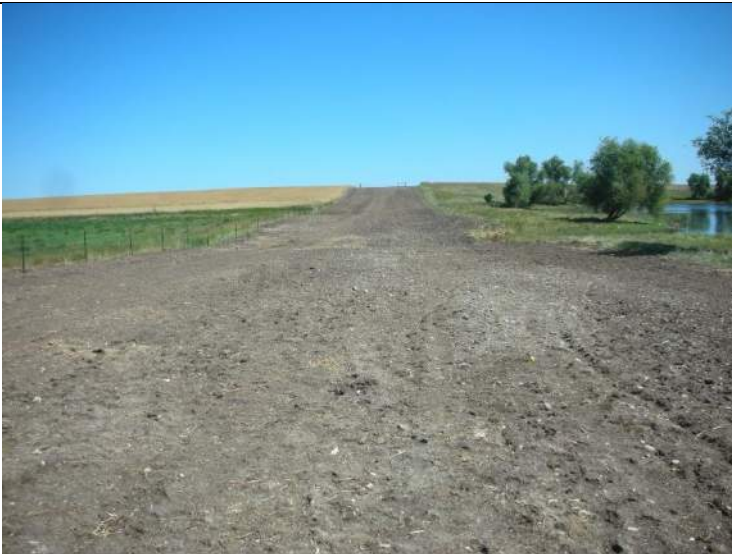
**Observation Point: 2736**

Photo Description: Satisfactory reclamation of ROW. Recommend rock picking.

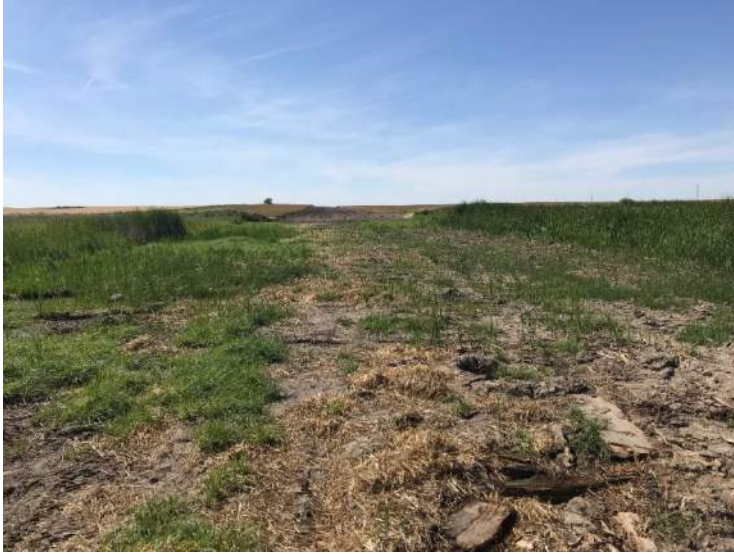
**Observation Point: 903**

Photo Description: Wetland area reclamation seems satisfactory.
