Interim As-Built Construction Inspection Report Cenex 10" Refined Fuels Pipeline PU-17-97

Prepared for:
**North Dakota Public Service
Commission**

WENCK Associates, Inc.
301 1st Street NE, Suite 202
Mandan, ND 58554
Phone: 701-751-3370
Fax: 763-479-4242

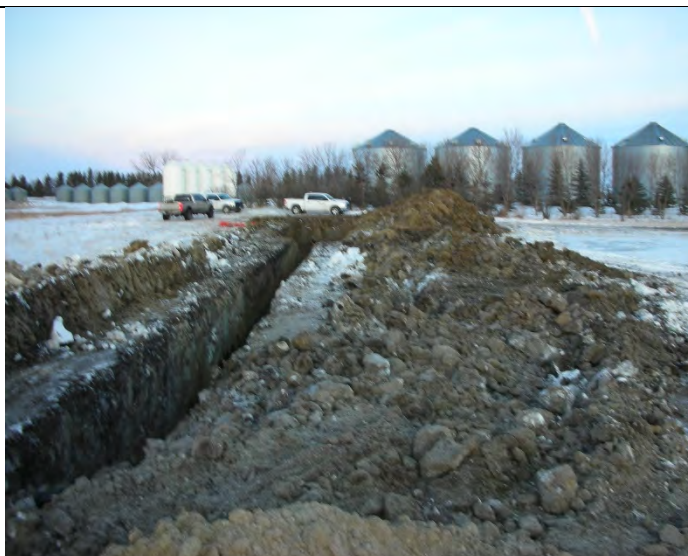
**Observation Point: 2809e**

Photo Description: Previously stripped ROW with topsoil to south (left), awaiting spring replacement; no issues.

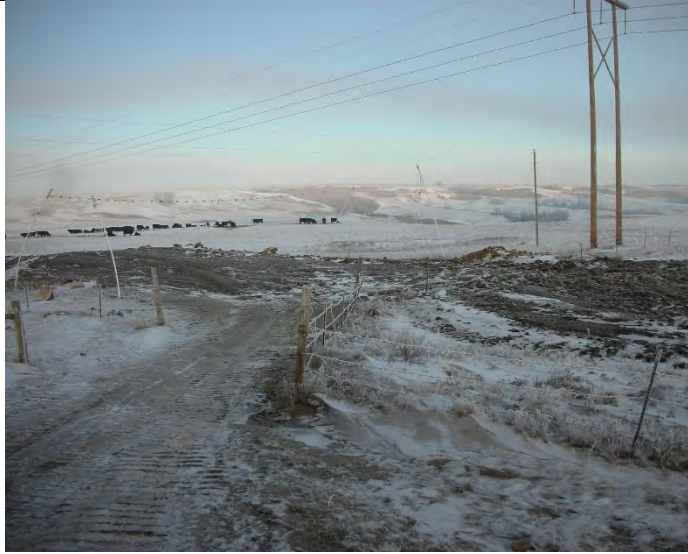
**Observation Point: 2813nw**

Photo Description: Rebuilt fence and soils appropriately replaced along ROW.

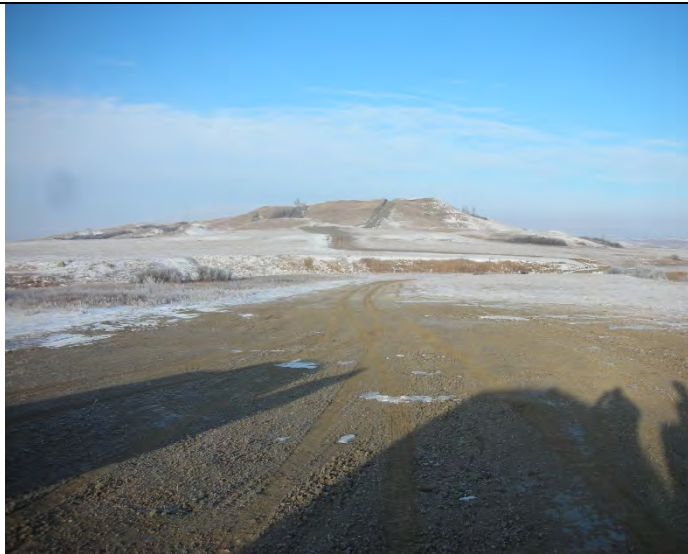
**Observation Point: 2817w**

Photo Description: Overview of typical conditions within ROW, exemplifying final work product of pipe trench backfilling and topsoil replacement construction phase.

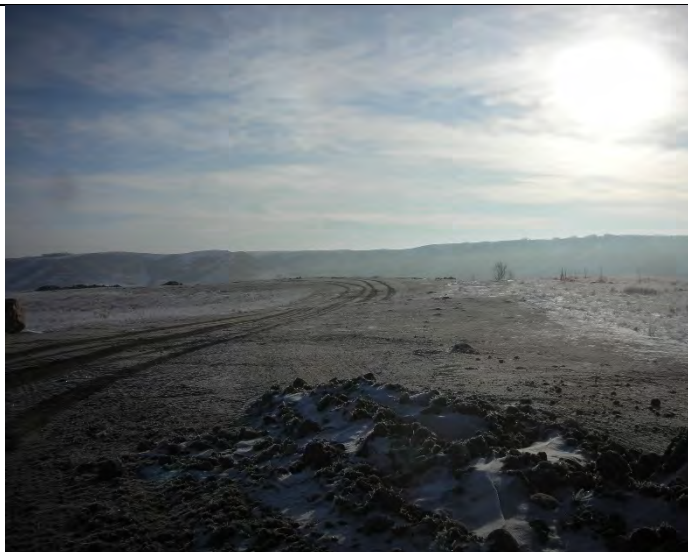
**Observation Point: 2821e**

Photo Description: Overview of typical conditions within ROW, exemplifying final work product of pipe trench backfilling and topsoil replacement construction phase.

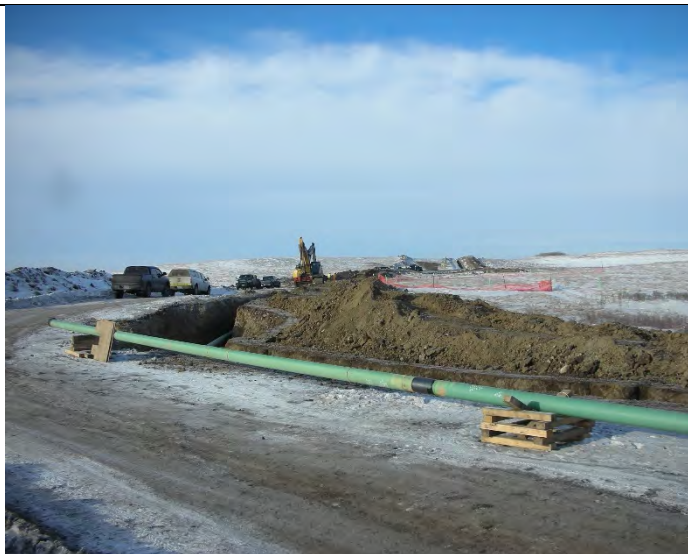
**Observation Point: 2824w**

Photo Description: Exemplification of topsoil mixed with subsoil stockpiles described in Observation Point 2825e.

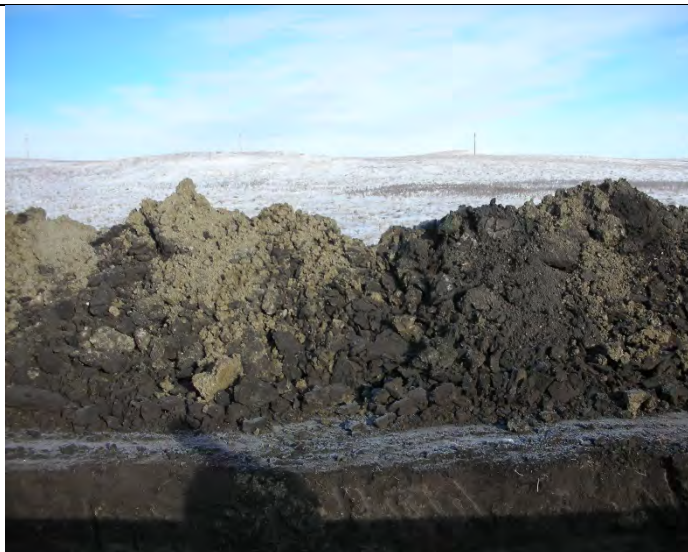
**Observation Point: 2827**

Photo Description: Overview of topsoil stockpile exemplifying stockpile uniformity of size. Topsoil stockpiles should vary in size based upon salvage depths described in Observation Point 2825e.
