**PU-17-97  
Cenex Pipeline, L.L.C.  
10" Refined Fuels Pipeline  
Reclamation Inspection Report**

File No. 227701128

August 2022

**North Dakota Public Service Commission**  
600 E. Boulevard Avenue  
Bismarck, ND 58505-0480

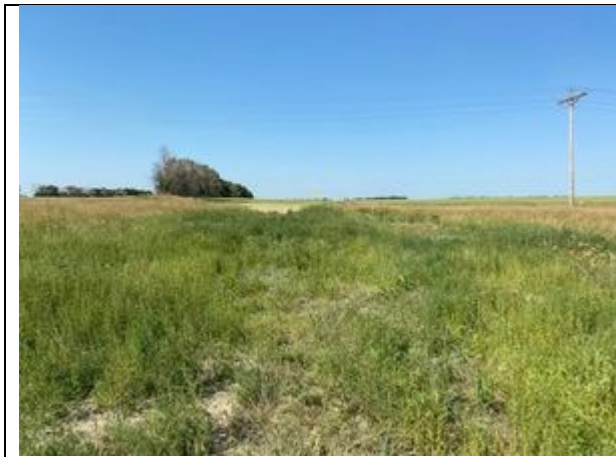
### Observation Point: 2

Date Taken: August 1, 2022 4:43 PM  
Direction Photo is Taken: North  
Land Use: Rangeland

Photo Description: Adequate plant cover. 50% kochia, other species: green foxtail, crested wheatgrass, brome. Surrounding areas have some native grasses. Revegetation is progressing in rangeland.

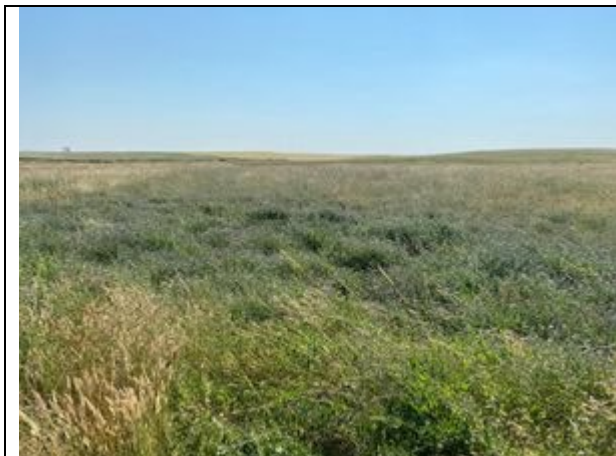
### Observation Point: 3

Date Taken: August 1, 2022 4:48 PM  
Direction Photo is Taken: Northeast  
Land Use: Rangeland

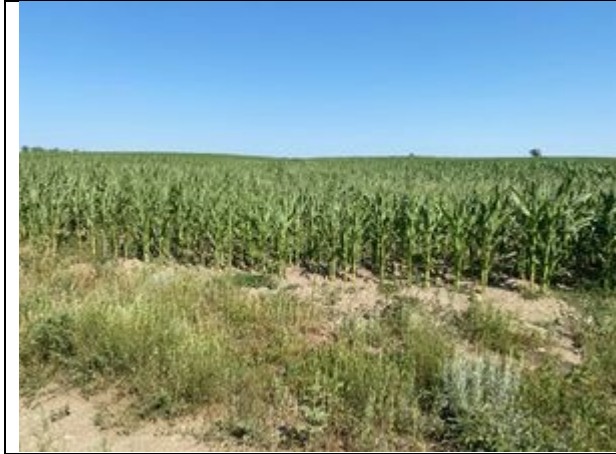
**Observation Point: 4**

Date Taken: August 1, 2022 5:13 PM  
Direction Photo is Taken: East  
Land Use: Cropland

Photo Description: Kochia and red root pigweed dominate reclaimed row. Corn growth in reclaimed farmland is adequate and comparable to surrounding land.

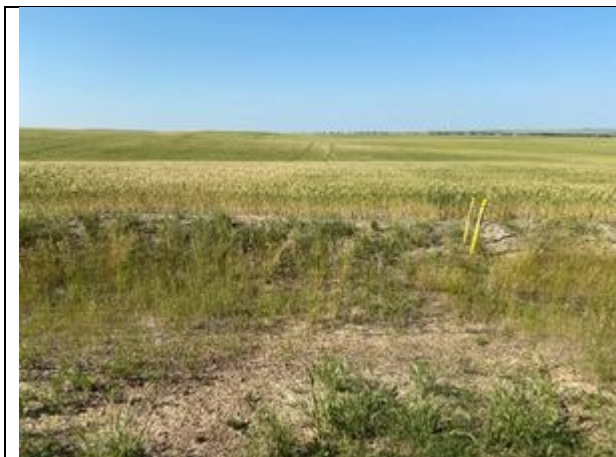
**Observation Point: 5**

Date Taken: August 1, 2022 5:25 PM  
Direction Photo is Taken: North  
Land Use: Cropland

Photo Description: Wheat growth suggests successful reclamation of right away. Ditch was well graded and contains perennial vegetation.

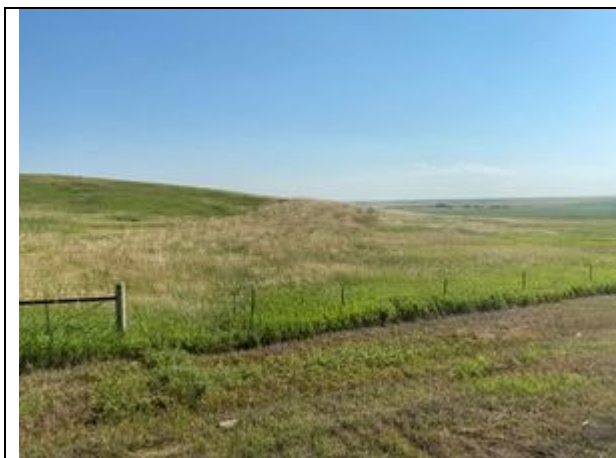
**Observation Point: 6**

Gravel roads crossed by the ROW had been bored underneath to avoid cuts and were in good condition (**Appendix A; Observation Points 6 and 9**). Access points through roadside ditches and approaches had a prevalence of annual weedy species and smooth brome grass. All fences and fenceposts appeared to have been fixed and/or replaced, and no access roads were found to remain. Overall, the ROW was maintained in good condition. Observed aboveground infrastructure (i.e., valve sites) were fenced, secured, and maintained well (**Appendix A; Observation Points 42, 55**).

Date Taken: August 1, 2022 5:59 PM  
Direction Photo is Taken: Southwest  
Land Use: Rangeland

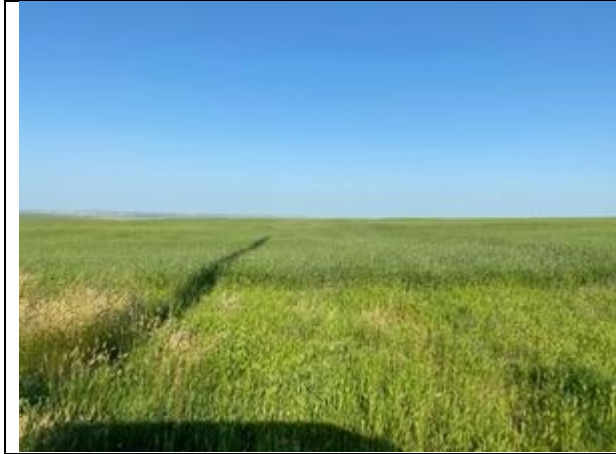
**Observation Point: 7**

Date Taken: August 1, 2022 6:44 PM  
Direction Photo is Taken: East  
Land Use: Cropland

Photo Description: Excellent wheat growth in ROW.

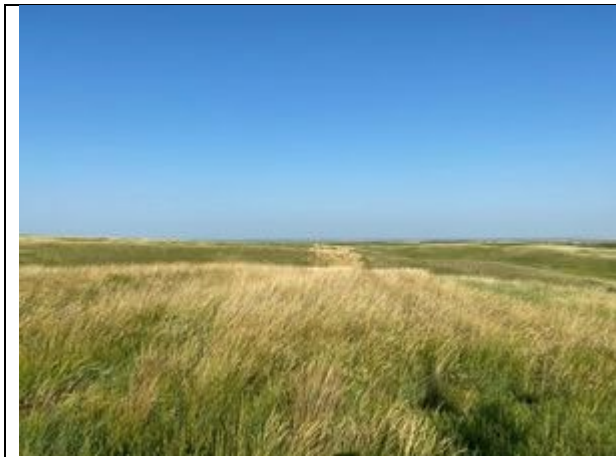
**Observation Point: 8**

Date Taken: August 1, 2022 6:51 PM  
Direction Photo is Taken: East  
Land Use: Rangeland

Photo Description: Land around block valve 352 is noxious weed-free. Kochia dominates area. ROW is covered in perennial grass >90% total cover.

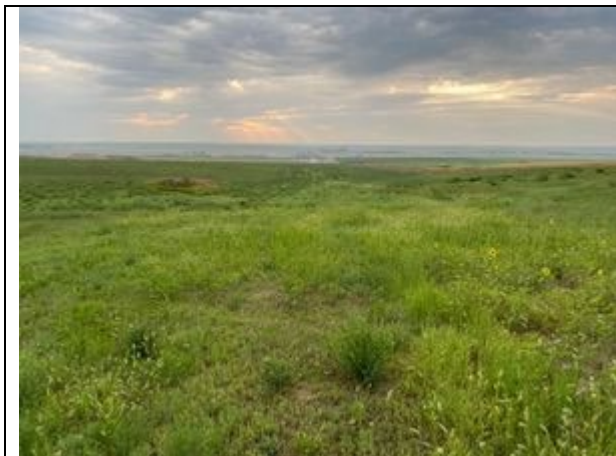
**Observation Point: 9**

Date Taken: August 2, 2022 7:48 AM  
Direction Photo is Taken: East  
Land Use: Rangeland

Photo Description: Grasses are present in reclaimed ROW. No noxious weeds. Green foxtail, alfalfa, kochia, wild sunflower. Returning to original condition.

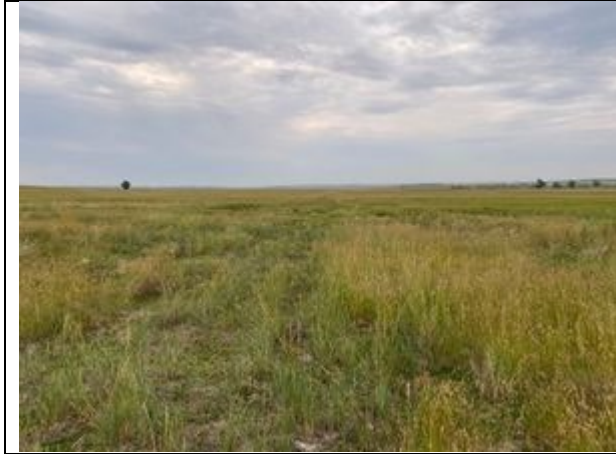
**Observation Point: 10**

Date Taken: August 2, 2022 8:52 AM  
Direction Photo is Taken: Southwest  
Land Use: Hay land

Photo Description: Crested and western wheatgrasses dominate with 70% coverage. No noxious weeds present. Topsoil appears replaced and soil reclamation is appropriate.

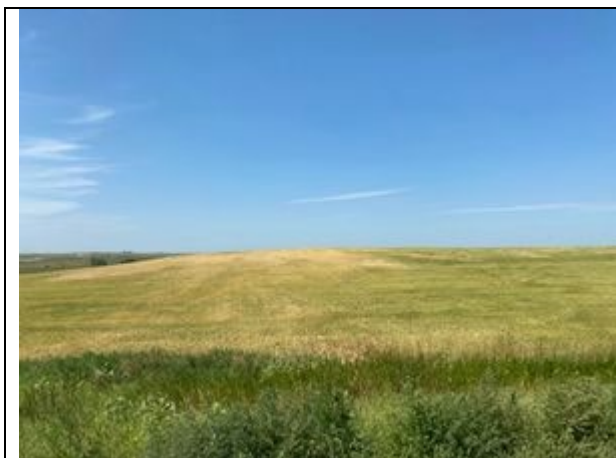
**Observation Point: 12**

Date Taken: August 2, 2022 12:25 PM  
Direction Photo is Taken: West  
Land Use: Rangeland

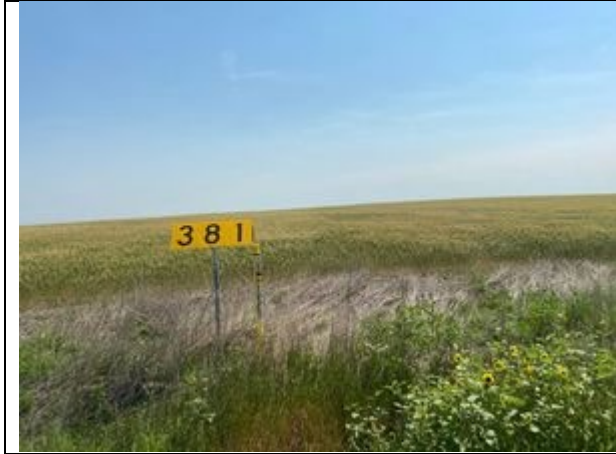
**Observation Point: 13**

Date Taken: August 2, 2022 12:25 PM

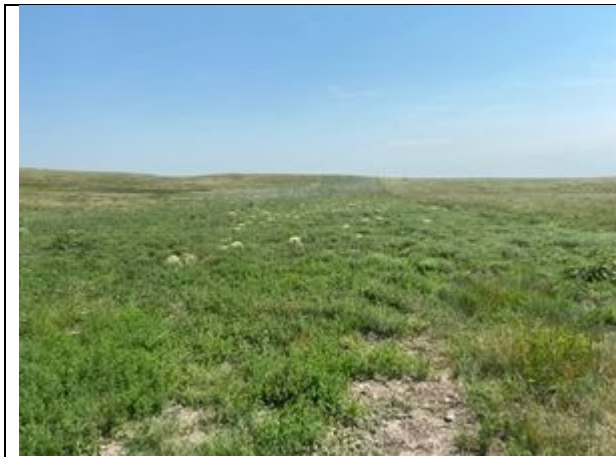
**Observation Point: 14**

Date Taken: August 2, 2022 12:32 PM

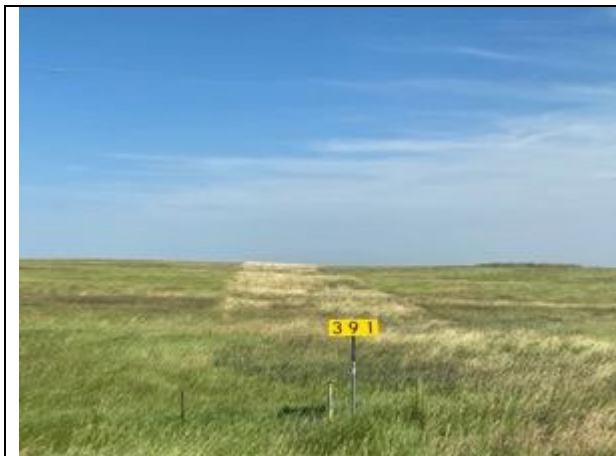
**Observation Point: 15**

Date Taken: August 2, 2022 4:00 PM

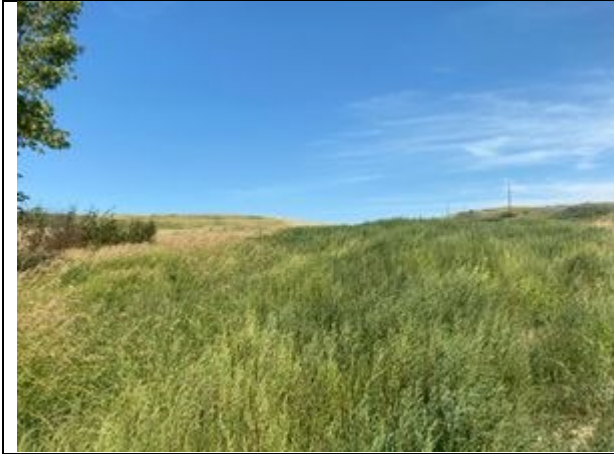
**Observation Point: 16**

Date Taken: August 2, 2022 4:13 PM  
Direction Photo is Taken: East  
Land Use: Rangeland

Photo Description: Kochia dominates the ROW. Brome and other grasses are filling in on margins. Slight erosion, or shallow topsoil due to steep grade.

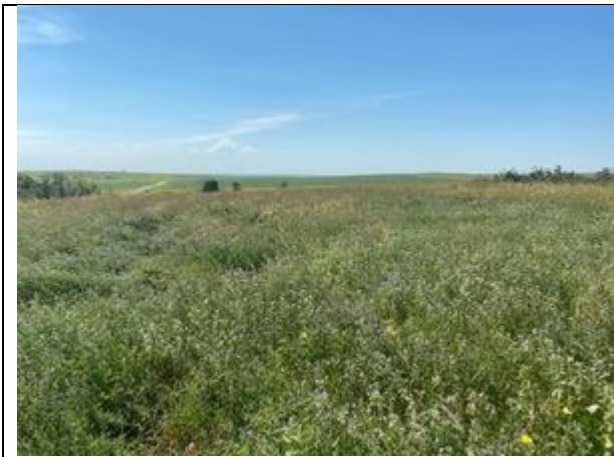
**Observation Point: 17**

Date Taken: August 2, 2022 4:25 PM  
Direction Photo is Taken: West  
Land Use: Rangeland

Photo Description: Alfalfa, sweet clover, and western wheatgrass. 100% cover. Good reclamation.

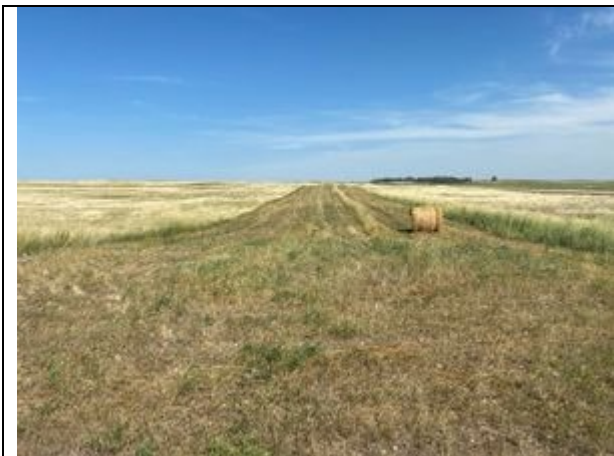
**Observation Point: 18**

Date Taken: August 2, 2022 4:31 PM  
Direction Photo is Taken: East  
Land Use: Hay land

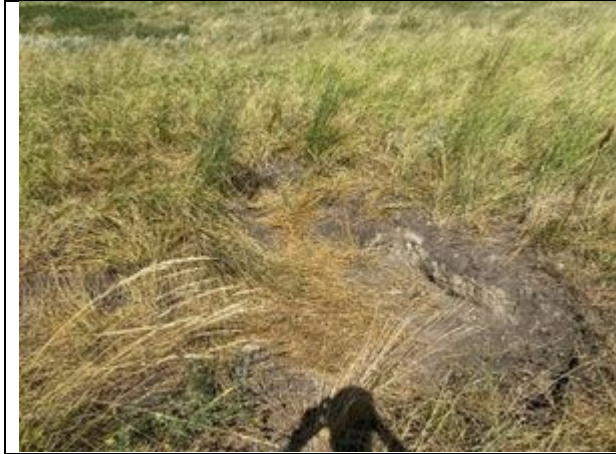
### Observation Point: 19

Uneven, bare, and compacted soil was present at **Observation Point 19 (Appendix A)**, suggesting subsidence issues related to soil settling along the ROW. Erosion was also observed on rangeland due to poor vegetation growth on a steep shoulder (**Observation Point 45**). Kochia and prickly Russian thistle were common at **Observation Point 48**. Canada thistle and Plumeless thistle (*Carduus acanthoides*) noxious weeds were also observed at **Observation Points 43 and 44**, respectively. Additional, minor annual weeds were also observed in reclaimed rangeland ROW parcels. Efforts to control these weed species may be needed. Otherwise, the majority of the ROW under rangeland land use contained appropriate grading, revegetation, and minimal areas of erosion.

Date Taken: August 2, 2022 4:43 PM  
Direction Photo is Taken: Ground  
Land Use: Rangeland

Photo Description: Overall good vegetative cover on the reclaimed ROW, but approximately evidence of  $\geq 5$ in subsidence observed.

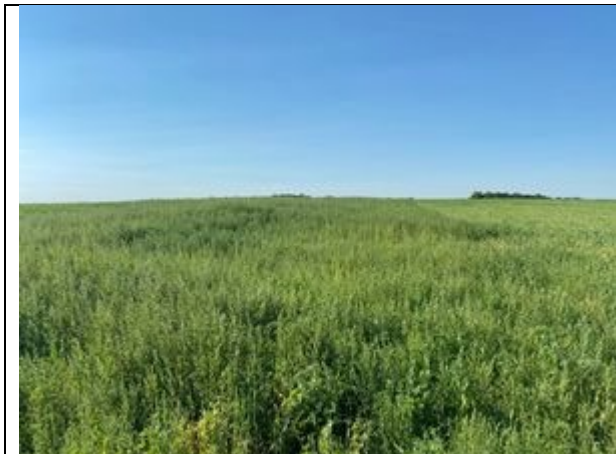
### Observation Point: 21

Date Taken: August 2, 2022 5:24 PM  
Direction Photo is Taken: Northwest  
Land Use: Cropland

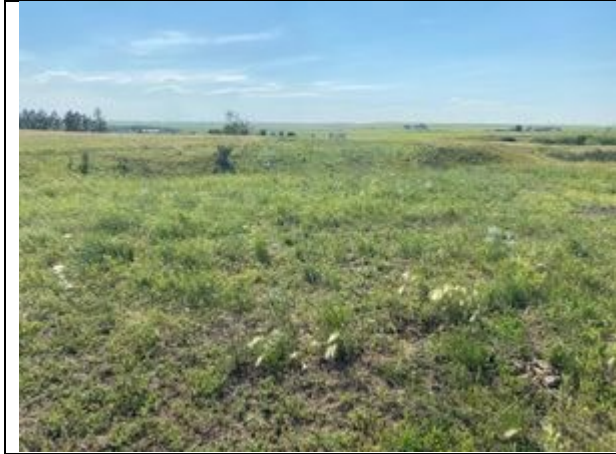
**Observation Point: 22**  
Date Taken: August 2, 2022 5:31 PM  
Direction Photo is Taken: West  
Land Use: Hay land

Photo Description: Predominance of seeded grasses, with alfalfa in Hay land. Well reclaimed.

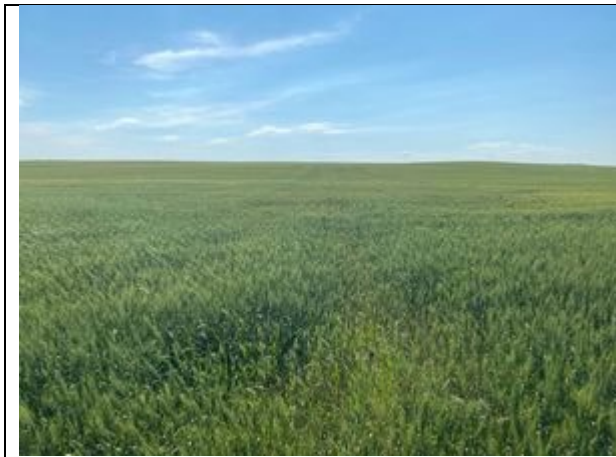
**Observation Point: 23**  
Date Taken: August 2, 2022 5:37 PM  
Direction Photo is Taken: West  
Land Use: Cropland

Photo Description: Kochia, green foxtail, and alfalfa along wheat field edge. No evidence of subsidence. Reclaimed well.

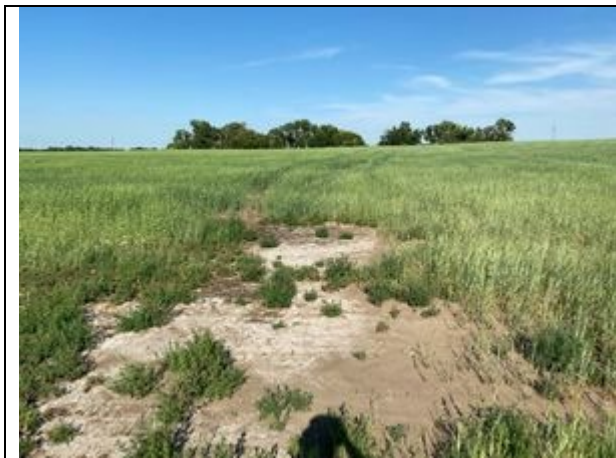
Two open cut wetland crossings were examined (**Appendix A; Observation Points 24 and 31**). The final topography matched the areas outside of the ROW, with no evidence of severe erosion, but there was a prevalence of salt accumulation at the soil surface, and some unvegetated areas in the wetland at **Observation Point 24**. Soil replacement and vegetation establishment was appropriate at **Observation Point 31**. Two other stream/wetland crossing were observed where the HDD crossing method was used (**Appendix A; Observation Point 4 and 39**). The boring staging areas were observed to be appropriately reclaimed, and contained adequate vegetative cover.

**Observation Point: 24**  
Date Taken: August 2, 2022 6:05 PM  
Direction Photo is Taken: East  
Land Use: Cropland

Photo Description: Pipeline trenched through this wetland. Salinity has hindered crop growth, but may be naturally occurring. Foxtail barley and kochia dominant in saline areas.

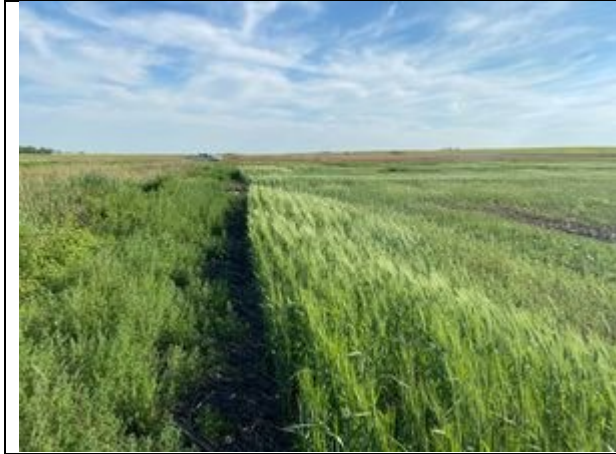
**Observation Point: 25**

**Observation Points 25, 53, and 60** noted populations of Canada thistle (*Cirsium arvense*) which is a ND noxious weed.

Date Taken: August 2, 2022 6:12 PM

The two noxious weed species observed were Canada thistle (perennial) and plumeless thistle (biennial). Stantec recommends Cenex address the infestations of noxious weeds in the ROW. For Canada thistle control, Stantec recommends infested areas be treated at the beginning of the 2023 growing season according to Cenex's weed management plan and from the recommendations from the local noxious weed board and landowners (per PU-17-97 Docket #1). The locations observed with noxious weeds should be monitored for at least two years to allow for the lifecycle of weeds, and to ensure infestations do not spread.

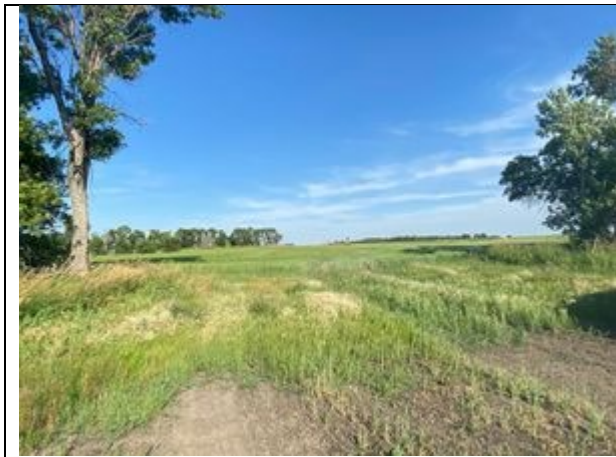
**Observation Point: 26**

The soil in a majority of the inspected cropland had been adequately replaced and was matching existing surface topography. However, **Observation Points 26, 27, 28, 40, and 53 (Appendix A)** noted visibly bare soil with an uneven surface, which could be indicative of subsidence and/or compaction in the ROW. Compaction would inhibit root penetration (as seen at **Observation Point 59**) and plant establishment, potentially decreasing water infiltration and increasing runoff. Soil was examined with a sharpshooter and found to be difficult to dig beyond 3 inches, suggesting the soil is compacted.

Date Taken: August 2, 2022 6:20 PM

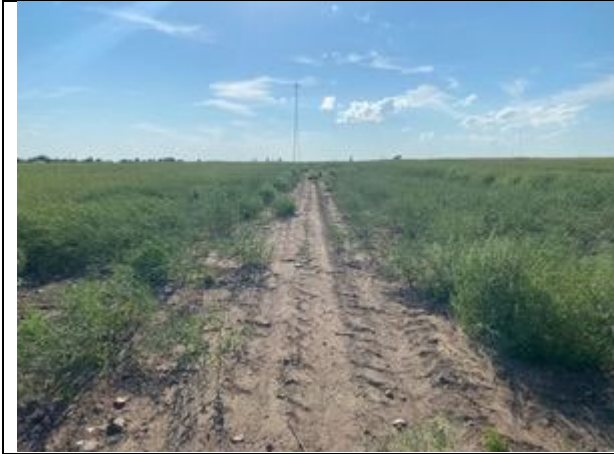
**Observation Point: 28**

Date Taken: August 2, 2022 6:30 PM  
Direction Photo is Taken: East  
Land Use: Cropland

Photo Description: Compaction along the right of way inhibiting proper plant growth. Recommend addressing to be compliant.

Soil decompaction and additional fill at select areas could mitigate the adverse impacts of observed compaction and subsidence (**Appendix A; Observation Points 28, 53, 59**). Without corrective measures, landowners producing crops in the compacted portions of the ROW soil may experience declined crop yields due to poor root penetration. Though these issues were isolated, Cenex should

coordinate with the landowner(s) on possible ways to address these areas noted through either tillage, cover crops, or other methods.

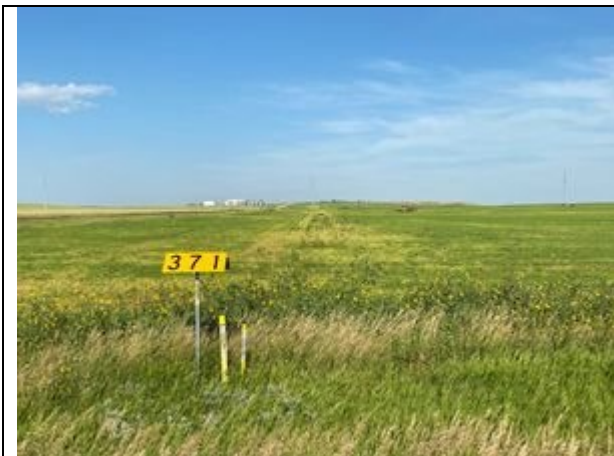
**Observation Point: 30**

Date Taken: August 2, 2022 6:38 PM  
Direction Photo is Taken: East  
Land Use: Cropland

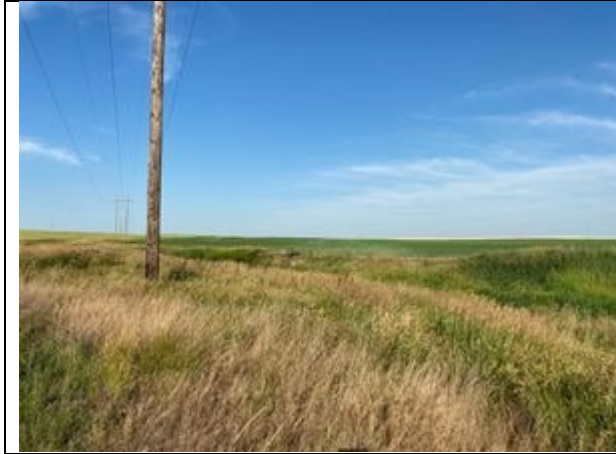
**Observation Point: 31**

Date Taken: August 2, 2022 6:55 PM  
Direction Photo is Taken: West  
Land Use: Rangeland

Photo Description: Adequate reclamation.

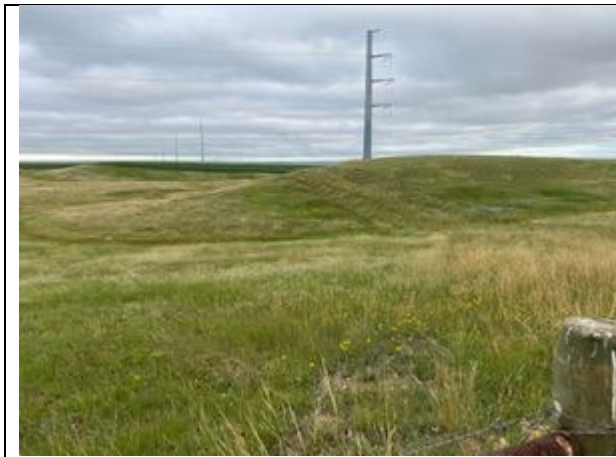
**Observation Point: 32**

Date Taken: August 3, 2022 8:28 AM  
Direction Photo is Taken: Northwest  
Land Use: Rangeland

Photo Description: Appropriate vegetative cover on reclaimed ROW. No observed excess weeds in rangeland/pasture.

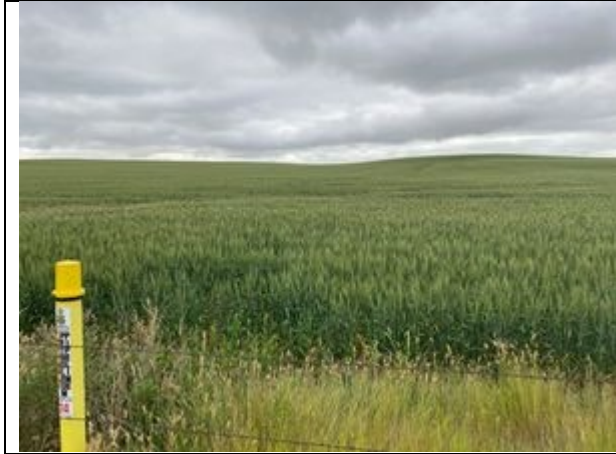
**Observation Point: 34**

Date Taken: August 3, 2022 9:36 AM  
Direction Photo is Taken: South  
Land Use: Cropland

Photo Description: Wheat field is comparable to surrounding land. Suggests successful reclamation.

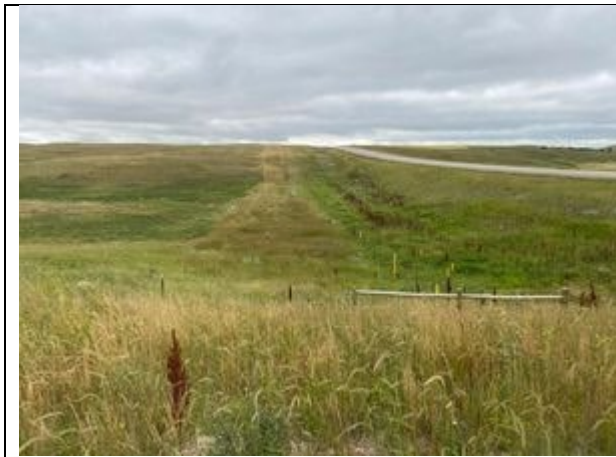
**Observation Point: 35**

Date Taken: August 3, 2022 9:48 AM  
Direction Photo is Taken: West  
Land Use: Rangeland

Photo Description: Wild rye, Curlycup gumweed, western wheatgrass. Minimal weeds and good veg cover.

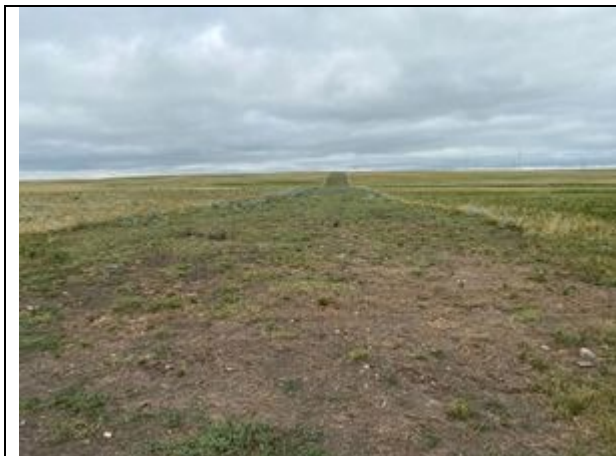
**Observation Point: 36**

Date Taken: August 3, 2022 10:02 AM  
Direction Photo is Taken: West  
Land Use: Rangeland

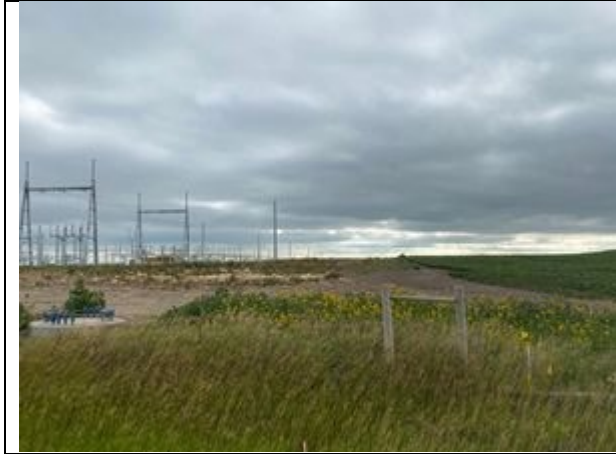
**Observation Point: 37**

Date Taken: August 3, 2022 10:03 AM

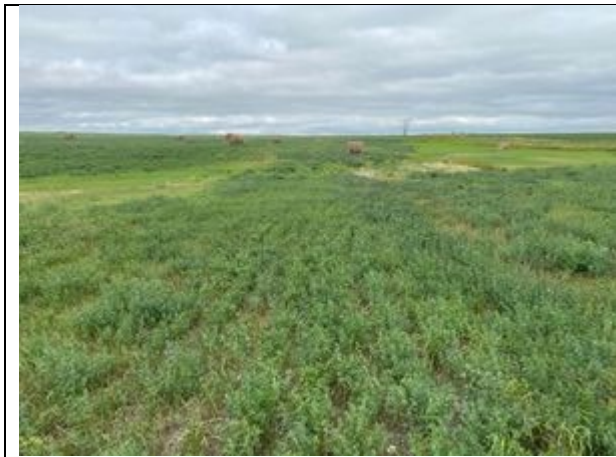
**Observation Point: 38**

Date Taken: August 3, 2022 10:16 AM

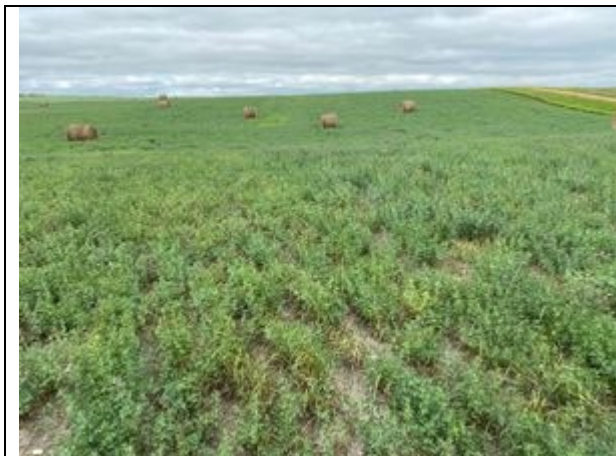
**Observation Point: 39**

Date Taken: August 3, 2022 10:21 AM

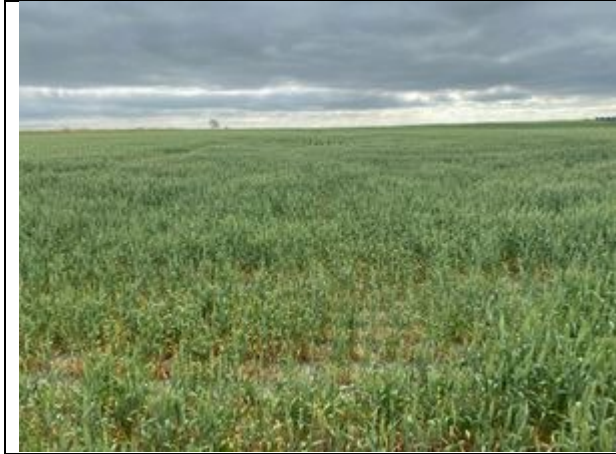
**Observation Point: 40**

Date Taken: August 3, 2022 10:26 AM

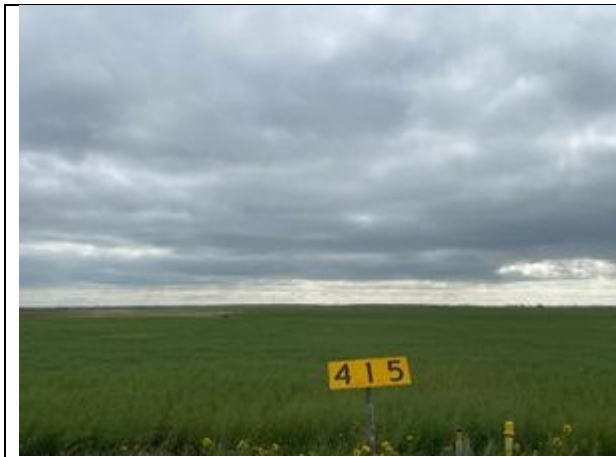
**Observation Point: 41**

Date Taken: August 3, 2022 10:34 AM

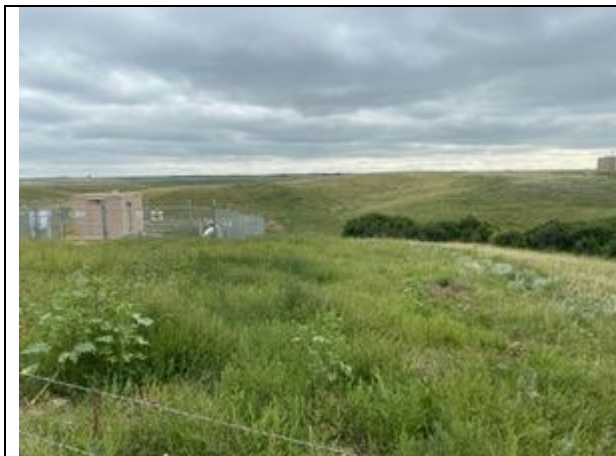
**Observation Point: 42**

Date Taken: August 3, 2022 10:45 AM

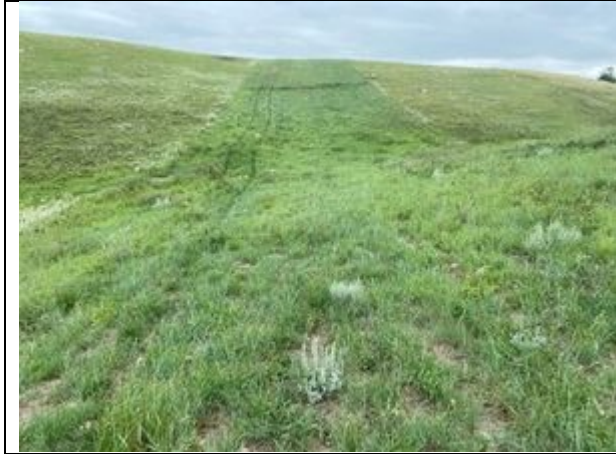
Plumeless and Canada thistle are noxious weeds, and observed at **Observation Points 25, 43, 44, 53, 60 (Appendix A)**. Some weeds occur in cropland, and may require coordination with landowners/tenants to control. Canada thistle is a ubiquitous and prolific weed species in the region, and often requires multiple attempts to suppress.

**Observation Point: 43**  
Date Taken: August 3, 2022 11:19 AM  
Direction Photo is Taken: East  
Land Use: Rangeland

Photo Description: Minimal erosion on rolling hills. Canada thistle prominent.

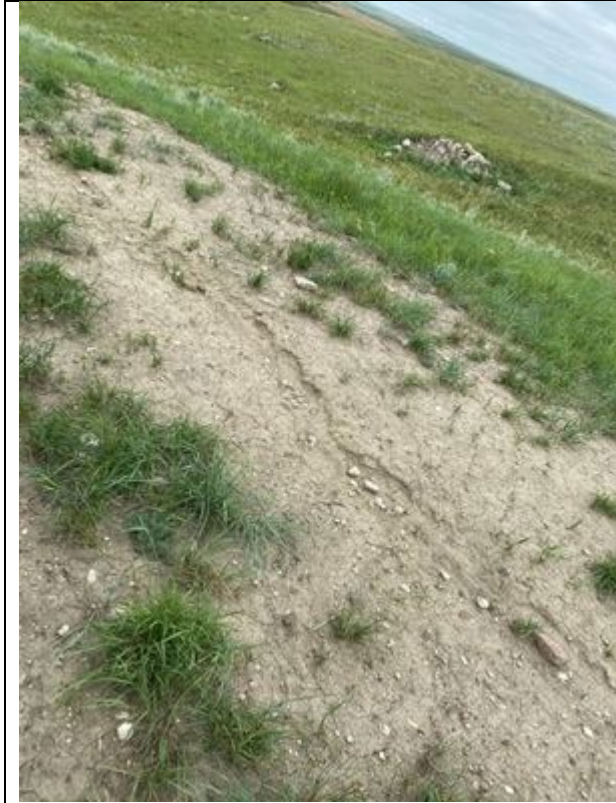
**Observation Point: 45**

Date Taken: August 3, 2022 11:25 AM

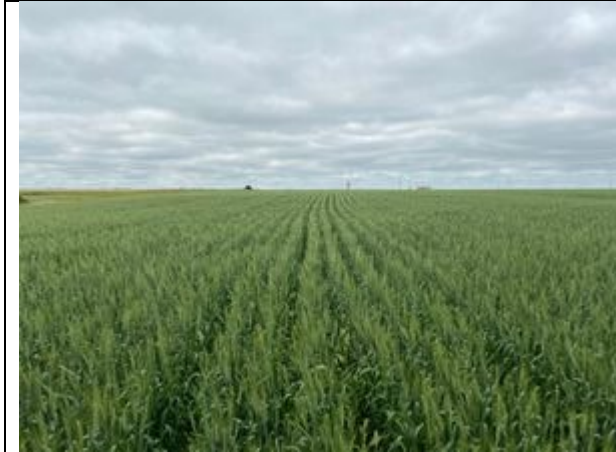
**Observation Point: 46**

Date Taken: August 3, 2022 11:31 AM

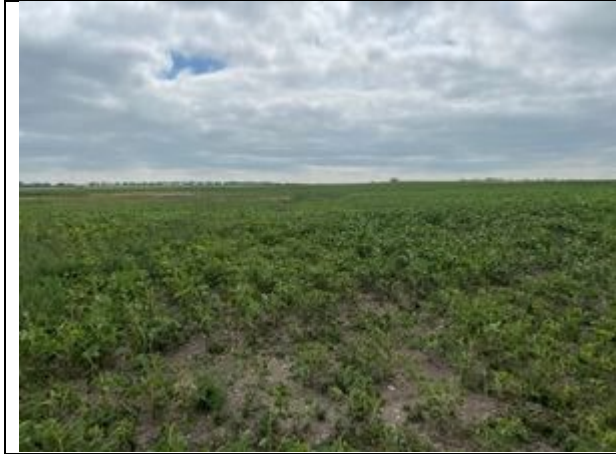
**Observation Point: 47**

Photo Description: Appropriately graded land with acceptable soybean growth in the reclaimed right of way. Some kochia is present.

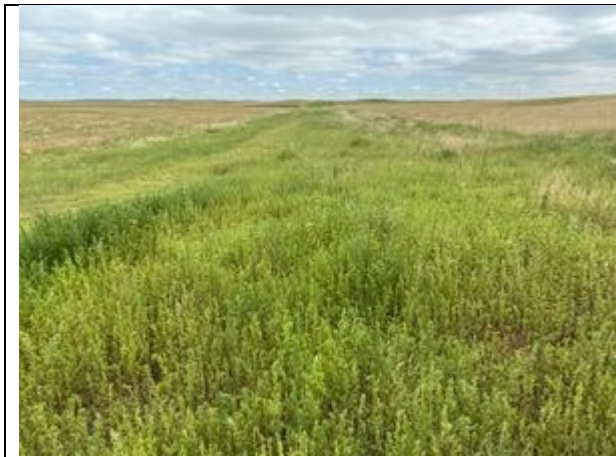
**Observation Point: 48**

Photo Description: Kochia dominates ROW. Recommended mowing and supplemental native grass seeding.

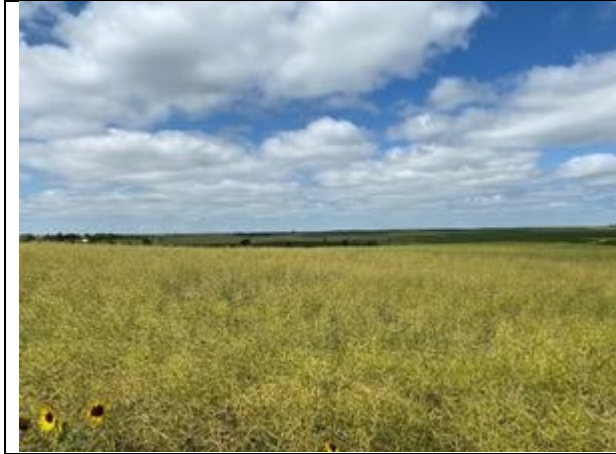
**Observation Point: 50**

Photo Description: Soil and plant density/stand height suggest successful reclamation to most practicable level.

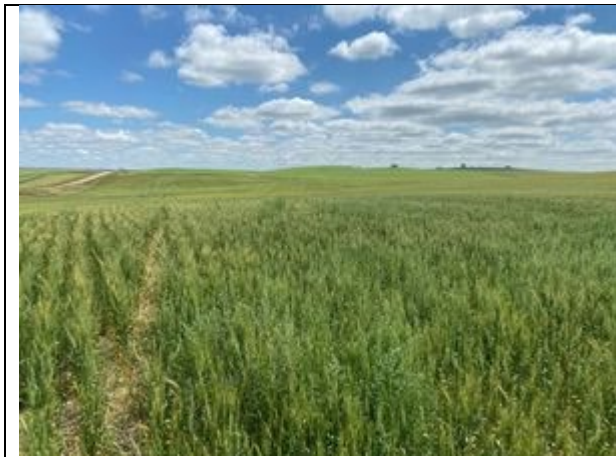
**Observation Point: 51**

Photo Description: Minimal signs of compaction stress in reclaimed area. Wheat is standing well and matches surrounding cropland.

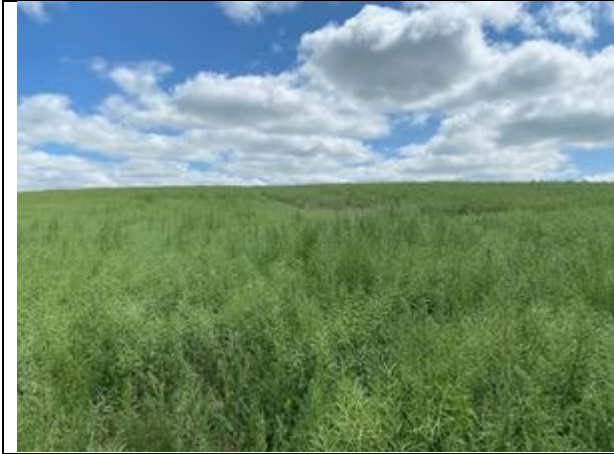
**Observation Point: 53**

Exposed subsoil and/or mixed topsoil was observed at one location (**Appendix A; Observation Point 53**) in the ROW, which was affecting crop growth surrounding the area. Stantec recommends the PSC inquire about this area with Cenex. Adding topsoil, biological amendments, or organic matter could be possible methods to increase the organic matter content and improve vegetative restoration.

Photo Description: Mixed topsoil and subsoil was replaced. Compaction and subsidence prevalent. The area west of observation point contains a significant amount of Canada thistle.

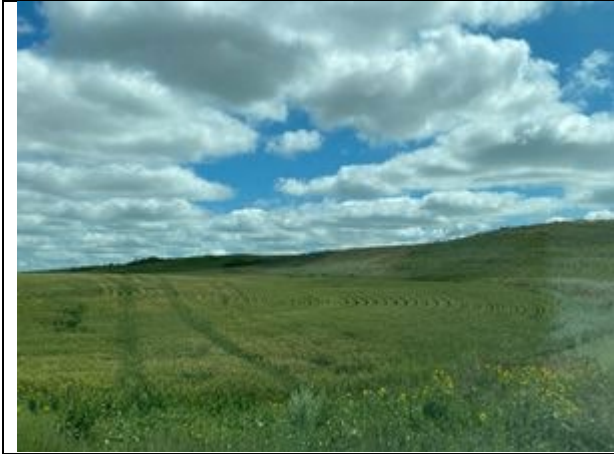
**Observation Point: 56**

Photo Description: Overall, ROW is well vegetated with wheat comparable to the surrounding field. No noxious weeds observed in the ditch, field, or reclaimed rangeland.

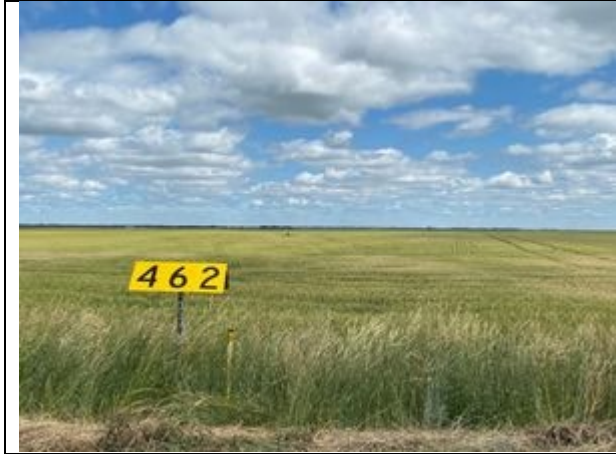
**Observation Point: 61**

Photo Description: Well reclaimed.

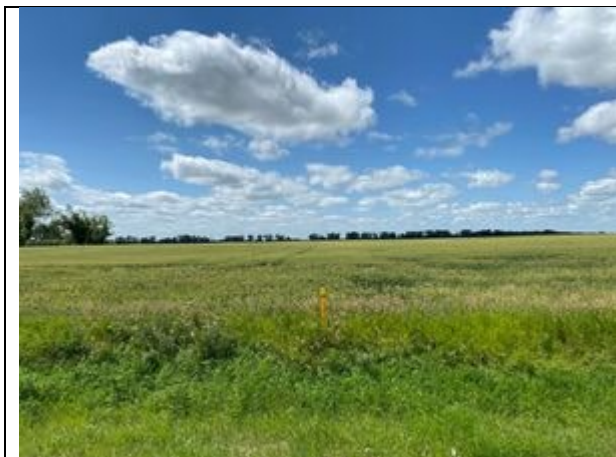
**Observation Point: 62**

Photo Description: Reclaimed wheat field in good condition.
