Public Service Commission State of North Dakota

INSPECTION REPORT

DATE OF INSPECTION: March 22, 2017

PERMITTEE - MINE: Dakota Westmoreland Corporation (DWC) - Beulah Mine

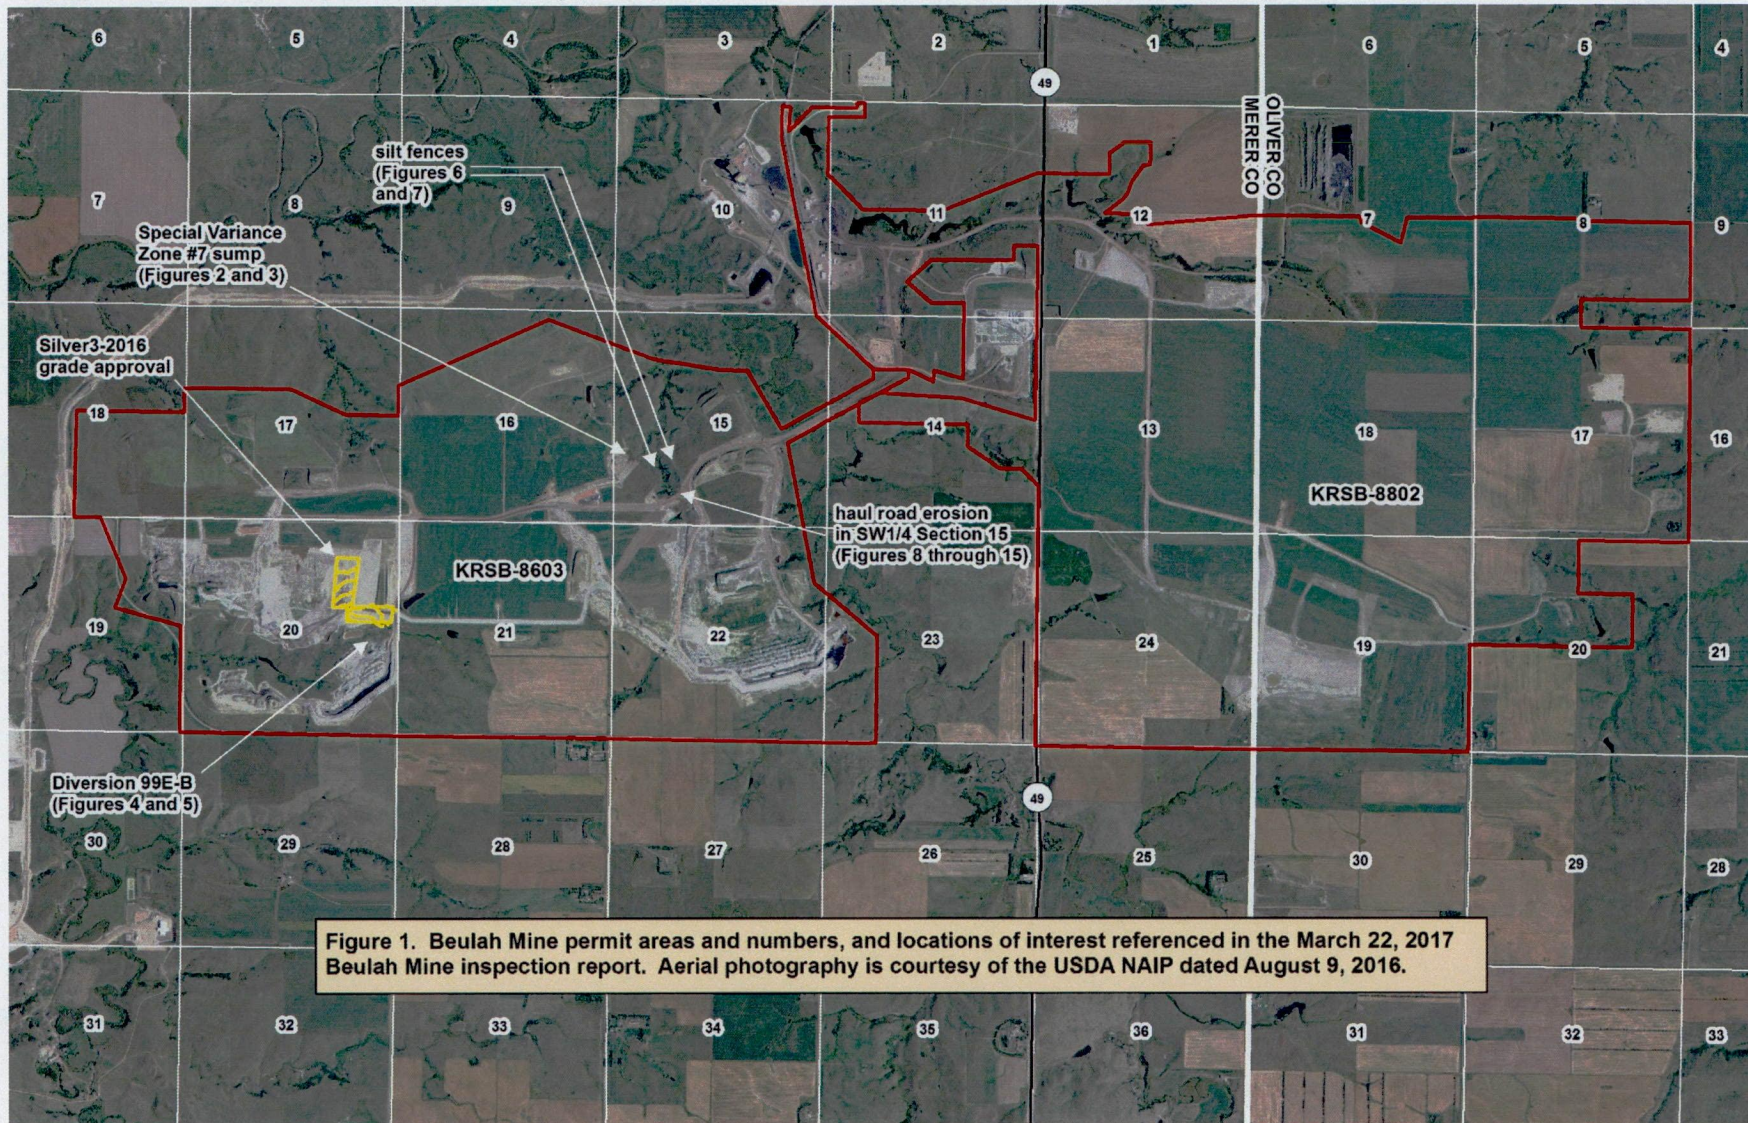
The sump in Special Variance Zone #7 (spoil stockpile to reclaim Pond 86 and its associated sump that also contains haul road runoff) located in the NW¼SW¼ of Section 15 was viewed during the inspection. Please refer to Figures 1 and 8 for the sump location. It appeared that the spoil stockpile sump overflowed and cut down to an adjoining linear sump to the north that was apparently installed to detain runoff from reclaimed land for which ten-year revegetation period was initiated in 2010 as pictured in Figure 2. It also appeared that comingled sump drainage flowed through a silt fence to the undisturbed intermittent stream bank in the NW¼SW¼ of Section 15 as pictured in Figure 3. Runoff detained in the spoil stockpile and haul road runoff sump must be pumped to Pond 86 as specified on page 3.8.8 of the KRSB-8603 permit rather than being discharged through a silt fence.

Figure 2. Special Variance Zone #7 spoil stockpile sump overflow to an adjoining linear sump to the north that was apparently installed to detain runoff from reclaimed land - facing north - see Figures 1 and 8 for location.
