Andeavor Y Grade Hub Reclamation Inspection Report PU-18-72

Prepared for:
**North Dakota
Public Service Commission**

WENCK Associates, Inc.
3303 Fiechtner Driver
Fargo, ND 58103
Phone: 701-297-9600
Fax: 701-297-9601

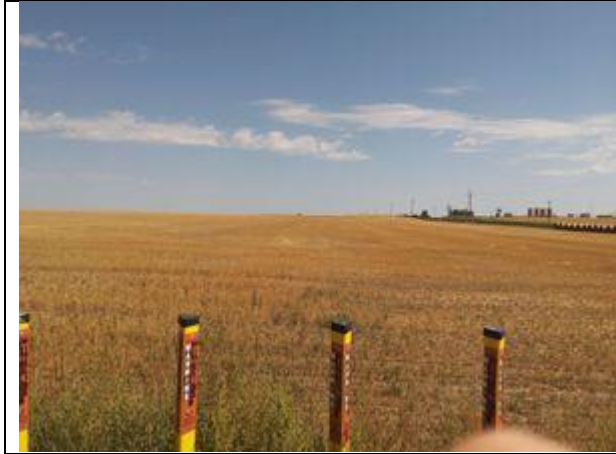
Observation Point: 4

Photo Description: Successfully harvested wheat field. Conditions comparable to undisturbed areas.

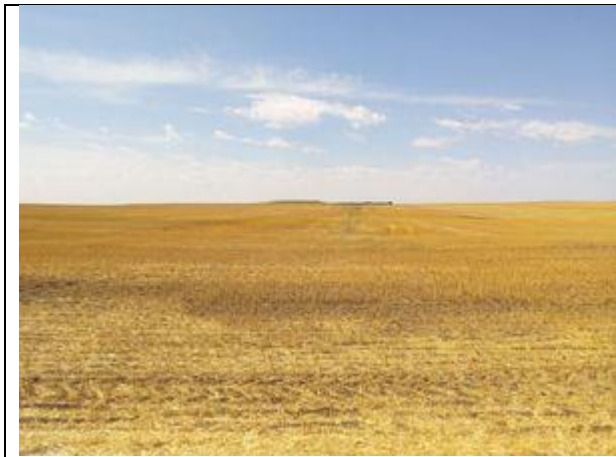
Observation Point: 5

Photo Description: Successfully harvested wheat field. Conditions comparable to undisturbed areas.

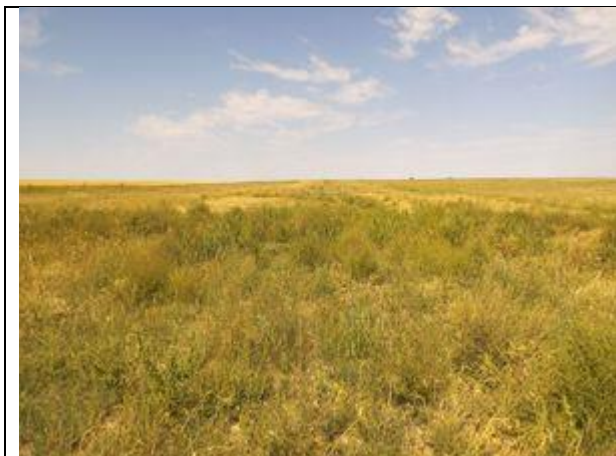
Observation Point: 6

Four open cut stream/drainage crossings were observed (**Appendix B; Observation Points 6, 9, 11, 41**). It was apparent, seeded vegetation did not match that of hydric conditions and a high rate of failure and weedy presence was observed. Some areas were poorly graded for conducive flow. Sevenmile Creek erosion was still evident from the as-built inspections. It is likely all open cut stream drainages require additional maintenance and/or vegetation management through appropriate seeding and weed management. Cherry Creek was also observed where the pipeline was horizontally bored underneath the stream (**Appendix B; Observation Point 40**).

Stream and/or drainages crossed by the Project ROW were not seeded with hydric tolerant species; therefore, crossings were largely devoid of desirable vegetation, mostly comprised of weed species, and left susceptible to erosion. Wenck recommends seeding be appropriate for encountered hydric conditions and erosion controls be left in place until 70% vegetation is achieved. Wenck recommends these areas be reseeded.

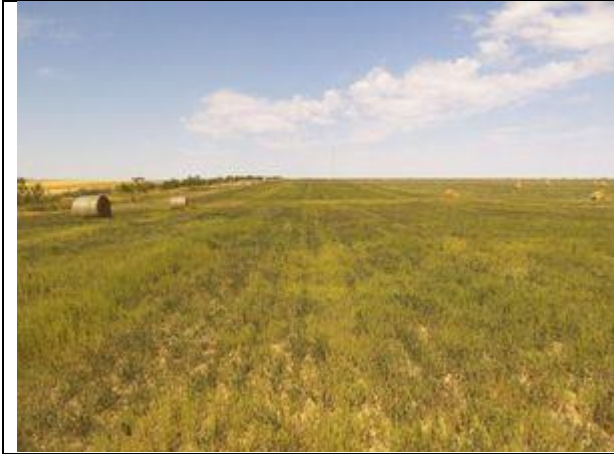
Observation Point: 7

Photo Description: Land cover usage is hay land. 50% cover achieved. ROW dominated by Kochia with Alfalfa at 10%; devoid of grasses found outside of ROW such as, western and slender wheat.

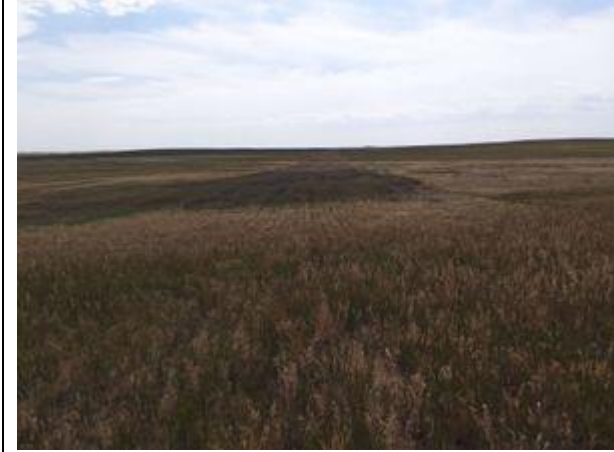
Observation Point: 10
Date Taken: 08/18/2020 3:51 PM
Direction Photo is Taken: Southwest
Spread: South Segment
Photo Description: Land cover usage is hay land. 35% cover achieved, comprised of smooth brome, crested wheat, sweet clover, alfalfa, foxtail barley, and curlycup gumweed. Outside of ROW comprised of western and slender wheat grass, smooth brome, curlycup gumweed, Kentucky bluegrass, quack grass, and crested wheat.
Latitude: 46.94115527
Longitude: -103.2116082

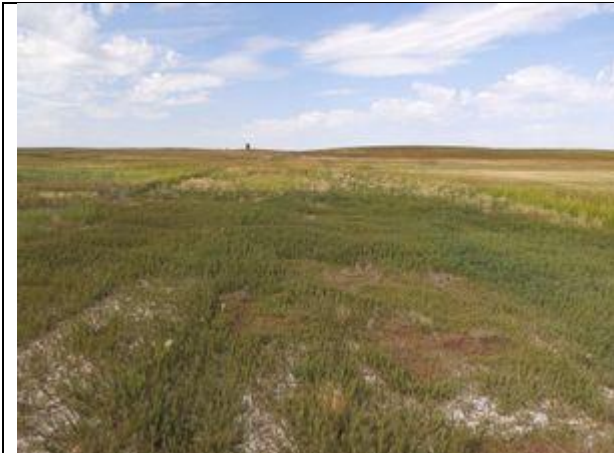
Observation Point: 11
Date Taken: 08/18/2020 4:08 PM
Direction Photo is Taken:
Spread: South Segment
Photo Description: Near reroute within ROW at stream crossing between to cultivated fields. 50% cover achieved, comprised of mostly kochia, inland salt grass and foxtail barley.
Latitude: 46.95123322
Longitude: -103.21221361

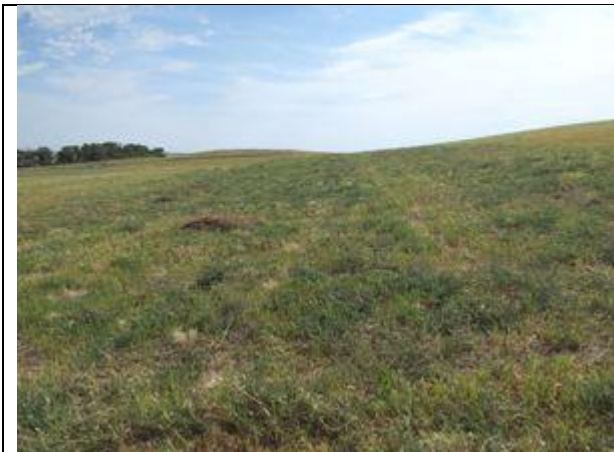
Observation Point: 12
Date Taken: 08/18/2020 4:18 PM
Direction Photo is Taken: South
Spread: South Segment
Photo Description: Land usage is hay land. 50% cover achieved. No desirable species present. ROW comprised entirely of weeds; however, comparable to adjacent vegetation outside of ROW. Kochia, yellow/green foxtail, and several other weeds.
Latitude: 46.96256942
Longitude: -103.21256619

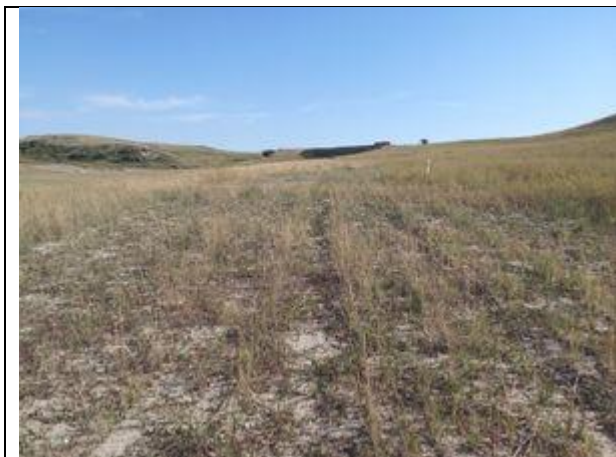
Observation Point: 23

Photo Description: Land usage is hay land, comprised of slender and western wheat and sweet clover. 30% cover achieved, comprised of slender and western wheat, sweet clover, field bind weed, cocklebur, and Horse weed.

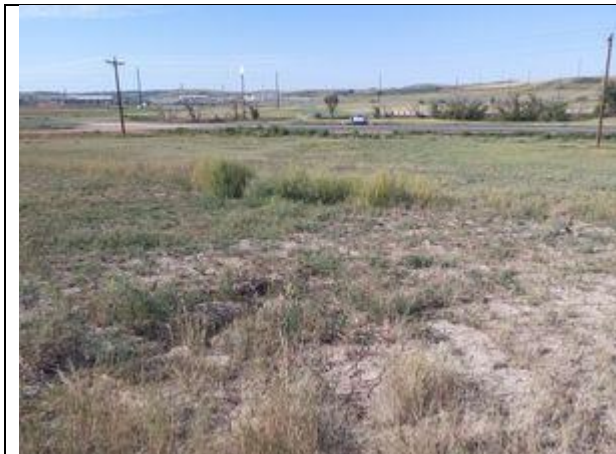
Observation Point: 24

Reclaimed rangeland parcels had achieved less than 40% total aerial coverage on average, comprised mostly of weedy species at 40% aerial coverage, primarily kochia and green/yellow foxtail among other lesser components; about 30% seeded grasses, and 20% introduced species likely from the original seedbank. No noxious weeds were observed in reclaimed hay land parcels. Individual parcels varied considerably in successful revegetation and composition of desired and undesired species; however significantly high weedy areas stood out against the landscape and most times were observed near access points and areas of topographical breaks, suggesting compaction and potentially topsoil depth issues common among rangeland hilltops in McKenzie County, respectively (**Appendix B; Observation points 24, 29, 39**).

Photo Description: Land usage is hay land. 20% cover achieved, comprised of setaria species, kochia, slender wheat, and annual weeds. Condition present from observation point to access road.

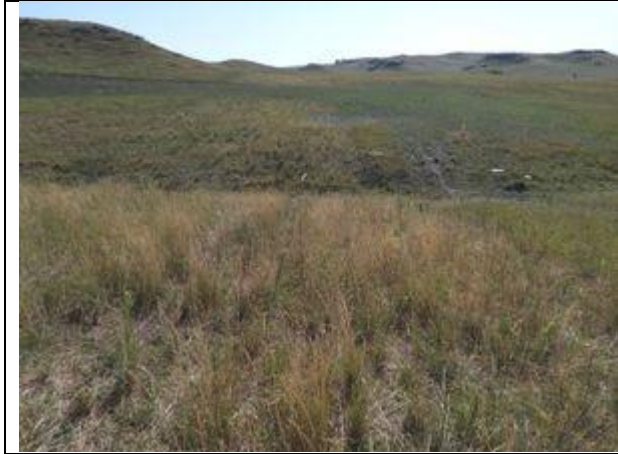
Observation Point: 25

Photo Description: Land usage is rangeland. 40% cover achieved, comprised of slender wheat, horse weed, cocklebur, and annual weeds.

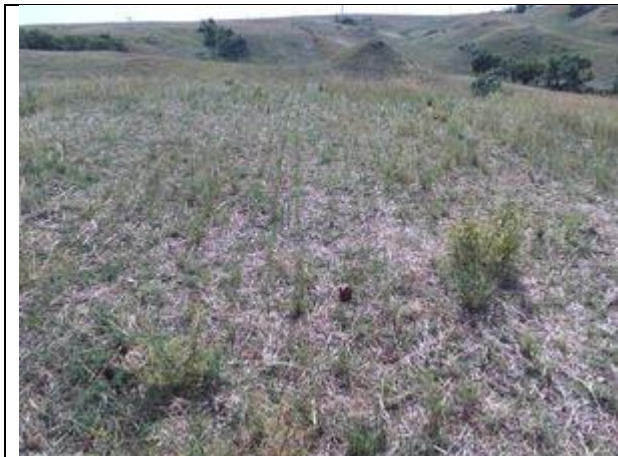
Observation Point: 26

Photo Description: Land usage is rangeland. 25% cover achieved, comprised of slender wheat, green needle, yellow coneflower, and sweet clover. Hilltop area appears to be deviation from proposed route. Lots of scoria and rocks on surface.

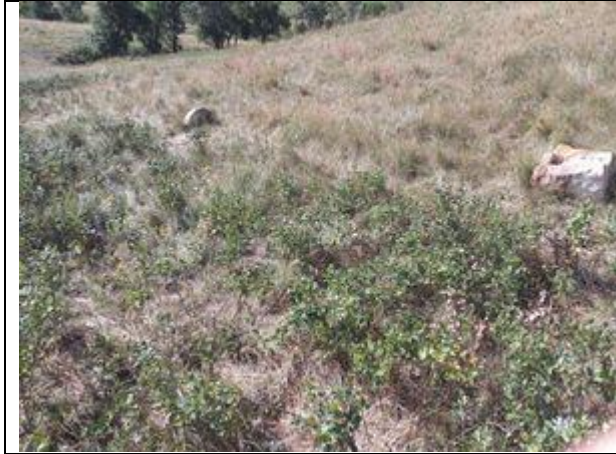
Observation Point: 28

Photo Description: Potential rocks at base of hill from stone outcropping at summit.

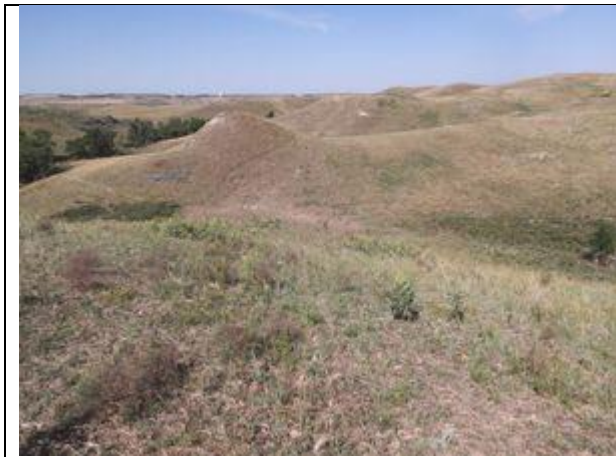
Observation Point: 29

Photo Description: Land usage is rangeland. 10 percent cover achieved, comprised of slender and western wheat, ragweed, and horse weed.

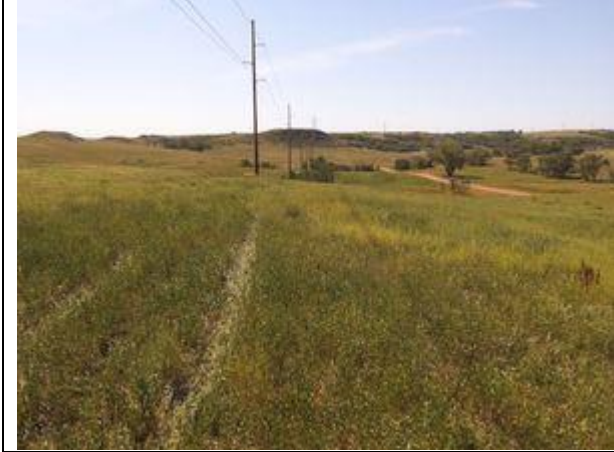
Observation Point: 31
Date Taken: 08/19/2020 12:10 PM
Direction Photo is Taken: South
Spread: North Segment

Photo Description: Land usage is hay land. 30% cover achieved, comprised of alfalfa and kochia. Weed management may be required.

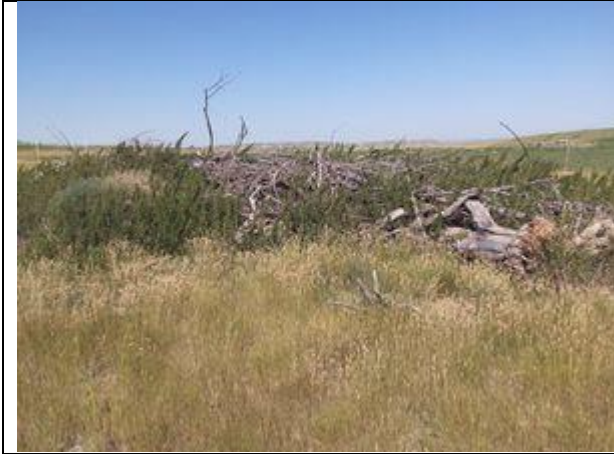
Observation Point: 34

Photo Description: Woody debris pile far off row. Google Earth historical imagery suggests it could be associated with the adjacent pipeline through wooded area to west as early as 2013.

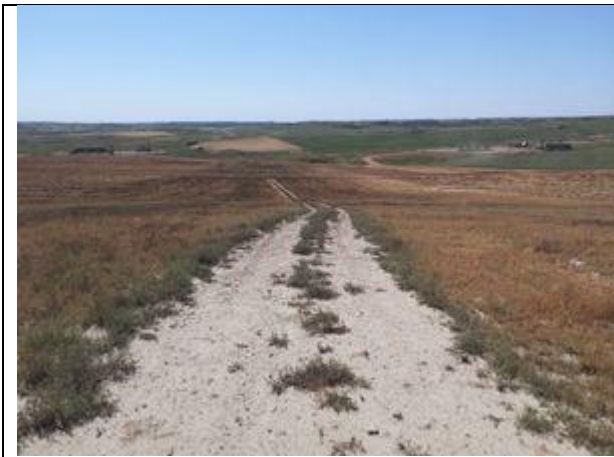
Observation Point: 35

Photo Description: Land usage is hay land. Pipeline construction access road present. Access road appears to be utilized for numerous pipelines in the area.

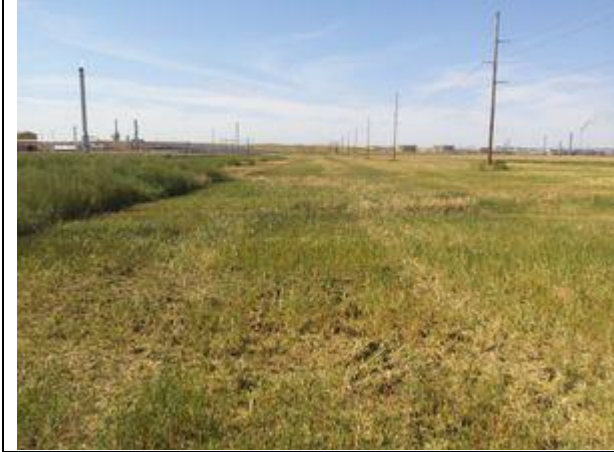
Observation Point: 37

Photo Description: Land usage is agricultural. 60% cover achieved, comprised of kochia, setaria species, and unharvested old canola.

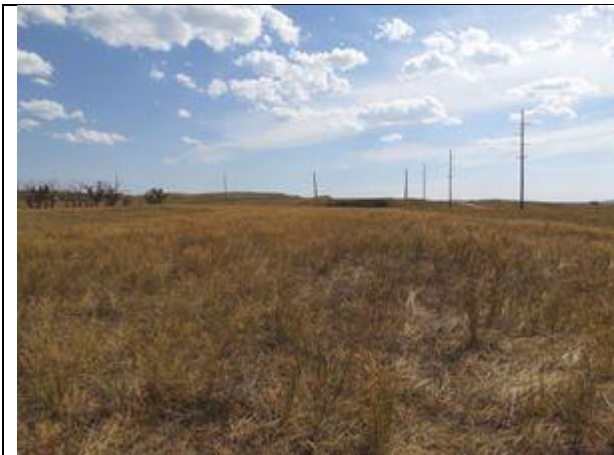
Observation Point: 38

Photo Description: Land usage is hay land. Cover is equal to outside of ROW, comprised of sweet clover, green needle grass, crested wheat grass, and slender wheat grass.

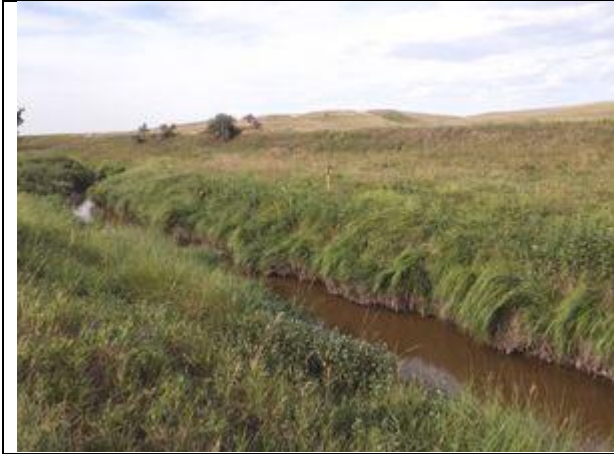
Observation Point: 40

Photo Description: No disturbance at Cherry Creek.
