Public Service Commission
State of North Dakota

Re: ND One-Call Excavation Notice System: North Dakota Century Code Chapter 49-23

Enclosed is a copy of a ND One-Call Complaint, with attachments, against Northern Improvement Company, received by the North Dakota Public Service Commission on November 13, 2018, from Scott MacLean at Montana Dakota Utilities, of Dickinson, ND, Case Number PU-18-388. The location of the damage identified in the complaint is approximately the southeast corner of the intersection of 3rd St E and 5th Ave E in Dickinson, ND.

ND ONE-CALL COMPLAINT

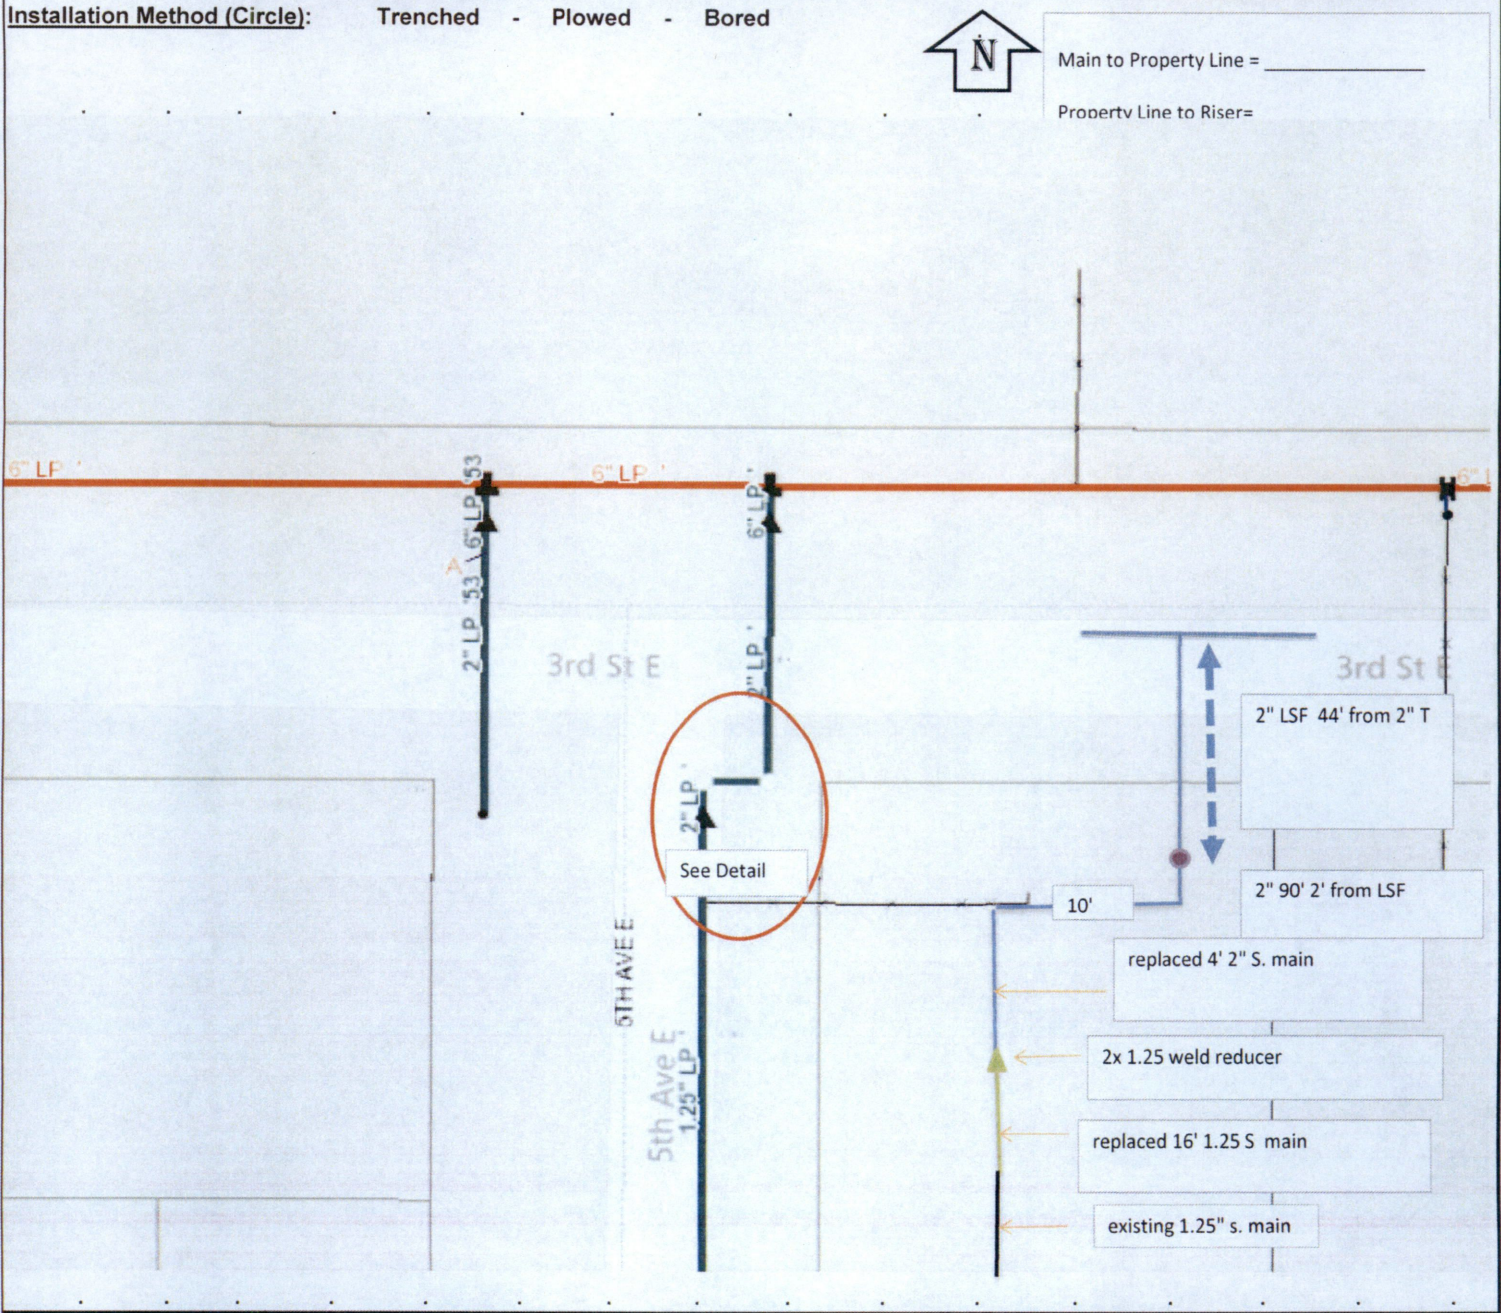
Description of Leak: excavator ripped apart 1.25 dresser 90
Method of Repair: Replaced portion of gas main
Date Repaired: 8/1/2017 S.O. #: MDUG-20170731-23908 Date of follow up (if required): _____
If a DOT Reportable Leak: _____ Date and Time of Telephone report: _____
To whom was leak reported: _____

Repair 2" steel main - Billable to Northern Improvement
