Initial Topsoil Inspection

To: Adam Renfandt, CFA
From: Matt Retka, Wenck Associates, Inc.
Date: May 24, 2019
Subject: PU-18-399, Demicks Lake Pipeline Initial Topsoil Inspection

PU-18-399 CONSTRUCTION INSPECTION

Initial Topsoil Removal Photographs

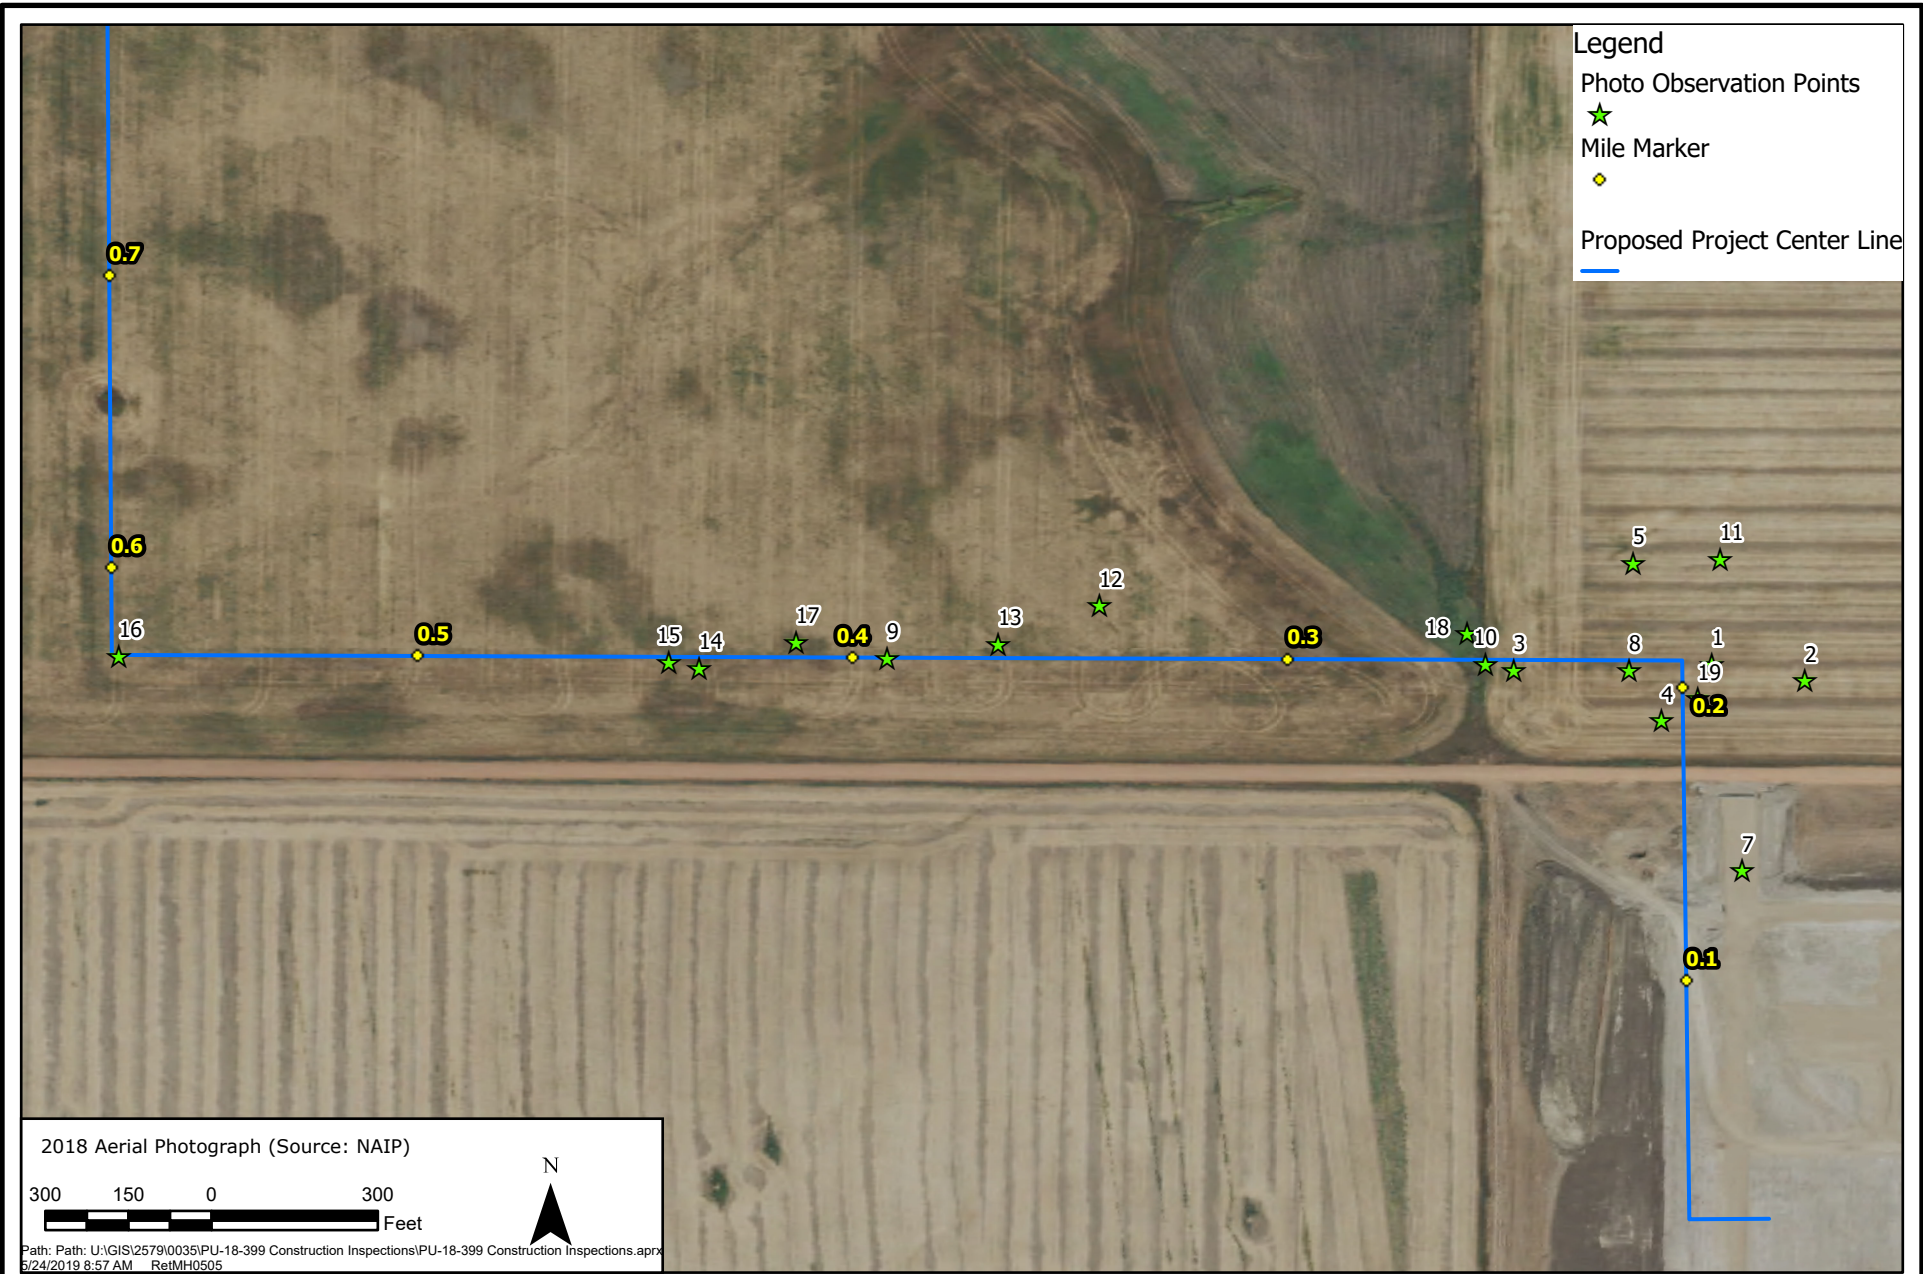
Topsoil was stockpiled north and east of the Right of Way (ROW). Topsoil depth was in an approximate range of 7-12 inches to a subsoil clay pan or calcareous soil horizon. Portions of a potential buried quarter section road revealing scoria deposits was un-earthed at station 13+00. Topsoil stripping was terminated at that location. Observation of color changes during stripping unveiled a calcareous subsoil at Station 22+00. Topsoil stripping was terminated with very little subsoil deposited in the topsoil stockpile area at that location. Construction of a road approach was observed at station 10+00. Fill was obtained using subsoil from surrounding work area (see Attachment A and B).
