# Demicks Lake NGL Pipeline Project Construction Inspection Report PU-18-399

*Prepared for:*  
**North Dakota  
Public Service Commission**

**WENCK Associates, Inc.**  
301 1st Street NE, Suite 202  
Mandan, ND 58554  
Phone: 701-751-3370  
Fax: 763-479-4242

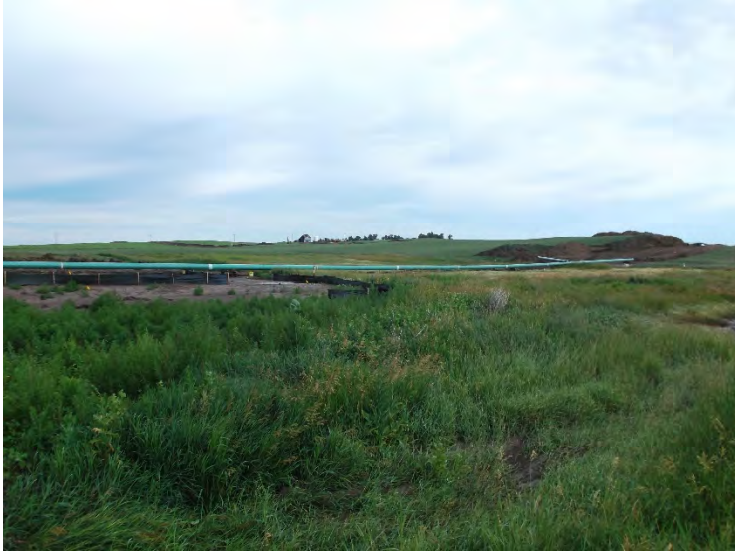
**Observation Point: 116**

Photo Description: Wetland (W-1) with silt fence installed. Pipe strung for open trenching.

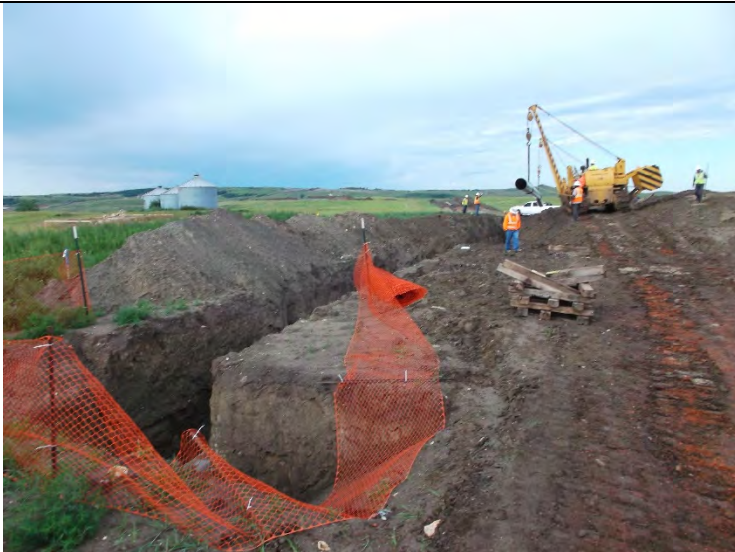
**Observation Point: 117b**

Photo Description: Jomax crew placing pipe in trench. Subsoil stockpiles are spoils from trenching.

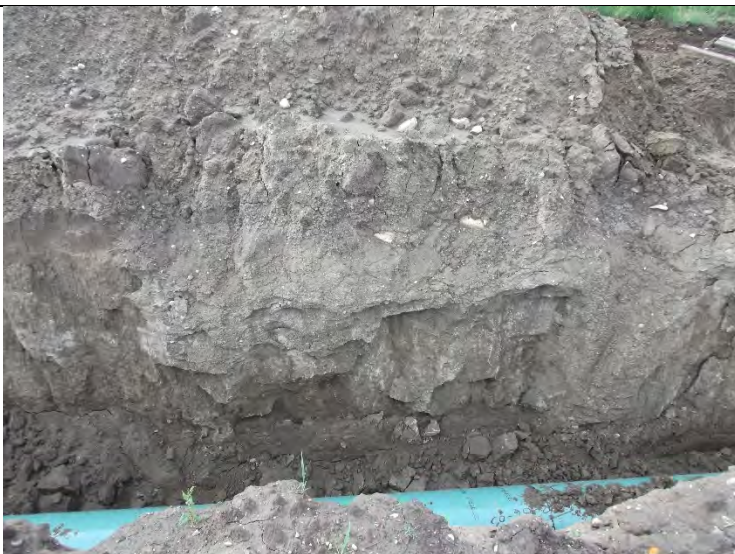
**Observation Point: 118**

Photo Description: Appropriately no topsoil in trench profile. Pipe depth at approximately 60-inches.

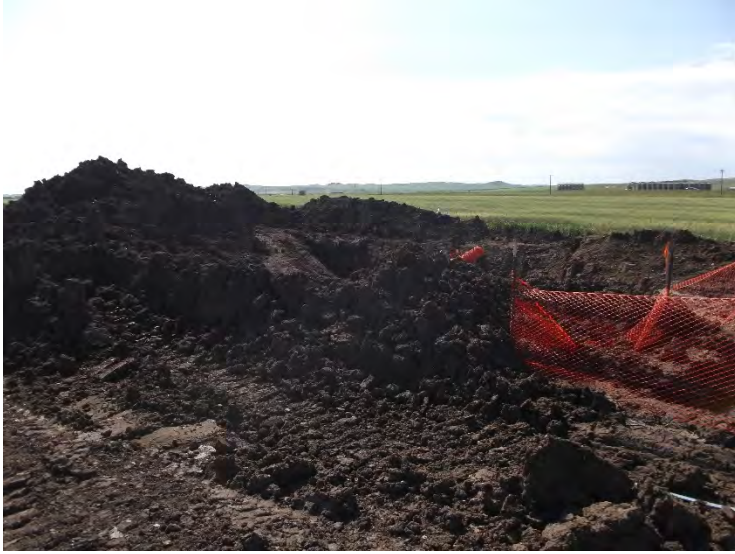
**Observation Point: 122a**

Photo Description: Boring entry for undeveloped sectional line.

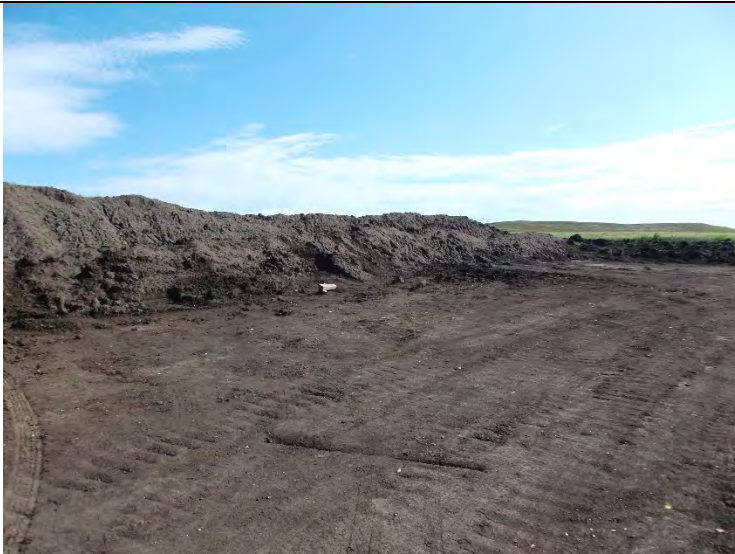
**Observation Point: 122b**

Photo Description: Extra workspace cleared. Topsoil and subsoil segregated properly.

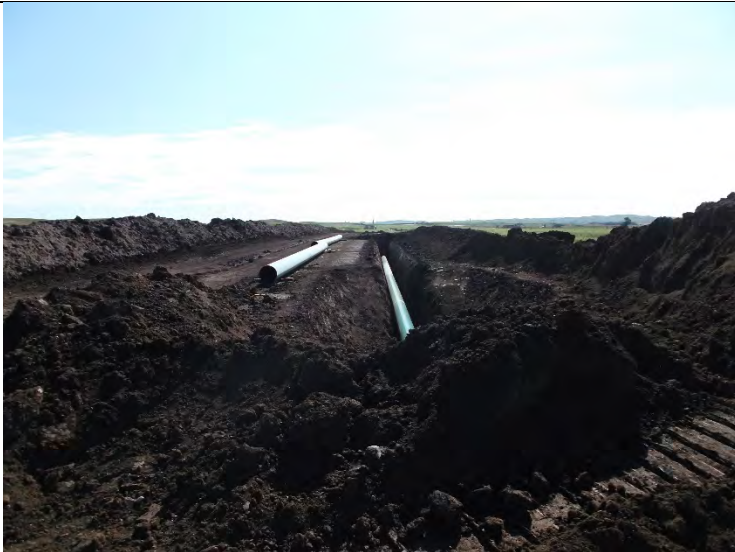
**Observation Point: 123**

Photo Description: Pipe placed in trench and pipe waiting to be connected to bore pipe from sectional line crossing.

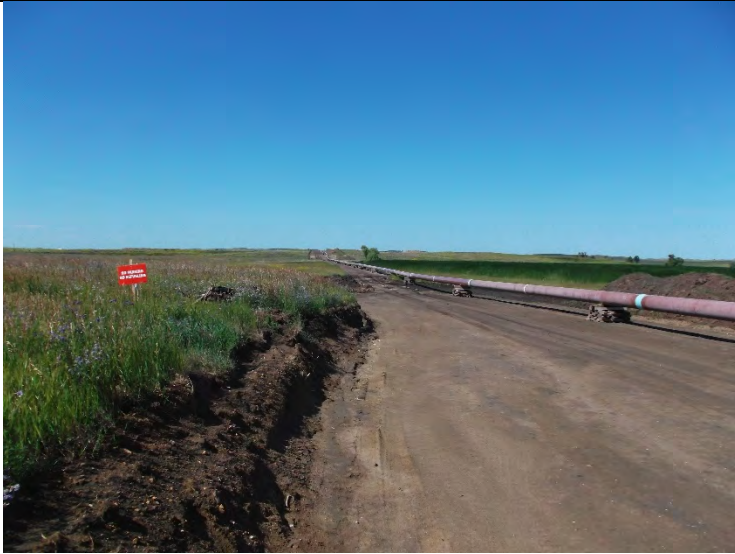
**Observation Point: 125**

Photo Description: Pullback area for US HWY 85 HDD. NO PARKING/NO REFUELING marked.

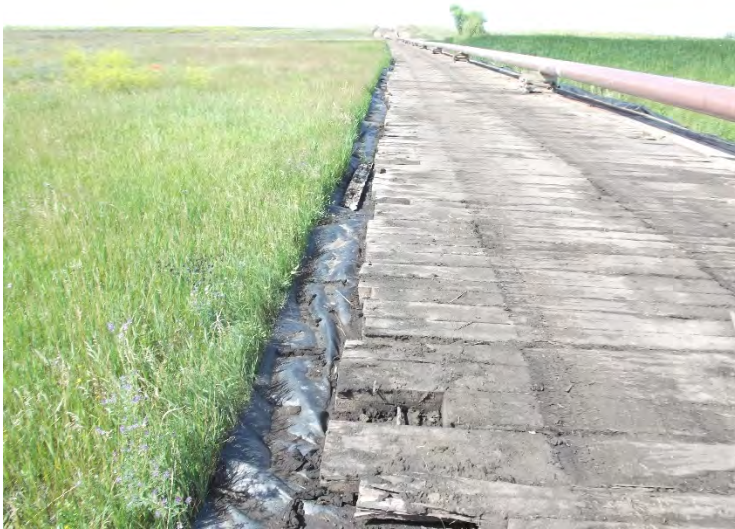
**Observation Point: 126a**

Photo Description: Timber mats with plastic barrier underneath to prevent potential contaminants from entering wetland (W-42).

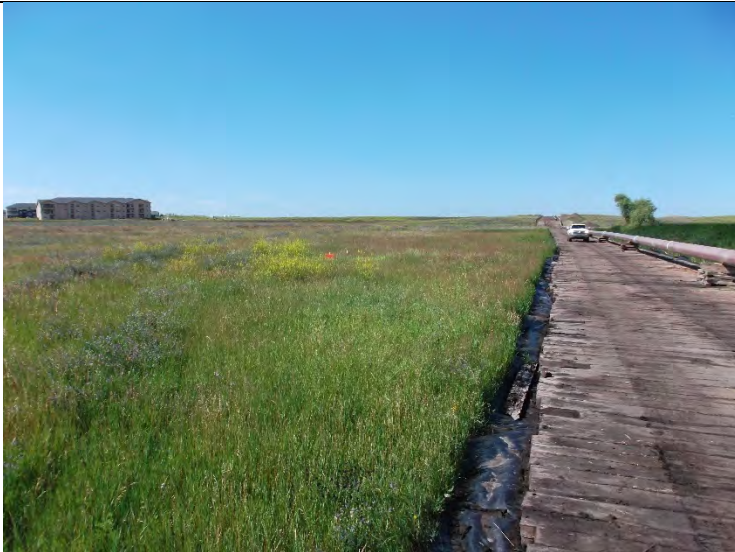
**Observation Point: 126b**

Photo Description: Orange sign marking Wetland (W-42).

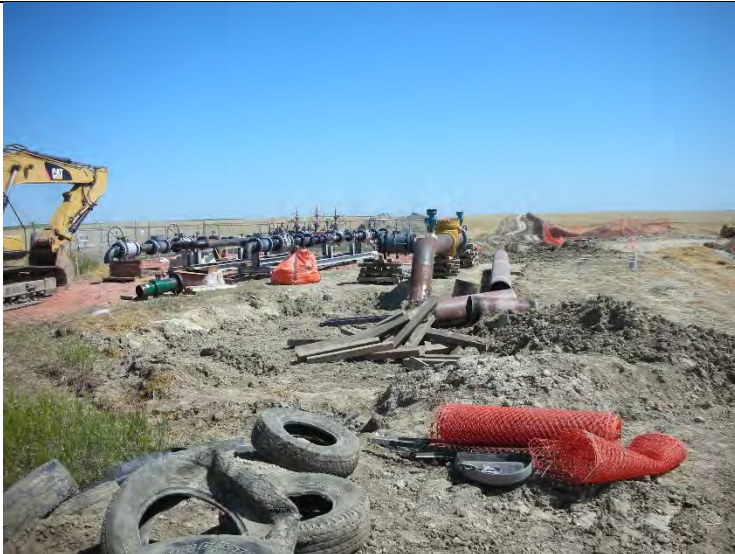
**Observation Point: 2763e**

On 21 August 2019, Mr. Retka and Mr. Leitner visited the Project and was met by Allen Kitchens, QCS Assistant Chief Inspector, during the construction inspections. Trenched pipe measurements were appropriate or deeper than required. Trench wall profiles showed that topsoil had been stripped appropriately (**Appendix A, Observation Point 2760, 2764, 2769, and 2772**). Observed wetlands (W-20 and W-25) along the construction corridor were appropriately open-cut or bored under with appropriate erosion mitigation practices and clearly marked (**Appendix A, Observation Point 2768, 2770, and 2771**). Other observations of a constructed block value and ROW work were also made (**Appendix A, Observation Point 2763 and 2773**).

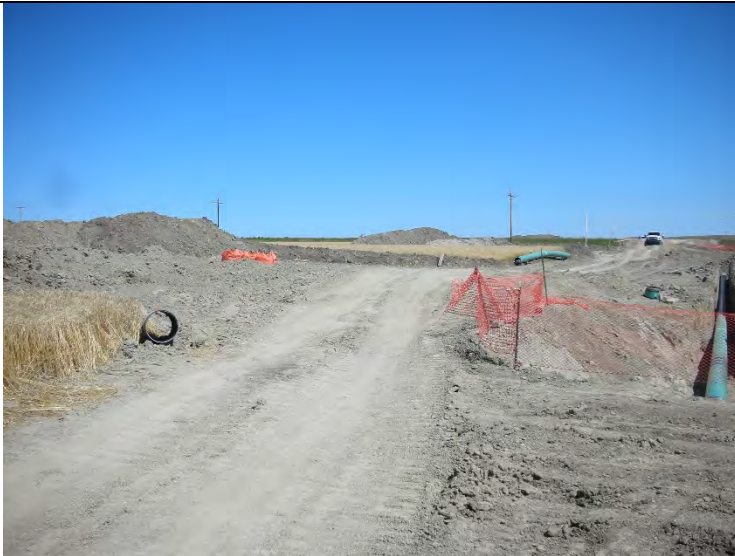
**Observation Point: 2771e**

Photo Description: Overlooking ROW and Wetland (W-25) bore entry. Safety fence installed around entry area.

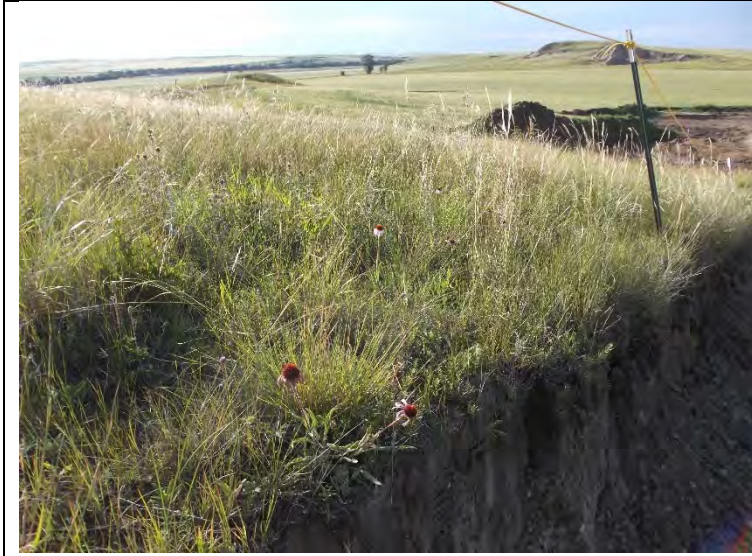
**Observation Point: 109**

Photo Description: Vegetation within the boundary of the ESA-035. Purple cone flower (*Echinacea purpurea*) and Little bluestem (*Schizachyrium scoparium*) are present within the area.

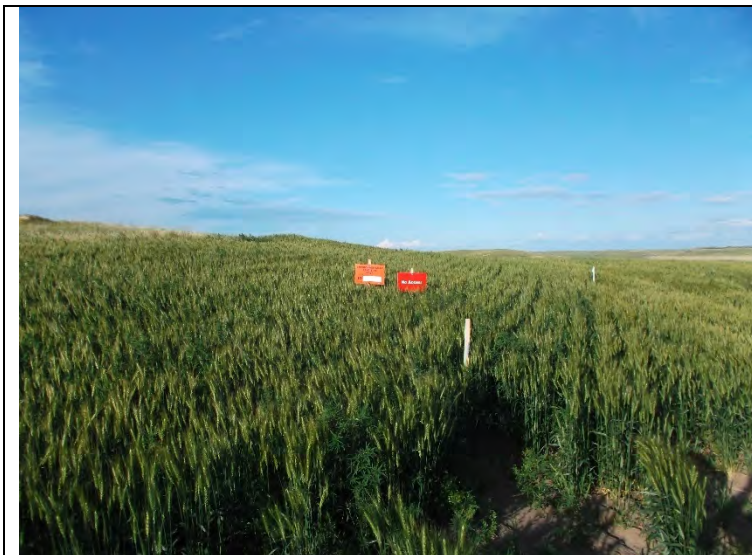
**Observation Point: 111**

Photo Description: ESA-304 clearly marked with NO ACCESS. No construction activities (foot traffic only) until permission granted.

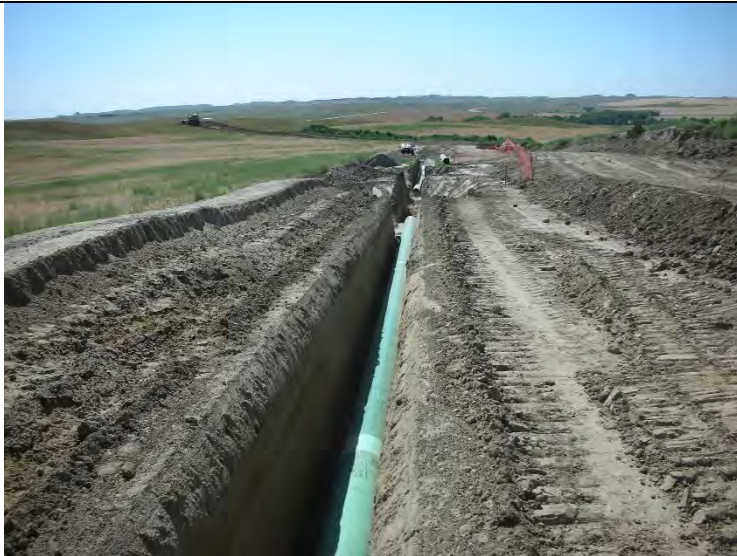
**Observation Point: 2774w**

Photo Description: Pipe depth at approximately 60-inches. Appropriately no topsoil in trench profile.

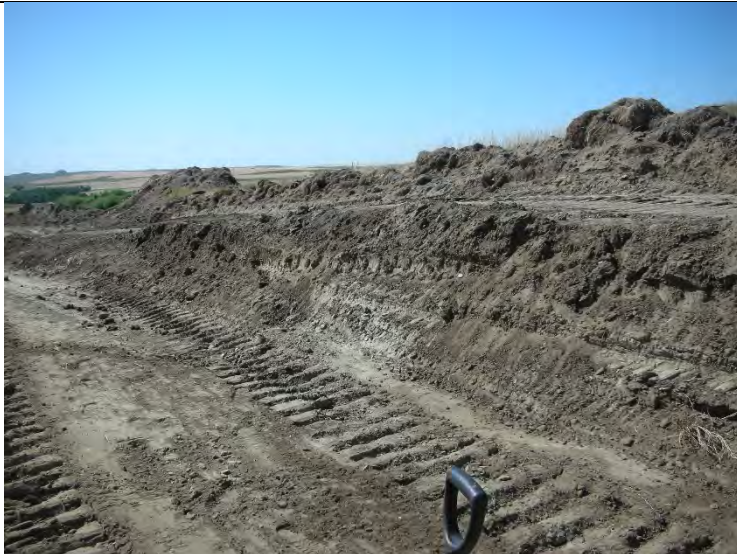
**Observation Point: 2775nw**

Photo Description: Overlooking benched ROW within ESA-034. Jomax limited impact to ESA-034 Dakota skipper habitat after skipper flight time by narrowing ROW. ONEOK proposed to restore habitat of ESA per PSC Siting Criteria #37.

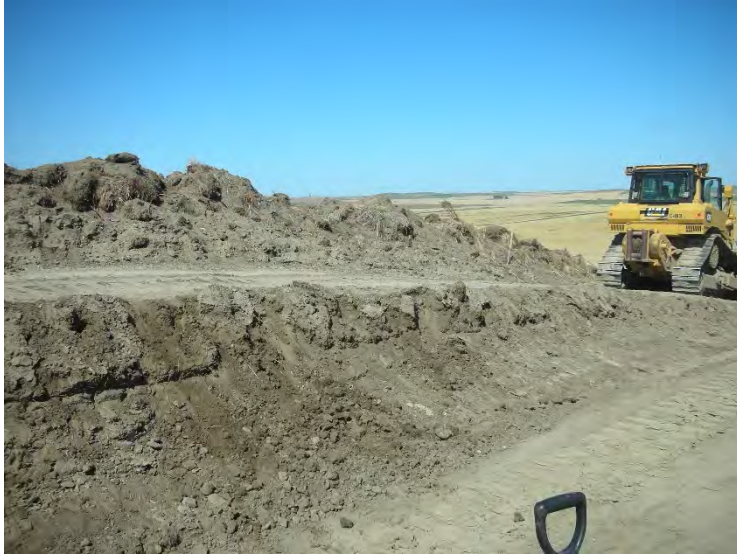
**Observation Point: 2776e**

Photo Description: Overlooking benched ROW within ESA-034. Jomax limited impact to ESA-034 Dakota skipper habitat after skipper flight time by narrowing ROW. ONEOK proposes to restore habitat of ESA per PSC Siting Criteria #37.

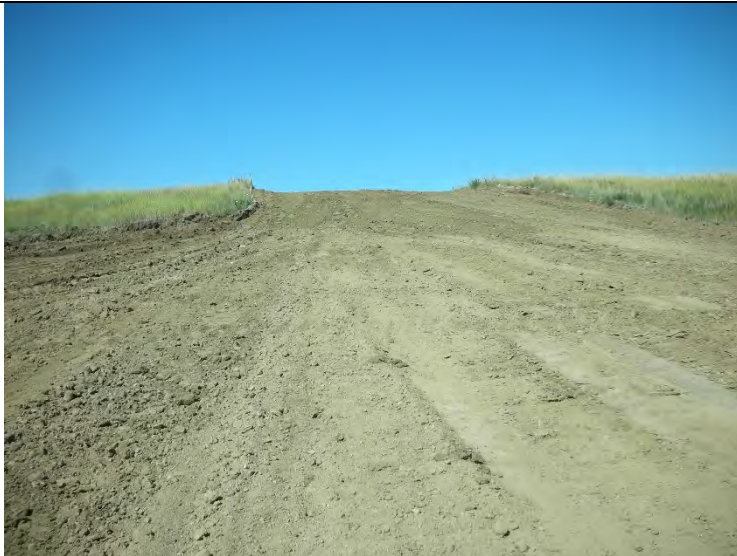
**Observation Point: 2777n**

Photo Description: Overlooking narrowed ROW adjacent to Dakota skipper habitat ESA-35.

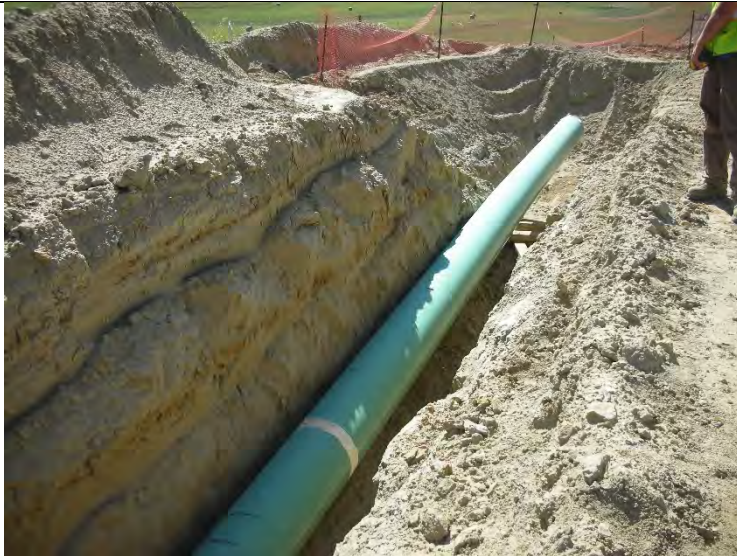
**Observation Point: 2779**

Photo Description: Pipe depth at approximately 66-inches. Appropriately no topsoil in trench profile.

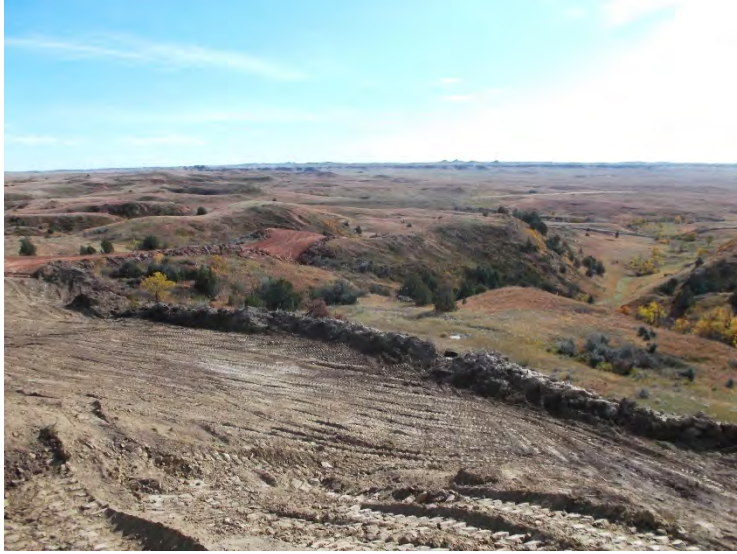
**Observation Point: 201**

Photo Description: Overlooking pipeline route and alternate route mentioned in the Final Comprehensive Field Reconnaissance Report by Braun Intertec. No stability issues were reported for Milepost 62.2 according to the Braun report and the alternate route was not taken.

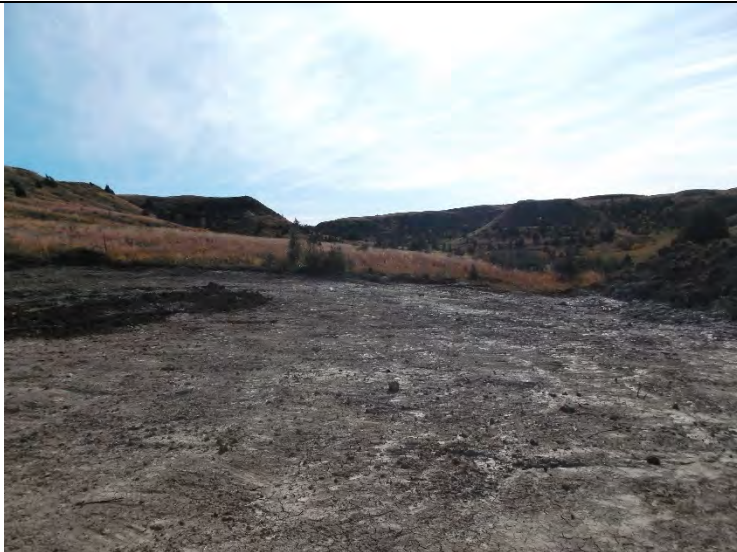
**Observation Point: 202**

Photo Description: Overlooking area where HDD was utilized across contoured terrain near Milepost 61.1, though there was no reported instability according to Braun report.

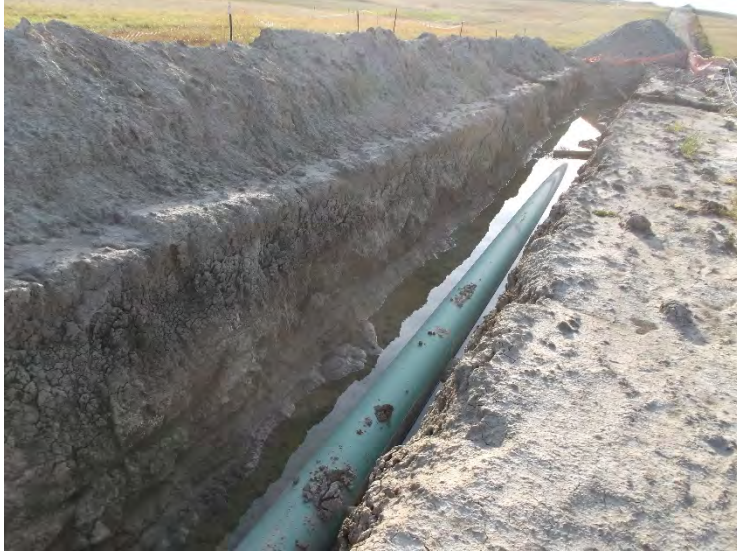
**Observation Point: 206a**

Photo Description: Pipe depth at approximately 72-inches. Appropriately no topsoil in trench profile.

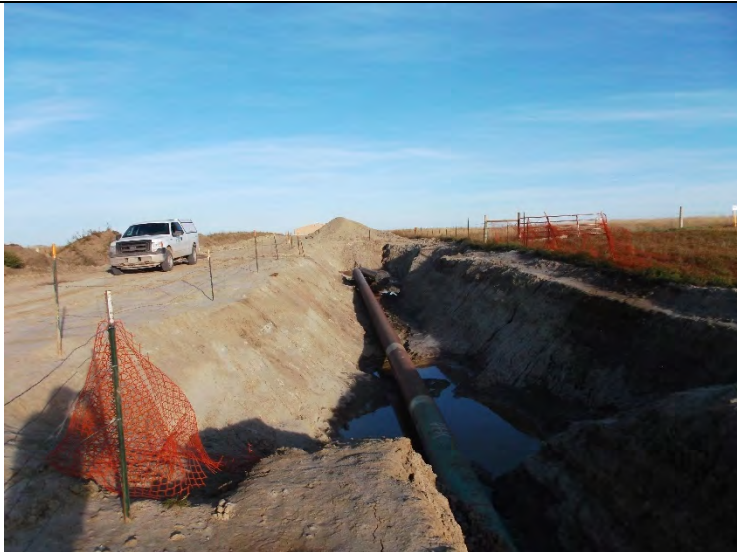
**Observation Point: 206b**

Photo Description: Pipe depth at approximately 72-inches. Appropriately no topsoil in trench profile.
