Demicks Lake NGL Pipeline Project Construction Inspection Report PU-18-399

Prepared for:
**North Dakota
Public Service Commission**

WENCK Associates, Inc.
301 1st Street NE, Suite 202
Mandan, ND 58554
Phone: 701-751-3370
Fax: 763-479-4242

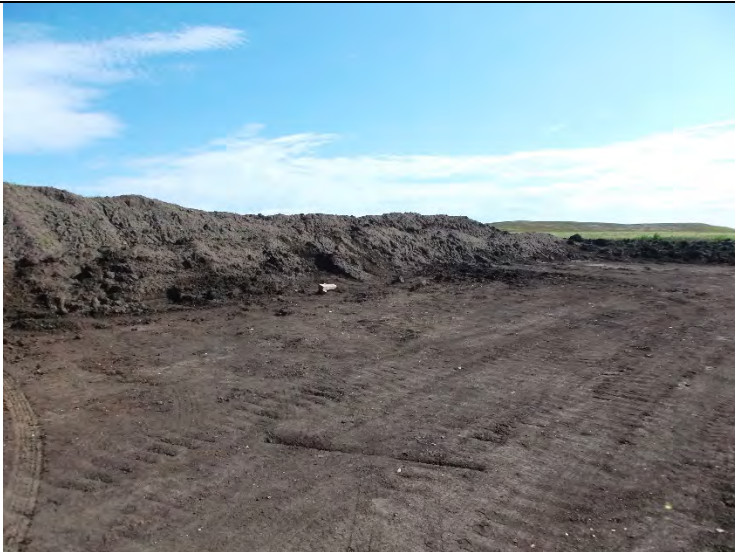
Observation Point: 122b

Photo Description: Extra workspace cleared. Topsoil and subsoil segregated properly.

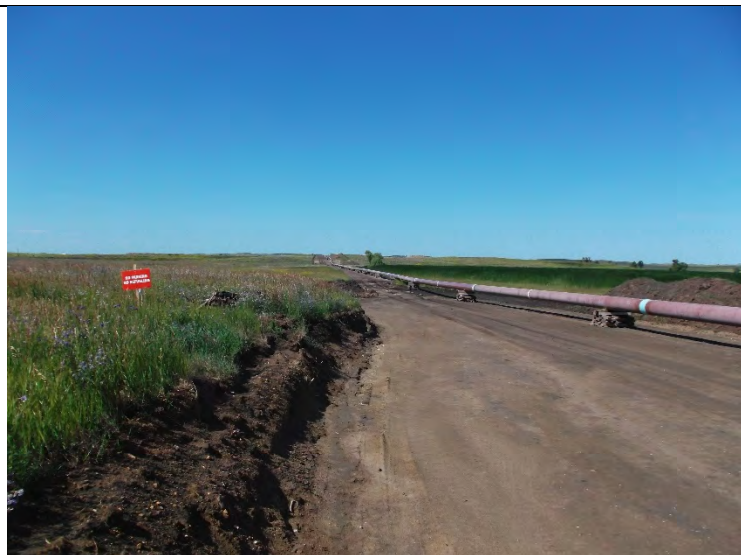
Observation Point: 125

Photo Description: Pullback area for US HWY 85 HDD. NO PARKING/NO REFUELING marked.

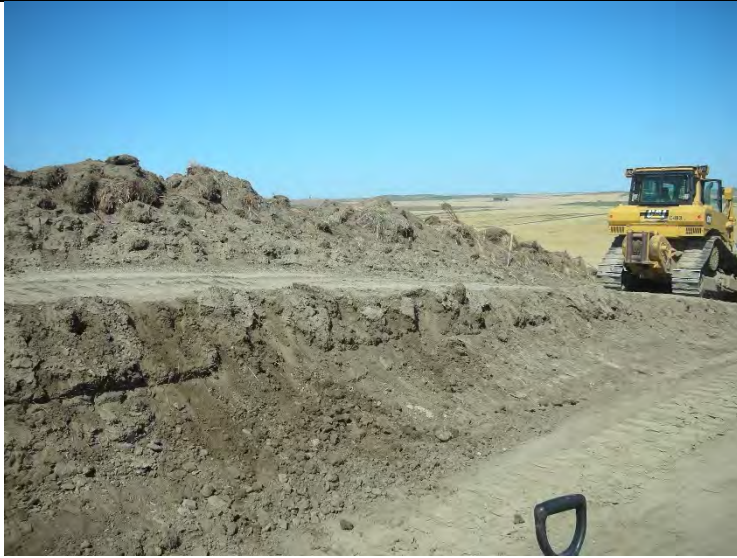
Observation Point: 2776e

Photo Description: Overlooking benched ROW within ESA-034. Jomax limited impact to ESA-034 Dakota skipper habitat after skipper flight time by narrowing ROW. ONEOK proposes to restore habitat of ESA per PSC Siting Criteria #37.

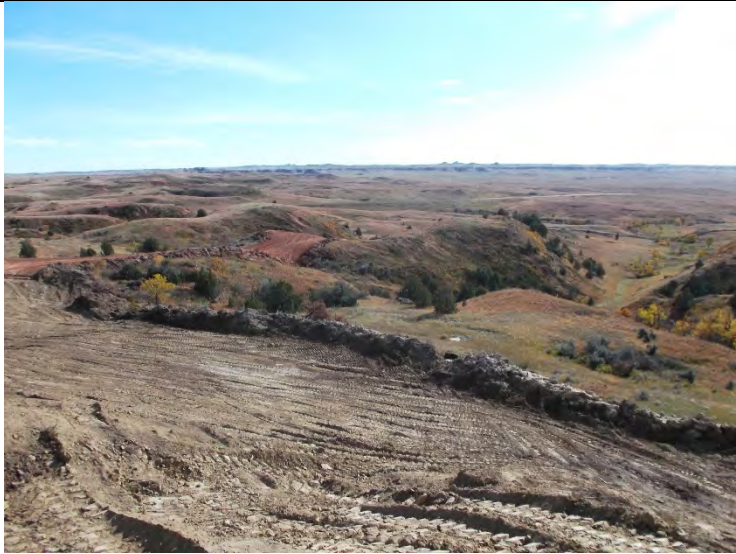
Observation Point: 201

Photo Description: Overlooking pipeline route and alternate route mentioned in the Final Comprehensive Field Reconnaissance Report by Braun Intertec. No stability issues were reported for Milepost 62.2 according to the Braun report and the alternate route was not taken.

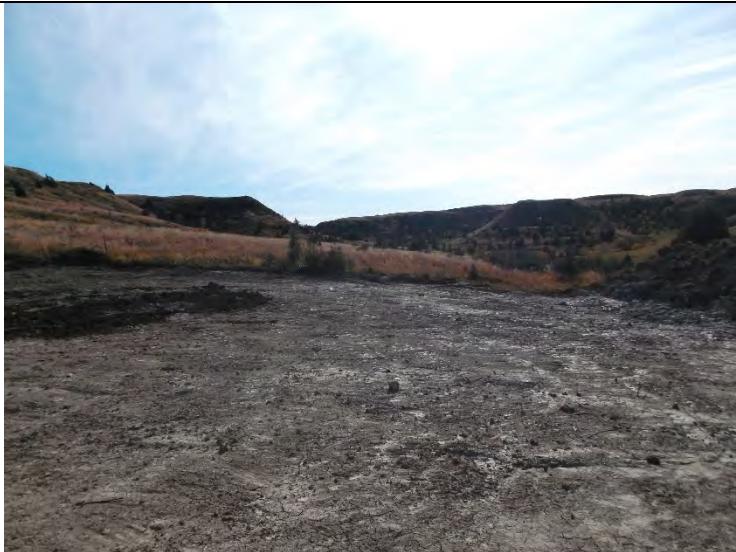
Observation Point: 202

Photo Description: Overlooking area where HDD was utilized across contoured terrain near Milepost 61.1, though there was no reported instability according to Braun report.

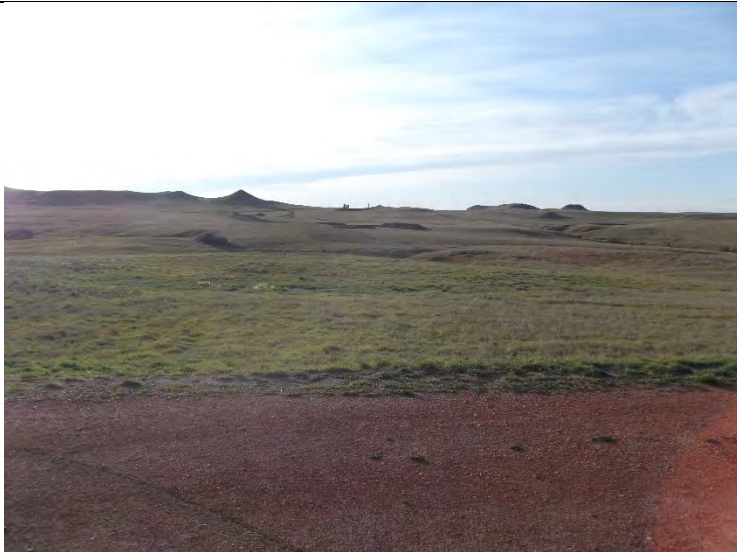
Observation Point: 207

Photo Description: Overlooking completed HDD under wetland and near potentially geologically unstable area between Mileposts 47.1 & 47.2.
