PU-18-399

Demicks Lake, 20-inch NGL
Pipeline

Reclamation Inspection Report

September 2021

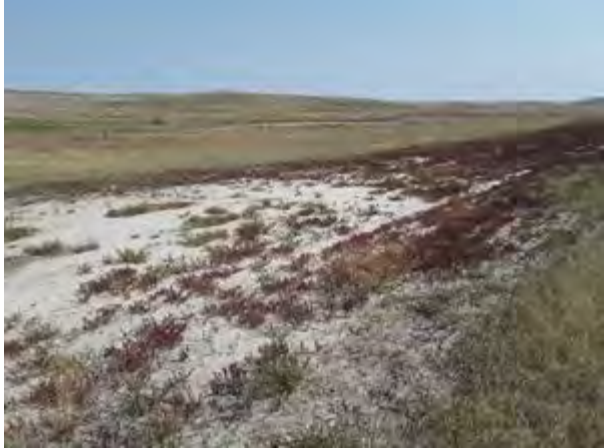
<p>Observation Point: 9090003 Date Taken: September 9, 2021 1:25 PM Direction Photo is Taken: North</p> <p>Photo Description: Historic aerial imagery suggests grassland land use, but ROW is now under crop production. Stantec could not determine if that is the preferred land use by land owner, or if there were seeding activities by ONEOK.</p> <p>Latitude: 47.694779303972 Longitude: -103.604189859029</p>

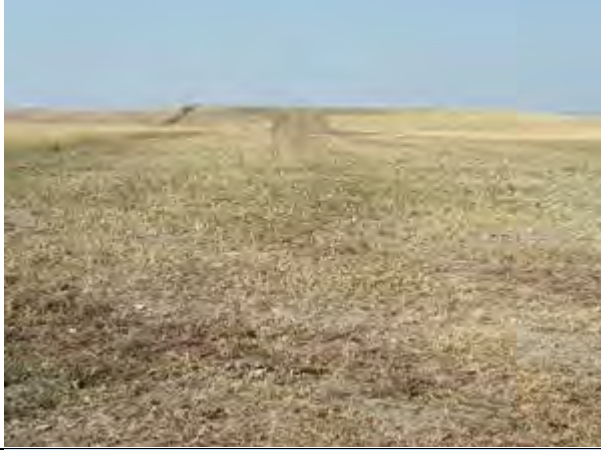
<p>Observation Point: 9090021 Date Taken: September 9, 2021 4:20 PM Direction Photo is Taken: North</p> <p>Photo Description: Mowed kochia surrounded by brome outside of the ROW. Vegetation density and cover does not match surrounding land, but it is expected to progress during future growing seasons.</p> <p>Latitude: 47.7685559 Longitude: -103.3576182</p>

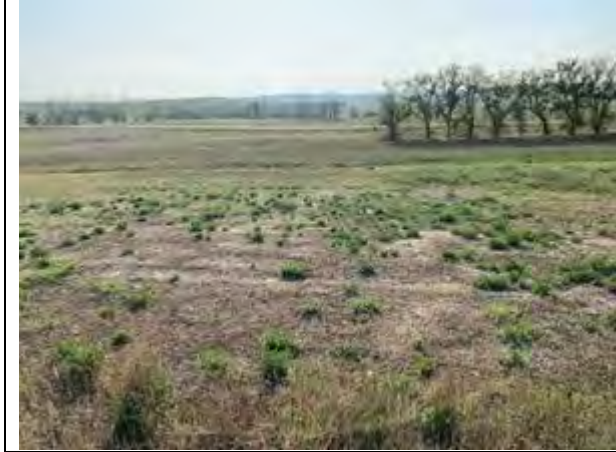
Observation Point: 9090031

Photo Description: Vegetation has not been fully restored to pre-construction conditions. Species include alfalfa, perennial grass, and Lambsquarter. However, vegetation is expected to trend toward successful restoration over time.
