**In re: Belle Fourche Pipeline Company  
8-inch Wilson-Bowline Pipeline Conversion Project  
Case No. PU-18-404  
Our File No. 013084-000013**

# Report of Geohazard Evaluation Wilson to Bowline Pipeline Segments West Central North Dakota

Tetra Tech Project No. 117-0533085

October 27, 2020

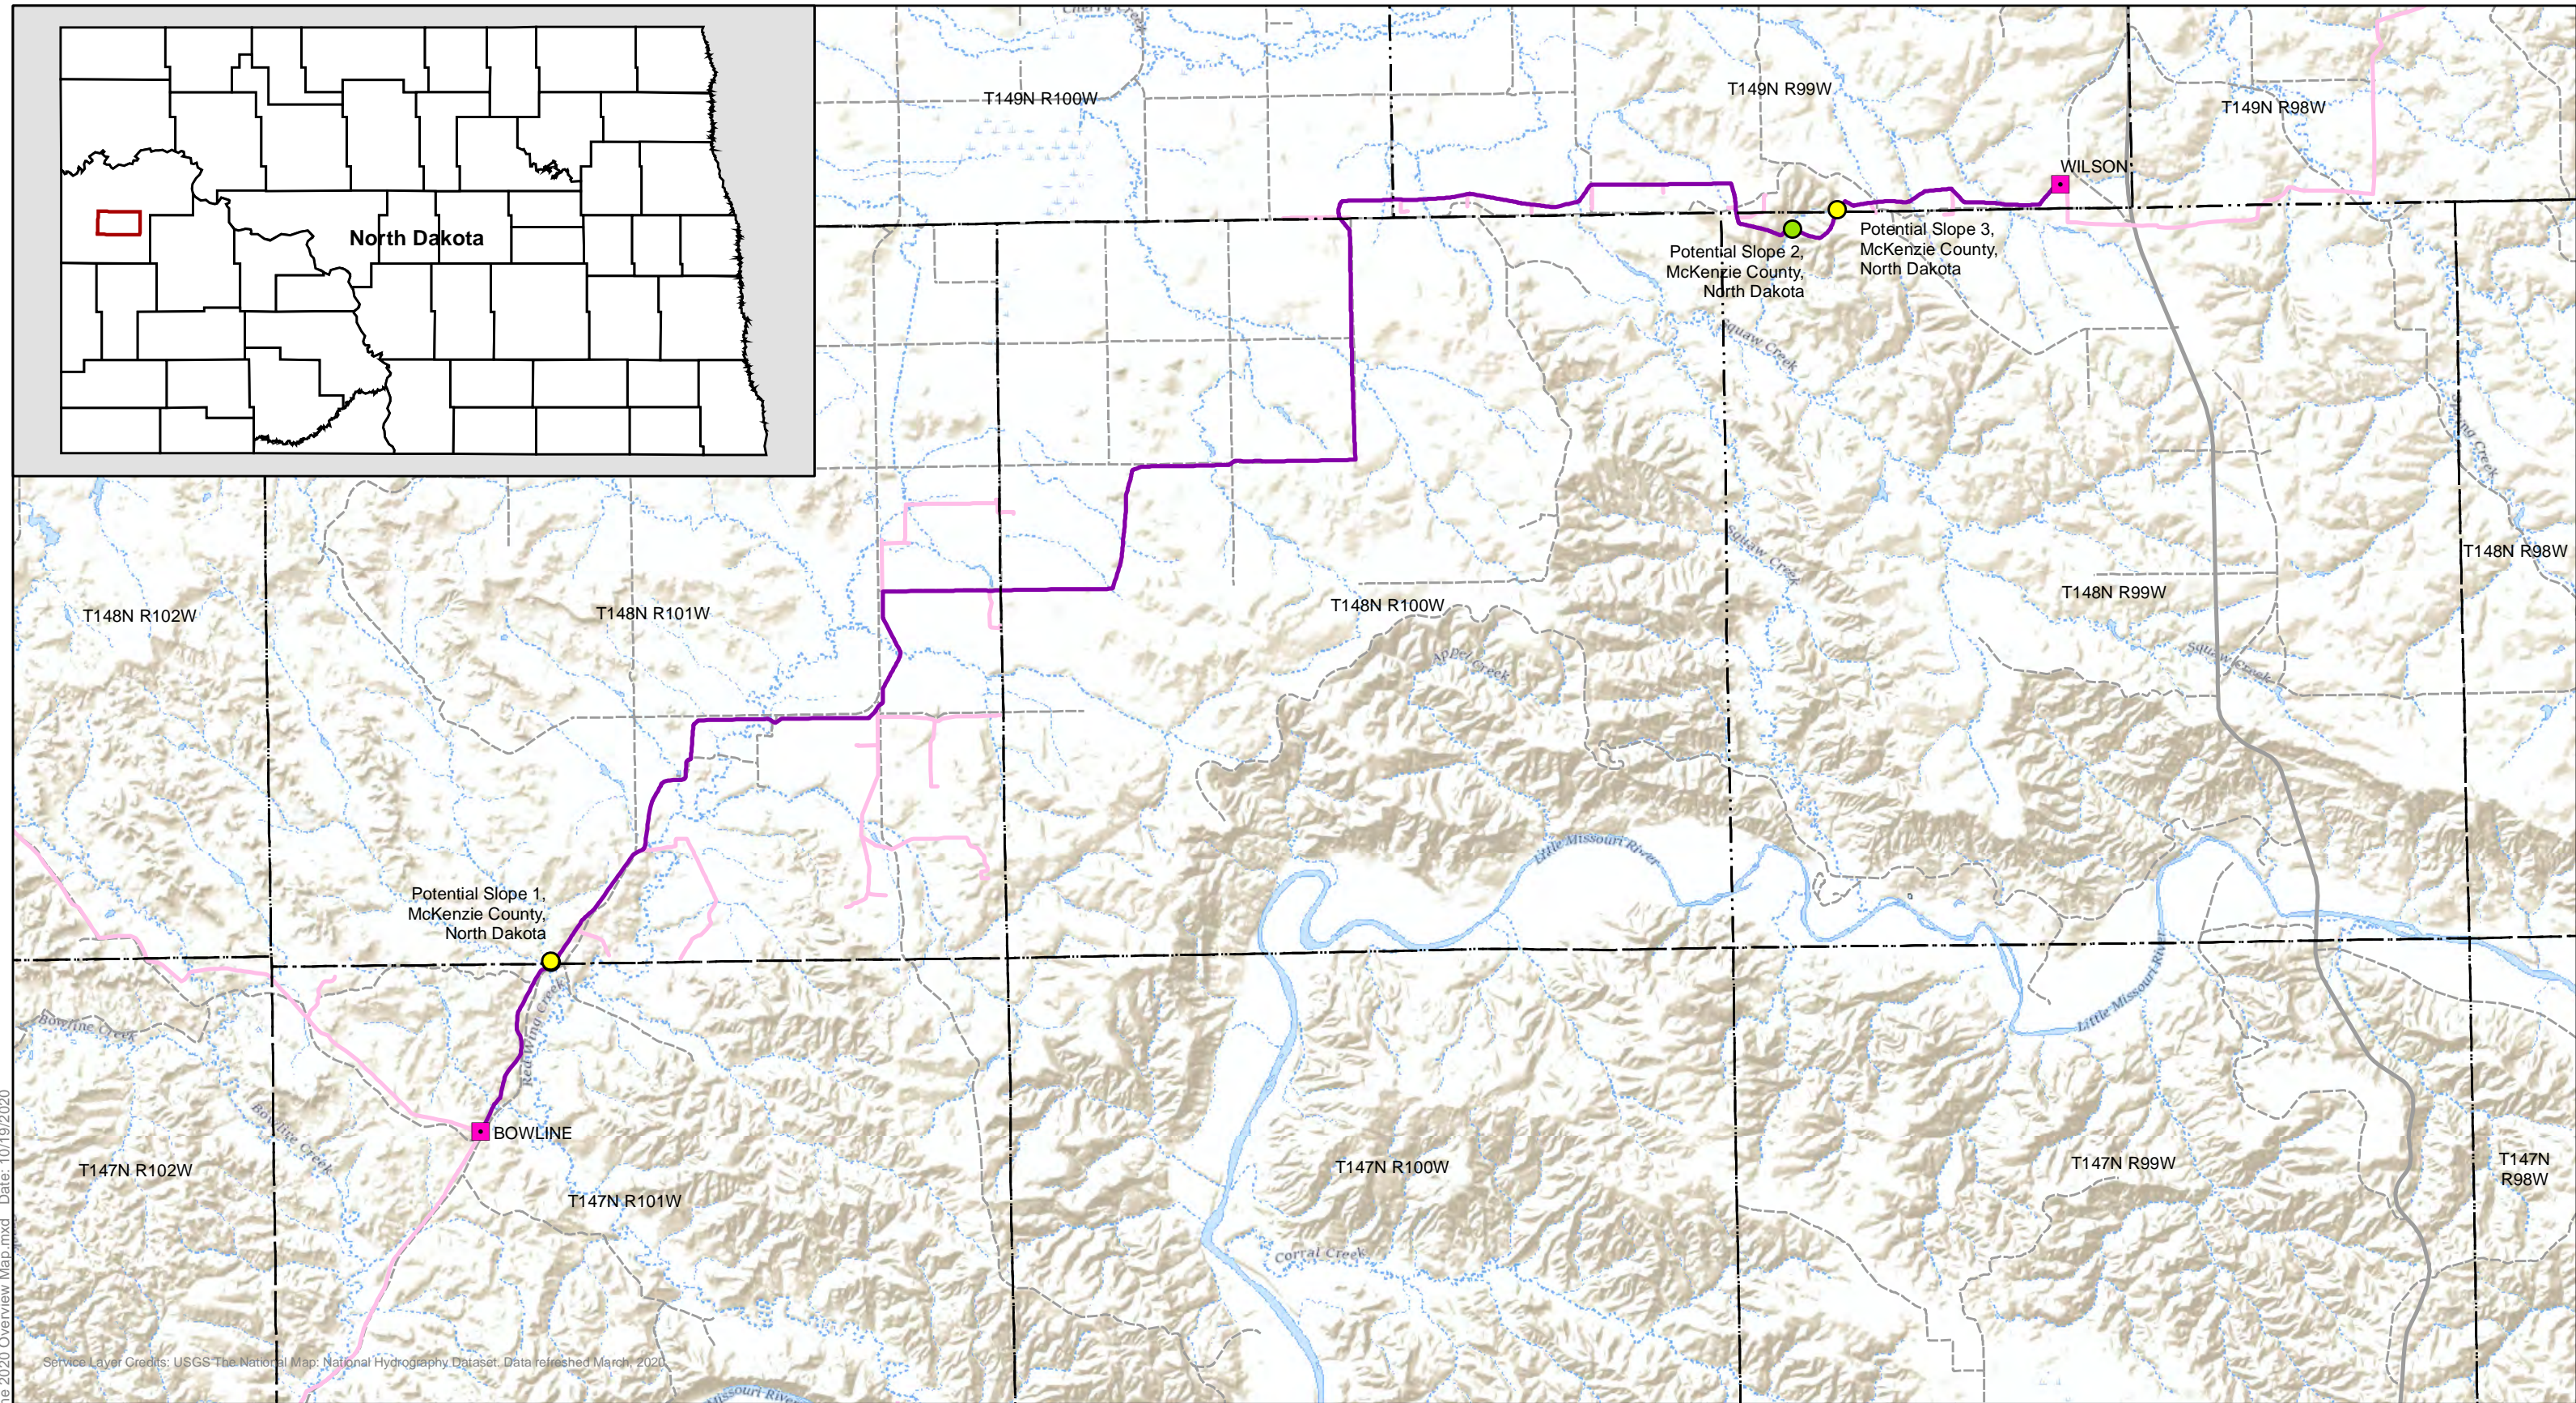
**FIGURE 1**

A geohazard intersect map (Figure 1) is included in the Appendix. Specific slope geohazard points are consecutively numbered by county, generally from west to east then north to south along the existing pipeline alignment.

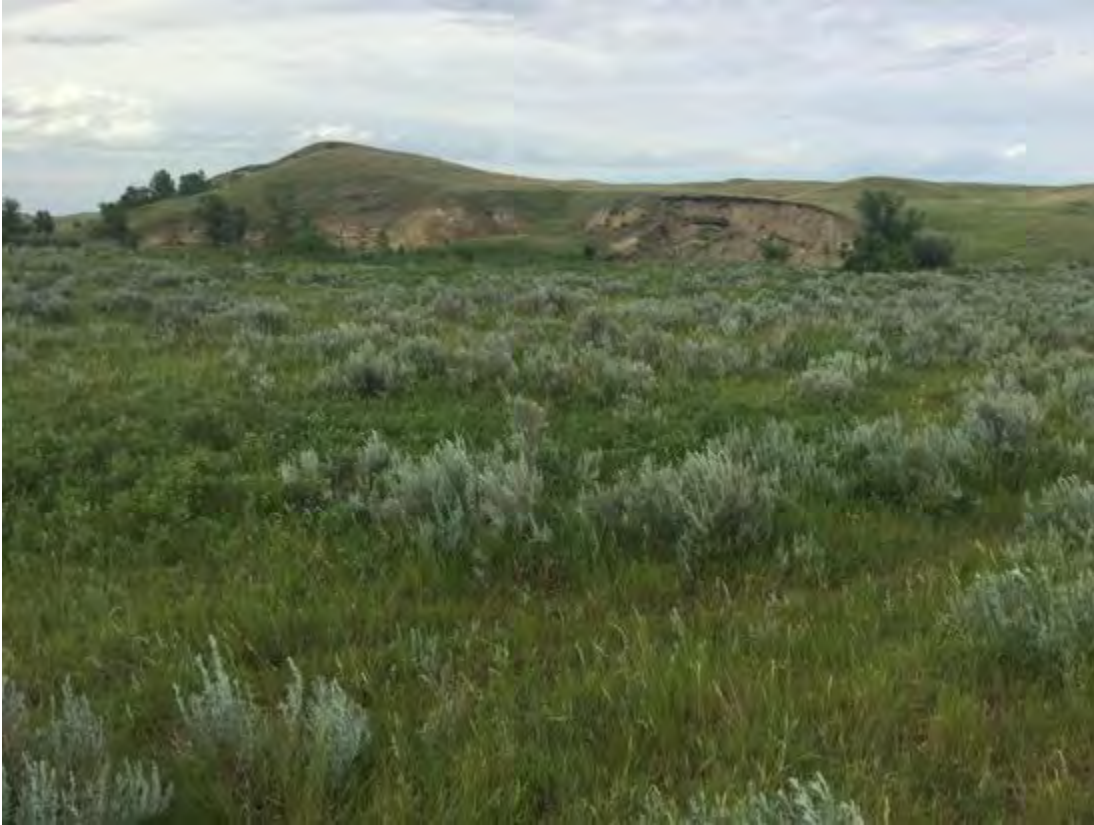
**Photo #1**

**Photo Description:** Looking at slope from access location.

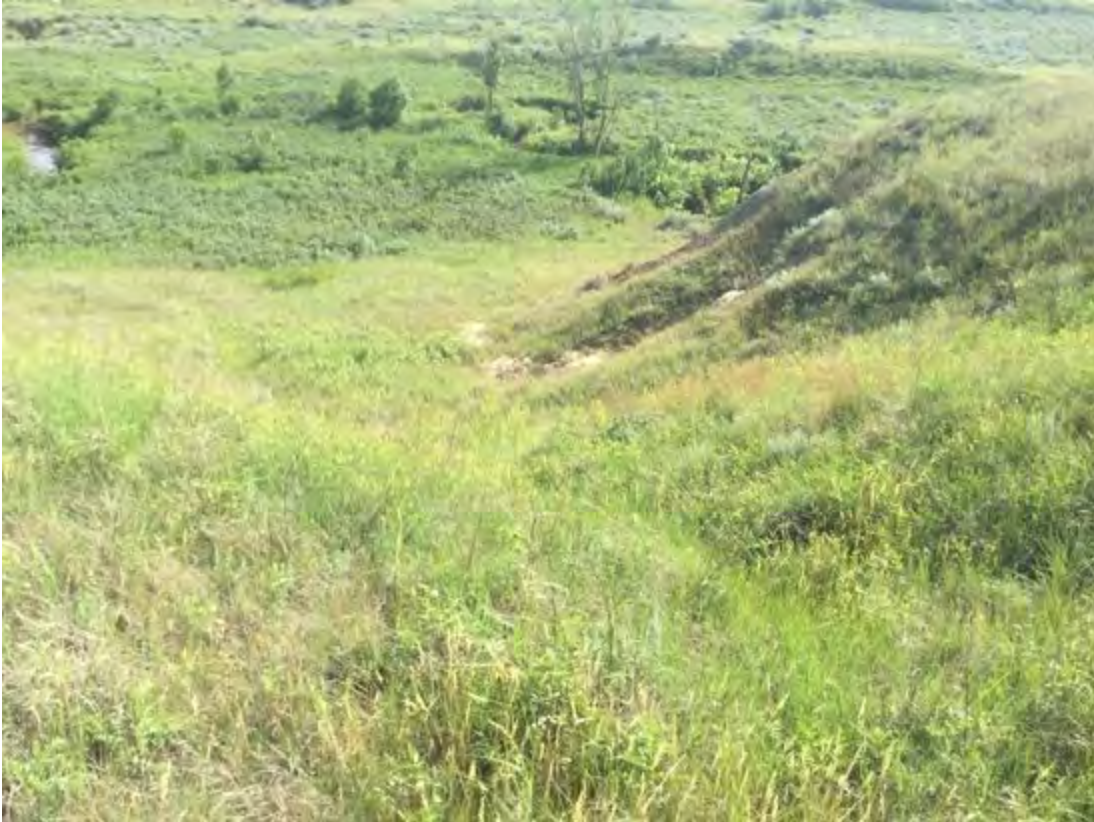
**Photo #6**

**Photo Type:** Looking downslope | **Photo Bearing:** 228 degrees  
**Photo Description:** Looking down slope along pipeline alignment.

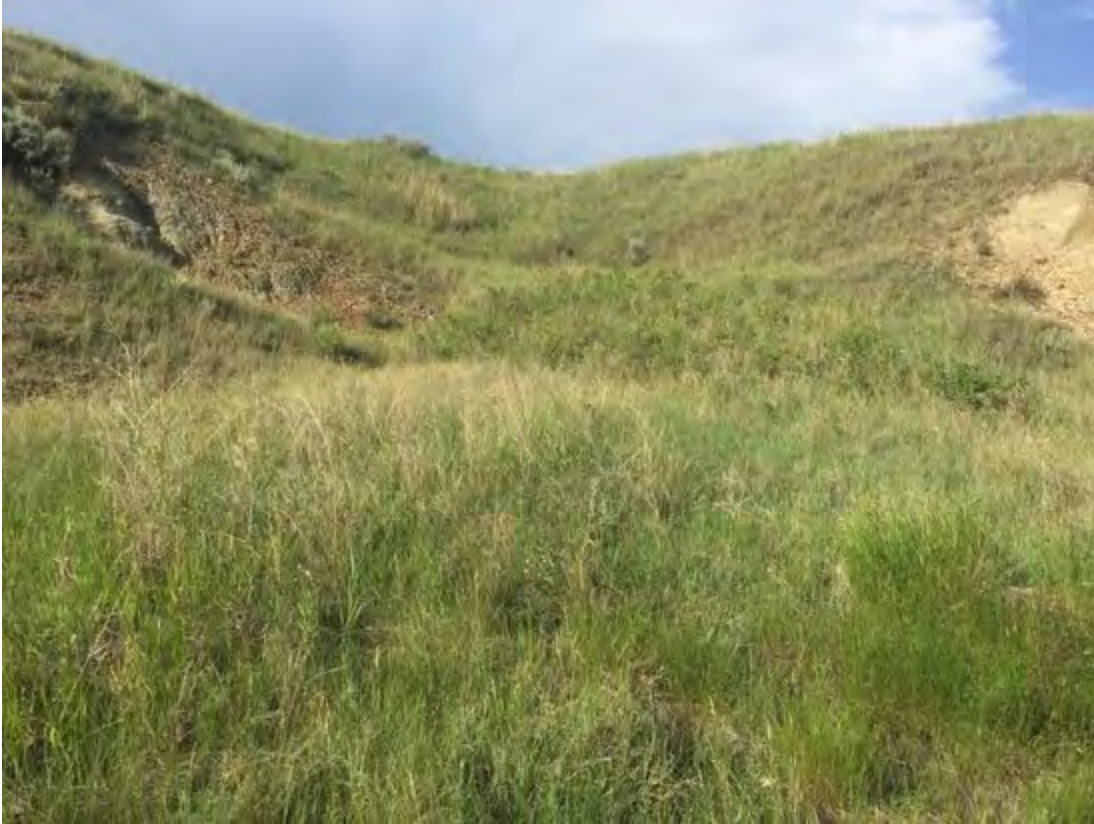
**Photo #7**

**Photo Type:** Looking upslope | **Photo Bearing:** 13 degrees

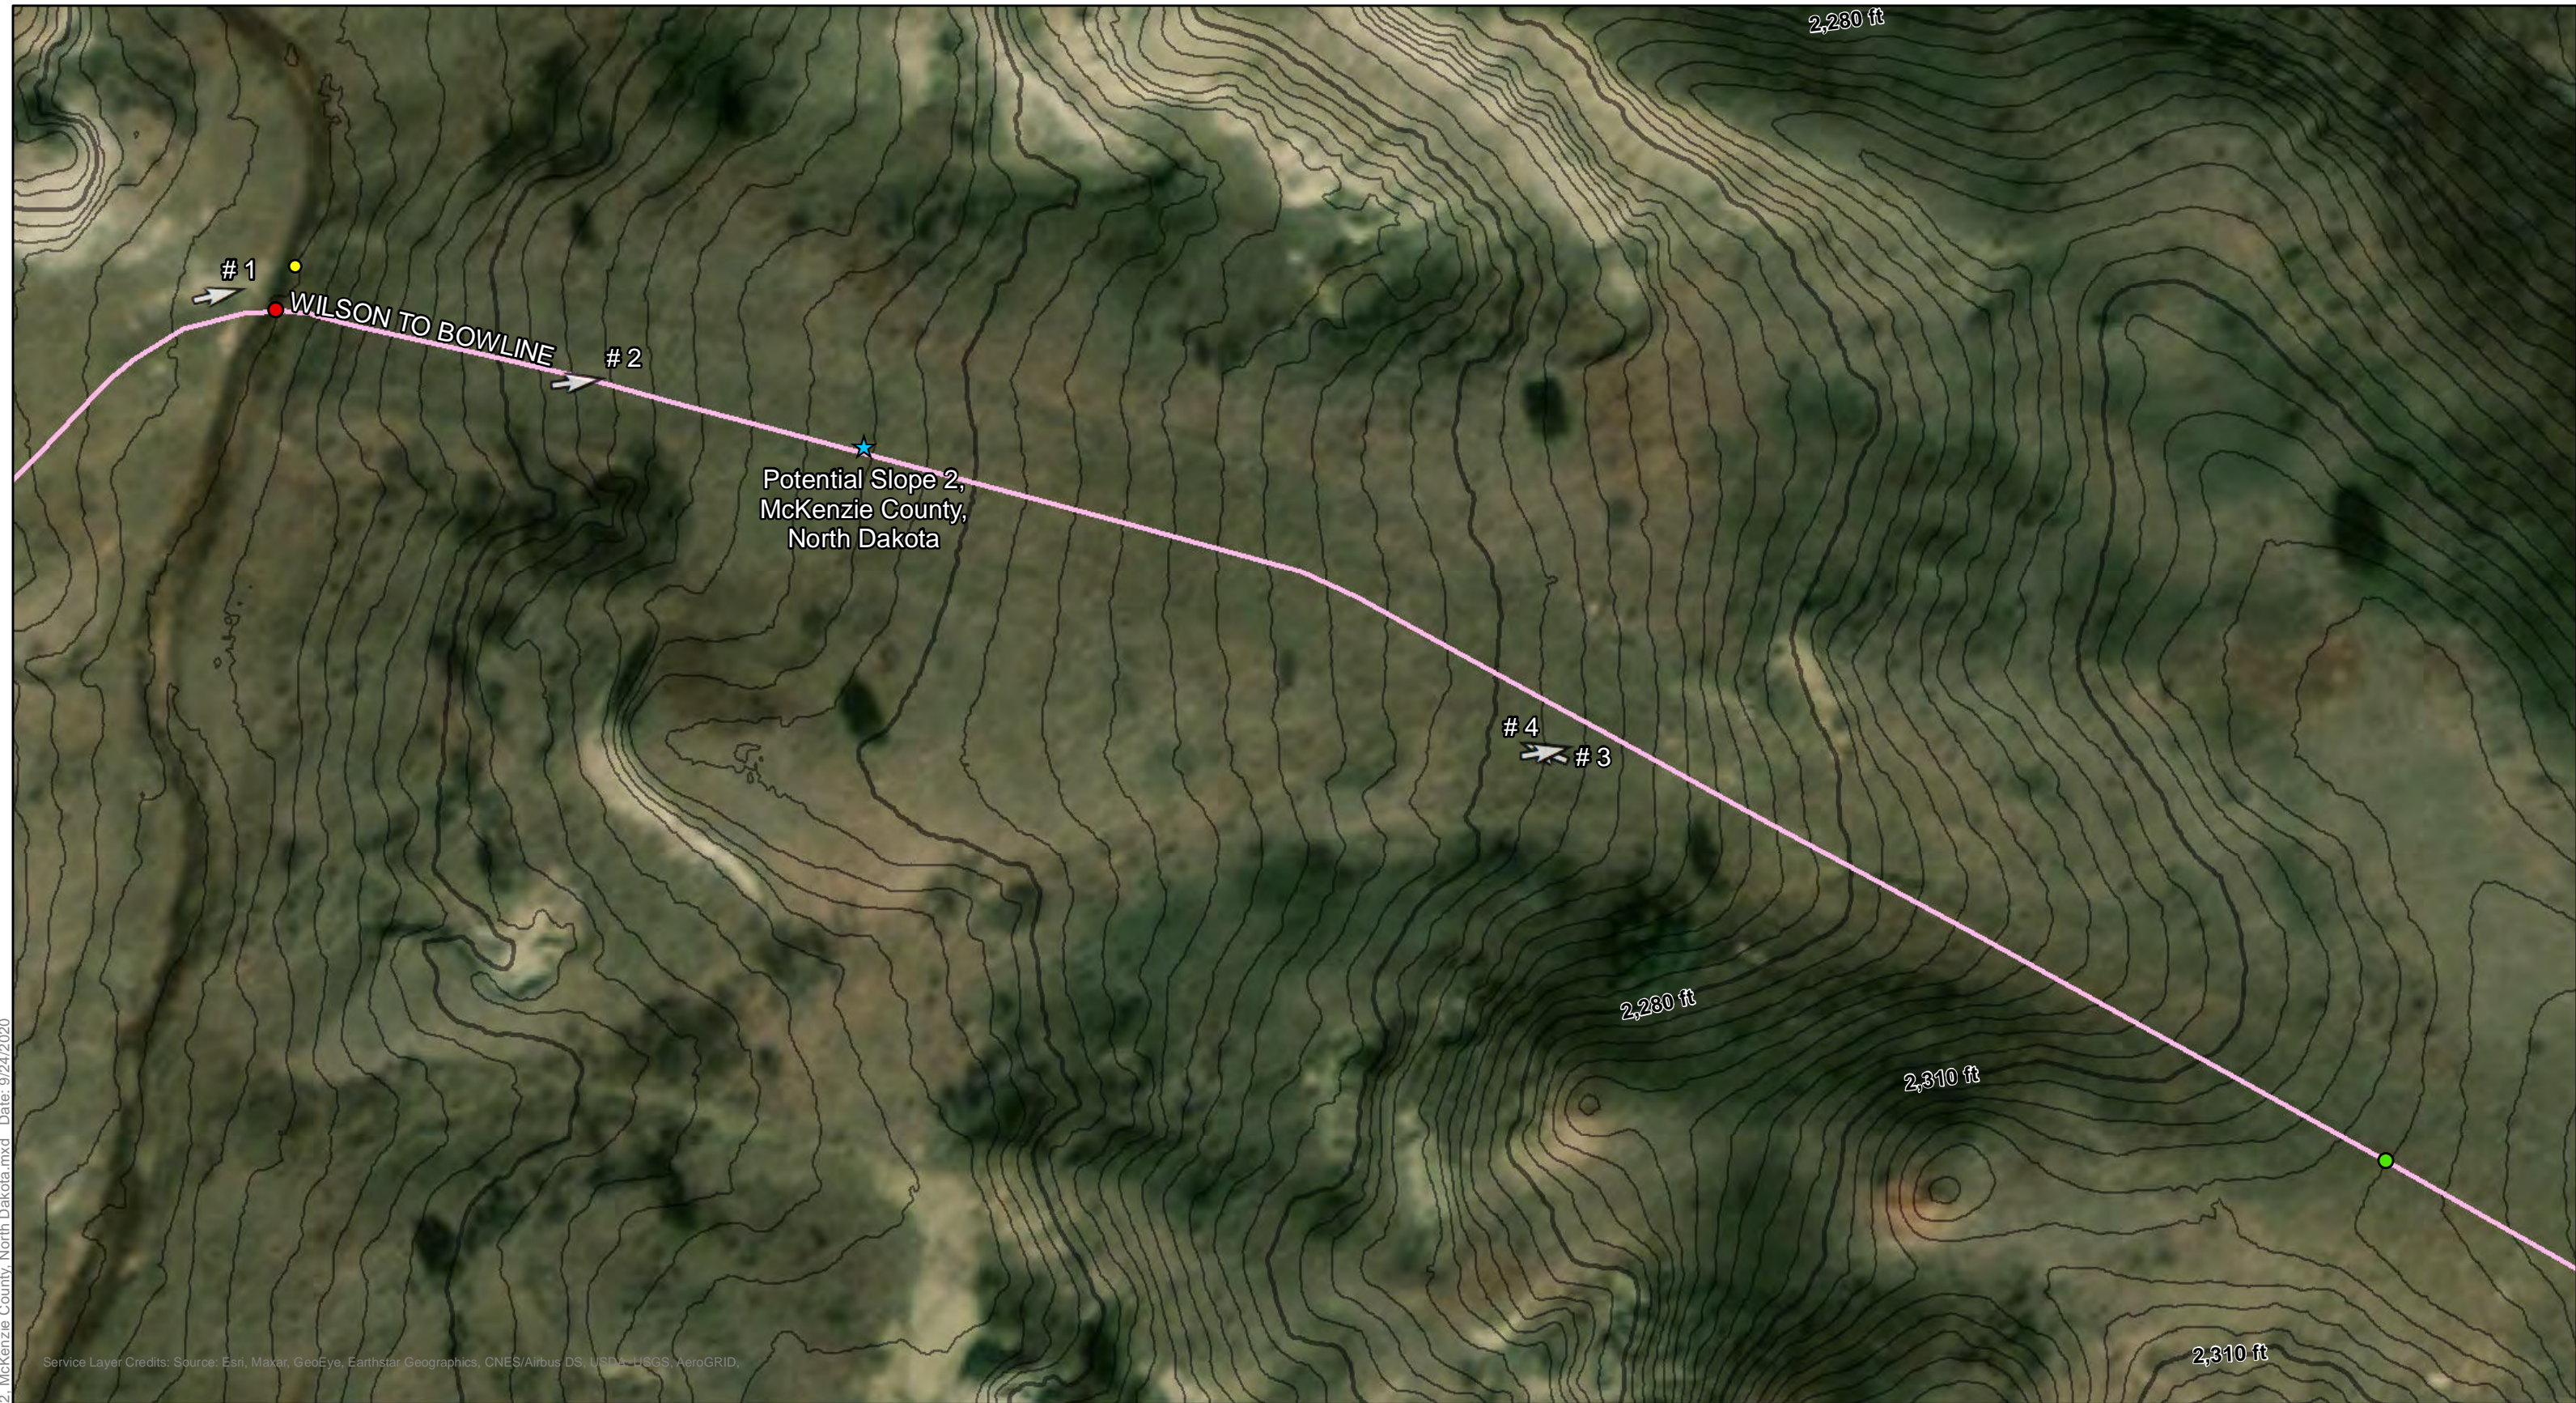
**Wilson to Bowline**  
**Potential Slope 2, McKenzie**  
**County, North Dakota**  
*Belle Fourche Pipelines*  
**FIGURE 3**

The slope is steep and well vegetated and located along the southern edge of a local finger drainage with intermittent water. A historic slump was observed near the toe of the slope with dimensions on the order of 25 feet by 25 feet, with the maximum height of the mass being roughly 3 feet. A slide was observed roughly 100 feet northwest of the slope and pipeline corridor near the confluence of a larger drainage, with approximate dimensions of 50 feet wide by 75 feet long and 5 feet deep. The slope appeared stable at the time of assessment with no apparent indications of recent slope movement.

Monitor the slope for signs of changing conditions or movement during future site visits. A slide was observed approximately 100 feet northwest of the pipeline corridor at the confluence of a larger drainage, suggesting this slope may also be susceptible to sliding.

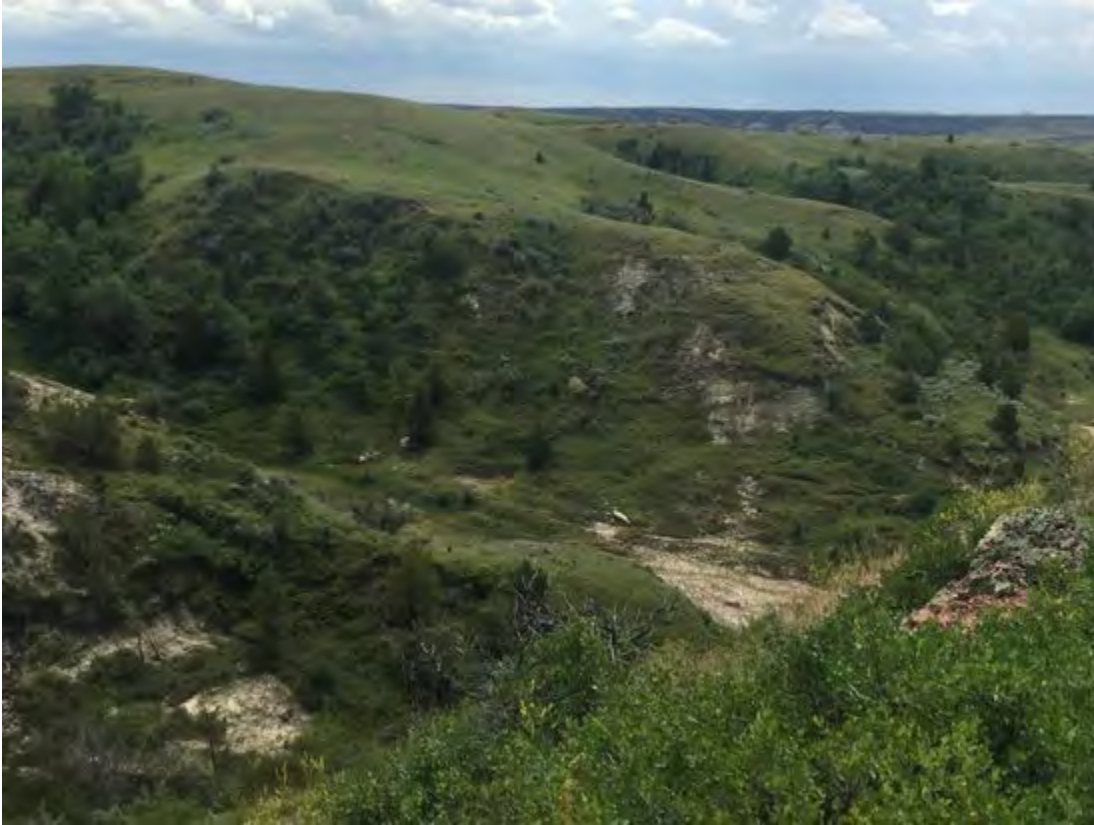
**Photo #1**

**Photo Type:** Looking upslope | **Photo Bearing:** 223 degrees  
**Photo Description:** Looking at slope from opposite drainage slope.
