PU-19-144 Merricourt Wind Power Project Construction Inspection Report

Prepared for:
**North Dakota
Public Service Commission**

Observation Point Photolog

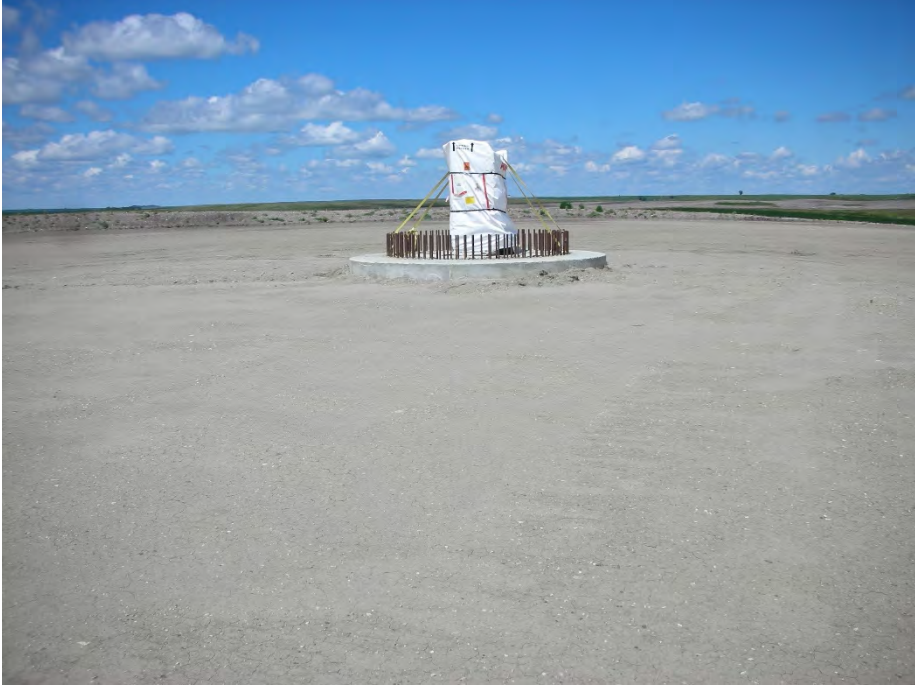
<p>Photo Point: 2834</p>

<p>Location of Photo: Lat: 46.147409 Long: -99.072673</p>	
<p>Direction Taken: West</p> <p>Description: Recently constructed Turbine 26 platform that looked appropriately stripped. Good topsoil separation.</p>	
<p>Photo Point: Z-1</p>

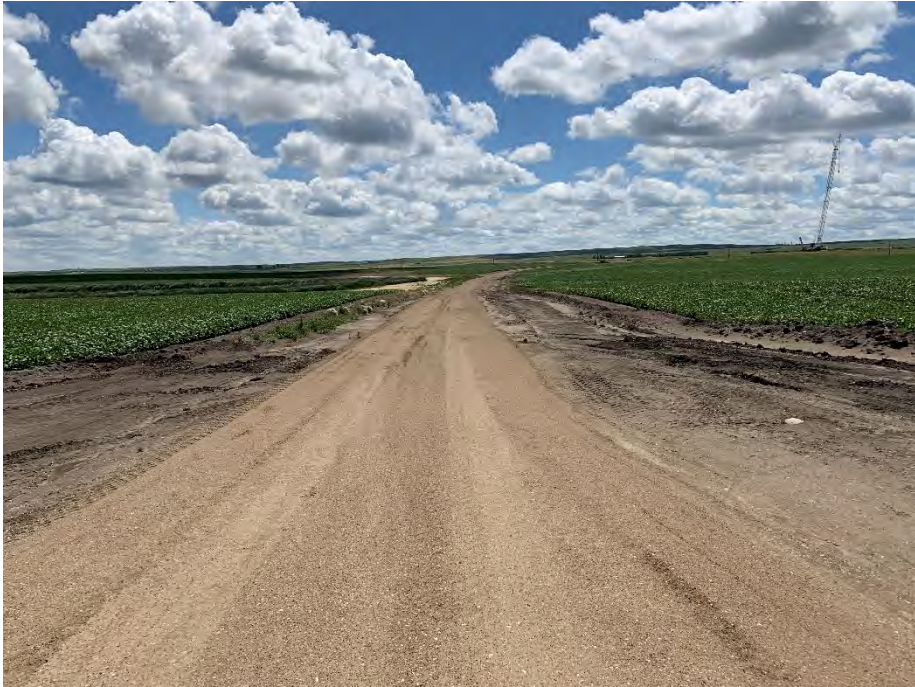
<p>Location of Photo: Lat: 46.146903 Long: -99.07229</p>	
<p>Direction Taken: South</p> <p>Description: Access road coming to Turbine 26.</p>

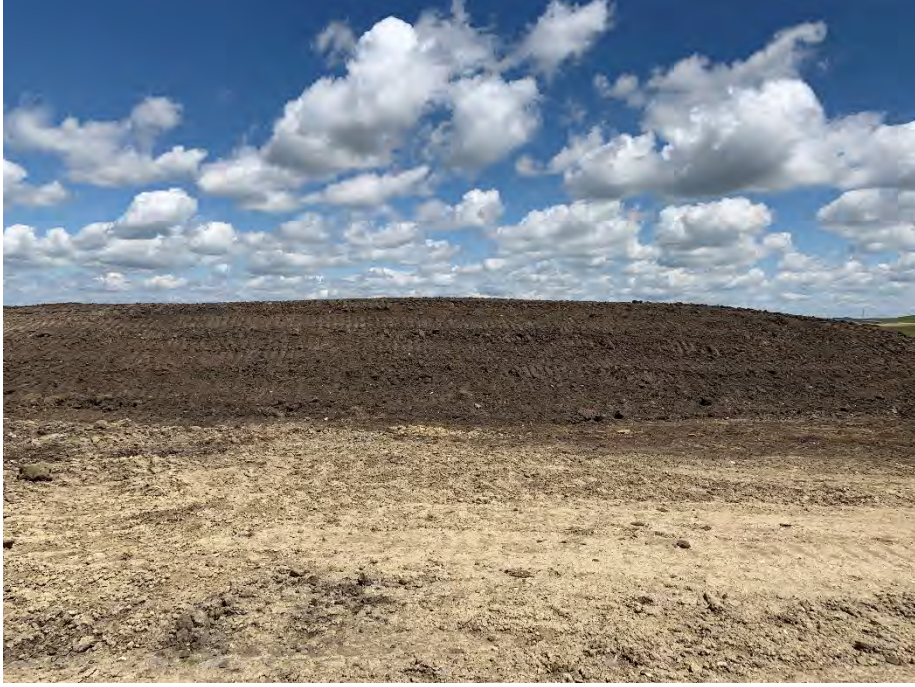
<p>Location of Photo: Lat: 46.11634933 Long: -99.02667935</p>	
<p>Direction Taken: East</p> <p>Description: Large stockpile that was stripped appropriately. Turbine 36.</p>

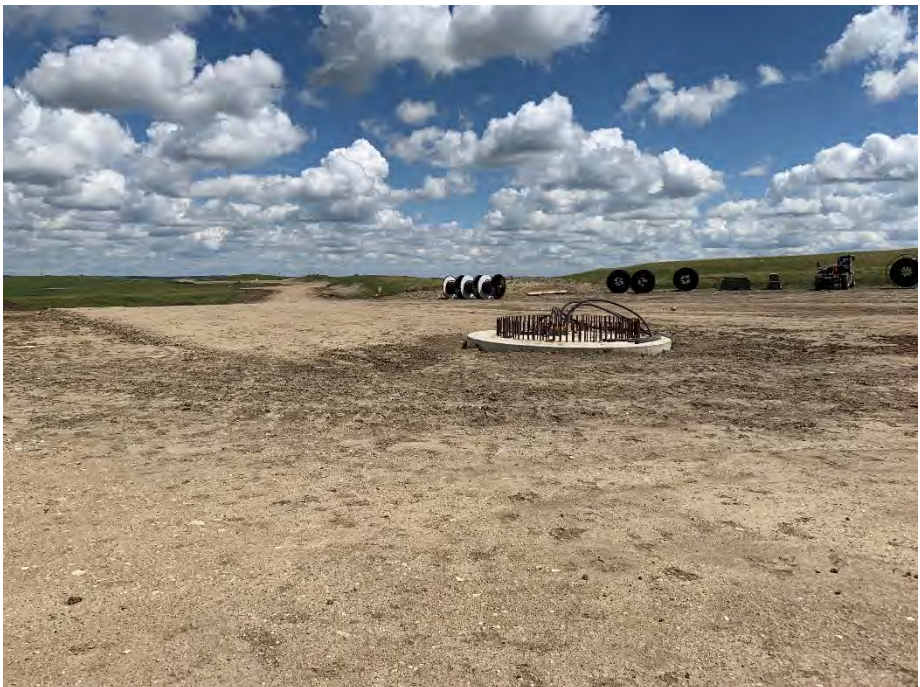
<p>Direction Taken: Southeast</p> <p>Description: Constructed Turbine 36 foundation with appropriately stripped topsoil.</p>

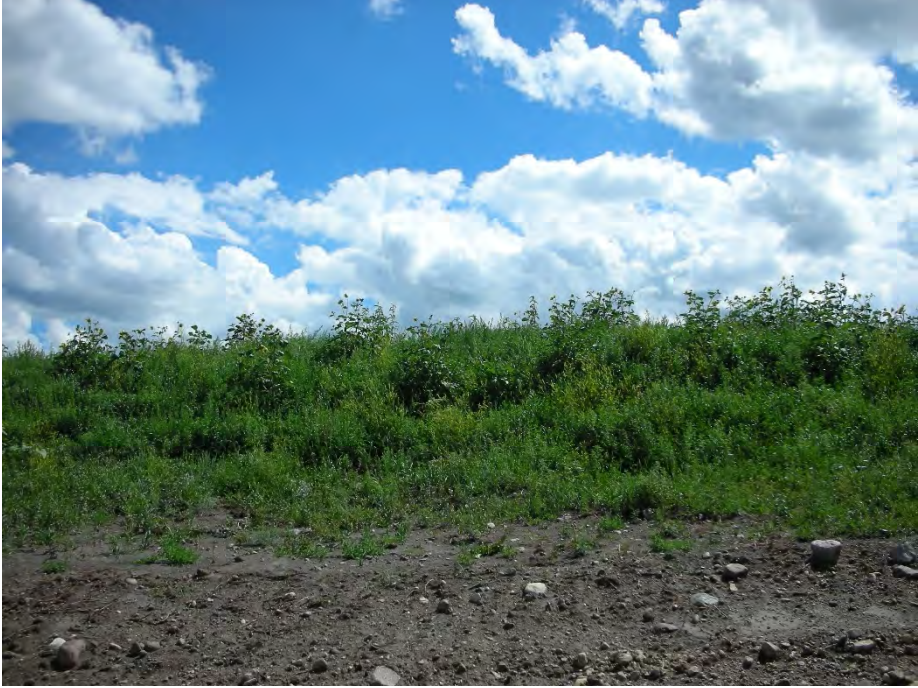
<p>Photo Point: 2845</p>

<p>Location of Photo: Lat: 46.07955069 Long: -99.04801241</p>	
<p>Direction Taken: South</p> <p>Description: Large, and appropriately stripped topsoil stockpile with good vegetation cover at Turbine 49.</p>	
<p>Photo Point: 2846</p>

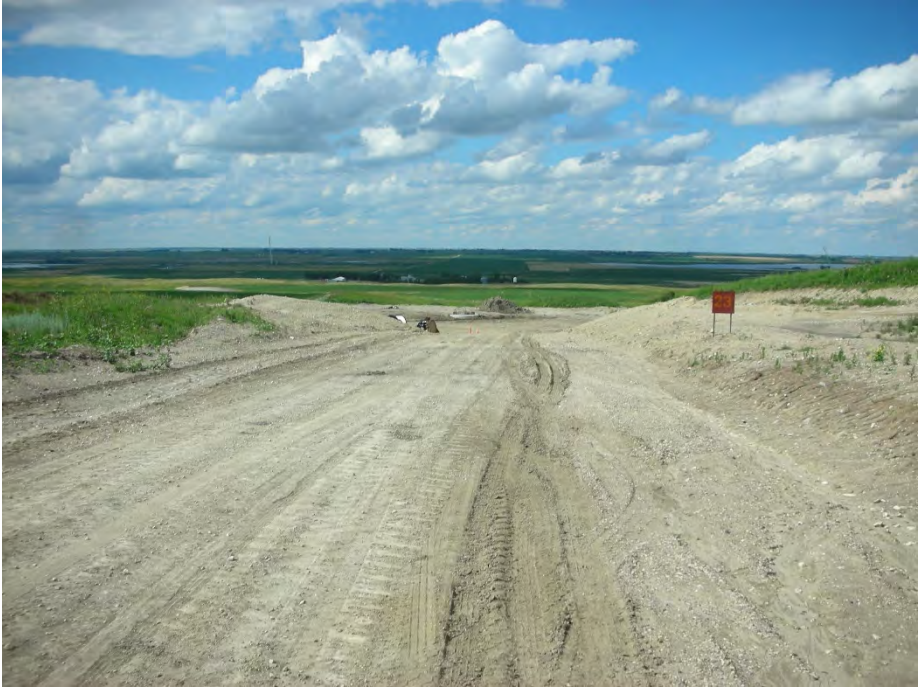
<p>Location of Photo: Lat: 46.11515849 Long: -99.06199446</p>	
<p>Direction Taken: North</p> <p>Description: Access road to turbine 23 appropriately stripped of topsoil.</p>

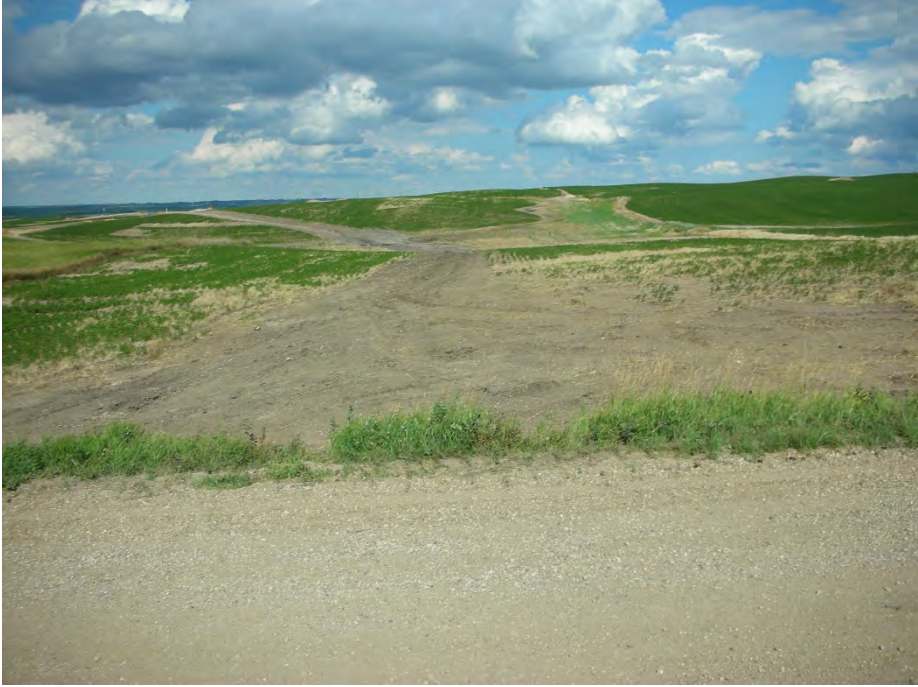
<p>Photo Point: 2859</p>

<p>Location of Photo: Lat: 46.11753776 Long: -99.08708963</p>	
<p>Direction Taken: East</p> <p>Description: Overlooking collection line corridor through/underneath 62nd st. to the East. Trenching appears to have been completed. Road intact.</p>	
<p>Photo Point: 2860</p>

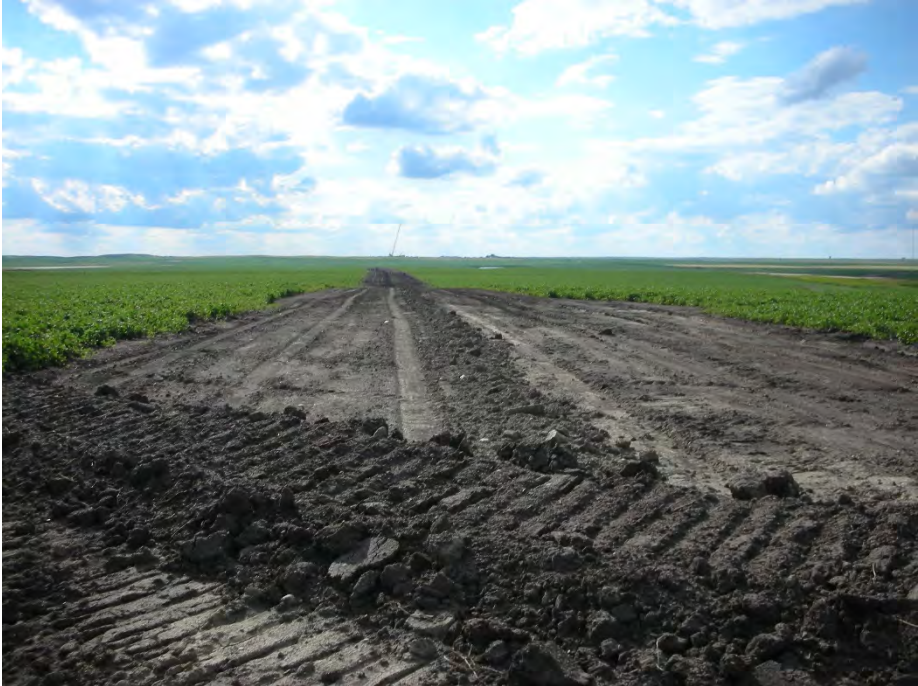
Direction Taken: West Description: Completed collection line at Turbine 34 traveling towards Turbine 29.
