**Merricourt Wind Power Project
As-Built Inspection Report**

File No. 227701305

November 2021

**North Dakota Public Service
Commission**

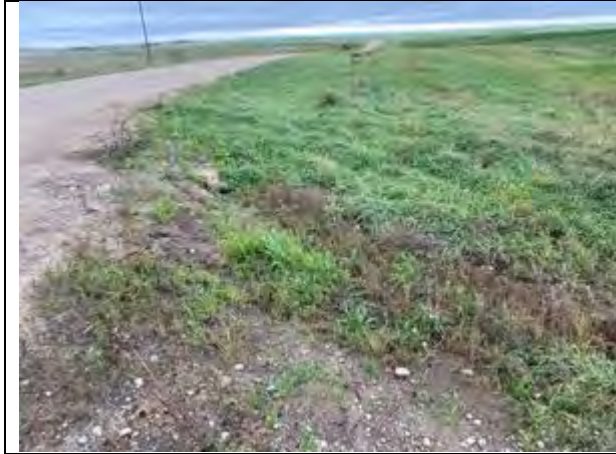
Observation Point: 1

Photo Description: Old BMP's present. Vegetation on access road is sparser than surrounding areas, but overall, satisfactory.

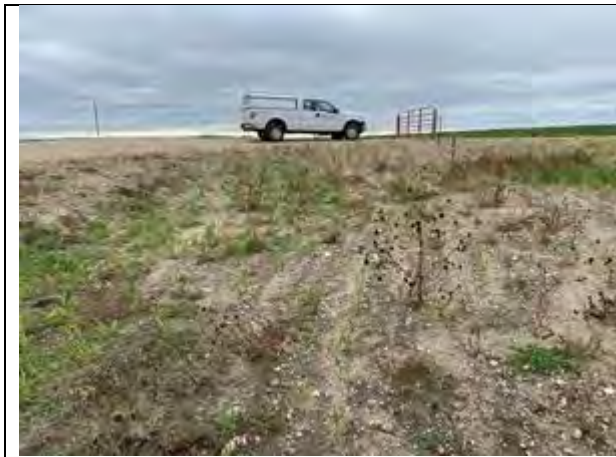
Observation Point: 2

Photo Description: Road and repaired approach for access road is eroding into ditch with evident rills forming. No BMP's are present except seeded plants. Grading match's section road and field.

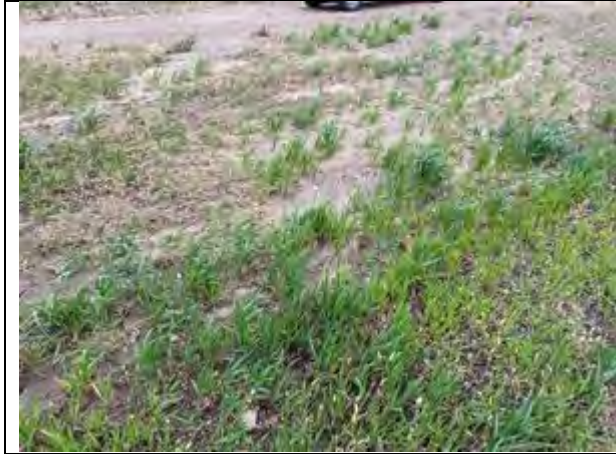
Observation Point: 7

Photo Description: Road fill washing into and covering topsoil in neighboring hay field. Seeded vegetation is emerging slower where road fill is covering topsoil. Appropriate grading.

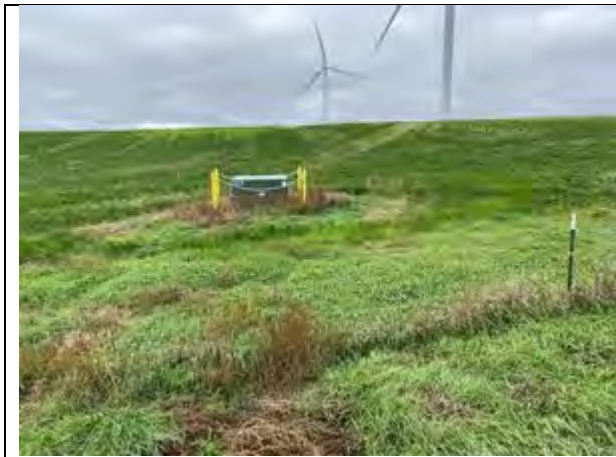
Observation Point: 8

Photo Description: Collection lines is consistent with as built drawings.

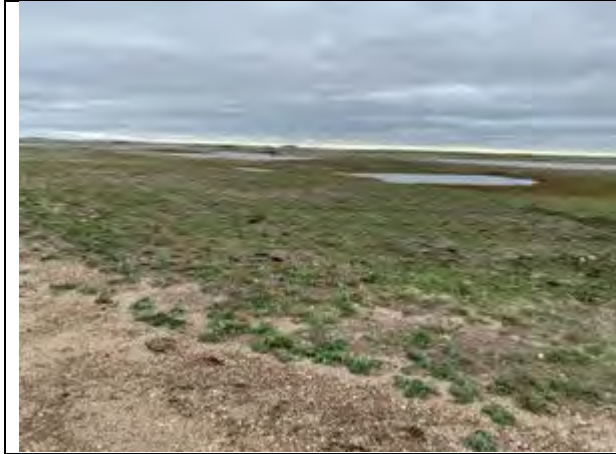
Observation Point: 10

Photo Description: T-75 pad is well reclaimed and adequately constructed. No signs of erosion and is graded well.

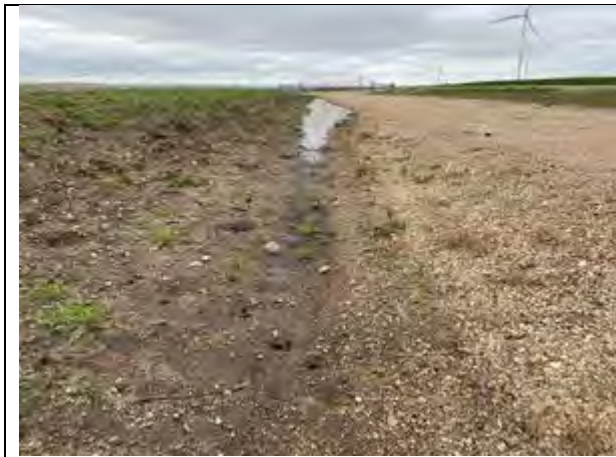
Observation Point: 11

Photo Description: Ponding water from rain on constructed access road. Regrading to allow water flow may be necessary to ensure the road stays in good condition and to reduce further erosion. Topsoil replacement is satisfactory.

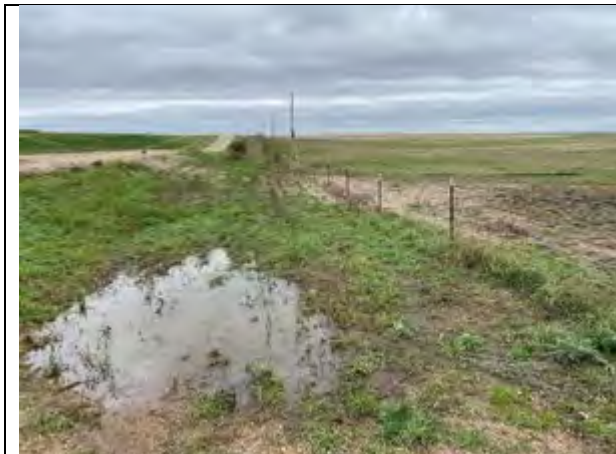
Observation Point: 12

Photo Description: Telephone pole remains in the pasture, but it is uncertain if it was from Project construction activity. Road ditch is improperly graded and does not match the existing grade of the section road. Old access area or temporary approach in photo is seeded but not matching surrounding area.

- Status of reclamation activities, notably, maintenance of BMPs, and potential need for additional BMPs until sufficient perennial vegetation is permanently established
- Status of repair for the Drain Crossings and Culverts identified in the report
- Status of bare soil with gully erosion at Points 76 and 77
- Status of filled wetland drainageway and other poorly graded drainageways
- Status of slumping access road side slopes
- Status of recent plowing and/or seeding evidenced by bare eroding soil at Points 61, 62, and 64
- Status of SWPPP related deficiencies on construction work along intersection of 62nd Ave SE and 88th St SE
- Status of temporary approach and telephone pole remaining as observed at Point 12

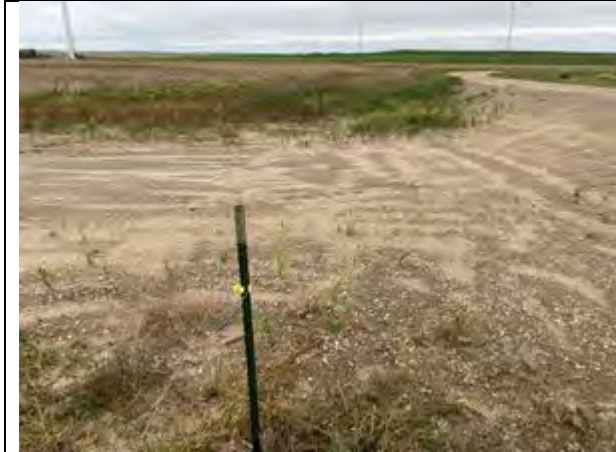
Observation Point: 13

Photo Description: Section of fence is missing at access road and there may be an unrepaired access road. Uncertain if this is at landowners request. Access approach is eroding into ditch. Grading does not match.

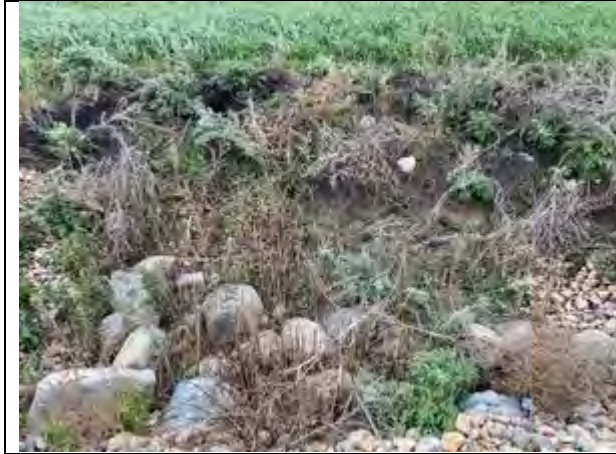
Observation Point: 16

Photo Description: Drain Crossing #102 via culvert is filled with sediment and may causing drain failure in the future.

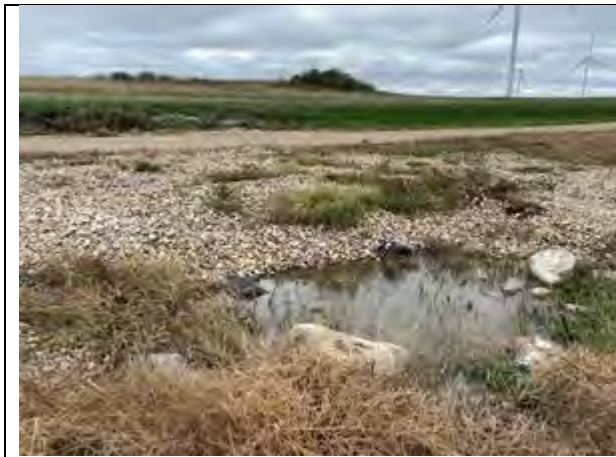
Observation Point: 17

Photo Description: South side of Drain Crossing #102 appears to be in better condition, with riprap present to mitigate erosion.

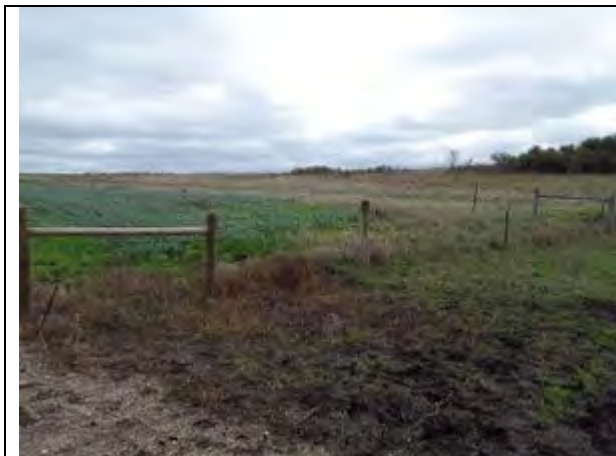
Observation Point: 18

Photo Description: Fencing is repaired and in good condition.

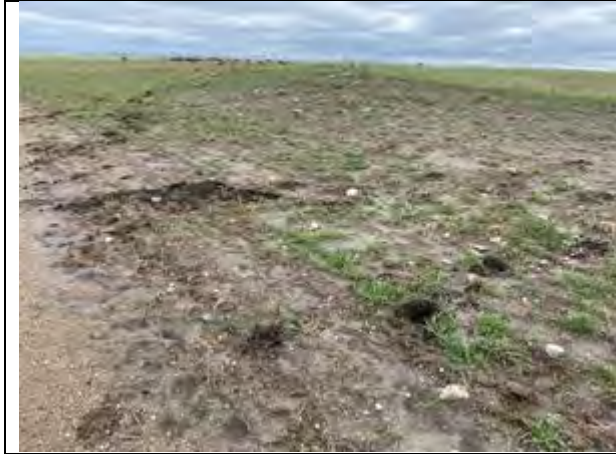
Observation Point: 19

Photo Description: Replaced topsoil is washing onto permitted access road near T-72.

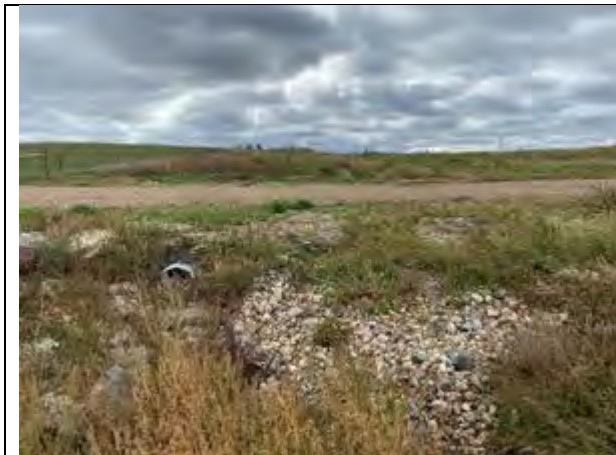
Observation Point: 20

Photo Description: Culvert crossing access is well graded and no sign of erosion.

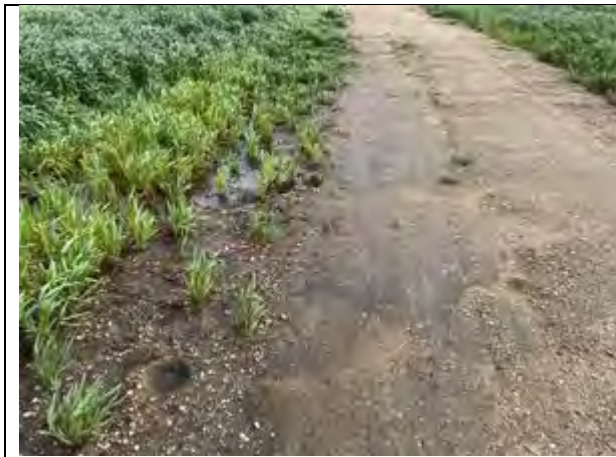
Observation Point: 23

Photo Description: Water washing the replaced and graded topsoil onto access road. South side is well graded.

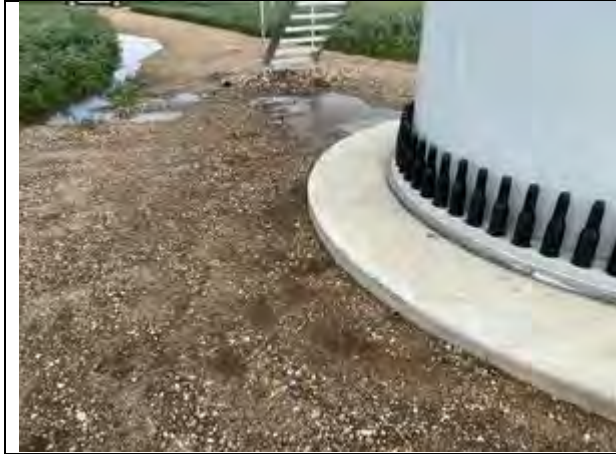
Observation Point: 25

Photo Description: T-52 was subject to last-minute layout changes, and was observed in agreeance with final As-Built files. Water is ponding on pad in some spots.

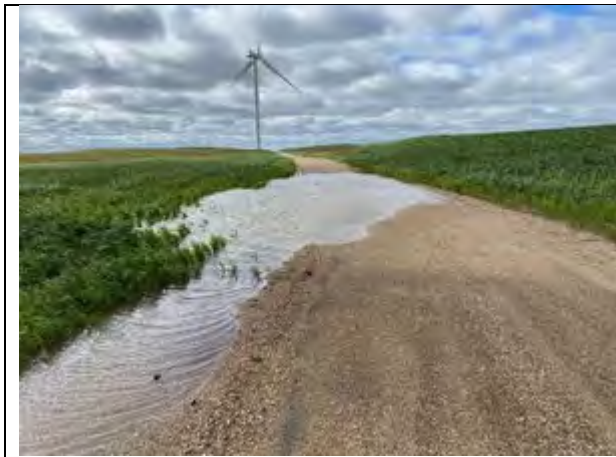
Observation Point: 26

Photo Description: Impassable and could not inspect T-53 due to ponded water.

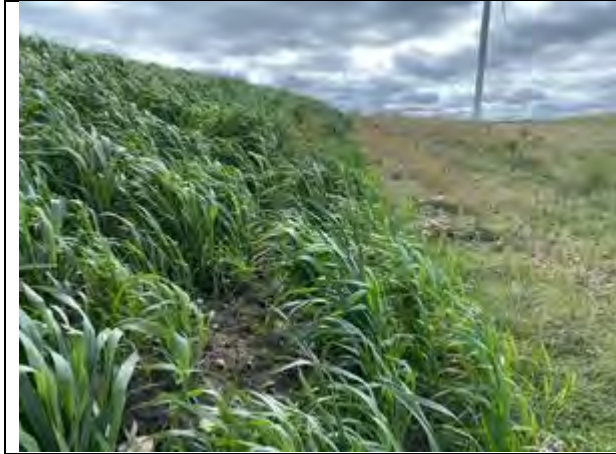
Observation Point: 28

Photo Description: Appropriate grading and revegetation of road and collection line area.

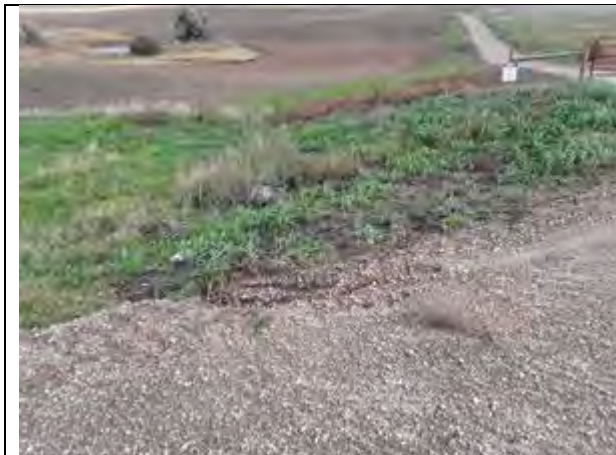
Observation Point: 29

Photo Description: North side of repaired approach has adequate grading and construction of Culvert #20.

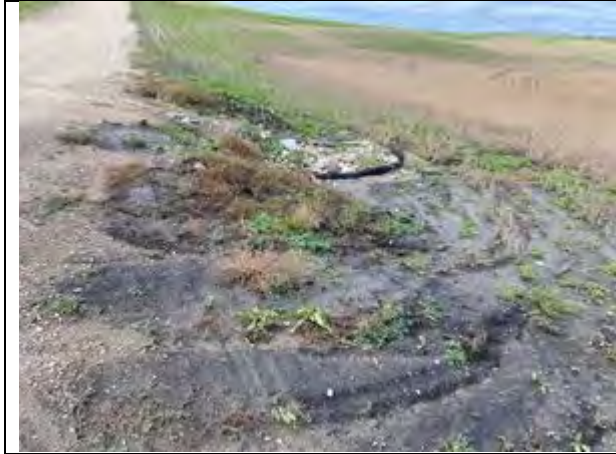
Observation Point: 31

Photo Description: Grading appears appropriate, but road wash is depositing on topsoil on soybean field. Drain 84 is full of topsoil. Straw roll BMP needs replacing and/or maintenance.

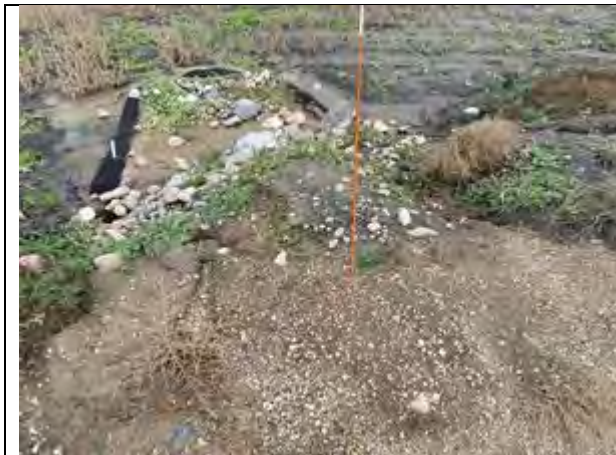
Observation Point: 32

Photo Description: Drain #84 is washed out and eroding into field towards wetland.

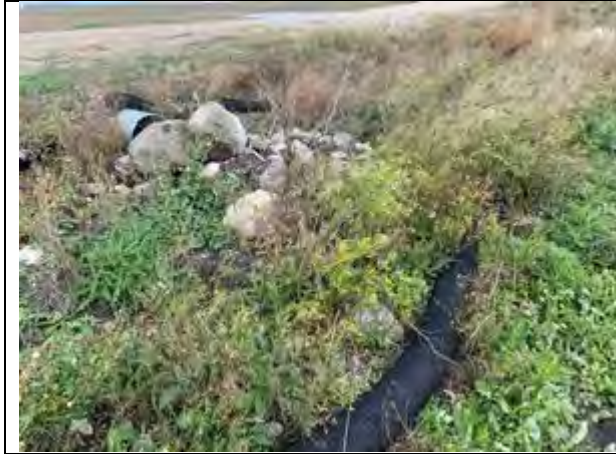
Observation Point: 34

Photo Description: Straw roll is working, and preventing sediment from entering wetland. Continued maintenance/monitoring might be needed to ensure protection of wetland.

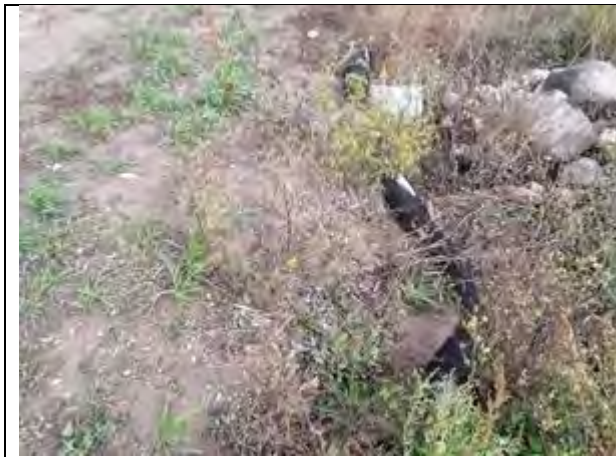
Observation Point: 35

Photo Description: Closeup of view of culvert and drain in Observation Point 34.

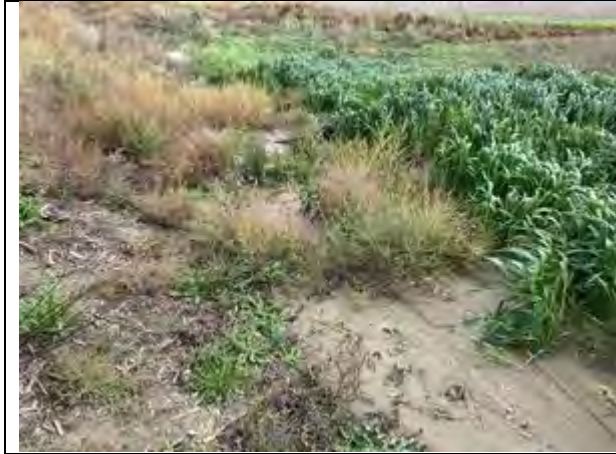
Observation Point: 37

Photo Description: Evidence of subsoil and/or road material washing downslope into wetland.

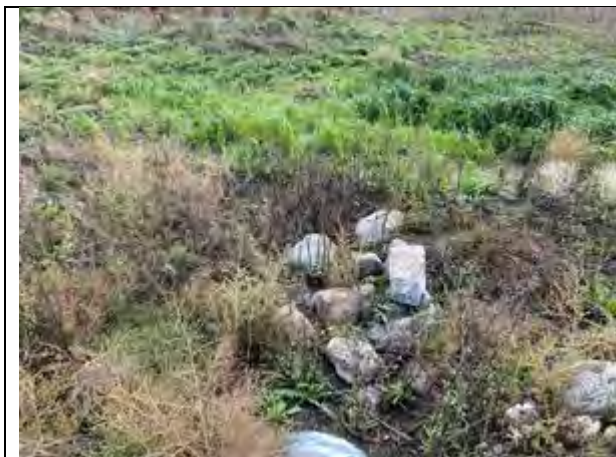
Observation Point: 38

Photo Description: Evidence of subsoil and/or road material washing downslope appears to be entering a wetland.

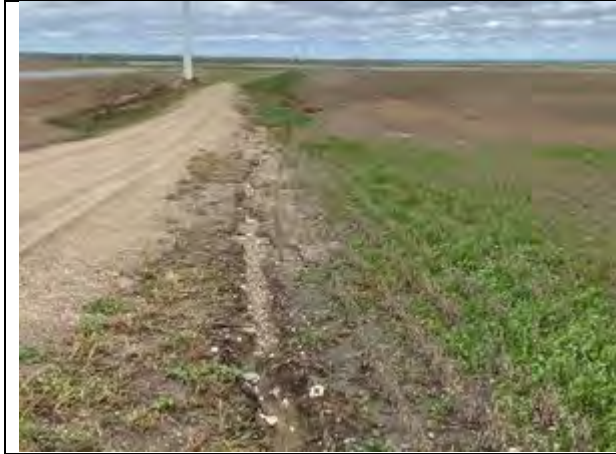
Observation Point: 40

Photo Description: Erosion down slope from access road is washing topsoil and subsoil into soybean field. Needs BMP such as straw rolls. Road matting is visible.

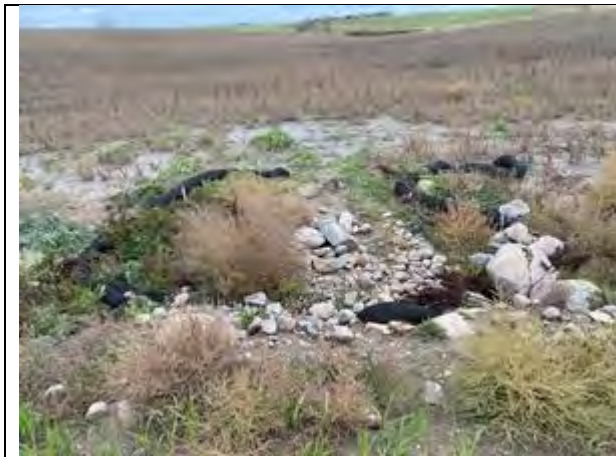
Observation Point: 41

Photo Description: Drain Crossing #88 is appropriate. May need continued maintenance or monitoring.

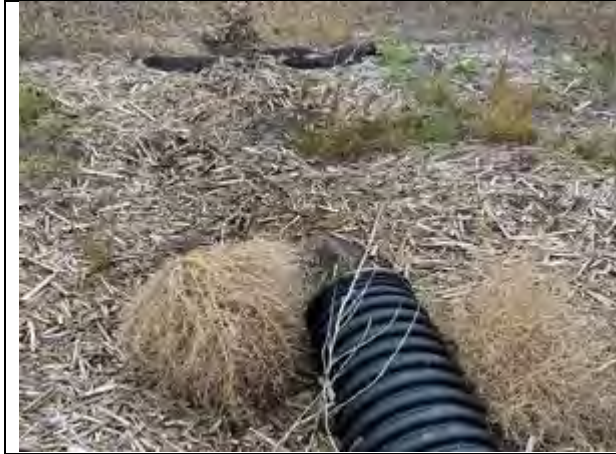
Observation Point: 43

Photo Description: Drain Crossing #79 has BMP's in better condition than others noted in this report. Future maintenance/monitoring is recommended.

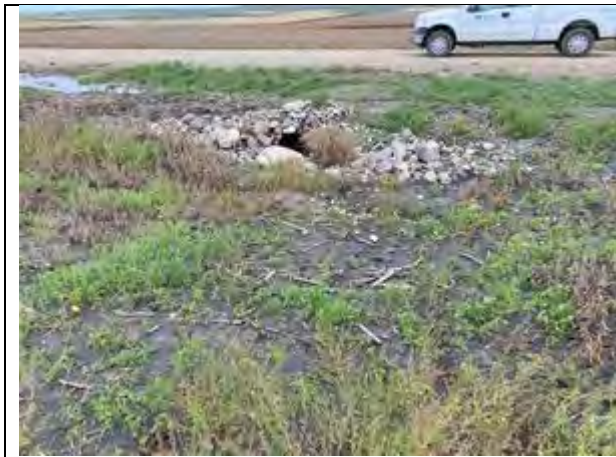
Observation Point: 44

Photo Description: Inadequate grading around Drain Crossing #79 culvert inlet. Roadsides are flooded and not draining to it. Topsoil is eroding.

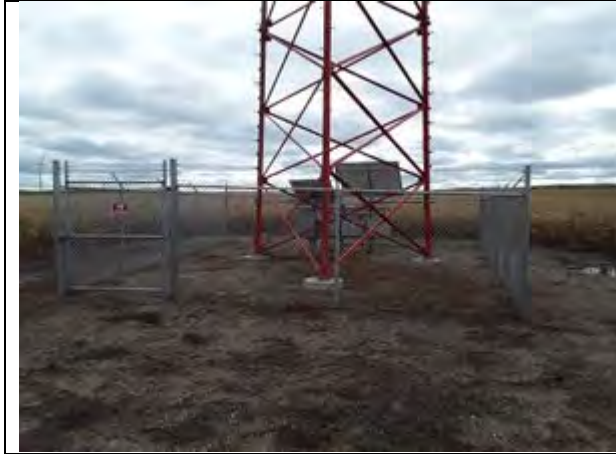
Observation Point: 49

Photo Description: MET- 2 tower and pad adequately constructed but permanent access road is constructed over unstripped topsoil.

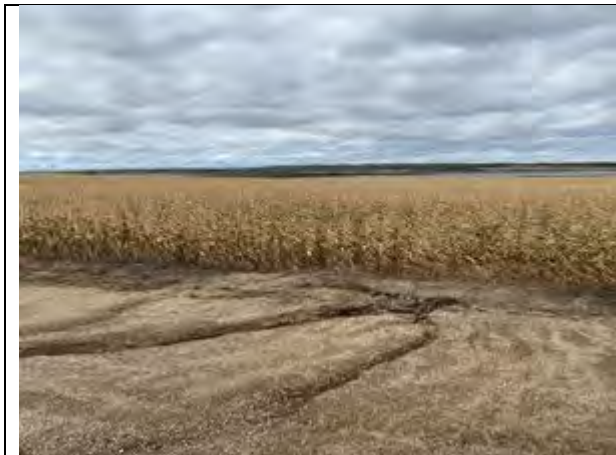
Observation Point: 50

Photo Description: No BMP's present. Road fill and topsoil washing into corn field.

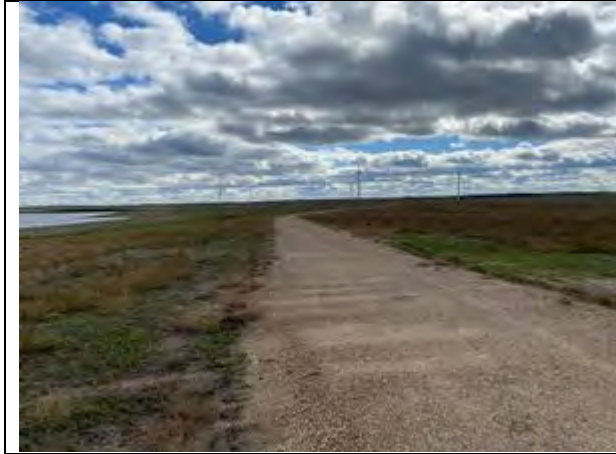
Observation Point: 52

Photo Description: Road and T-64 is satisfactory. Final grading appears adequate, and there is minimal erosion.

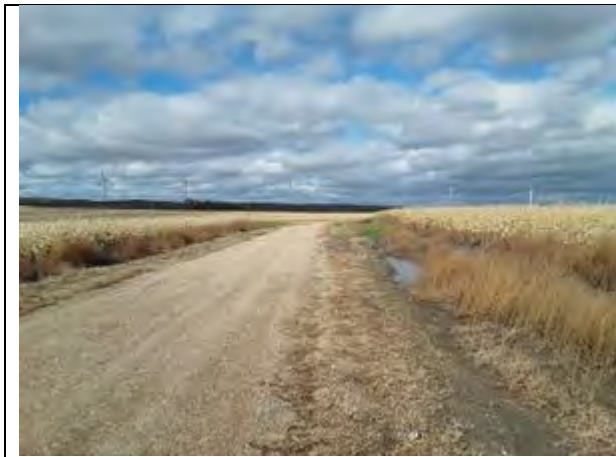
Observation Point: 53

Photo Description: Overall, the access road is well graded, but soil upgradient may be eroding into the road from grading or stabilization issues.

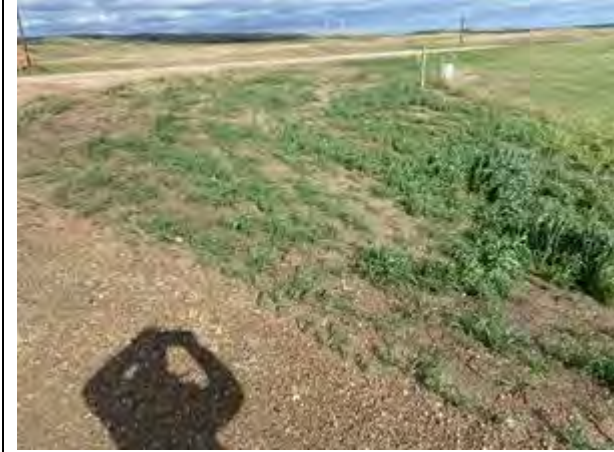
Observation Point: 55

Photo Description: Section road is reclaimed appropriately, and matches surrounding grade. Ditch grading appears adequate, with minimal erosion from road. Vegetation near center of road/corner may be slightly washed out.

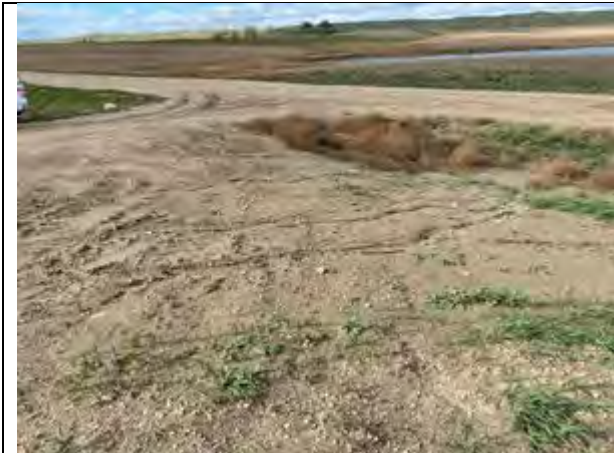
Observation Point: 56

Photo Description: East side of access road is eroding into ditch. Ditch is graded well but the regraded area lack BMPs.

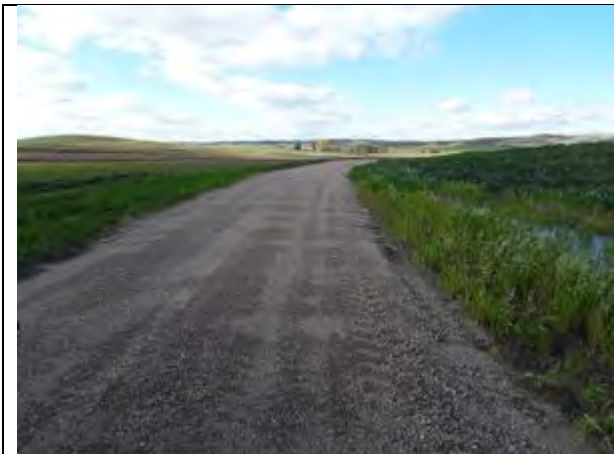
Observation Point: 57

Photo Description: Access road appears in satisfactory condition. Ditch approach is well graded with minimal erosion. Vegetation emergence appears adequate.

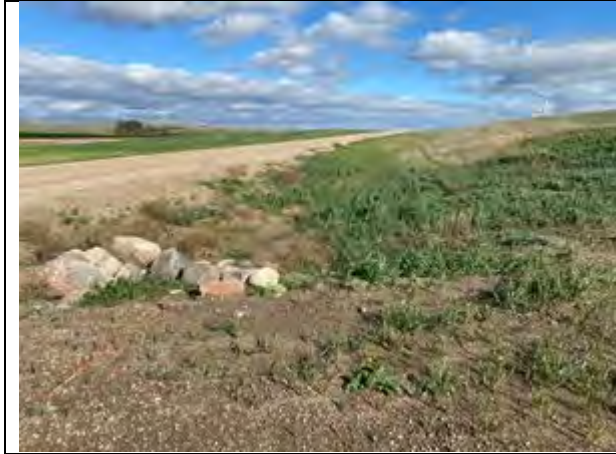
Observation Point: 58

Photo Description: Construction appears adequate, and there is minimal observable soil erosion.

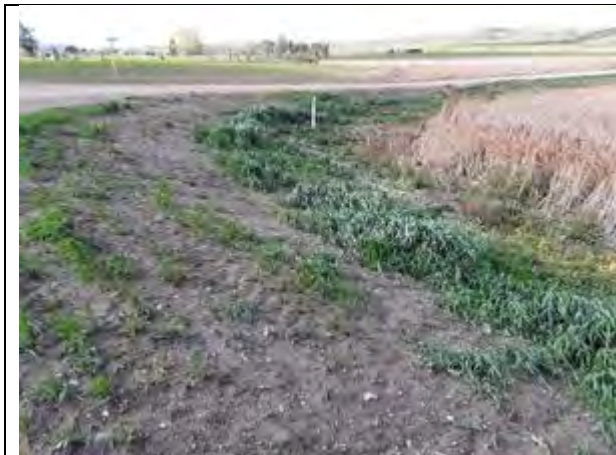
Observation Point: 59

Photo Description: Road appears appropriately repaired with good grading. Straw roll needs maintenance soon but is actively mitigating sediment.

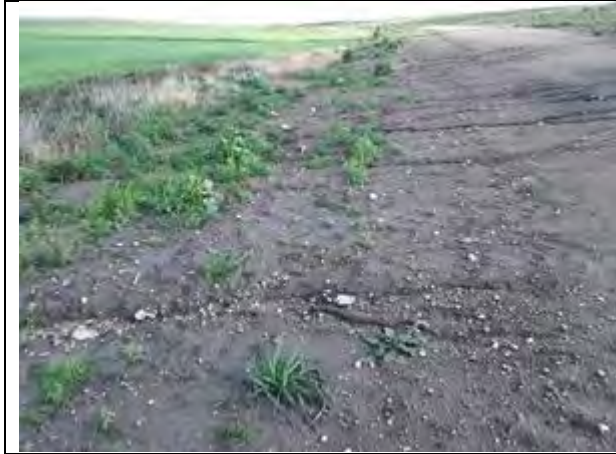
Observation Point: 64

Photo Description: Replaced topsoil is eroding and washing across access road to T-59.

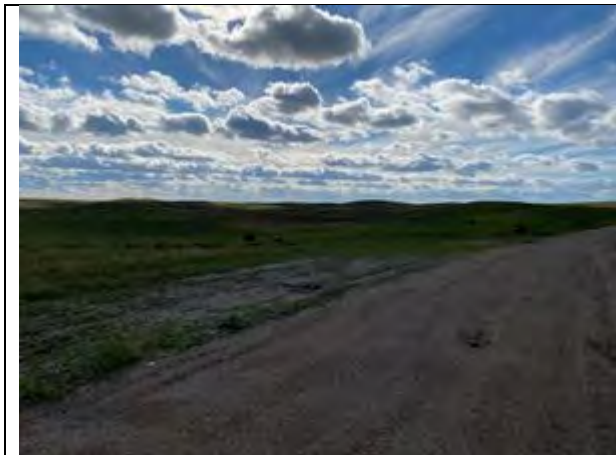
Observation Point: 65

Photo Description: T-41 appears to be constructed appropriately. Soil appears graded to surrounding area and seeded vegetation is emerging.

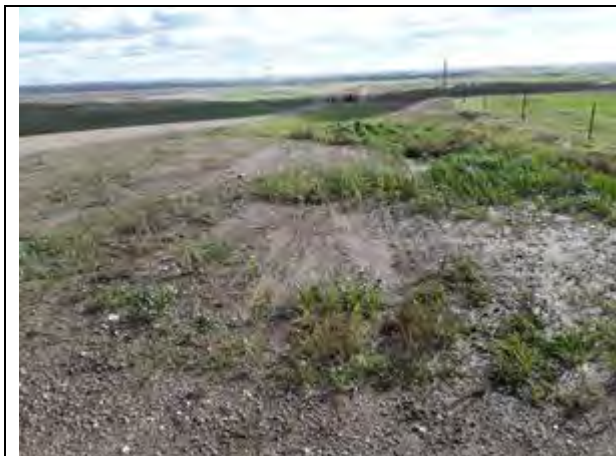
Observation Point: 66

Photo Description: Access road appears adequately graded. Section line fence and gate replaced and in good condition.

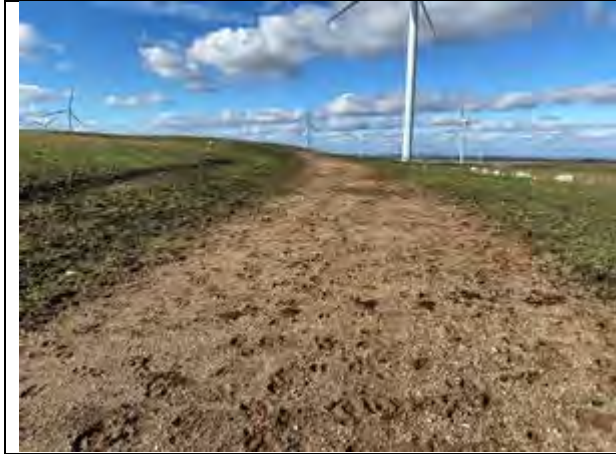
Observation Point: 67

Photo Description: Adequate grading with seeded vegetation coming in. Frequent cattle traffic in the replaced soil.

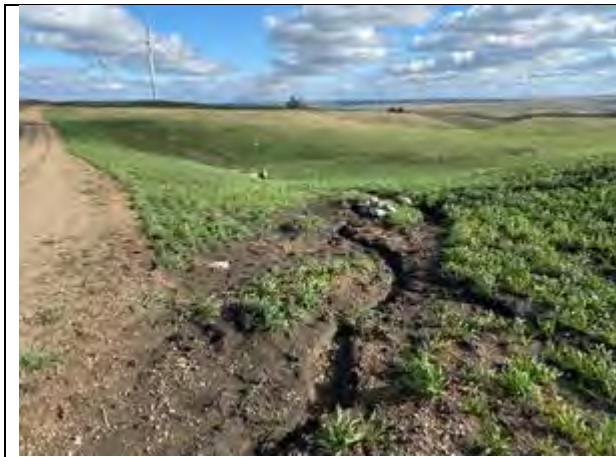
Observation Point: 68

Photo Description: Replaced topsoil is eroding. A large gully appears to be depositing topsoil into swale downslope.

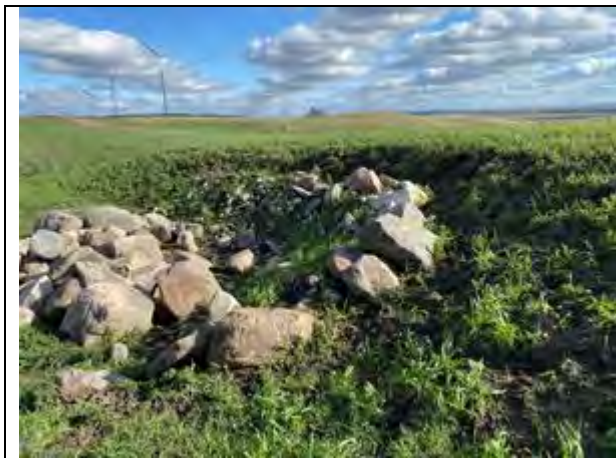
Observation Point: 69

Photo Description: Grading around Drain Crossing #21 appears to be poor or damaged from rain. Only the riprap rock is visible. Repair should be considered due to the slumping of the slope and erosion.

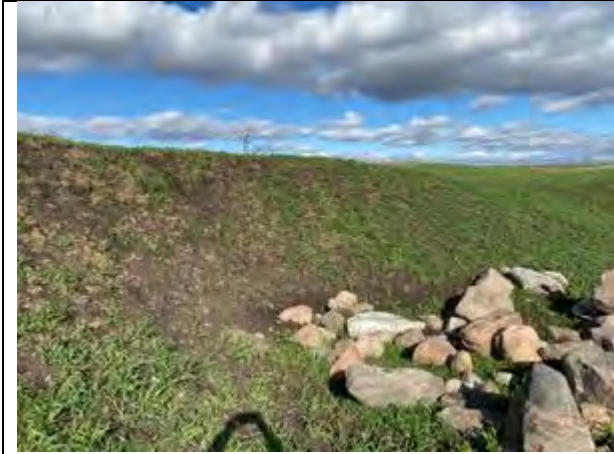
Observation Point: 70

Photo Description: Reclaimed slope and topsoil around access road is vegetated. However, the side slope is slumping around Drain #21. Culvert is filled with sediment. Stantec recommends repair to remain compliant with SWPPP and not affect landowners.

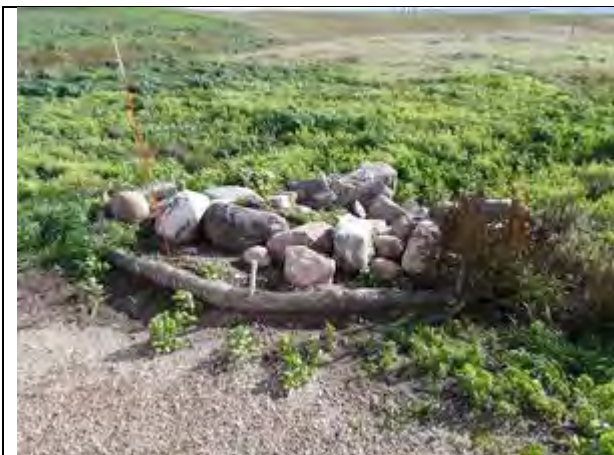
Observation Point: 72

Photo Description: Drain Crossing #23 and its BMP appear in good condition according to As-Built inspection.

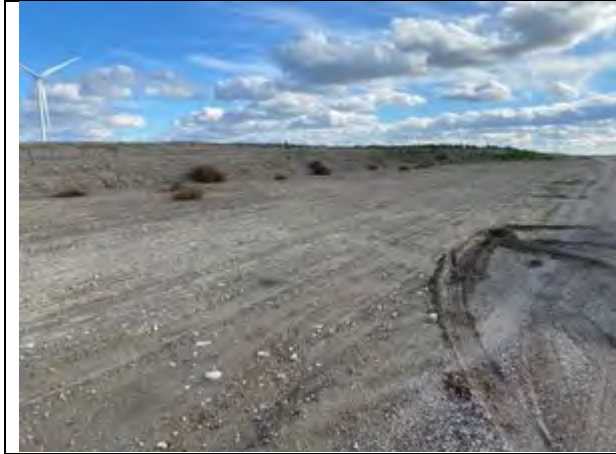
Observation Point: 73

Photo Description: T-10 access road appears to be graded. However, the adjacent area around access road is lacking topsoil replacement and vegetation.

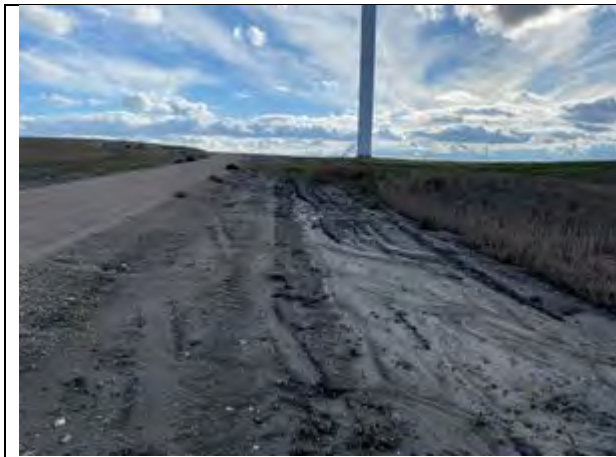
Observation Point: 74

Photo Description: The replaced topsoil along access road is unvegetated and severely eroding.

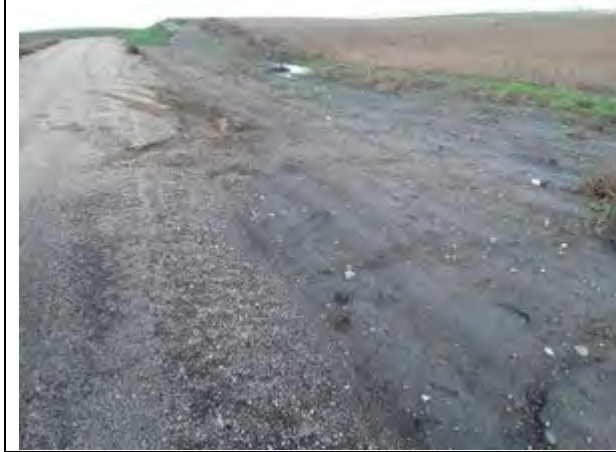
Observation Point: 76
Date Taken: October 14, 2021 4:01 PM
Direction Photo is Taken: Northeast

Photo Description: Sediment deposited into field, but not as severe as nearby locations. The grading is appropriate.

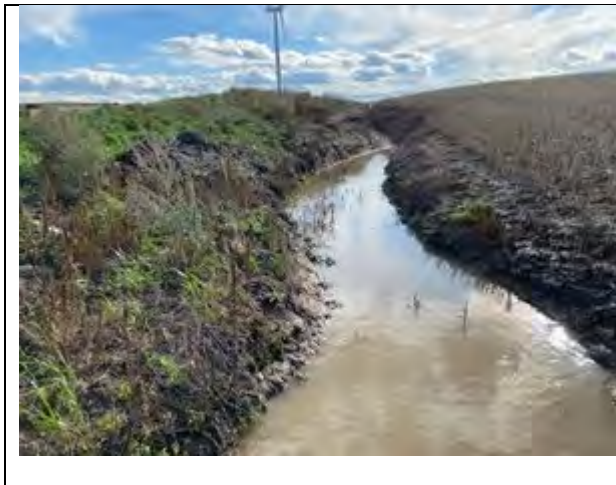
Observation Point: 77
Date Taken: October 14, 2021 4:03 PM
Direction Photo is Taken: South

Photo Description: Appears to be possible soil stockpile that does not match existing topography. Pictured shows a deep gully coming from the farm field and possible topsoil pile, but it may have been present prior to construction.

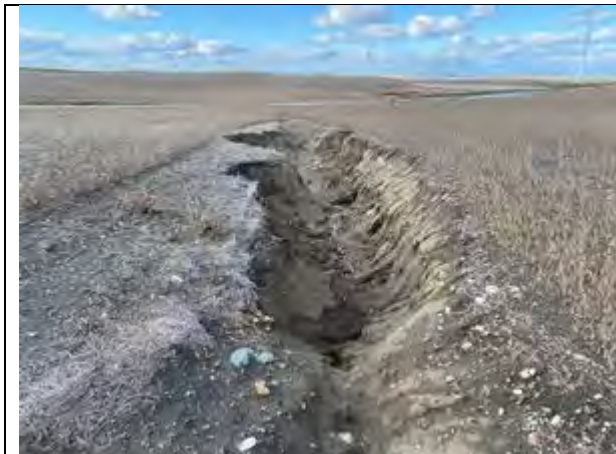
Observation Point: 78
Date Taken: October 14, 2021 4:07 PM
Direction Photo is Taken: Northwest

Photo Description: This point is an offsite historic gully. This photo shows this offsite gully could be a source of some of the sediment deposited on the nearby access road.

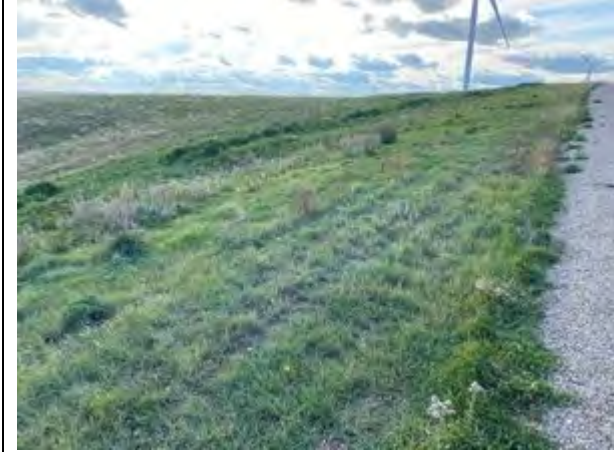
Observation Point: 79

Photo Description: Excellent grading and vegetation cover. This road appears to have been well established, and vegetation looks very healthy. Darker vegetation in the background of the photo background is from the collection line construction.

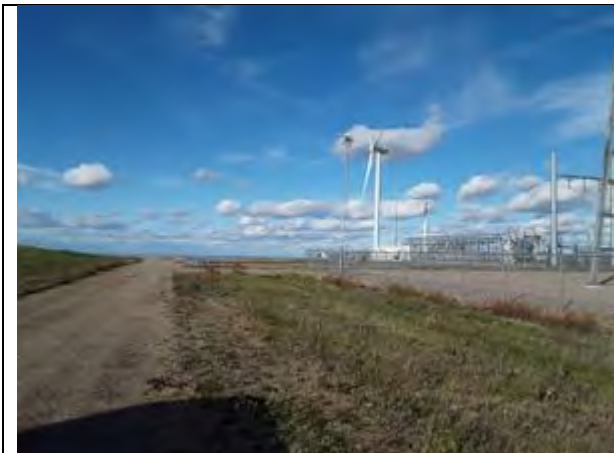
Observation Point: 80

Photo Description: Substation construction and boundary is consistent with As-Built drawings.

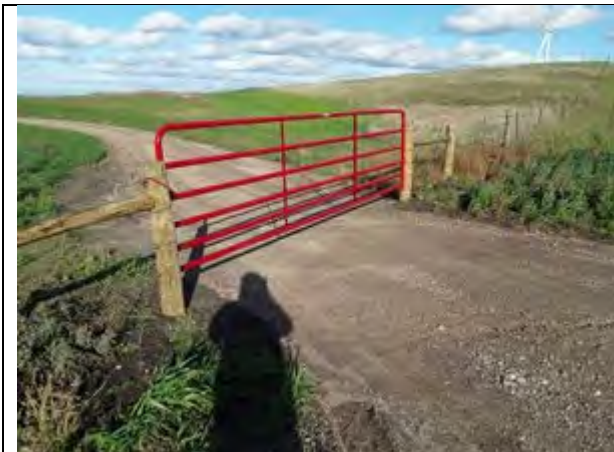
Observation Point: 81

Photo Description: Section line fence and gate repaired and replaced. Topsoil respreading and grading appears to match surrounding area

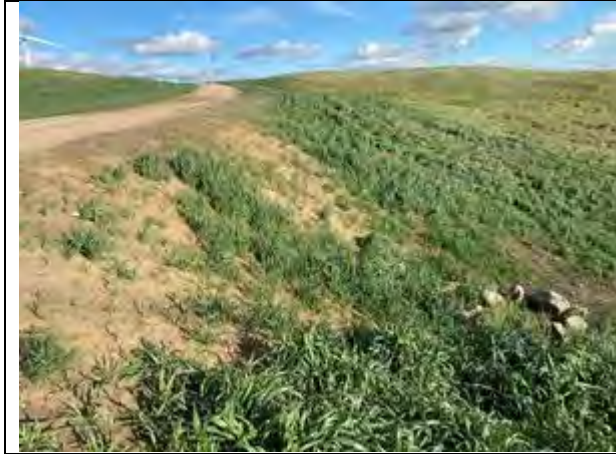
Observation Point: 82

Photo Description: Use of BMP's is evident. Grade for road may be too steep as there is visible erosion and slumping. Drain Crossing #57 is filled with sediment.

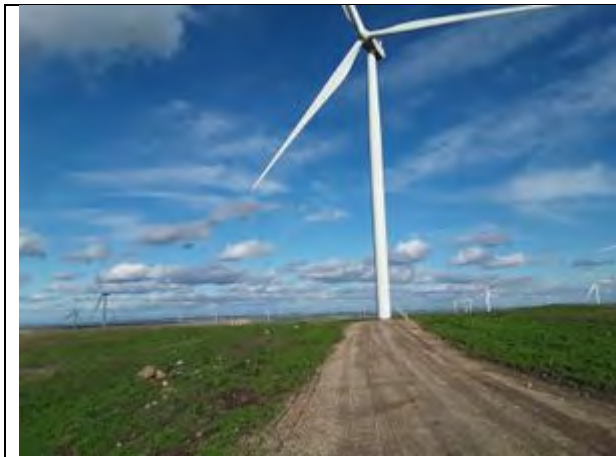
Observation Point: 83

Photo Description: The grading of access road near T-24 appears appropriate.

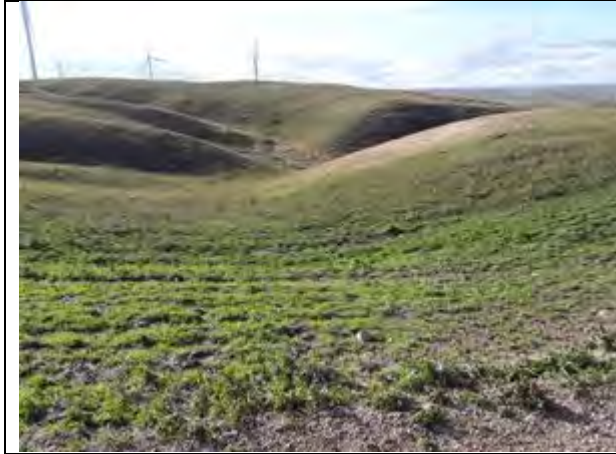
Observation Point: 85

Photo Description: Access road and replaced topsoil appear to match the grading of the surrounding landscape. No erosion visible near Drain Crossing #42.

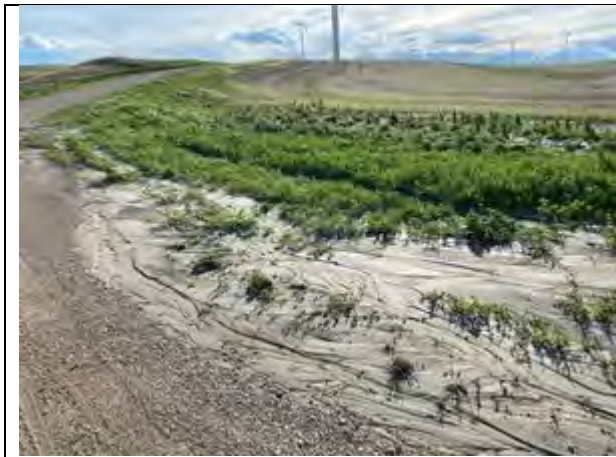
Observation Point: 86

Photo Description: Topsoil appears to be eroding down the access road from T-35. Regrading and seeding is recommended before the revegetation inspection.

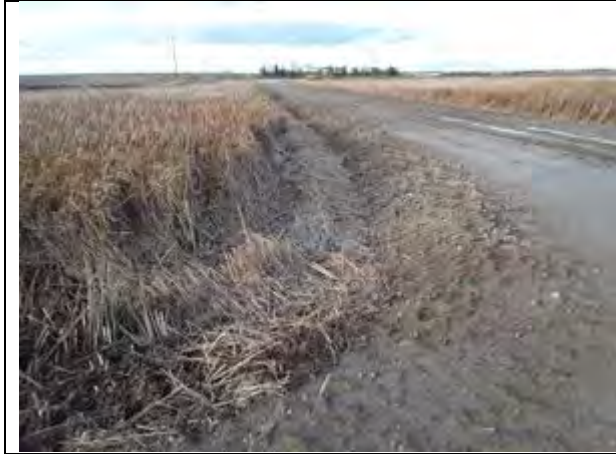
Observation Point: 94

Photo Description: Overlooking intersection that is being improved or repaired. It is not clear if this is activity related to Merricourt Project. PSC may want to clarify if this is EDF/Otter Tail-related activity or not.

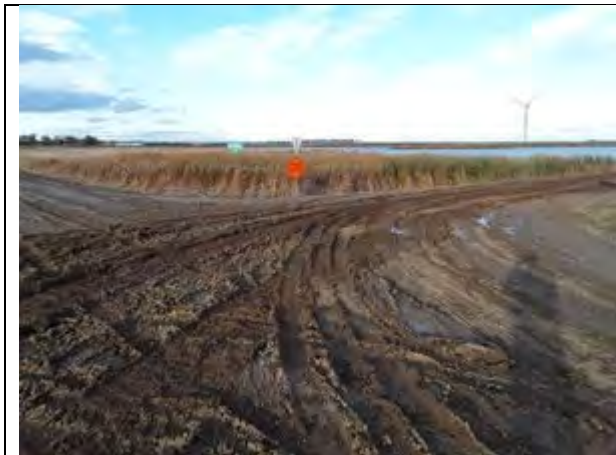
Observation Point: 95

Photo Description: More overview of recent road work.

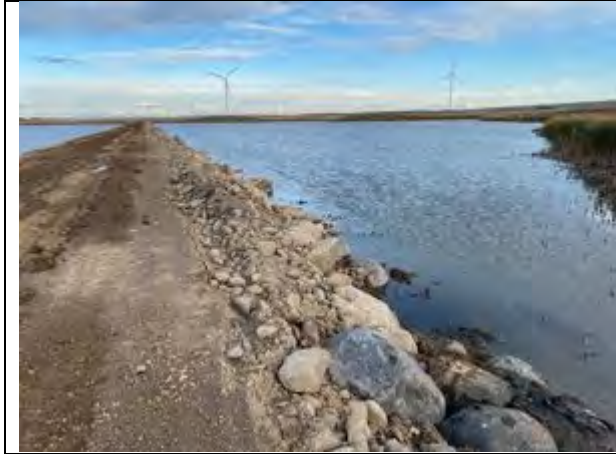
Observation Point: 97

Photo Description: No sediment control along open water. Overlooking section line road through open water.

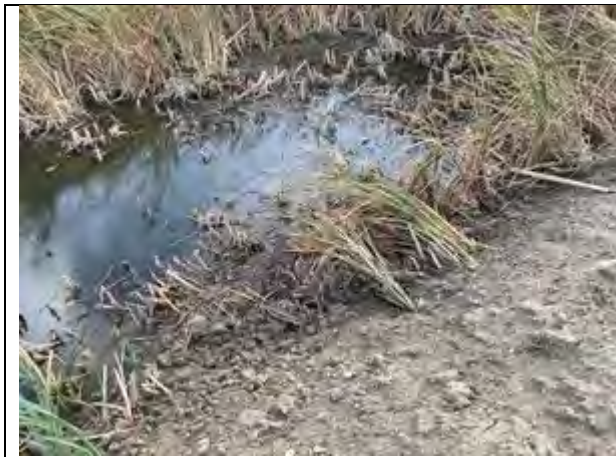
Observation Point: 98

Photo Description: Sedimentation into wetland. Unknown if associated with the Project.

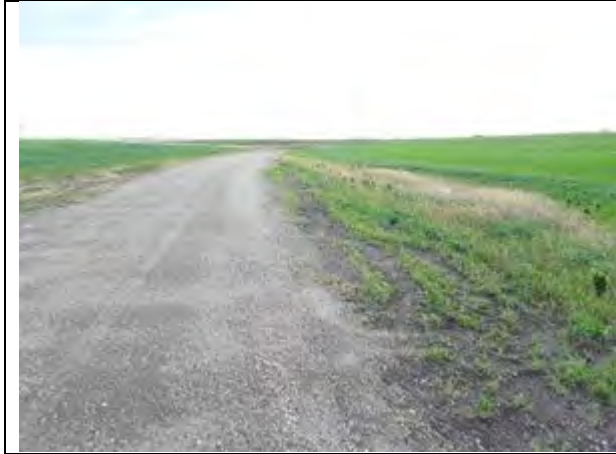
Observation Point: 100

Photo Description: Road approach for T-15 appears well graded and vegetated. Section road is in good condition.

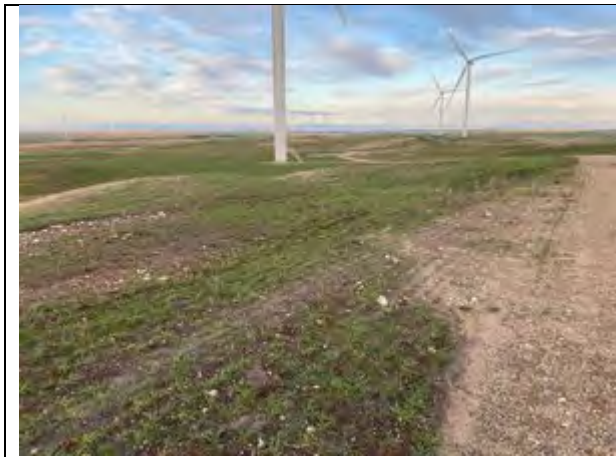
Observation Point: 101

Photo Description: Topsoil is overall adequately replaced and graded to surrounding area. Drain Crossing #45 culvert appears to be in good condition.

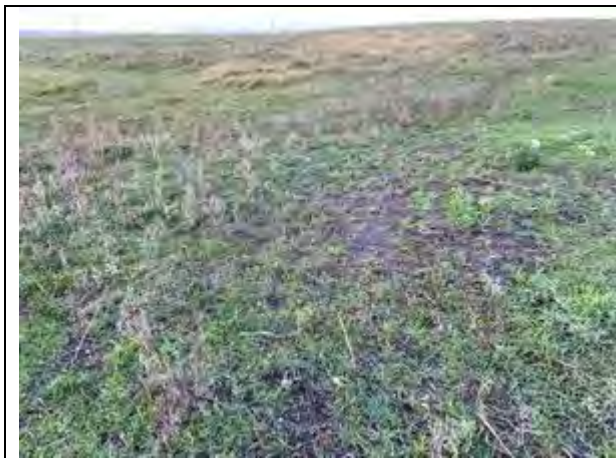
Observation Point: 102

Photo Description: Final topsoil replaced close to a delineated wetland.

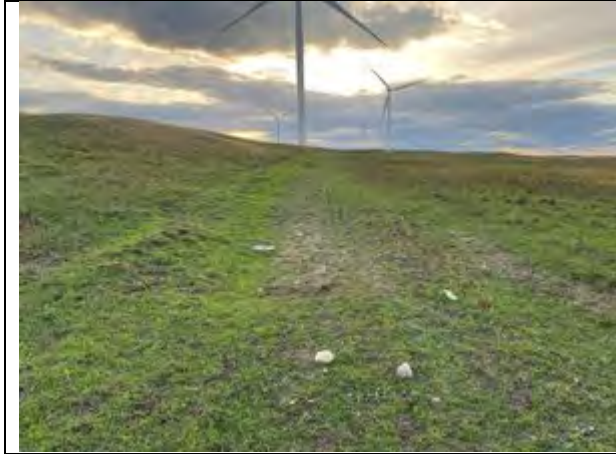
Observation Point: 103

Photo Description: Collection line appears consistent with as built. Some seeding equipment parts remained.

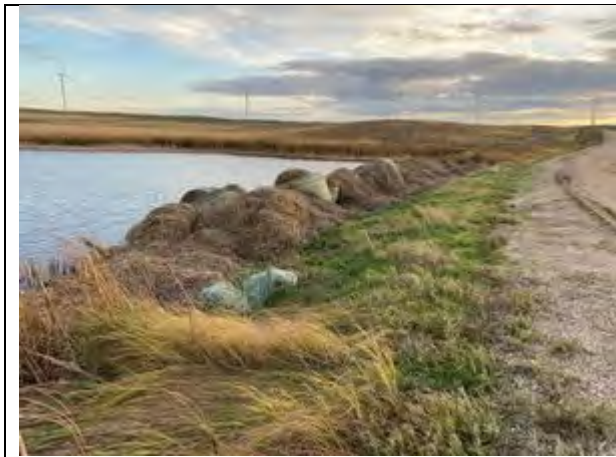
Observation Point: 104

Photo Description: Haybales are in a delineated wetland but is likely not EDF-related.

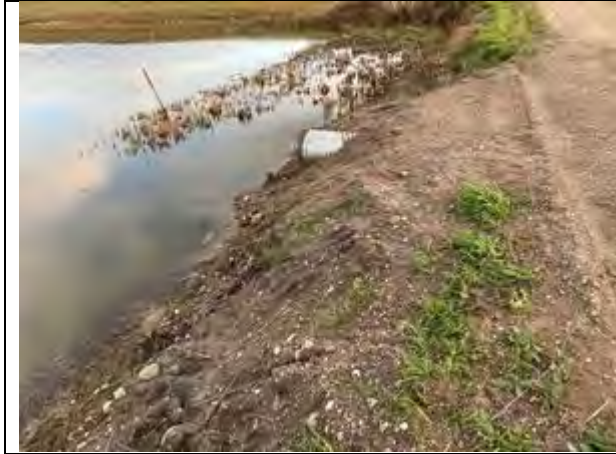
Observation Point: 106

Photo Description: This access road has been repaired. East side slope and water line is lacking vegetation. Minimal sign of road material washing in.

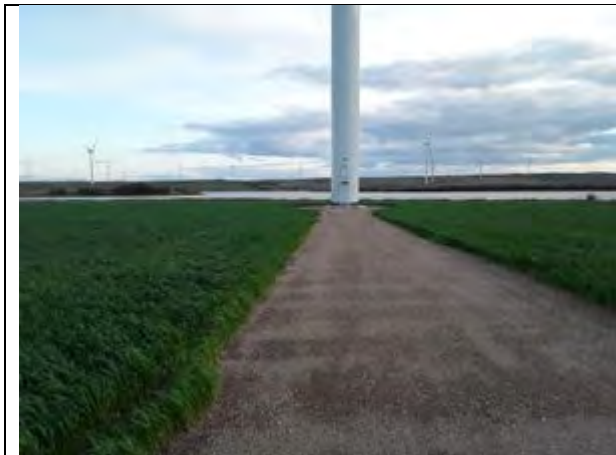
Observation Point: 107

Photo Description: T-30 appears appropriately reclaimed and located in agreement with the as-built files. Vegetation is well established.
