N O R T H  
**Dakota** | Environmental Quality  
 Be Legendary.™

October 3, 2019

**April 13<sup>th</sup>, 16<sup>th</sup>, and 28<sup>th</sup>, 2015 portions of inspection reports attached.**

## INSPECTION REPORT

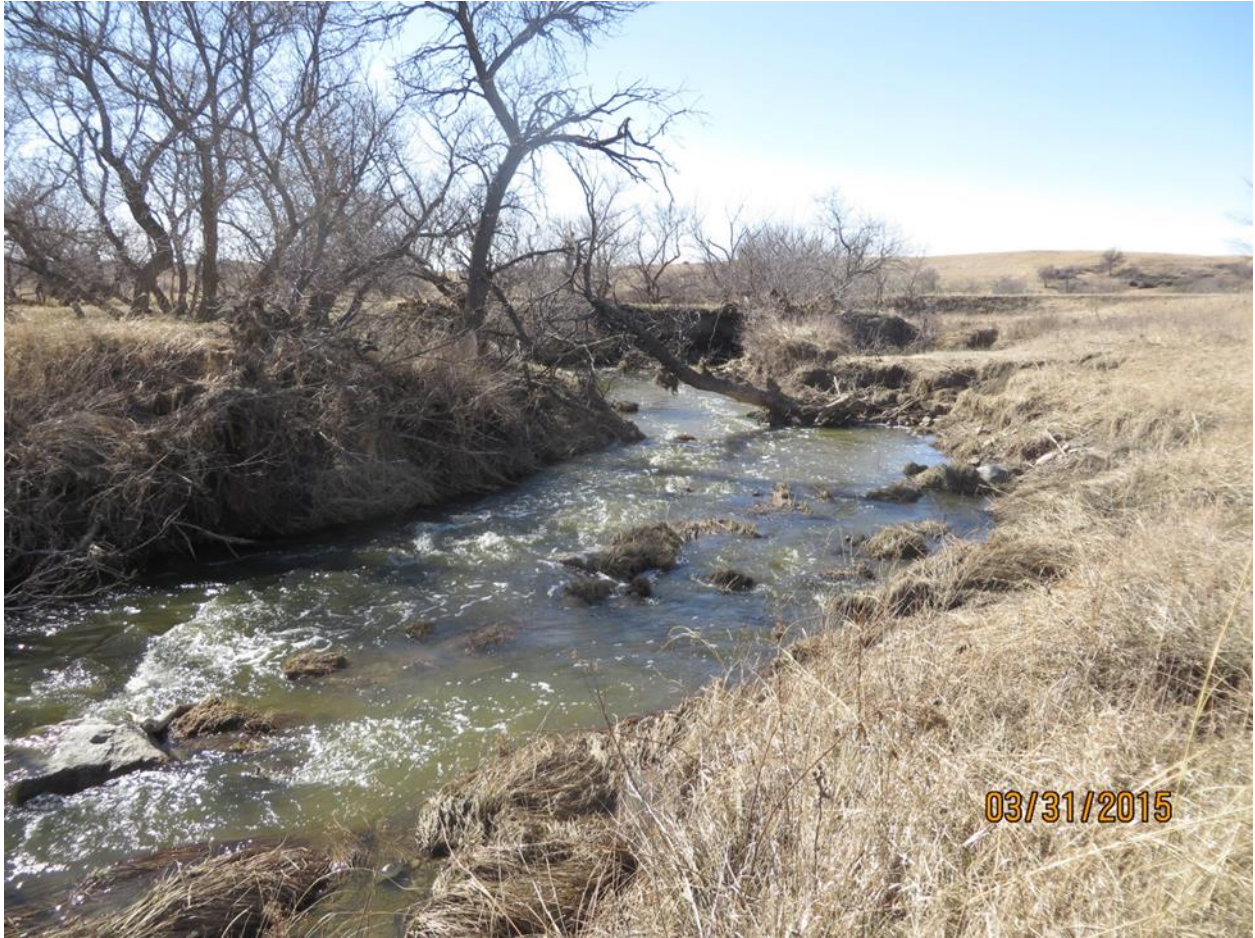
Figure 1. Coyote Creek

Coyote Creek was flowing water at a level higher than expected given the low amount of snow received this past winter. Figure 1 is a picture of Coyote Creek where the temporary crossing will be constructed.

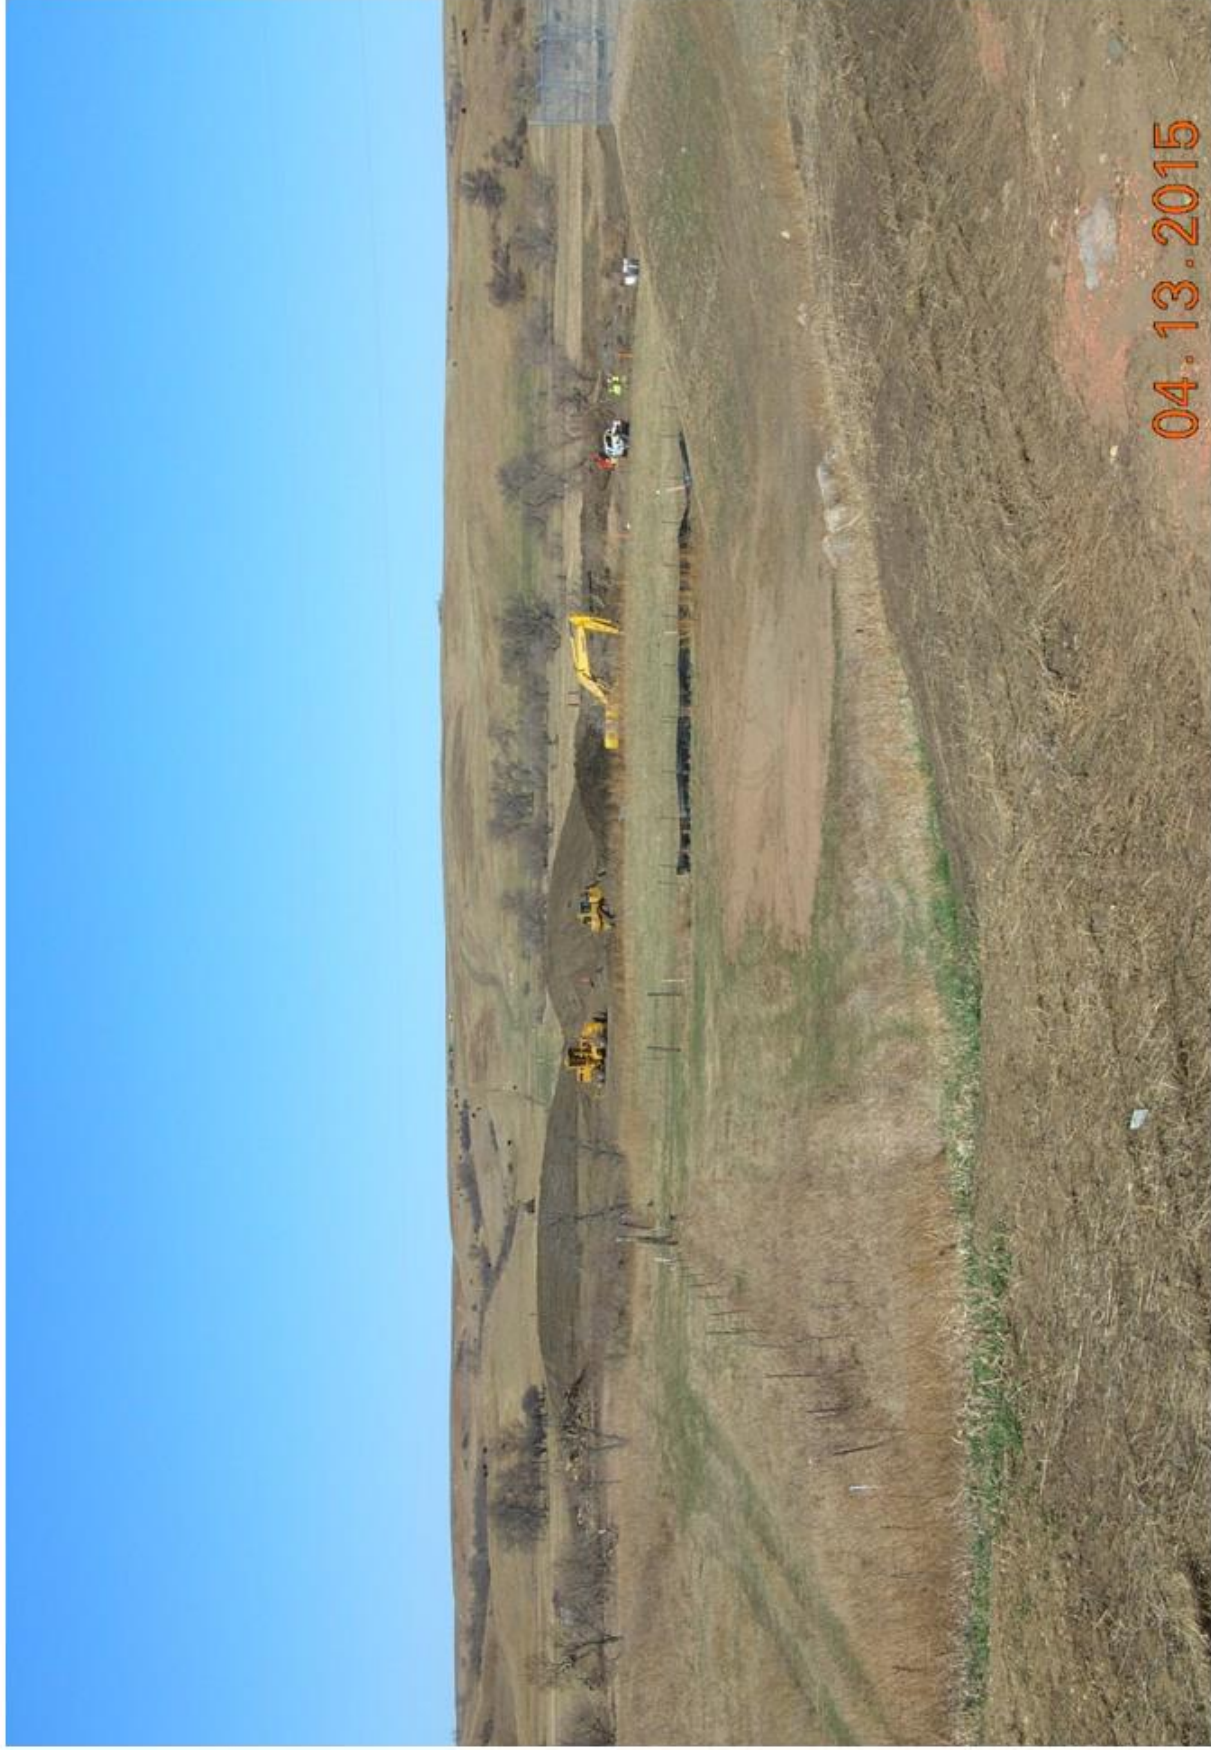
**Figure 3. SPGM removal for a four-acre segment of the Shop Access Road on both sides of Coyote Creek with a temporary topsoil stockpile in left background and a temporary subsoil stockpile in middle background – facing west with fence line in center-west marking the section line common to Section 30 on right (north) and Section 31 on left (south) – photograph taken south of large white hoop building pictured in right background in Figure 1**

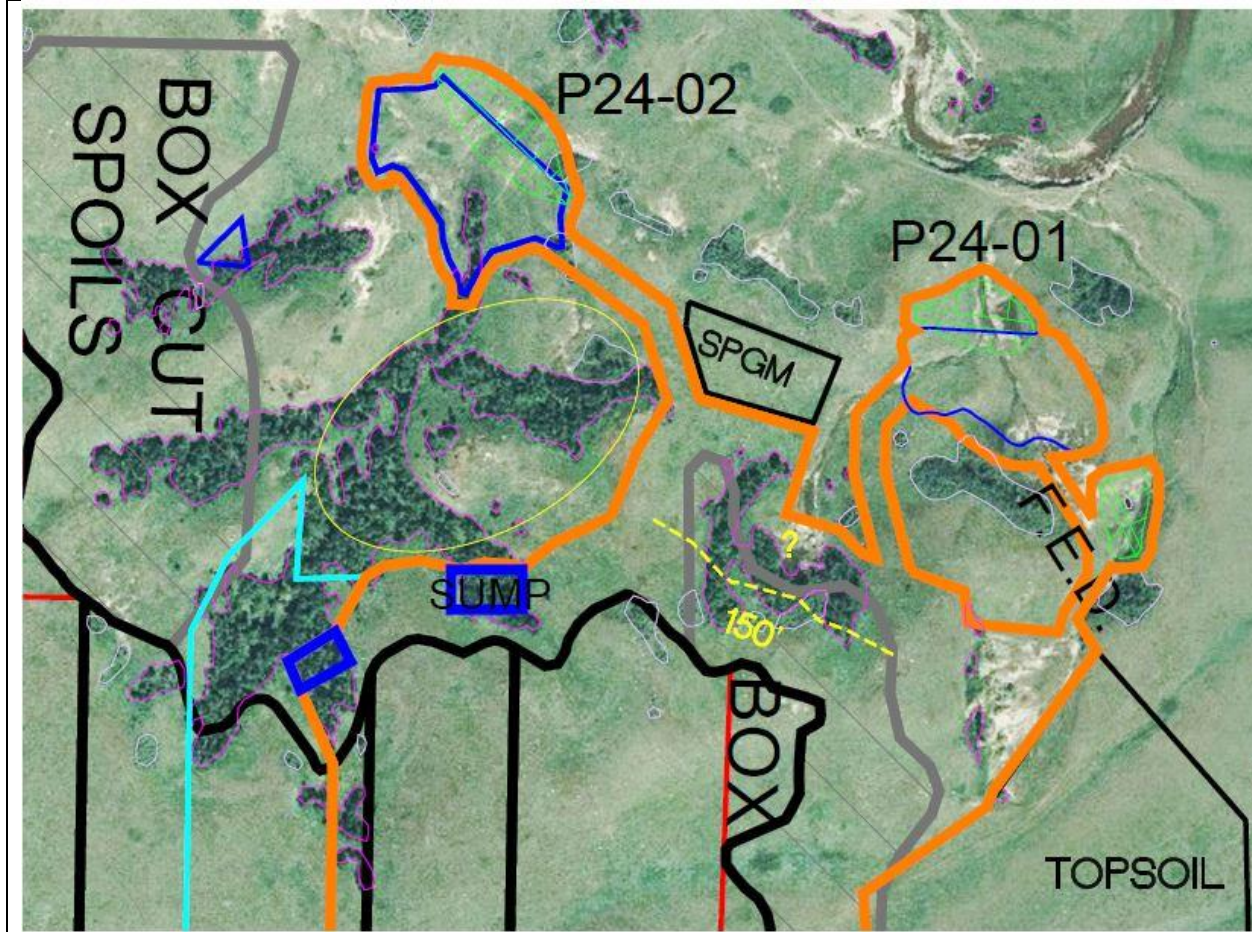
Figure 1: SE1/4 of Section 24

It appeared that perhaps an acre or less of woodlands would be disturbed in the SE1/4 of Section 24 if appropriate measures are taken to avoid woodlands in this area in 2015. Numerous photographs were taken and are on file with the Reclamation Division.

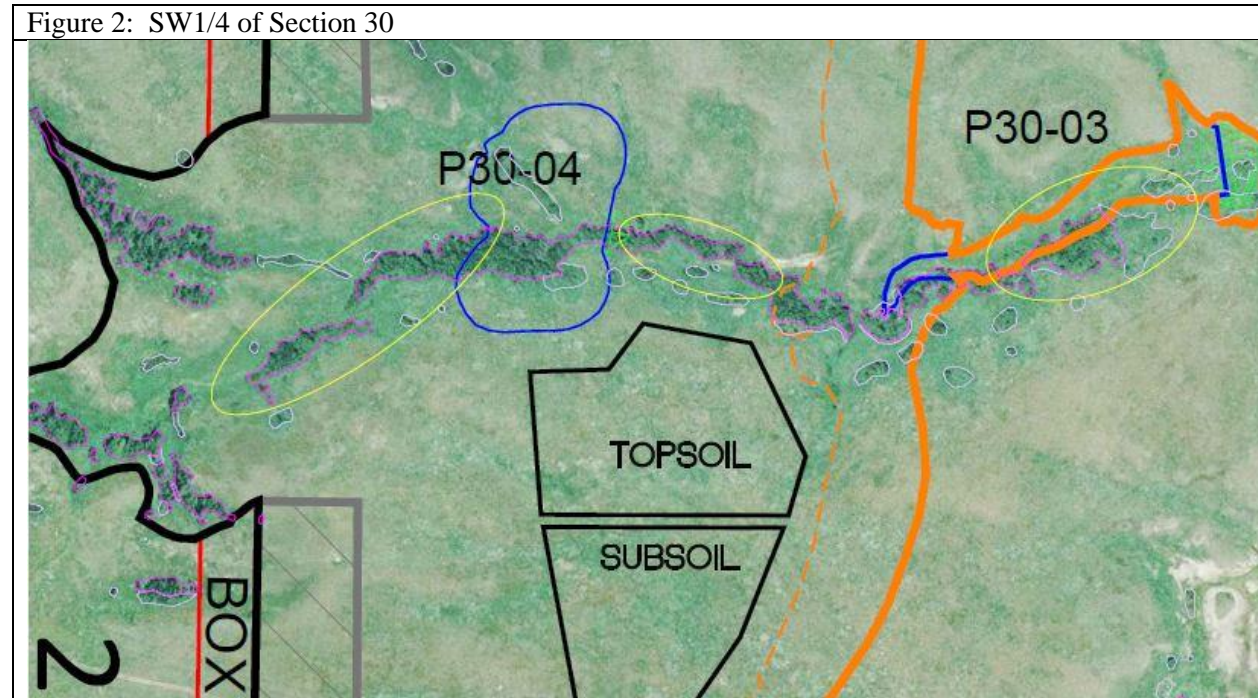
The drainage way between the haul road and pond P30-03 was not inspected. Although not discussed during this inspection, it is not clear to the Reclamation Division if this pond is necessary since the

stockpiles originally planned east of the haul road are no longer going to be placed on that side of the road. In addition, Coyote Creek has verbally indicated that they are no longer planning to mine the federal coal in Section 30 which should free up room for stockpiles. This issue should be further reviewed with pending Revision 1 to NACC-1302. Figure 2 is the map that was provided for the review of this area.

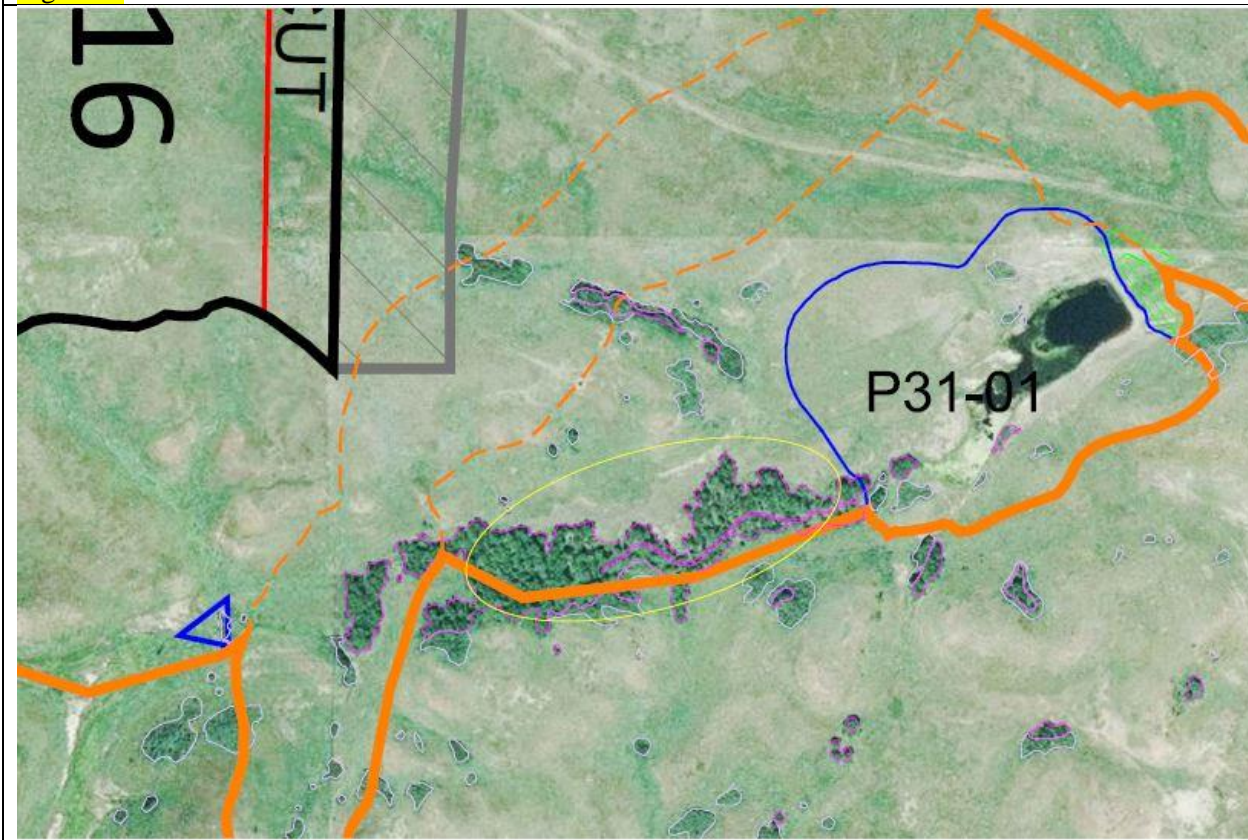
**Figure 3:** NW1/4 of Section 31.

Woodlands associated with the drainage above pond P31-01 were inspected. Very little woodland acreage will be disturbed for construction of the pond (a fraction of an acre), but the drainage above the pond is quite heavily wooded. Most of the woodlands above this pond are identified as an area that will be avoided but the west end of the drainage is to be affected by the haul road. Given the size of the watershed above this pond it was discussed that perhaps runoff should not be allowed to pass through the undisturbed wooded drainage way. It appeared that this could be accomplished by a ditch block and the construction of a diversion that could be located along the north side of the drainage. Figure 3 is the map that was provided for the review of this area.

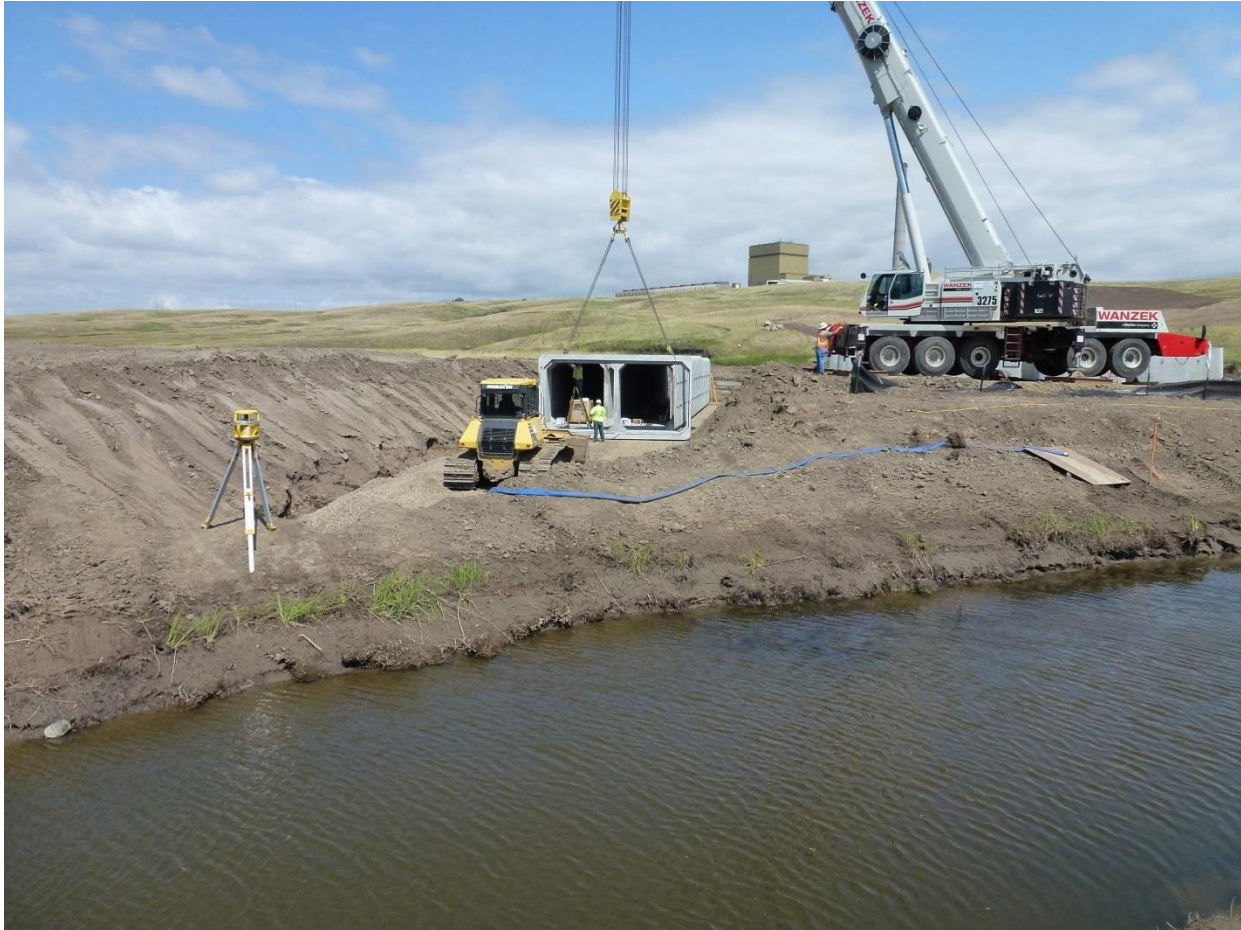
## Brush Creek box culvert installation

In the SE1/4 of Section 10, a contractor (Wanzek Construction Inc.) was installing the box culvert at the Brush Creek haul road crossing. At the time of the inspection it appeared that about half of the precast sections had been set. Large rock had been placed around the low flow culvert outlet and it appeared some additional rock would be placed at the outlet. The inlet and outlet ends of the low flow culvert were completely submerged. A low rate of flow was observed in the Brush Creek channel downstream of the culvert.

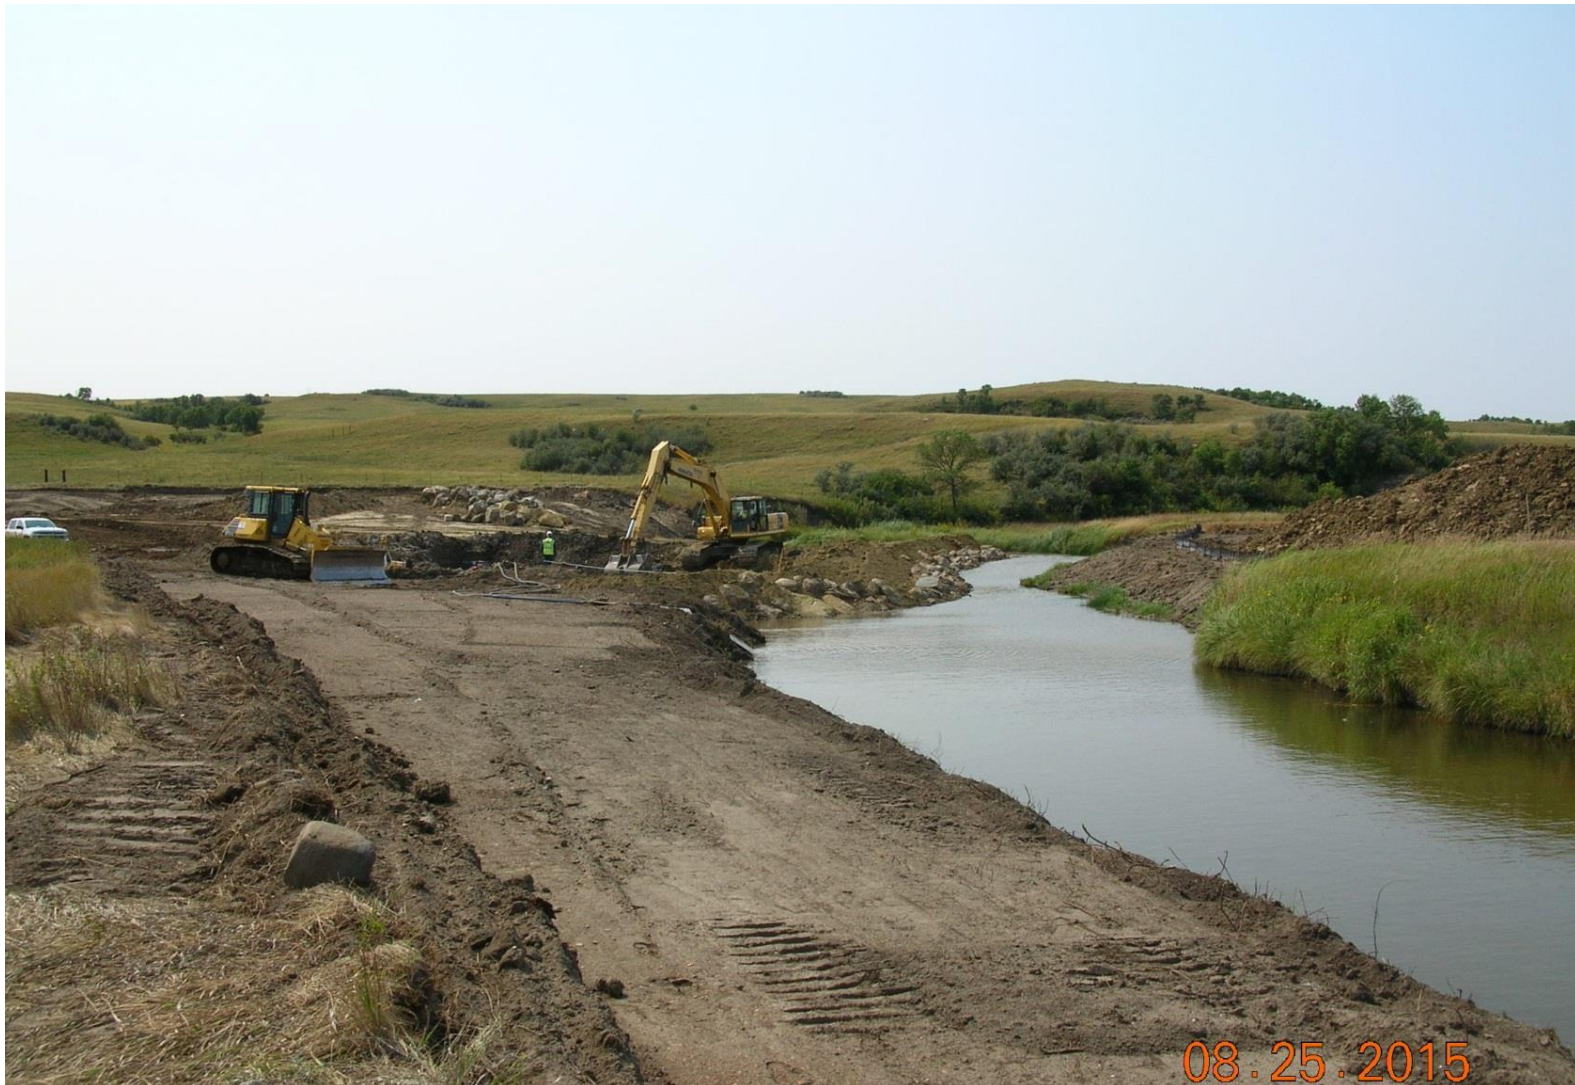
Permit NACC-1302: The PC400 shovel was excavating the box culvert trench along the south side of Coyote Creek for the north-south haulroad creek crossing in the SW¼ of Section 19 as pictured in Figure 1.

**Figure 1. PC40 shovel excavating the box culvert trench along the south side of Coyote Creek for the north-south haulroad creek crossing in the SW<sup>1</sup>/<sub>4</sub> of Section 19 – facing west-southwest.**

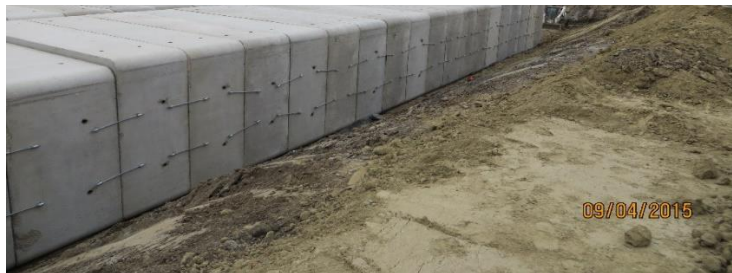
Wanzek Construction, Inc. has nearly completed the box culvert installation at the second Coyote Creek crossing in the SW1/4 of Section 19. A shallow sump pump was placed on the downstream (west) side of the culvert installation area and was discharging an estimated 8-10 gpm to Coyote Creek and an energy dissipater was in place at the discharge outfall.

### **Coyote Creek culvert installation – SW1/4 of Section 19 (looking northeast)**

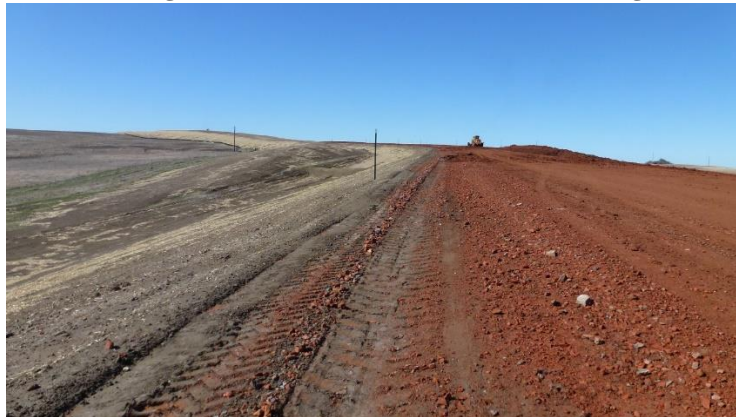
A contractor was repairing a water line leak near the water load-out station at the coal handling facility. The drainage channel from the water load-out station to pond P10-01 will need to be reshaped and stabilized. The erosion and sediment controls along the haul road were reviewed and appeared to be mostly unaffected by the recent low intensity rains. A few areas requiring maintenance or adjustment of the control measures (BMP's) were identified and discussed. A small rill was forming in the ditch up gradient of the erosion control blanket near haul road discharge #11 in the SW1/4 of Section 8. Sediment removal was needed from the sump outlet at haul road discharge #12 in the NE1/4 of Section 18. A small area below the silt fence outlet needs to be revegetated at haul road discharge #14 in the SW1/4 of Section 18.

#### **Haul road and drainage ditch in the NE1/4 of Section 18 looking to the southwest**

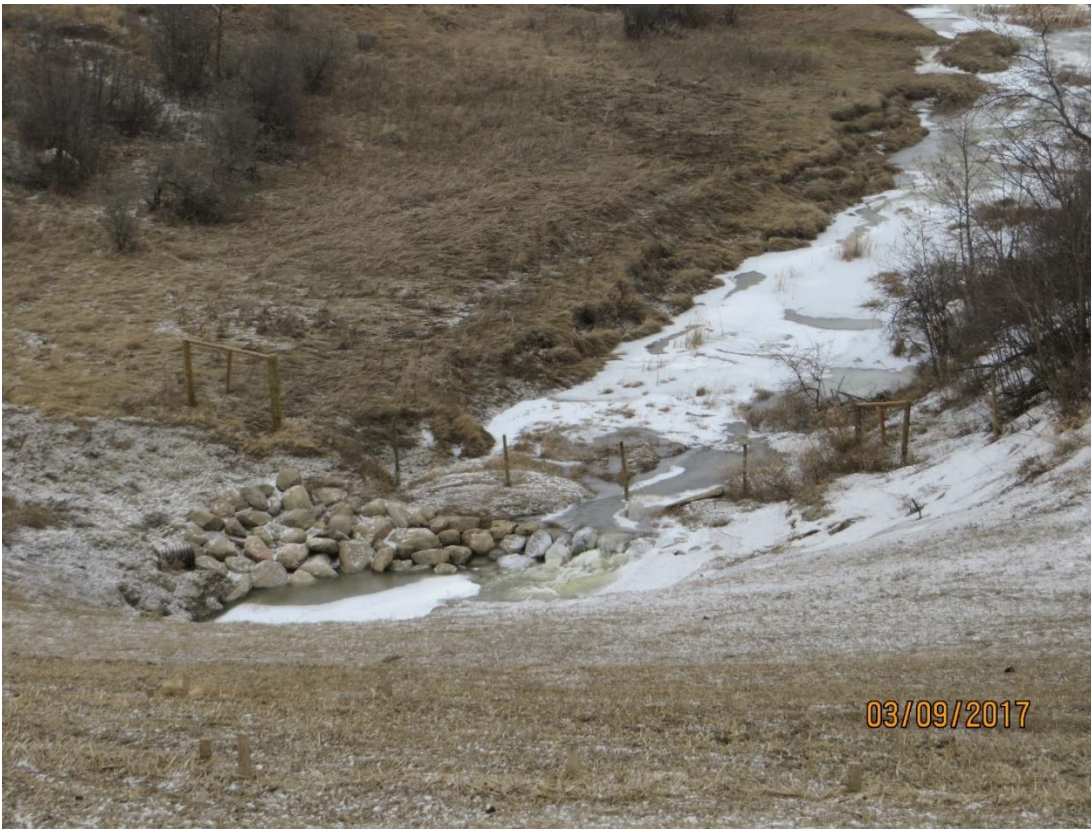
**Figure 1. DWC discharge through Section 18 drainage**

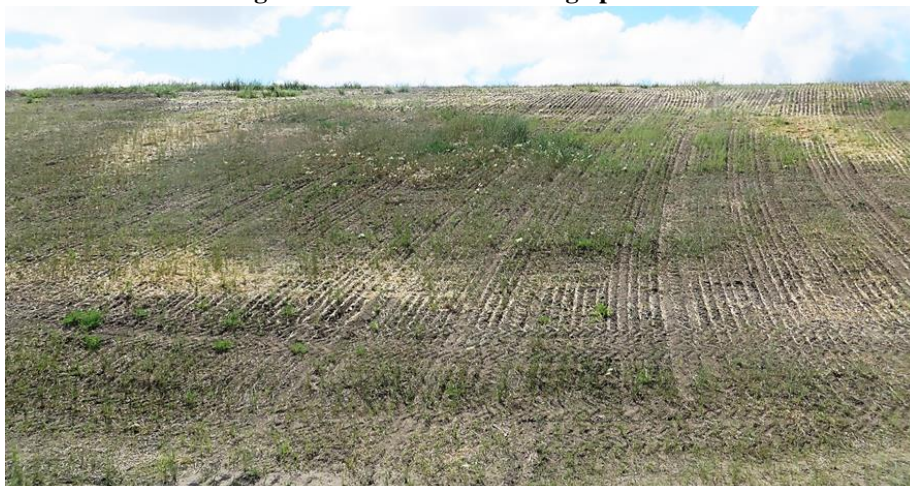
but the grass stand is thin even where establishment is the best. Most of the ditches and slopes associated with the haulroad north of County Road No. 12 were reseeded with a mixture of slender wheatgrass, sand dropseed, western wheatgrass and switchgrass and seeding was nearly complete. The ditches and slopes were seeded perpendicular to the previous seeding and the road rather than parallel. The operation did not appear to have affected or drastically disturbed the soil surface and the established vegetation was continuing to grow as shown in Figure 1.

**Figure 1: Haul road reseeding operation**

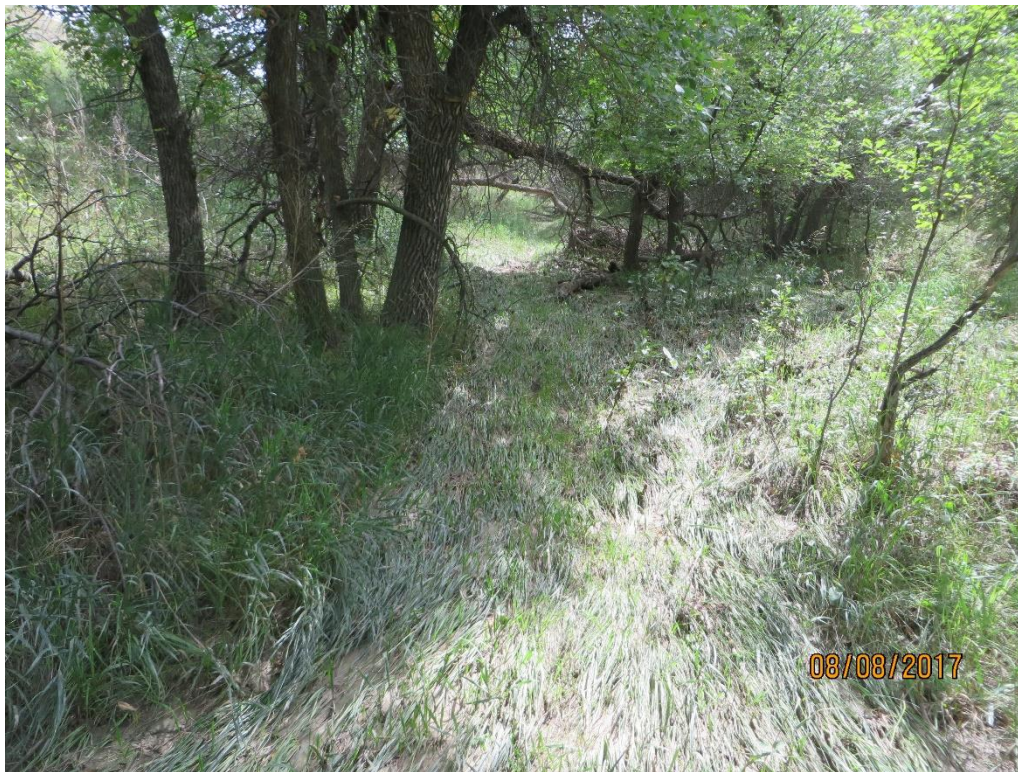
A couple of containment sumps were constructed last year along the north end of active operations in the SE1/4 of Section 24 in an effort to protect the wooded draw leading to sediment pond P24-02. During permit review and at the request of the Reclamation Division, Coyote Creek Mine agreed to not remove any SPGM or trees or otherwise disturb the wooded draw. The stripped areas south of the headwater drainages to pond P24-02 had also been reinforced with silt fences behind the sumps. A thunderstorm during the past week had provided enough water to overwhelm the furthest east sump and a small amount of sediment-laden water had breached the silt fence, resulting in basically a thin crust of sediment as can be viewed in **Figure 1**. Coyote Creek Mine was unaware of the minor breach prior to today and Mr. Barth said that clean-up operations would commence immediately, likely with wheelbarrows. If operationally feasible within the tight working quarters of the sump locations, Coyote Creek should make an additional effort to increase the size of the sumps and reinforce the existing silt fence, possibly with two rows of silt fence.

**Figure 1.**  
**Drainage above sediment pond P24-02, view is to the northwest**

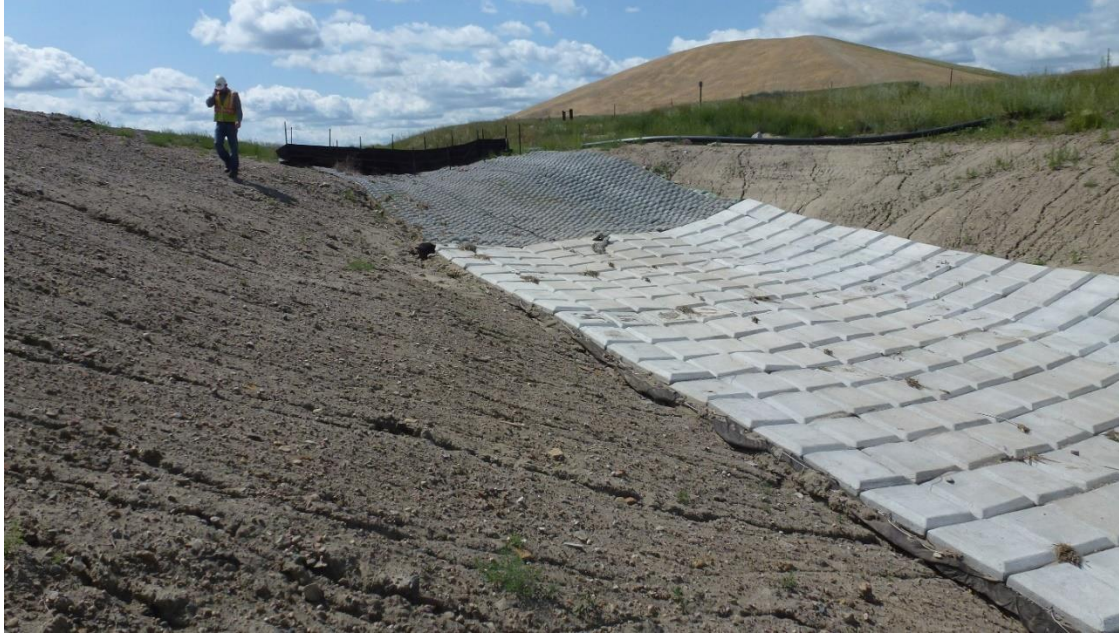
The erosion and sediment controls along the haul road north of the Coyote Creek crossing in Section 19 were briefly viewed. The combination of established plant cover and other erosion and sediment controls along the haul road appeared mostly effective in controlling erosion from recent rain events. However, sediment clean-out and other adjustments are now needed at several locations. Coyote Creek crews had started clean-out and silt fence repairs near the Brush Creek box culvert area. Sediment removal is needed at silt fences and sumps in the following locations: the south side of the haul road at the tributary crossing in the SW1/4 of Section 10, the western-most of the three culverts in the SE1/4 of Section 9, the culvert outlet area in the SW1/4SW1/4 of Section 8, and the culvert outlet in the SW1/4NE1/4 of Section 18. In addition, the cable concrete mat installed in the southwest quadrant of the Section 19 culvert crossing had settled and an erosion rill had formed along the east side of the mat. The erosion appeared to have been partly the result of water flowing around the silt fence installed above the erosion control matting. We agreed that the repairs and erosion control installation should be completed as soon as possible at this haul road ditch outlet to Coyote Creek.

**Haul road outlet to Coyote Creek in the SE1/4 of Section 19**

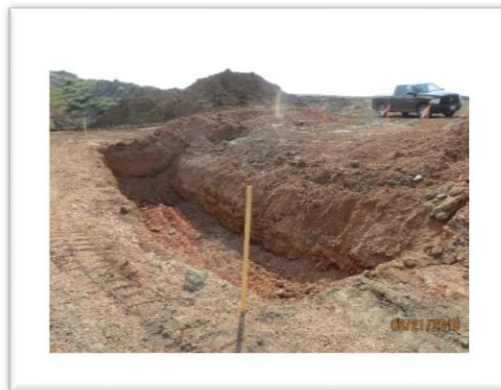
**Figure 1. Newly constructed sump between existing sumps No. 1 and 2  
View is toward the east**

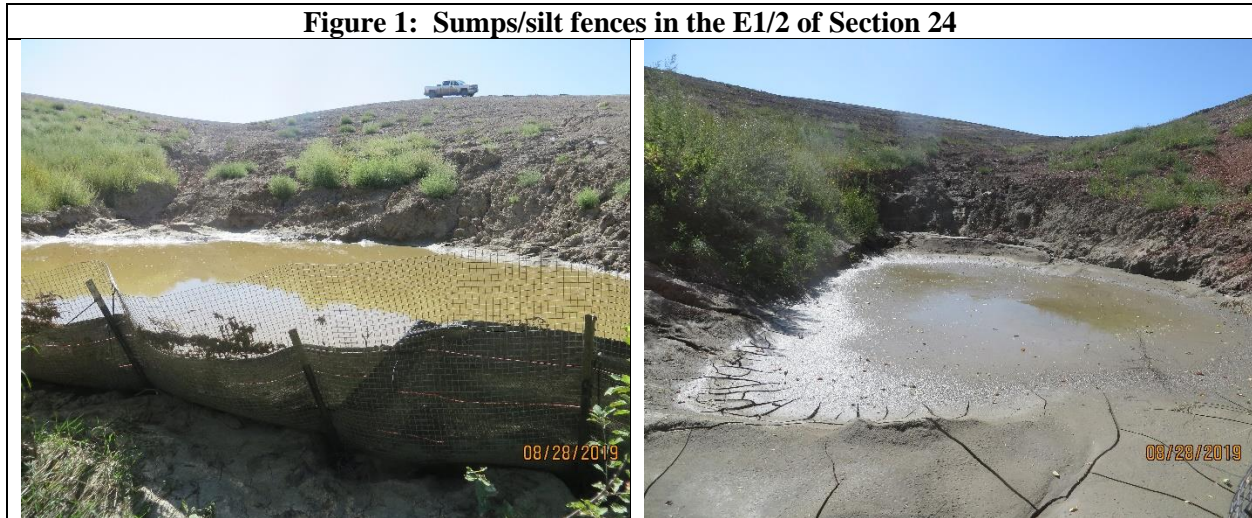
**Figure 1**

the two inspected sumps at the disturbance boundary need maintenance. Sediment has accumulated in these sumps and the silt fence of one sump is bent over from the force of water from a runoff event.

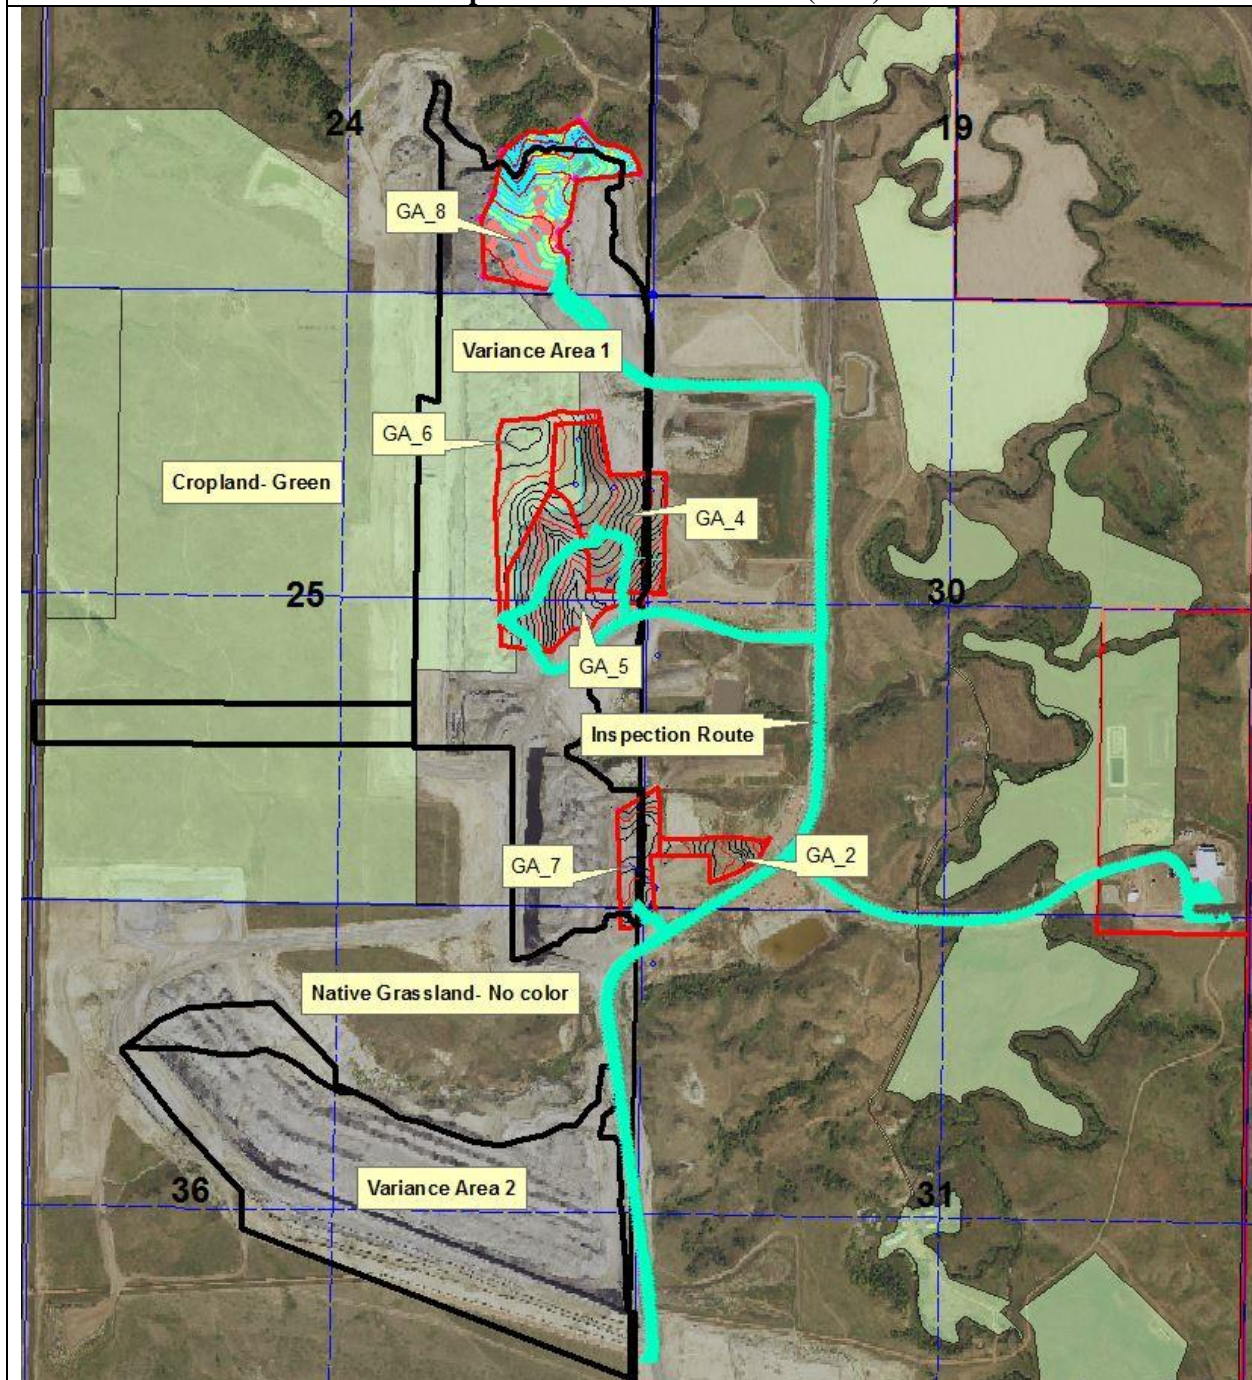
Grade approved areas that have been respread with subsoil and topsoil in the E1/2 of Section 25 and the SE1/4 of Section 24 were inspected. This included portions of grade approvals COY\_004, COY\_005, COY\_007 and COY\_008. Grade approval COY\_004 was respread with topsoil in 2018 and the other grade approvals were respread with topsoil in 2019. Rocks are generally picked after topsoil-respreading operations have been completed and the approved seed mixture or a temporary cover crop is then planted to protect the soil from erosion. Mulch may be applied and crimped into the soil surface if topsoil-respreading operations are completed outside of the growing season. The post-mining land uses within these grade approvals are cropland and native grassland. Narrative in Permit NACC-1302 allows CCMC to delay planting native grasslands for a year or more to control invasive non-native perennial grasses. Figure 1 below, depicts the grade approval areas and the route traveled during this inspection.

**Figure 1: Variance Areas 1 and 2 (outlined in Black), grade approvals (outlined in Red) and inspection route on 10/1/2019 (Blue)**
