Reclamation and Revegetation Inspection Report

Denbury 12" Cedar Hills CO2 Pipeline
Denbury Green Pipeline- North Dakota, LLC

ND PSC Case No. PU-19-294

November 2023

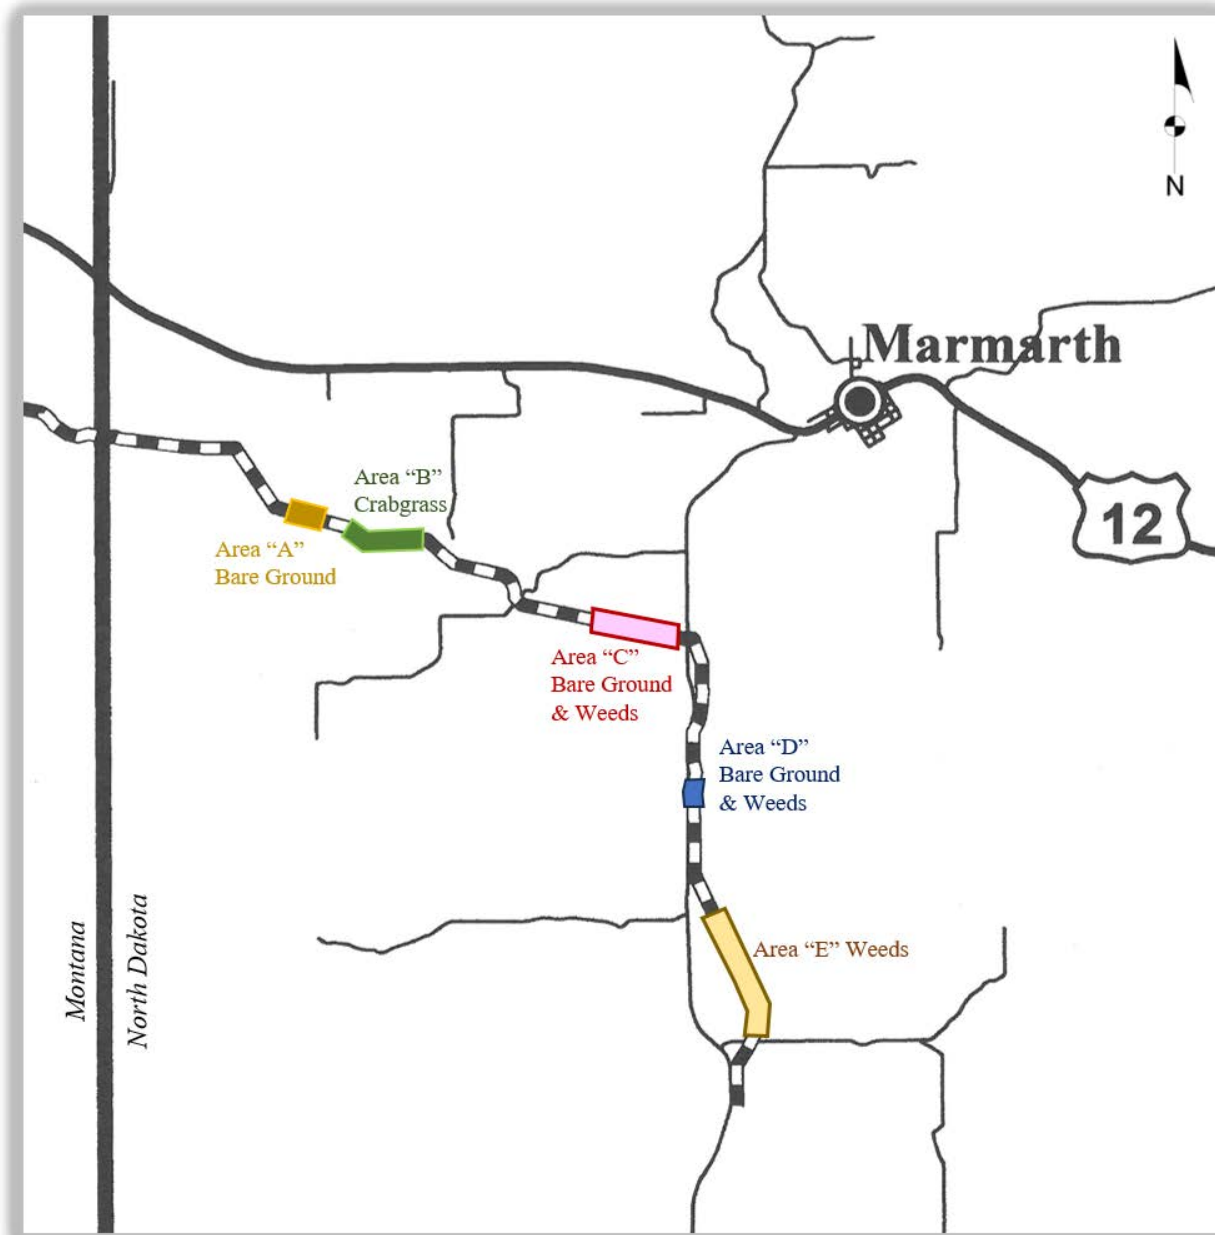
Area "C" 46° 16' 5" N, 103° 57' 3" W to 46° 16' 8" N, 103° 57' 22" W

Approximately 0.5 miles long, based on historical photographs soils in this area probably tight clays to the point holds water on a regular basis but without organic matter to support vegetative cover. The pre-construction condition of the site must be considered when setting expectations for reclamation and revegetation. So not expectedly, no vegetative cover exists in most areas, and what exists is largely weeds of one type or another.
