PU-19-368
ONEOK Bakken Pipeline, L.L.C.
Tioga Lateral NGL Pipeline
Reclamation Inspection Report

File No. 227701547

August 2022

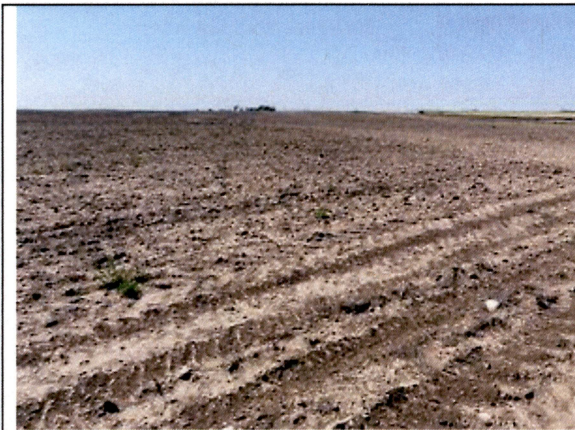
Observation Point: 1

Photo Description: 8-in of topsoil replaced over subsoil. Area is well graded and minimal stone cover. Matches existing land

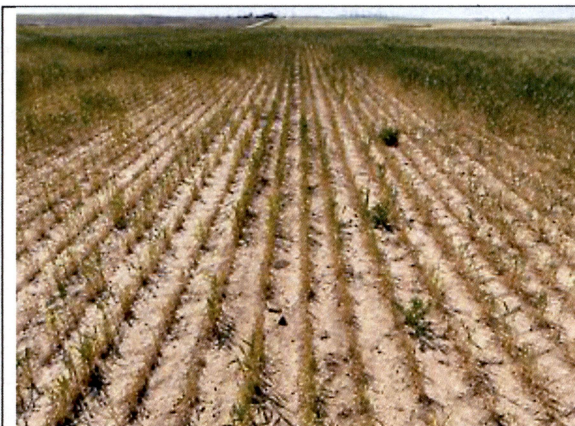
Observation Point: 3

Photo Description: Commonly stressed and stunted wheat compared to non-disturbed area. The right of way is relatively thin but is compacted. Erosion and bare soil is observed to the east. Minimal weed cover.

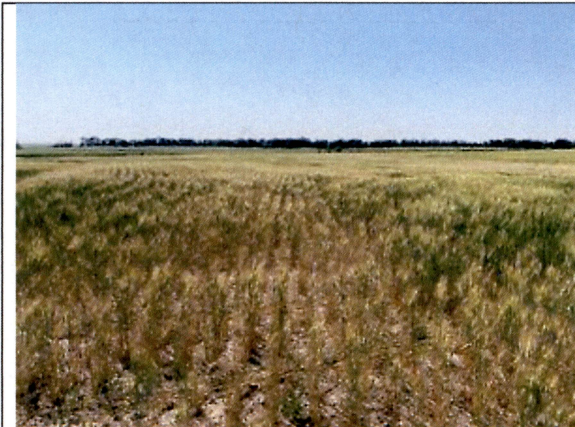
Observation Point: 5

Photo Description: Wheat is slightly more stressed than surrounding plants but does not contain invasive weeds. Soil in appropriate condition. Overall reclamation is satisfactory.

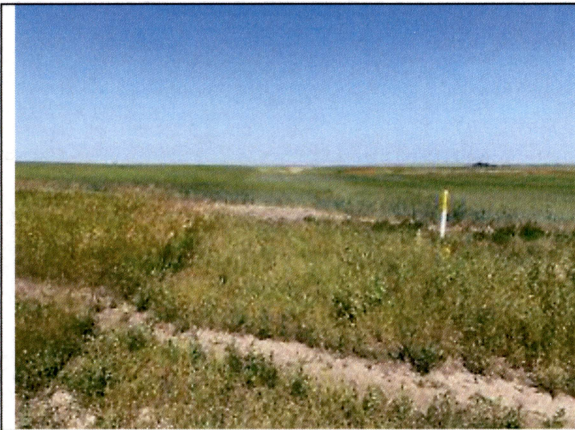
Observation Point: 6
Date Taken: August 1, 2022 4:28 PM
Direction Photo is Taken:
Land Use: Cropland

Photo Description: Comparable wheat stand compared to undisturbed cropland.

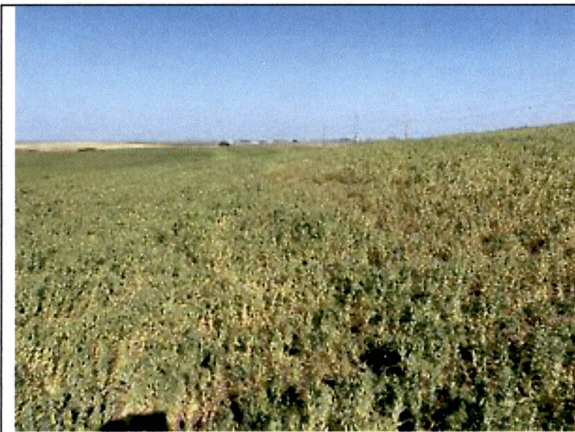
Observation Point: 7
Date Taken: August 1, 2022 6:05 PM
Direction Photo is Taken: East
Land Use: Cropland

Photo Description: Excellent field pea growth. Stand density and height appears consistent with undisturbed areas in the reclaimed right of way.

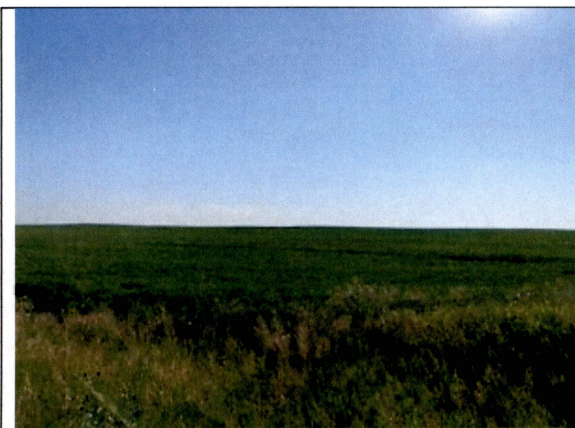
Observation Point: 8
Date Taken: August 1, 2022 6:15 PM
Direction Photo is Taken: West
Land Use: Cropland

Photo Description: Pea field that is reclaimed has 90% cover and is comparable in height and density to undisturbed cropland.

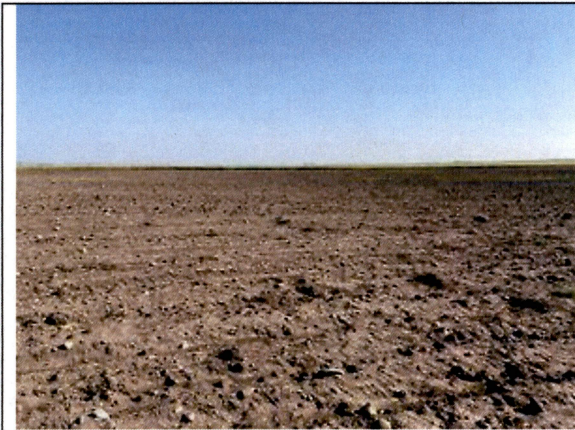
Observation Point: 9

The soil in most cropland appeared to have been adequately replaced and was matching existing topography (**Appendix A; Observation Points 1, 9, 18**). However, one soil observations contained little-to-no topsoil mixed with subsoil (**Observation Point 4**). The reclaimed area was also compacted, which appeared to impact crop growth. Soil reclamation issues were also noted at **Observation Points 29, 35, 39, 45, 57**, where subsidence was negatively impacting crop growth, and erosion at **Observation Point 14 and 25**. Lastly, woody debris, possibly from pipeline installation activities, was present at **Observation Point 28**, and may need to be addressed. Populations of annual weeds, predominantly kochia (*Bassia scoparia*), were common in the portions of low crop vigor in the ROW, but were overall not a concern.

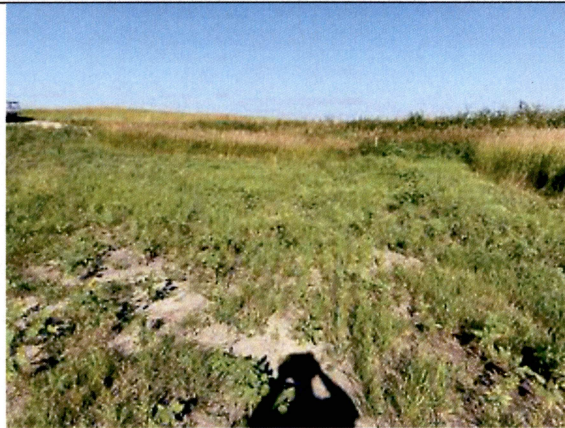
Observation Point: 10

Canada thistle had been previously observed in rangeland, and some as-built inspection observations points were reinspected. At **Observation Point 10, 41, and 53 (Appendix A)**, Canada thistle was observed to be recently mowed, which demonstrates compliance with PSC Order Provision #21.

Photo Description: Canada Thistle is being controlled since last inspection. Additional chemical or mechanical treatment recommended to remove population from the right of way. More desirable vegetation is establishing and trending toward successful reclamation.

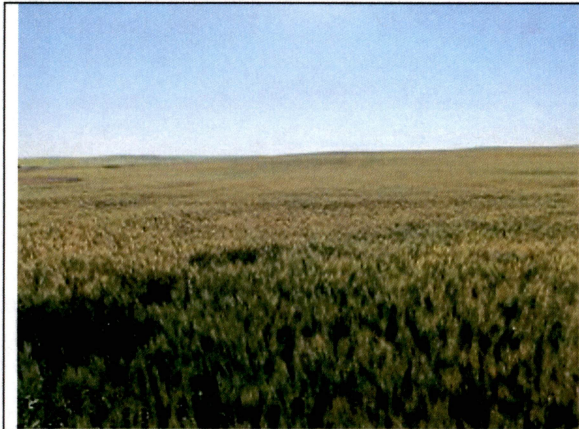
<p>Observation Point: 12 Date Taken: August 1, 2022 6:32 PM Direction Photo is Taken: Land Use: Cropland</p> <p>Photo Description: Very good wheat growth. Successful reclamation achieved.</p> <p>Latitude: 48.30055909 Longitude: -103.7133518</p>
---	---

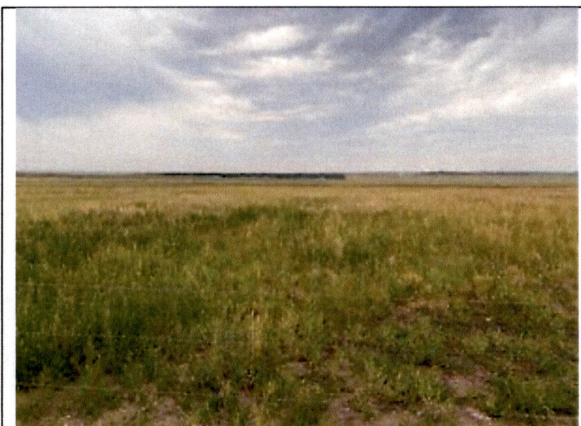
<p>Observation Point: 17 Date Taken: August 2, 2022 8:20 AM Direction Photo is Taken: West Land Use: Rangeland</p> <p>Photo Description: Desirable seeded grasses common. Meets PSC order for successful reclamation.</p> <p>Latitude: 48.30586267 Longitude: -103.58318542</p>
---	--

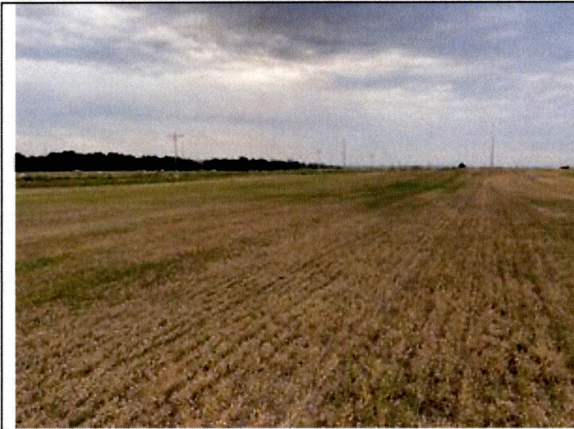
Observation Point: 18

Photo Description: Topsoil replaced well and harvested grain is consistent with surrounding area. No debris observed in right of way from last inspection.

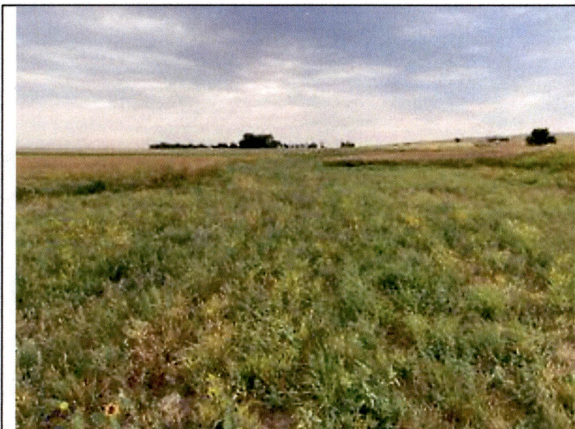
Observation Point: 21

built containing Canada thistle (*Cirsium arvense*) were observed to be being properly controlled (**Observation Point 21**). However, one area with a prevalence of Canada thistle were noted (**Observation Point 57**).

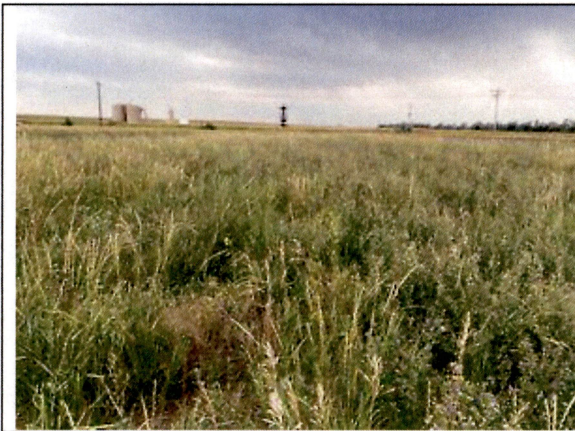
No soil mixing was observed by Stantec in hay land. However, a minimal area of subsidence was observed in hay land at **Observation Point 44 (Appendix A)**. **Observation Points 23 and 32**, were dominated by Kochia and prickly Russian thistle (*Salsola tragus*) while the surrounding area contained alfalfa, and was not being hayed by the producer unlike the surrounding area. Overall, areas from the as-

Observation Point: 23
Date Taken: August 2, 2022 9:23 AM
Direction Photo is Taken: South
Land Use: Hay Land

Photo Description: Landowner not haying ROW. Soil reclaimed moderately well, regrading is appropriate. Kochia and Prickly Russian thistle throughout hayfield. Alfalfa and western wheatgrass present.

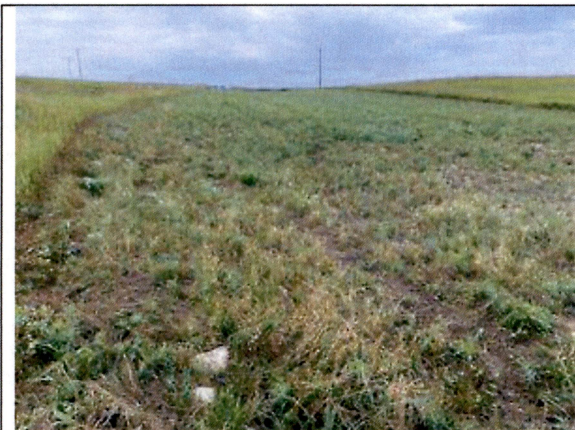
Observation Point: 24
Date Taken: August 2, 2022 9:37 AM
Direction Photo is Taken:
Land Use: Rangeland

Photo Description: Treatment of leafy spurge evident. Right of way is being mowed and contains BMPs. Overall nearing reclamation goals.

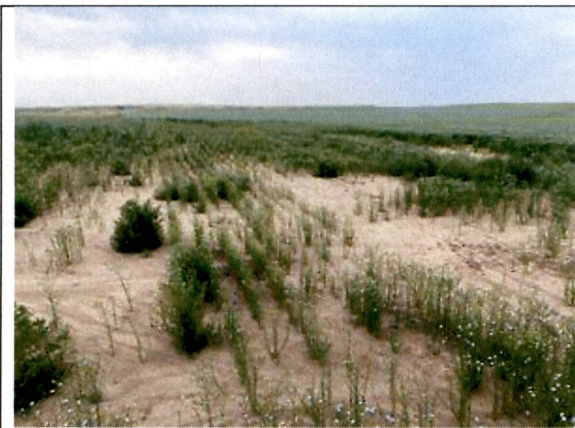
Observation Point: 25
Date Taken: August 2, 2022 10:17 AM
Direction Photo is Taken: South
Land Use: Cropland

Photo Description: Flax field stressed in the reclaimed right of Way. Moderate erosion but kochia cover is minimal. Otherwise reclaimed to a practicable level.

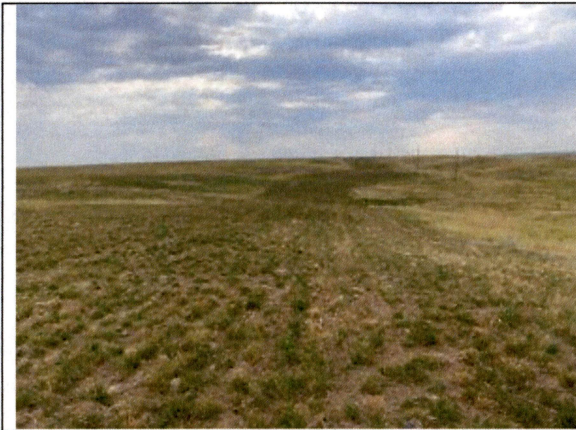
Observation Point: 27
Date Taken: August 2, 2022 10:26 AM
Direction Photo is Taken: East
Land Use: Rangeland

Photo Description: Successful revegetation with perennial grass. Contains some kochia but vegetative cover is adequate. ROW recently mowed.

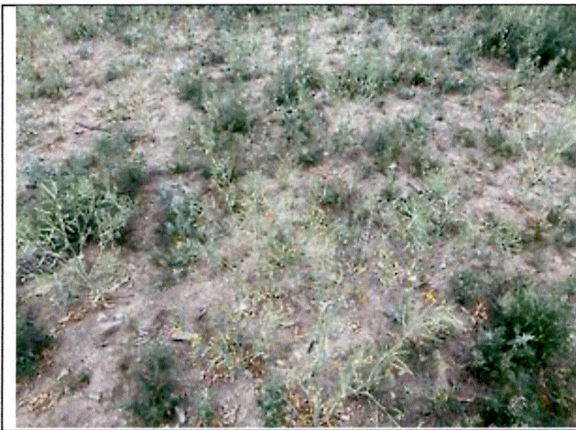
The Project ROW crosses numerous parcels of cropland, either bisecting or following the outer boundaries of the fields. Fields were under crop production including canola, lentils, field peas, flax, sunflower, and wheat. No visual grain yield estimate or stand height comparisons were made, however, the stand density and color of harvested grains within the ROW were observed. Overall, the physical characteristics of the crops in the reclaimed ROW were consistent to the surrounding, undisturbed land at **Observation Points 5, 6, 7, 8, 11, 12, 15, 26, 30, 34, 35, 36, 37, 43, 49, 51, 52, 54, 55, 56 (Appendix A)**. At **Observation Points 3, 11, 20, and 28**, crop growth was not consistent with the surrounding undisturbed areas, but may recover as time since reclamation increases. All cropland observations were trash and debris-free, except for **Observation Point 28**.

Observation Point: 28
Date Taken: August 2, 2022 10:44 AM
Direction Photo is Taken:
Land Use: Cropland

Photo Description: Woody debris common through reclaimed canola field. Land is well-graded, but canola growth is inhibited.

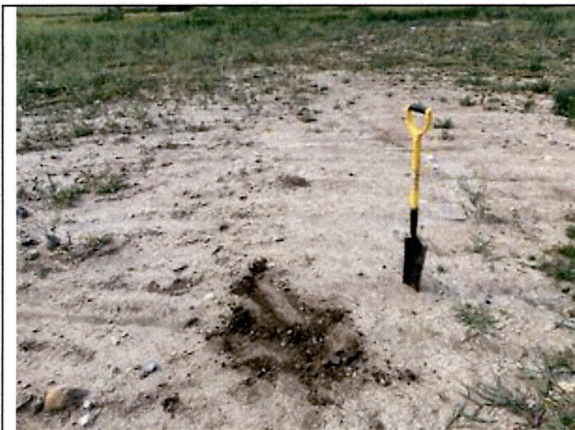
Observation Point: 29
Date Taken: August 2, 2022 10:49 AM
Direction Photo is Taken:
Land Use: Cropland

Photo Description: Severely compacted area poorly reclaimed area.

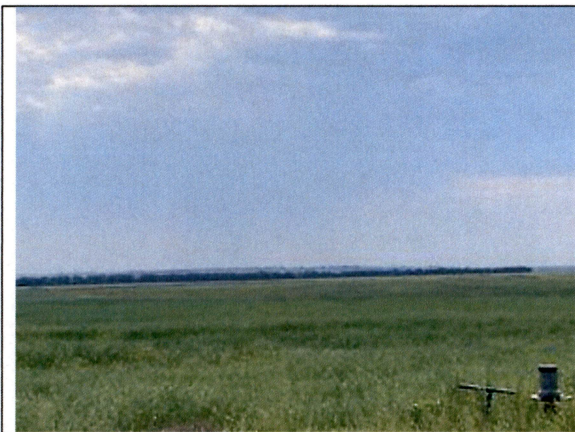
Observation Point: 30
Date Taken: August 2, 2022 10:52 AM
Direction Photo is Taken: East
Land Use: Cropland

Photo Description: Good canola growth.

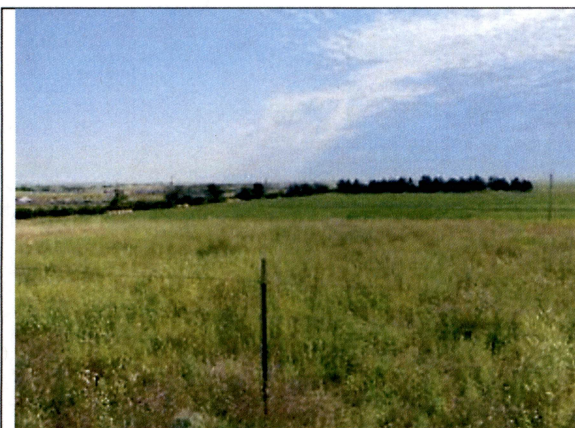
Observation Point: 31
Date Taken: August 2, 2022 11:00 AM
Direction Photo is Taken: Northeast
Land Use: Rangeland

Photo Description: Pipeline bored under Road. Reclaimed ditch and pasture contains some desirable species with good plant cover compared to undisturbed land and meets PSC provisions.

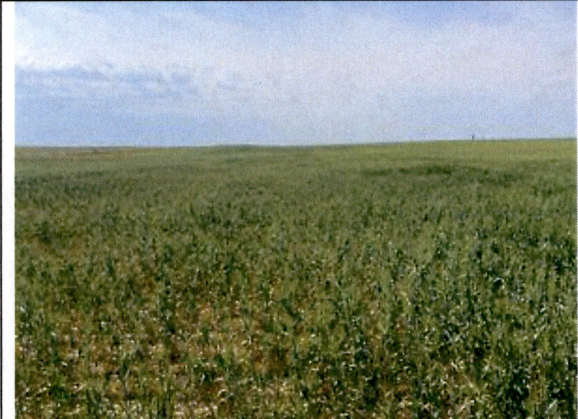
<p>Observation Point: 35 Date Taken: August 2, 2022 11:26 AM Direction Photo is Taken: South Land Use: Cropland</p> <p>Photo Description: Satisfactory wheat growth in reclaimed soil. Moderate signs of subsidence to south of photo point.</p> <p>Latitude: 48.26236571 Longitude: -103.26073829</p>
---	---

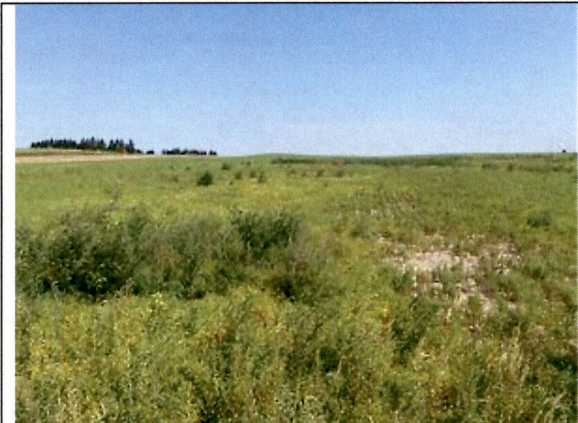
<p>Observation Point: 36 Date Taken: August 2, 2022 11:40 AM Direction Photo is Taken: North Land Use: Cropland</p> <p>Photo Description: Acceptable lentil coverage. Density is slightly less than the undisturbed areas, but overall healthy and suggest reclamation to a practicable level.</p> <p>Latitude: 48.28552535 Longitude: -103.25807076</p>
--	---

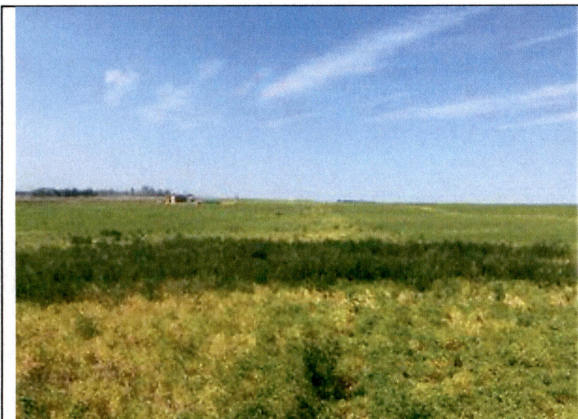
<p>Observation Point: 37 Date Taken: August 2, 2022 11:52 AM Direction Photo is Taken: West Land Use: Cropland</p> <p>Photo Description: Consistent lentil growth in reclaimed land.</p> <p>Latitude: 48.28627836 Longitude: -103.23815081</p>
---	---

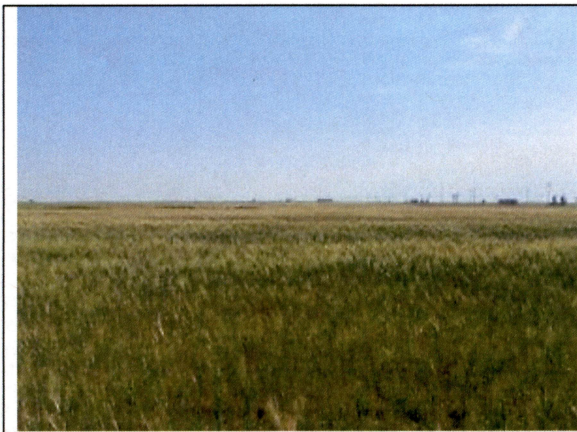
Observation Point: 39
Date Taken: August 2, 2022 11:58 AM
Direction Photo is Taken: East
Land Use: Cropland

Photo Description: Wheat growth in reclaimed ROW consistent. Slight depressions along the row suggest minor potential subsidence.

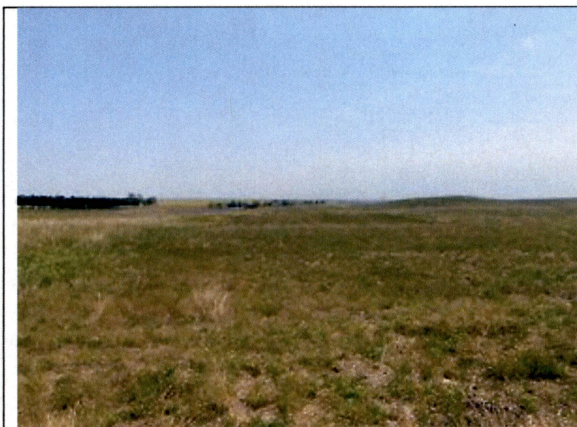
Observation Point: 40
Date Taken: August 2, 2022 12:09 PM
Direction Photo is Taken: East
Land Use: Rangeland

Photo Description: Seeded grass is emerging and growing. Annual weeds comprise minimal plant cover. Recently mowed.

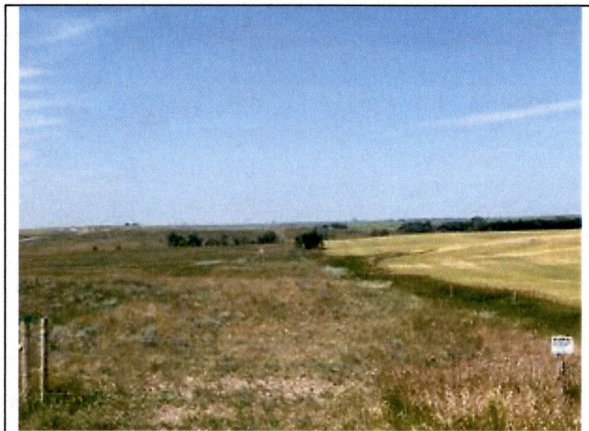
<p>Observation Point: 42 Date Taken: August 2, 2022 12:23 PM Direction Photo is Taken: West Land Use: Rangeland</p> <p>Photo Description: Well vegetated and reclaimed ROW.</p> <p>Latitude: 48.28782453 Longitude: -103.13080549</p>
---	--

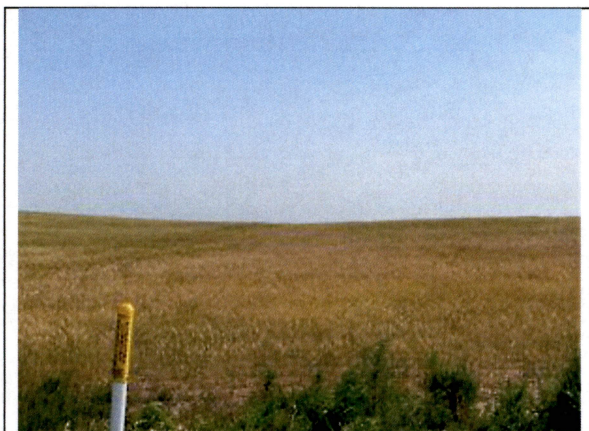
<p>Observation Point: 43 Date Taken: August 2, 2022 12:23 PM Direction Photo is Taken: East Land Use: Cropland</p> <p>Photo Description: Wheat growth in reclaimed ROW consistent with surrounding land.</p> <p>Latitude: 48.28786246 Longitude: -103.13056409</p>
--	---

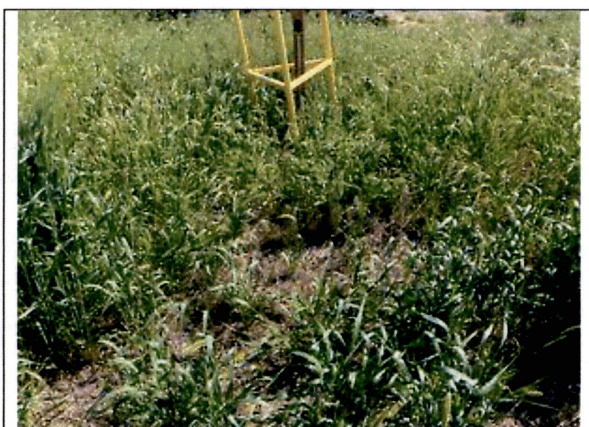
<p>Observation Point: 44 Date Taken: August 2, 2022 12:37 PM Direction Photo is Taken: Land Use: Hay Land</p> <p>Photo Description: Small area of subsidence.</p> <p>Latitude: 48.29909831 Longitude: -103.10911697</p>
---	--

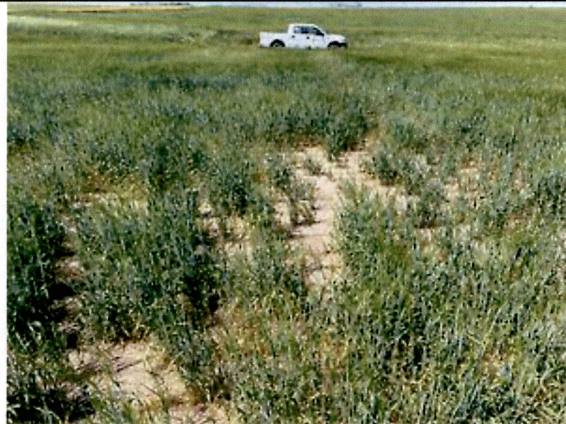
Observation Point: 45

Photo Description: Some subsidence present affecting crop growth. Majority of reclaimed ROW is in good condition. Recommend OneOK coordinating with landowner on addressing need for further reclamation measures.

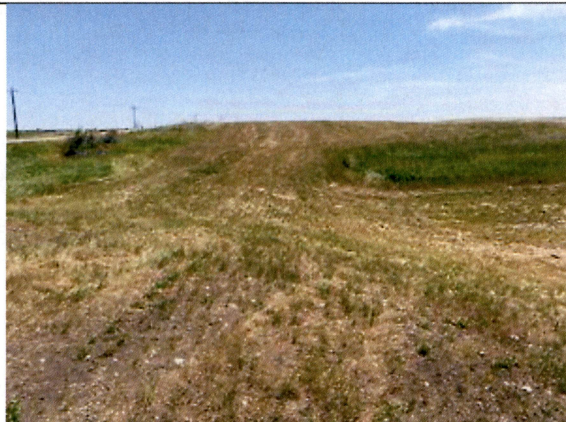
Observation Point: 47

Photo Description: Seeded vegetation throughout reclaimed ROW. Canada thistle to south of picture location and has gone to seed. Stantec recommends treatment of noxious weeds.

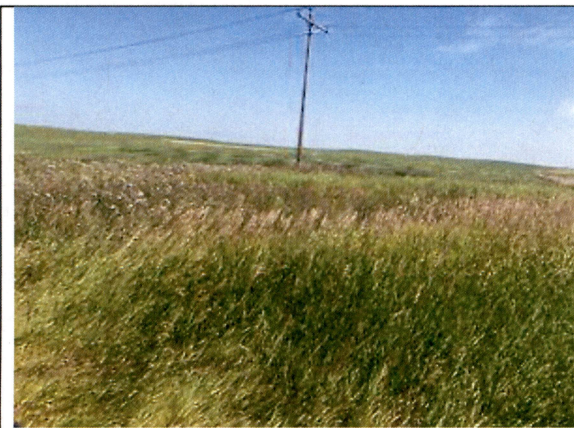
Observation Point: 50

Canada thistle and leafy spurge were the only noxious weeds observed during the inspection. Canada thistle was present at **Observation Points 2, 10, 41, 47, 50, 53, and 58 (Appendix A)**. All revisited observation points that contained Canada thistle had been controlled at least once, and only **Observation Points 15, 19 and 33** did not contain Canada thistle in 2022. However, **Observation Point 19** contained significant Leafy Spurge (*Euphorbia esula*) populations and control may be needed to be compliant. Canada thistle is a ubiquitous and prolific weed species in the region, and often requires multiple attempts to suppress.

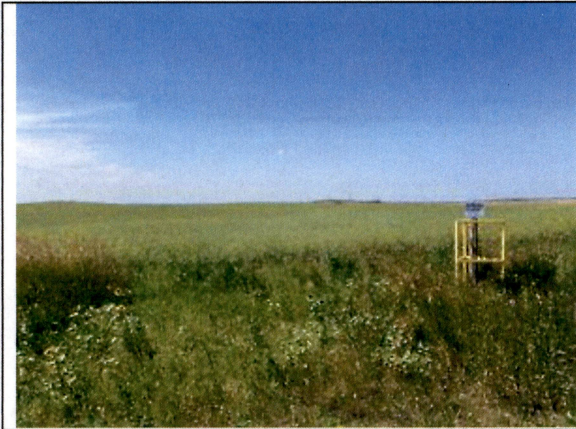
Observation Point: 51
Date Taken: August 2, 2022 1:46 PM
Direction Photo is Taken: West
Land Use: Cropland

Photo Description: Canola field consistent through reclaimed and undisturbed areas.

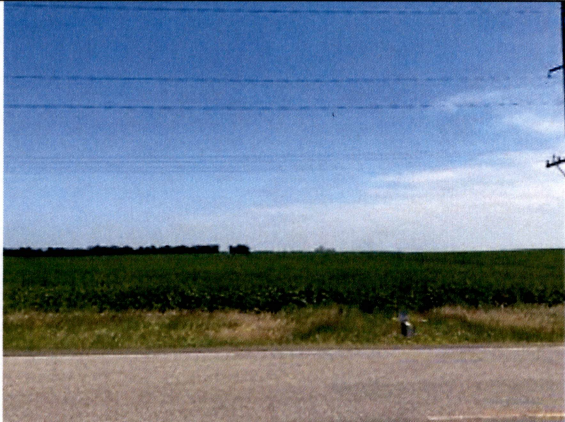
A photograph showing a wide, flat field of green sunflowers under a clear blue sky. In the foreground, there is a gravel or paved area. A utility pole is visible on the right side of the field.	<p>Observation Point: 54 Date Taken: August 2, 2022 2:09 PM Direction Photo is Taken: East Land Use: Cropland</p> <p>Photo Description: Sunflower stand is adequately growing in reclaimed HDD pad.</p> <p>Latitude: 48.36411511 Longitude: -102.9572682</p>
---	---

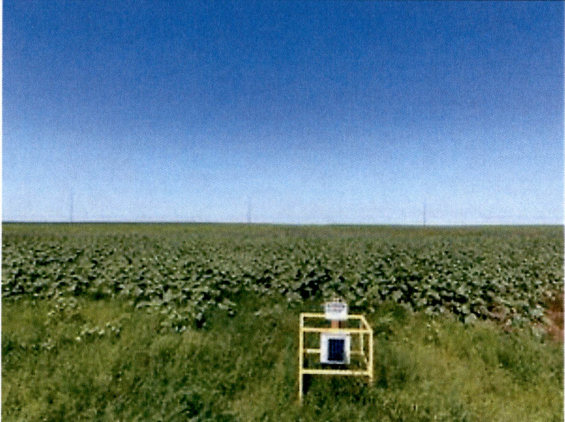
A photograph of a sunflower field with a yellow metal frame in the foreground. The sunflowers are in various stages of growth, and the sky is clear and blue.	<p>Observation Point: 55 Date Taken: August 2, 2022 2:21 PM Direction Photo is Taken: North Land Use: Cropland</p> <p>Photo Description: Healthy sunflowers in cropland ROW.</p> <p>Latitude: 48.35648304 Longitude: -102.94797911</p>
--	---

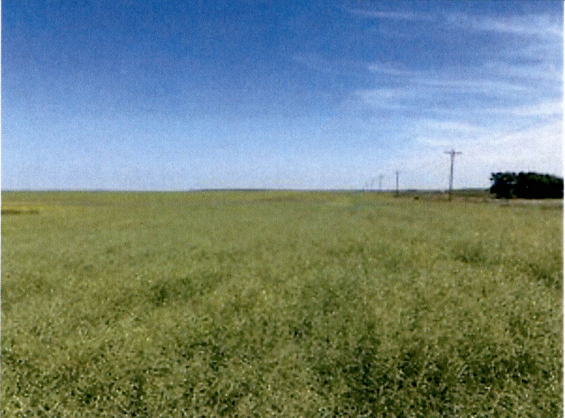
A photograph of a large, flat field of green canola plants. The sky is blue with some light clouds. A utility pole is visible in the distance on the right.	<p>Observation Point: 56 Date Taken: August 2, 2022 2:31 PM Direction Photo is Taken: East Land Use: Cropland</p> <p>Photo Description: Healthy canola stand with full pods in reclaimed ROW.</p> <p>Latitude: 48.37285138 Longitude: -102.91515848</p>
---	--

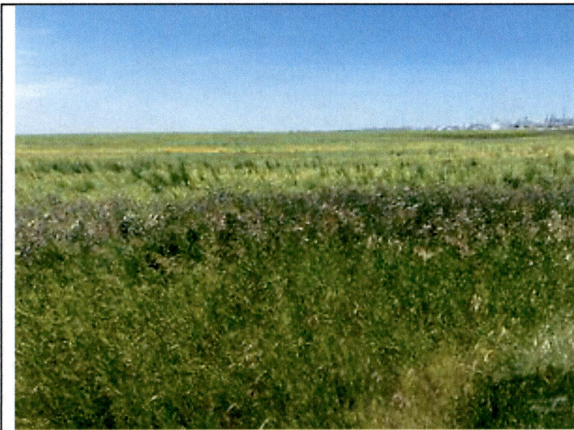
Observation Point: 58

Photo Description: Canada thistle cover. Stantec recommends

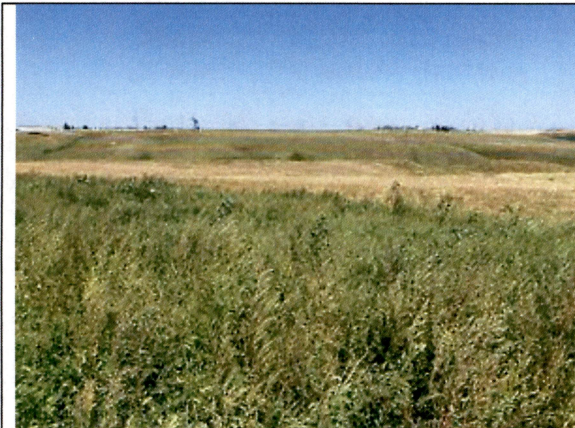
Observation Point: 61

Photo Description: Seeded perennial grass is coming in. Other plants include kochia, alfalfa, Lambsquarter, and wild sunflower. The reclaimed HDD and pipeline ROW is well graded with adequate topsoil replacement observed.
