# PU-19-368 Tioga Lateral NGL Pipeline Construction Inspection Report

*Prepared for:*  
**North Dakota  
Public Service Commission**

**WENCK Associates, Inc.**  
3303 Fiechtner Drive Ste 100  
Fargo, ND 58103  
Phone: 701-297-9600  
Fax: 701-297-9601

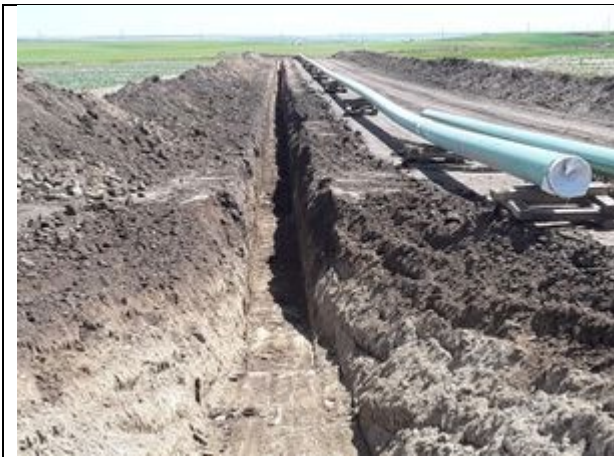
**Observation Point: 32**

Photo Description: Bottom of trench to top of trench measured 75".

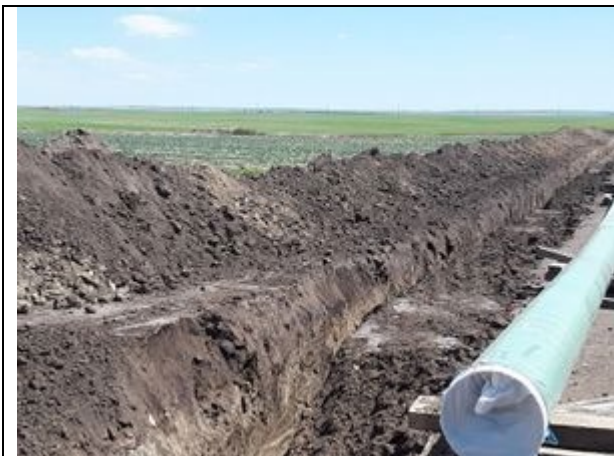
**Observation Point: 33**

Photo Description: Subsoil stockpile appears to have only traces of topsoil present in it.

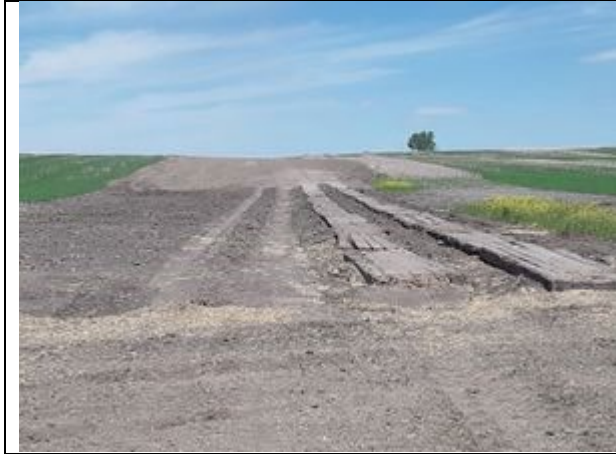
**Observation Point: 34**

Photo Description: Open cut through wet area not delineated as wetland, near delineated wetland. Topsoil spread and well graded. Timber matting used for driving access present.

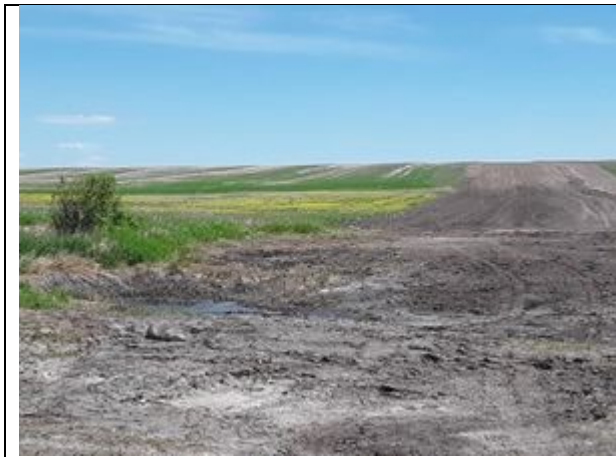
**Observation Point: 35**

Photo Description: Open cut through drainage. Topsoil spread and graded well to match existing topography.

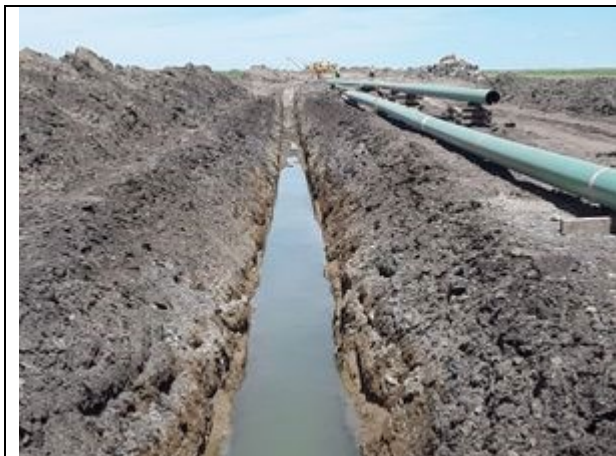
**Observation Point: 36**

Photo Description: Bottom of trench to top of trench measured 85". Stockpiles not well segregated along ROW and showed evidence of topsoil mixing with subsoil.

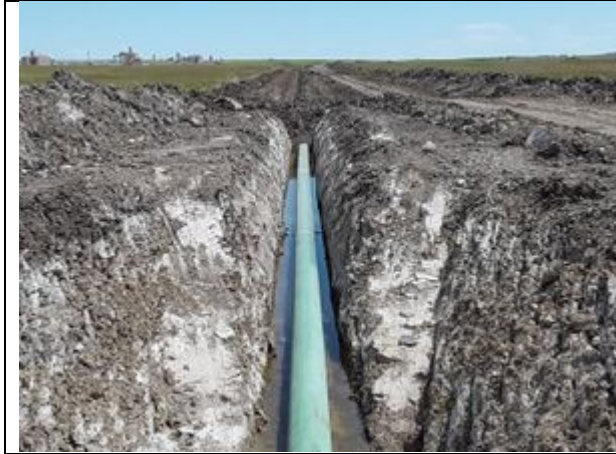
**Observation Point: 37**

Photo Description: Top of pipe depth approximately 75" to current top of trench.

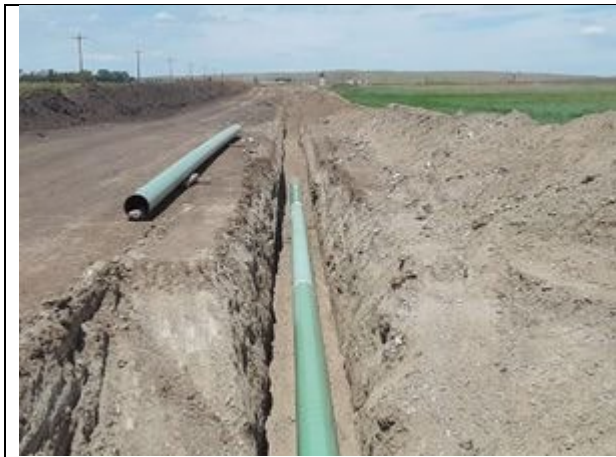
**Observation Point: 38**

Photo Description: Top of pipe depth roughly 55" to current top of trench. Minimum of 6" of topsoil will be re-graded to match existing topography. Topsoil and subsoil segregation adequate.

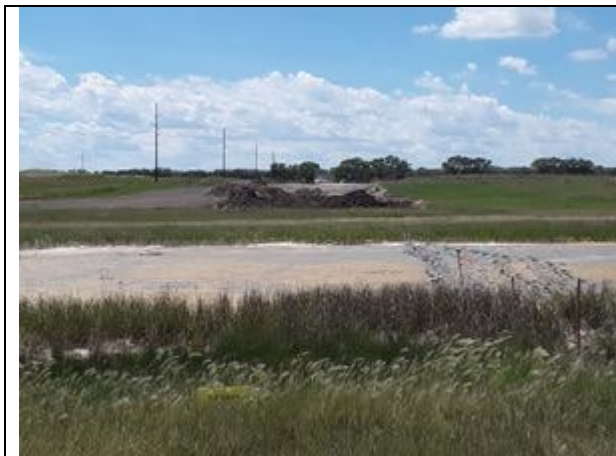
**Observation Point: 39**

Photo Description: HDD under wetland.
