**PU-19-368
ONEOK Bakken Pipeline, L.L.C.
Tioga Lateral NGL Pipeline
Reclamation Inspection Report**

File No. 227701547

August 2022

Stantec Consulting Services Inc.
3303 Fiechtner Drive, Suite 100
Fargo, ND 58103

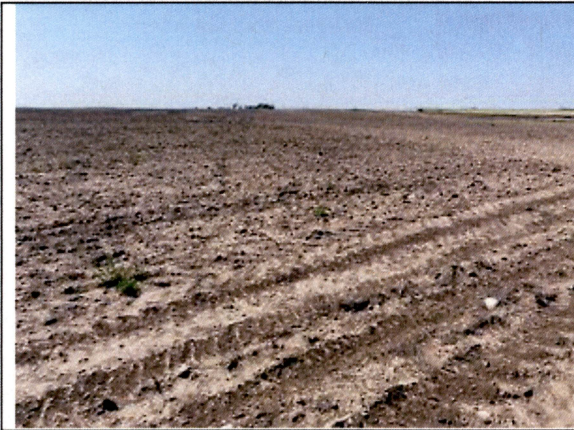
Observation Point: 1

One stream/wetland crossing was observed where the HDD crossing method was used (**Appendix A; Observation Point 1 and 2**). The boring area was observed to be appropriately reclaimed and contained adequate topsoil replacement. No issues were noted at other stream or wetland areas.

Photo Description: 8-in of topsoil replaced over subsoil. Area is well graded and minimal stone cover. Matches existing land

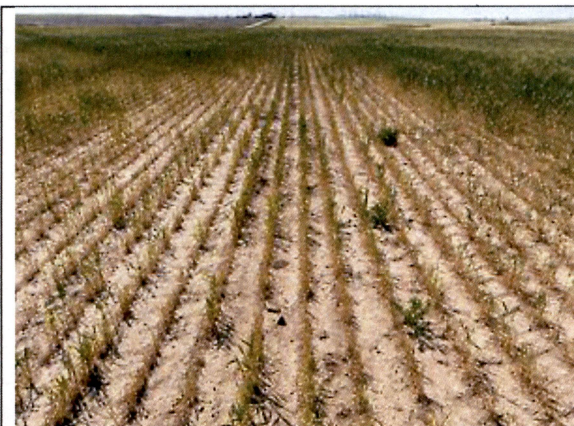
Observation Point: 3

Photo Description: Commonly stressed and stunted wheat compared to non-disturbed area. The right of way is relatively thin but is compacted. Erosion and bare soil is observed to the east. Minimal weed cover.

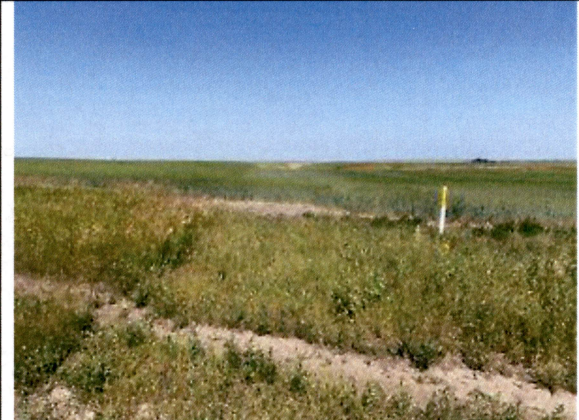
<p>Observation Point: 6 Date Taken: August 1, 2022 4:28 PM Direction Photo is Taken: Land Use: Cropland</p> <p>Photo Description: Comparable wheat stand compared to undisturbed cropland.</p> <p>Latitude: 48.23546764 Longitude: -103.86323424</p>
---	---

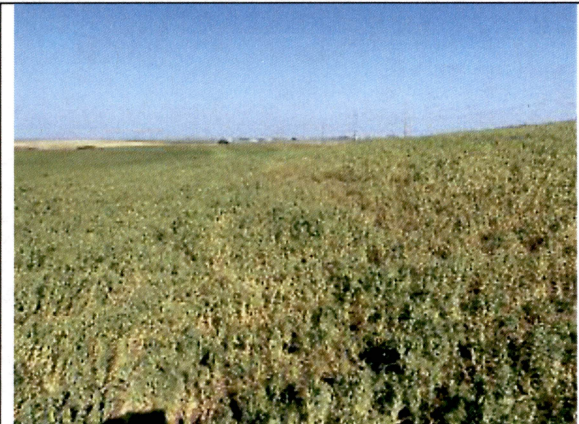
<p>Observation Point: 7 Date Taken: August 1, 2022 6:05 PM Direction Photo is Taken: East Land Use: Cropland</p> <p>Photo Description: Excellent field pea growth. Stand density and height appears consistent with undisturbed areas in the reclaimed right of way.</p> <p>Latitude: 48.27089408 Longitude: -103.780971</p>
--	---

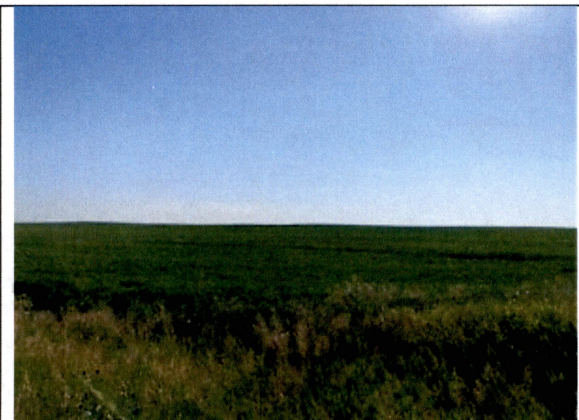
<p>Observation Point: 8 Date Taken: August 1, 2022 6:15 PM Direction Photo is Taken: West Land Use: Cropland</p> <p>Photo Description: Pea field that is reclaimed has 90% cover and is comparable in height and density to undisturbed cropland.</p> <p>Latitude: 48.27744443 Longitude: -103.77740759</p>
---	--

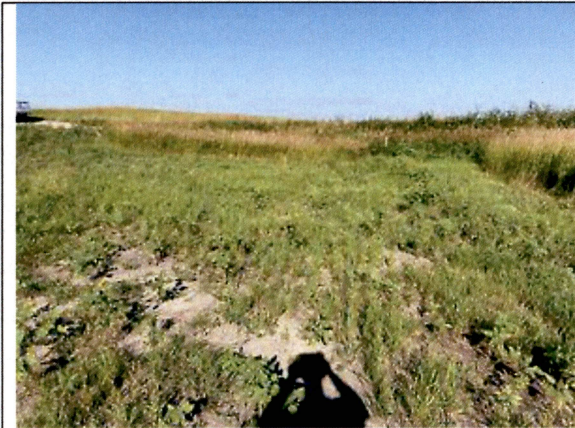
Observation Point: 10

Canada thistle had been previously observed in rangeland, and some as-built inspection observations points were reinspected. At **Observation Point 10, 41, and 53 (Appendix A)**, Canada thistle was observed to be recently mowed, which demonstrates compliance with PSC Order Provision #21.

Photo Description: Canada Thistle is being controlled since last inspection. Additional chemical or mechanical treatment recommended to remove population from the right of way. More desirable vegetation is establishing and trending toward successful reclamation.

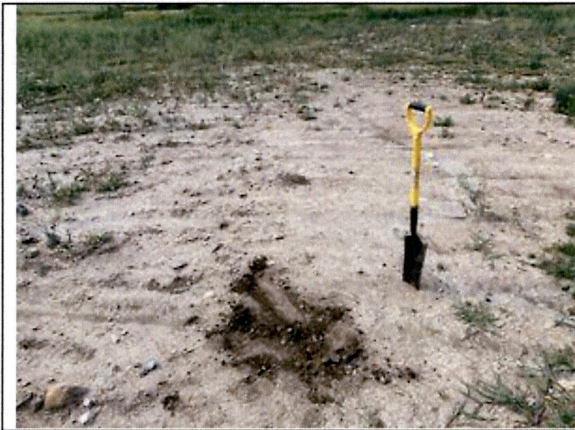
Observation Point: 29
Date Taken: August 2, 2022 10:49 AM
Direction Photo is Taken:
Land Use: Cropland

Photo Description: Severely compacted area poorly reclaimed area.

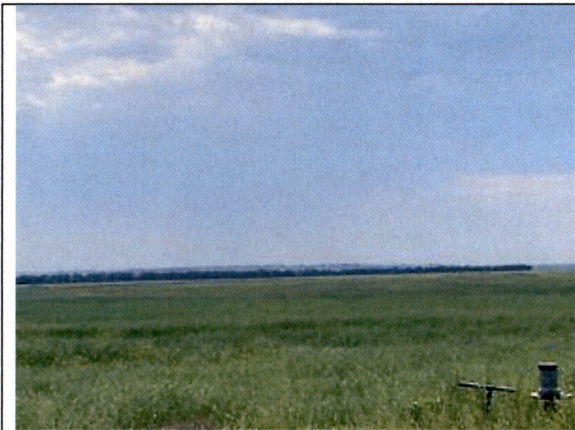
Observation Point: 30
Date Taken: August 2, 2022 10:52 AM
Direction Photo is Taken: East
Land Use: Cropland

Photo Description: Good canola growth.

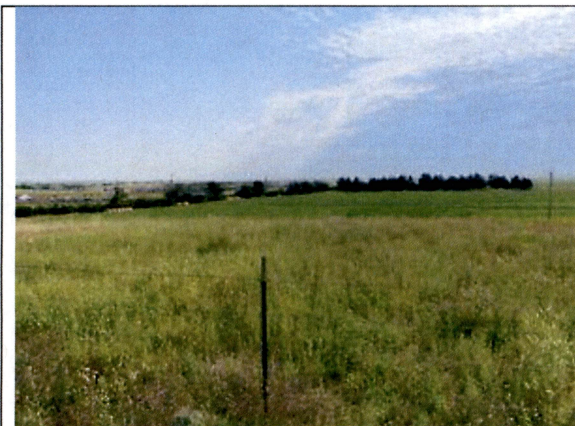
Observation Point: 31
Date Taken: August 2, 2022 11:00 AM
Direction Photo is Taken: Northeast
Land Use: Rangeland

Photo Description: Pipeline bored under Road. Reclaimed ditch and pasture contains some desirable species with good plant cover compared to undisturbed land and meets PSC provisions.

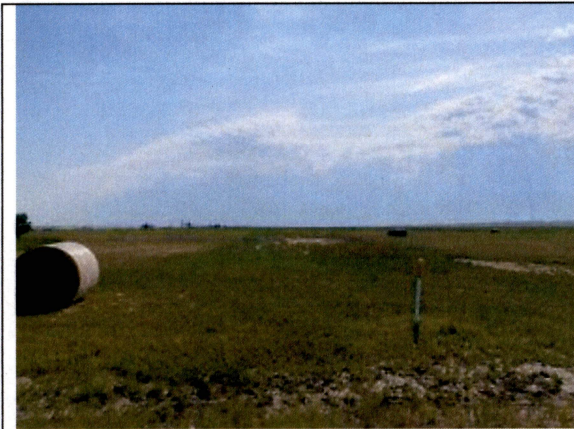
No soil mixing was observed by Stantec in hay land. However, a minimal area of subsidence was observed in hay land at **Observation Point 44 (Appendix A)**. **Observation Points 23 and 32**, were dominated by Kochia and prickly Russian thistle (*Salsola tragus*) while the surrounding area contained alfalfa, and was not being hayed by the producer unlike the surrounding area. Overall, areas from the as-

Observation Point: 32
Date Taken: August 2, 2022 11:07 AM
Direction Photo is Taken: East
Land Use: Hay land

Photo Description: Entire ROW well vegetated. Remains unharvested while other areas are. Kochia, foxtail barley, western wheatgrass present.

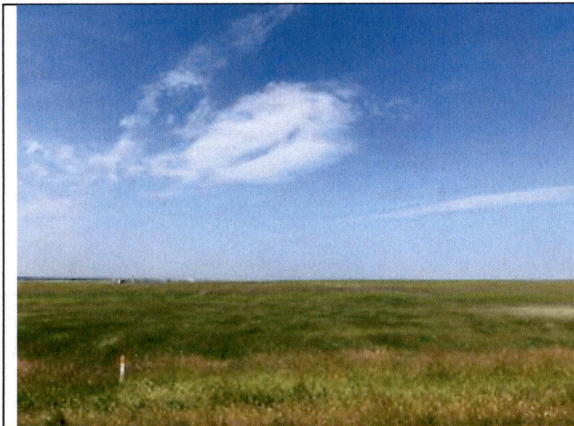
Observation Point: 34
Date Taken: August 2, 2022 11:17 AM
Direction Photo is Taken: West
Land Use: Cropland

Photo Description: Excellent crop stand in reclaimed ROW.

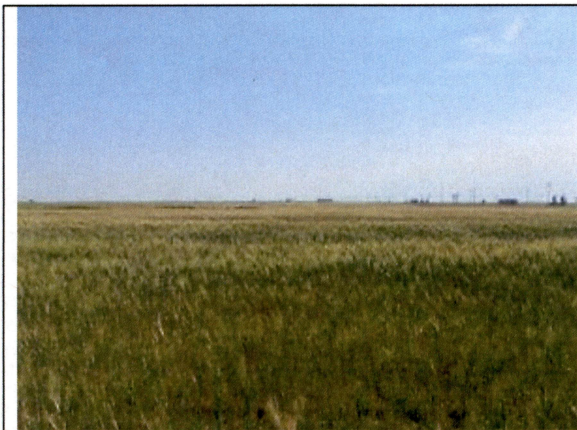
Observation Point: 39
Date Taken: August 2, 2022 11:58 AM
Direction Photo is Taken: East
Land Use: Cropland

Photo Description: Wheat growth in reclaimed ROW consistent. Slight depressions along the row suggest minor potential subsidence.

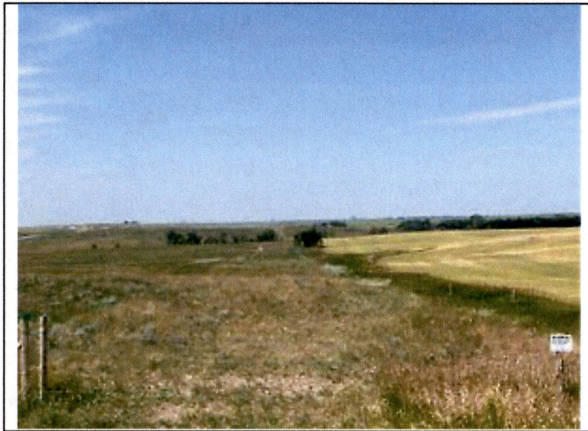
<p>Observation Point: 42 Date Taken: August 2, 2022 12:23 PM Direction Photo is Taken: West Land Use: Rangeland</p> <p>Photo Description: Well vegetated and reclaimed ROW.</p> <p>Latitude: 48.28782453 Longitude: -103.13080549</p>
---	--

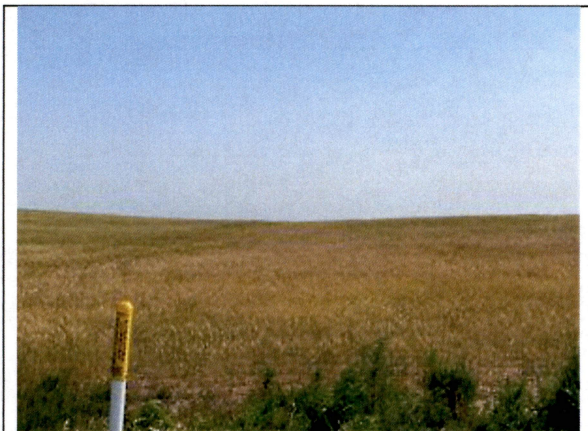
<p>Observation Point: 43 Date Taken: August 2, 2022 12:23 PM Direction Photo is Taken: East Land Use: Cropland</p> <p>Photo Description: Wheat growth in reclaimed ROW consistent with surrounding land.</p> <p>Latitude: 48.28786246 Longitude: -103.13056409</p>
--	---

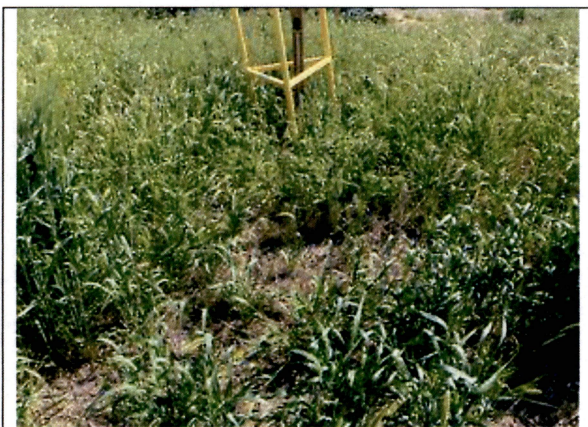
<p>Observation Point: 44 Date Taken: August 2, 2022 12:37 PM Direction Photo is Taken: Land Use: Hay Land</p> <p>Photo Description: Small area of subsidence.</p> <p>Latitude: 48.29909831 Longitude: -103.10911697</p>
---	--

Exposed subsoil and/or mixed topsoil was observed at several locations throughout the ROW. Minor, isolated areas of subsidence was observed in some inspected cropland tracts. Stantec recommends the PSC inquire about these areas with ONEOK. Adding topsoil or soil biological amendments could be possible methods to improve the organic matter content and improve vegetative restoration. Additional fill and re-grading, possibly coupled with temporary perennial vegetation, at locations of subsidence is likely to permanently stabilize these areas.

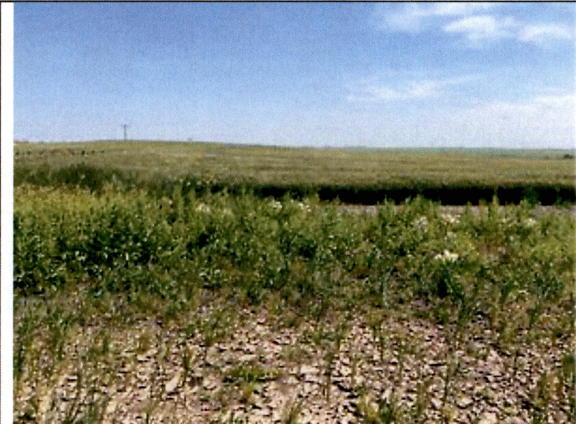
<p>Observation Point: 49 Date Taken: August 2, 2022 1:26 PM Direction Photo is Taken: East Land Use: Cropland</p> <p>Photo Description: Foxtail barley, cattails, curly dock, barnyard grass. HDD pad is reclaimed. Half is planted to wheat and half is covered with hydrophytic vegetation. Farmer planted around wetter area.</p> <p>Latitude: 48.35630306 Longitude: -103.04307414</p>
--	---

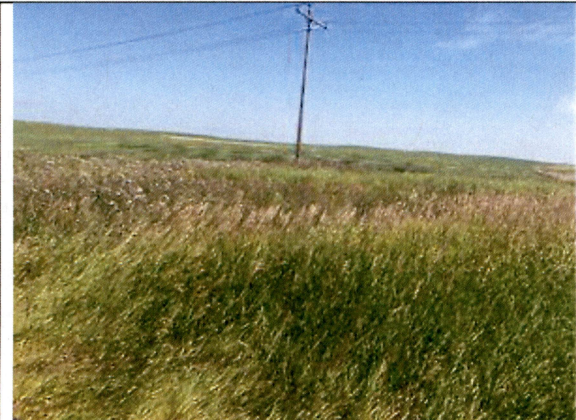
<p>Observation Point: 50 Date Taken: August 2, 2022 1:45 PM Direction Photo is Taken: Northeast Land Use: Rangeland</p> <p>Photo Description: Significant Canada thistle population.</p> <p>Latitude: 48.36376304 Longitude: -103.02235261</p>
---	---

The only noxious weed species observed was Canada thistle (perennial) and leafy spurge. Both species being controlled, mechanically. Stantec did not observed any areas of weeds that were recently sprayed with herbicide. Stantec recommends PSC contact ONEOK about the additional areas where Canada thistle and leafy spurge were observed in the ROW. For control, Stantec recommends infested areas continue to be treated immediately throughout the 2022 and 2023 growing seasons. The locations observed with noxious weeds should be monitored for at least two years to allow for the lifecycle of weeds, and to ensure infestations do not spread.

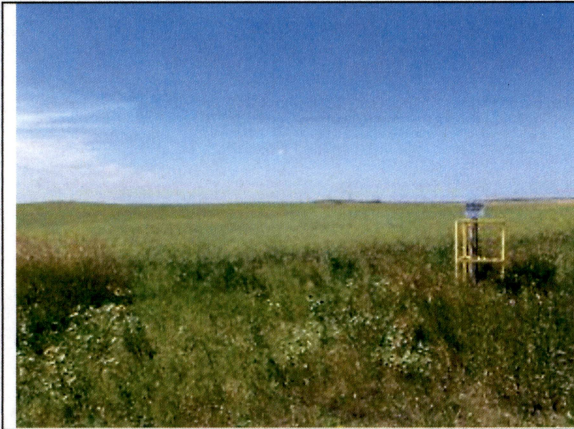
Observation Point: 51
Date Taken: August 2, 2022 1:46 PM
Direction Photo is Taken: West
Land Use: Cropland

Photo Description: Canola field consistent through reclaimed and undisturbed areas.

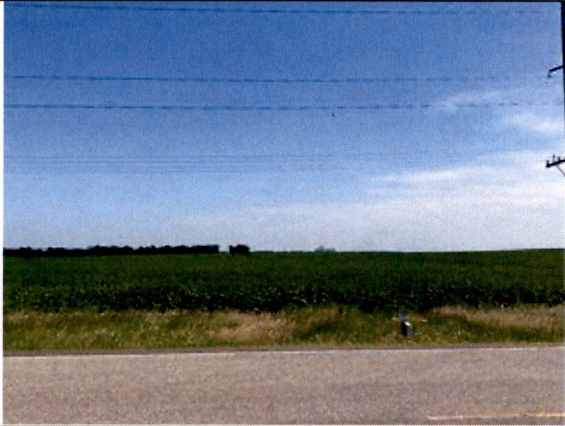
A photograph showing a wide, flat field of green sunflowers under a clear blue sky. In the foreground, there is a gravel or paved area. A utility pole is visible on the right side of the frame.	<p>Observation Point: 54 Date Taken: August 2, 2022 2:09 PM Direction Photo is Taken: East Land Use: Cropland</p> <p>Photo Description: Sunflower stand is adequately growing in reclaimed HDD pad.</p> <p>Latitude: 48.36411511 Longitude: -102.9572682</p>
---	---

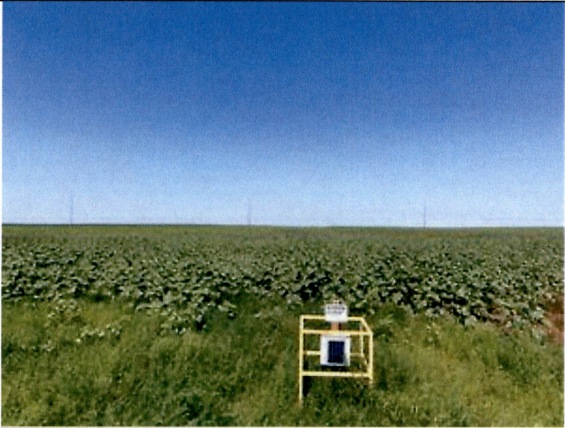
A photograph of a sunflower field with a yellow metal frame in the foreground. The sunflowers are in various stages of growth, and the sky is clear and blue.	<p>Observation Point: 55 Date Taken: August 2, 2022 2:21 PM Direction Photo is Taken: North Land Use: Cropland</p> <p>Photo Description: Healthy sunflowers in cropland ROW.</p> <p>Latitude: 48.35648304 Longitude: -102.94797911</p>
--	---

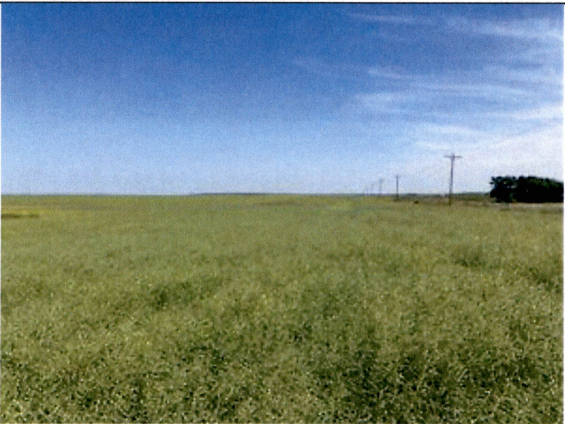
A photograph of a large, flat field of green canola plants. The sky is blue with some light clouds. A utility pole is visible in the distance on the right.	<p>Observation Point: 56 Date Taken: August 2, 2022 2:31 PM Direction Photo is Taken: East Land Use: Cropland</p> <p>Photo Description: Healthy canola stand with full pods in reclaimed ROW.</p> <p>Latitude: 48.37285138 Longitude: -102.91515848</p>
---	--

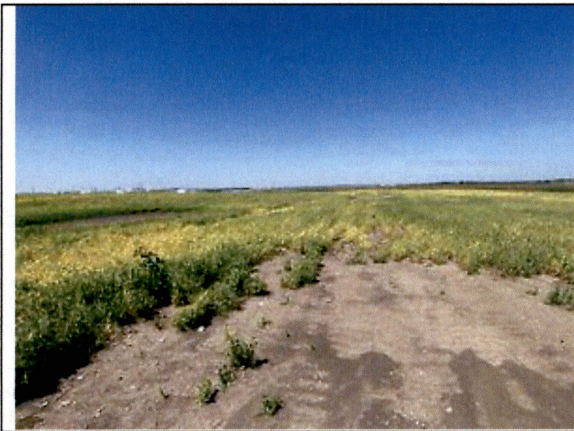
Observation Point: 57

built containing Canada thistle (*Cirsium arvense*) were observed to be being properly controlled (**Observation Point 21**). However, one area with a prevalence of Canada thistle were noted (**Observation Point 57**).
