Whiting Oil and Gas Corporation  
Robinson Lake Oil Conditioning – Mountrail County  
Case No. PU-19-369  
As-Built Construction and Reclamation Inspection Report

RE: Case No. PU-19-369  
Whiting Oil and Gas Corporation  
Robinson Lake Oil Conditioning –  
Mountrail County  
As-Built Construction and Reclamation  
Inspection Report

Project: Whiting Oil and Gas - Robinson Lake Oil Conditioning

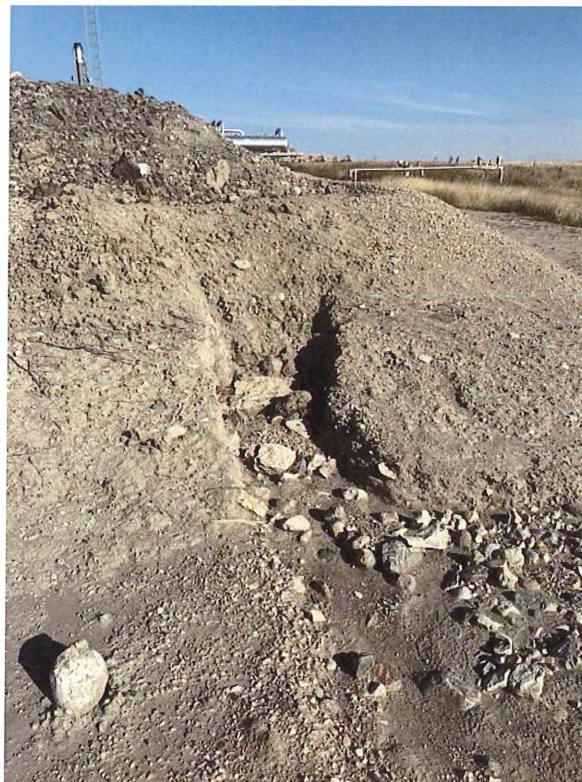
**Photo ID:** 20

- Site inspection indicated that existing earthen berm used for erosion containment had erosion issues where berm was deteriorating from water erosion. Berm needs repair in multiple locations to perform intended operation of erosion control. See pictures 14 and 20.

**Notes:** Erosion taking place, requires attention to berm

- Erosion Berm on SE corner requires maintenance to be brought back to optimal conditions.

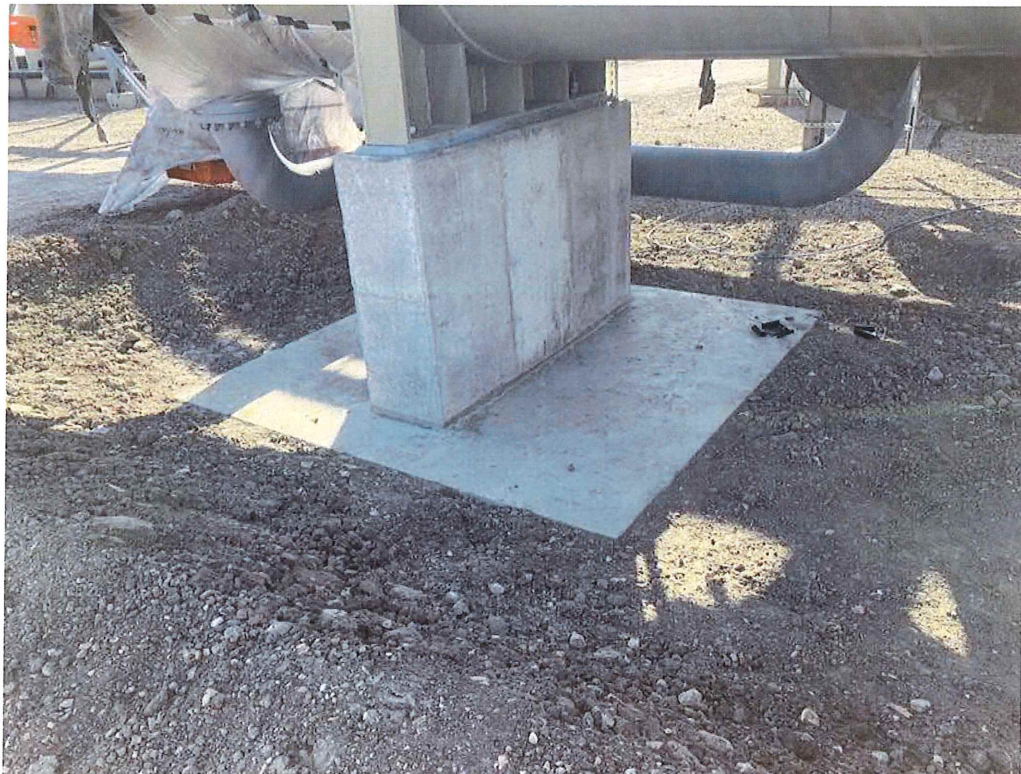
**Photo ID:** 25

- Gravel surfacing was leveled around site except near concrete bases. See photos 25 and 28. No site earthwork, gravel base work showed any issues. Site gravel matched existing gravel base of the construction pad area. See photo 25 as example of gravel base.

**Notes:** Sufficient backfilling completed around new concrete pad.
