Bill Sanderson Residue and NGL Pipelines Project

As-Built Inspection Report

Docket Number: PU-20-247

Prepared for North Dakota Public Service Commission

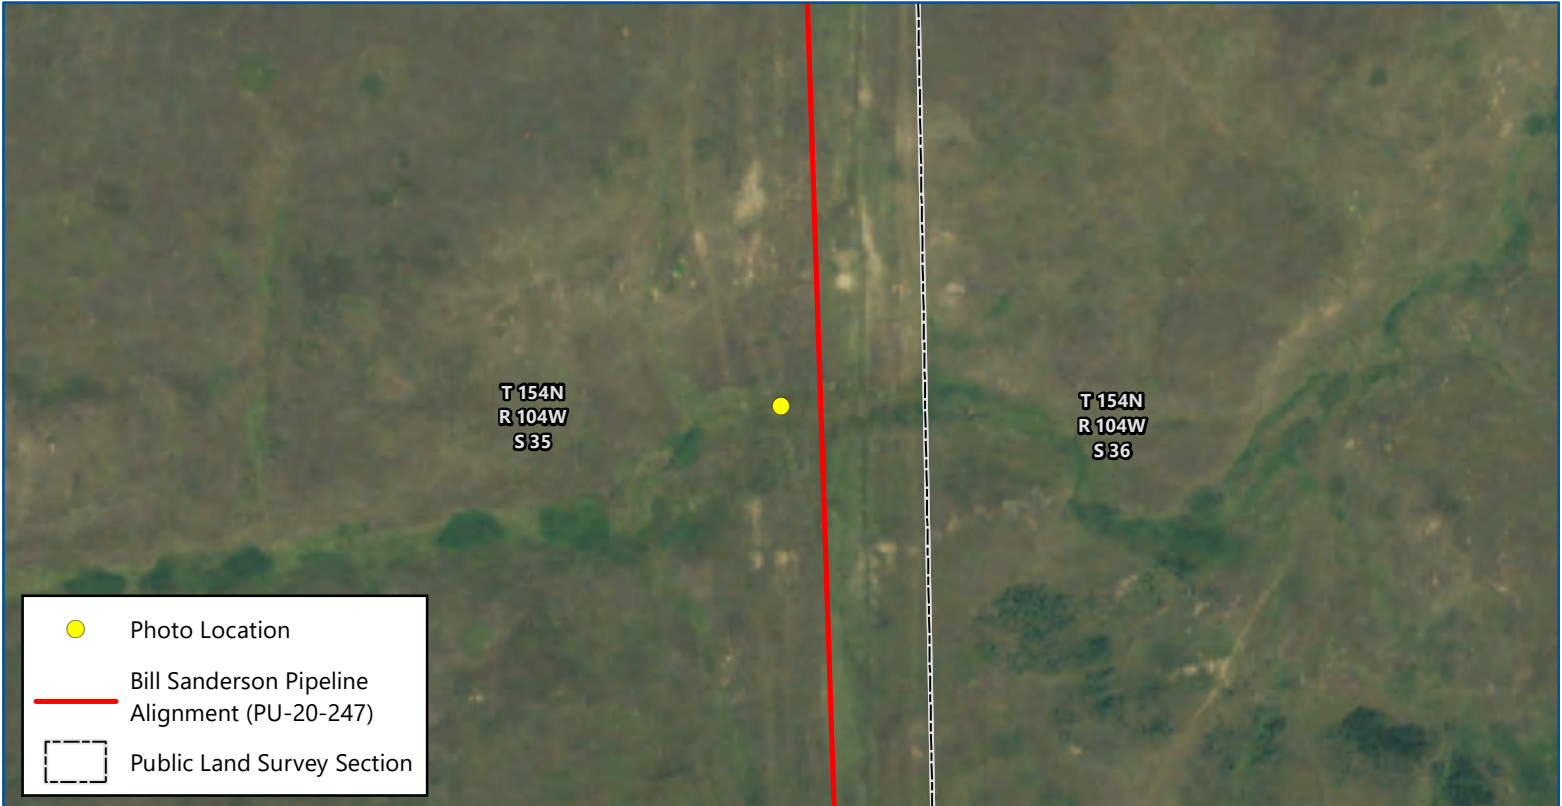
Map 4 of 10
**BILL SANDERSON NGL PIPELINES
 RECLAMATION INSPECTION**
PU-20-247
 North Dakota Public Service Commission
 Williams County, North Dakota

Date: 12/11/2020
 Photo Direction: North
 Comment: Mat in place, no visible issues.
 Latitude: 48.113814
 Longitude: -104.014636
 Coordinates are in the WGS84 datum.

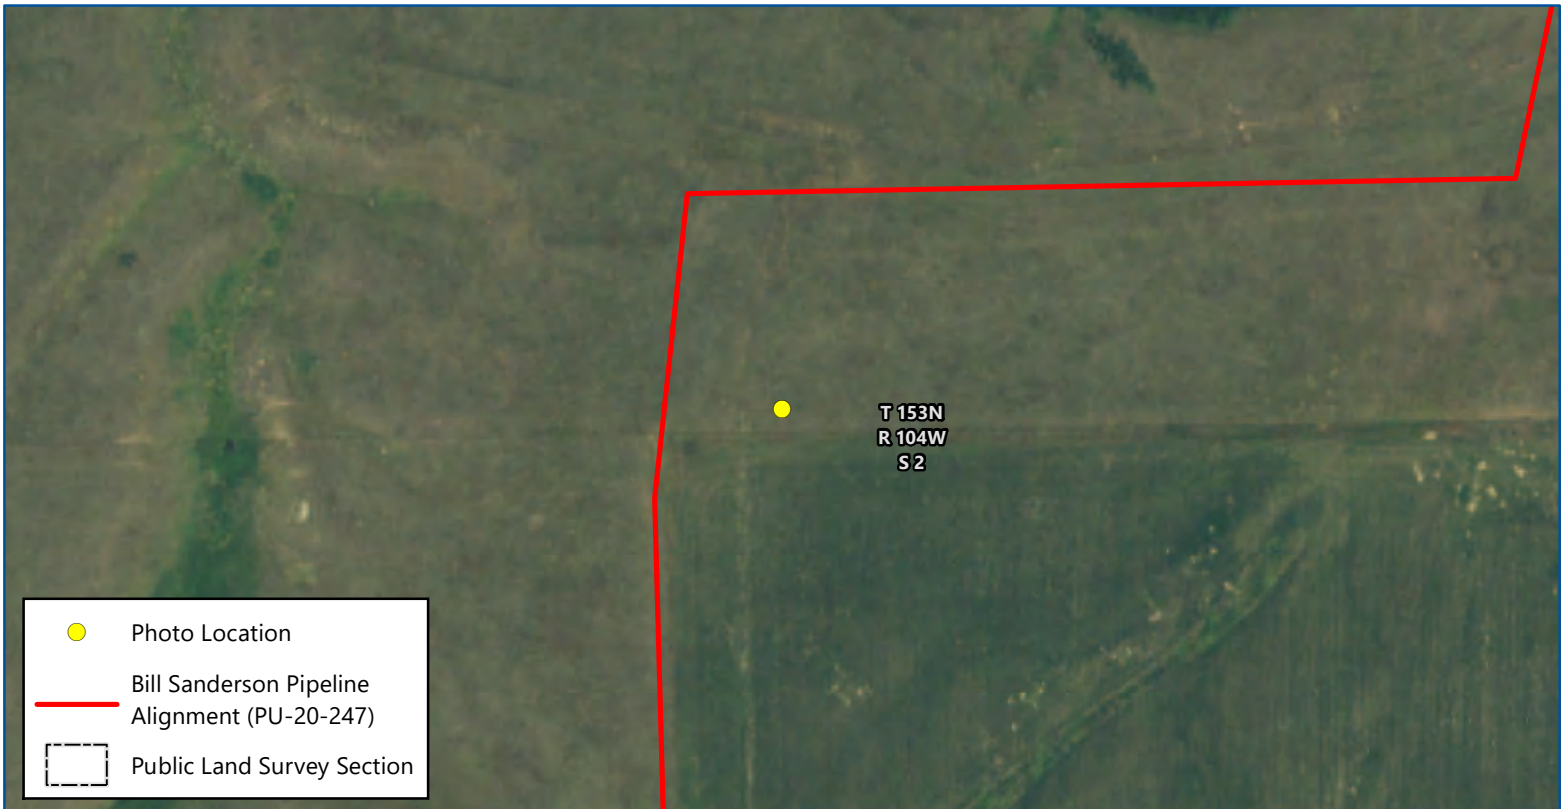
Map 8 of 10
**BILL SANDERSON NGL PIPELINES
 RECLAMATION INSPECTION**
PU-20-247
 North Dakota Public Service Commission
 Williams County, North Dakota

Date: 12/11/2020
 Photo Direction: Northeast
 Comment: No visible issues.
 Latitude: 48.104117
 Longitude: -104.029773
 Coordinates are in the WGS84 datum.
