# **NuStar 10" Pipeline Relocation Project**

## ***Construction Inspection Report***

***Docket Number: PU-20-381***

Prepared for North Dakota Public Service Commission

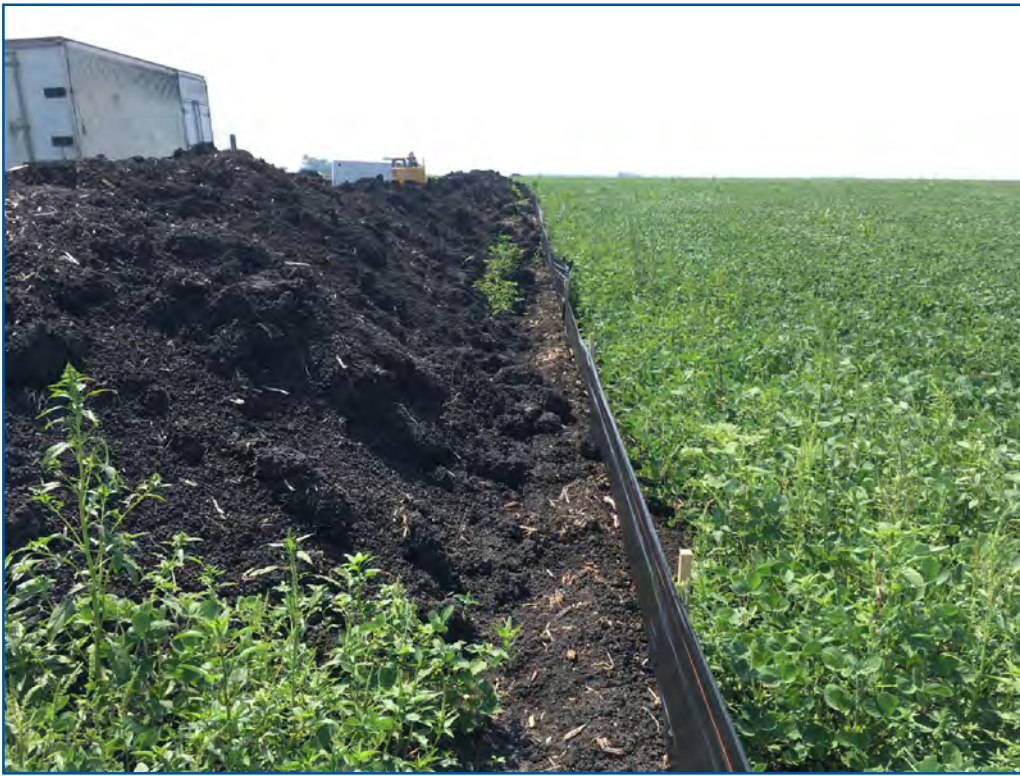
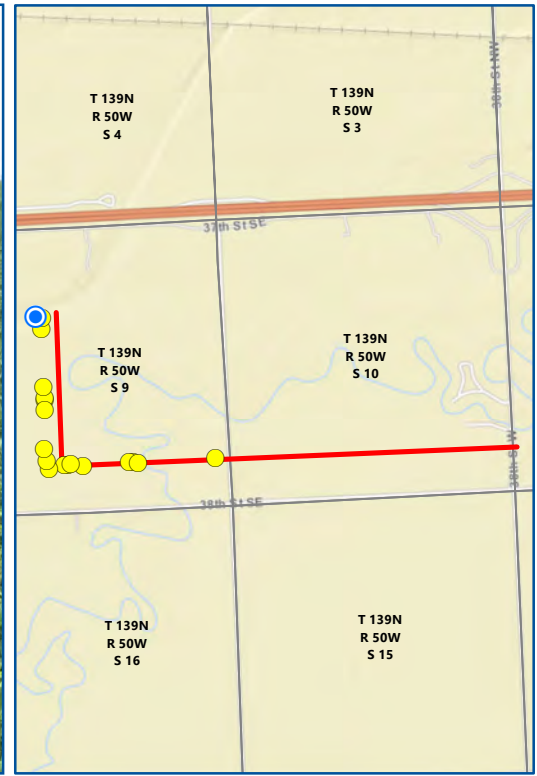
Map 1 of 18

Date: 7/13/2021  
 Photo Direction: South  
 Comment: Silt fence near topsoil stockpile;  
 no erosion observed

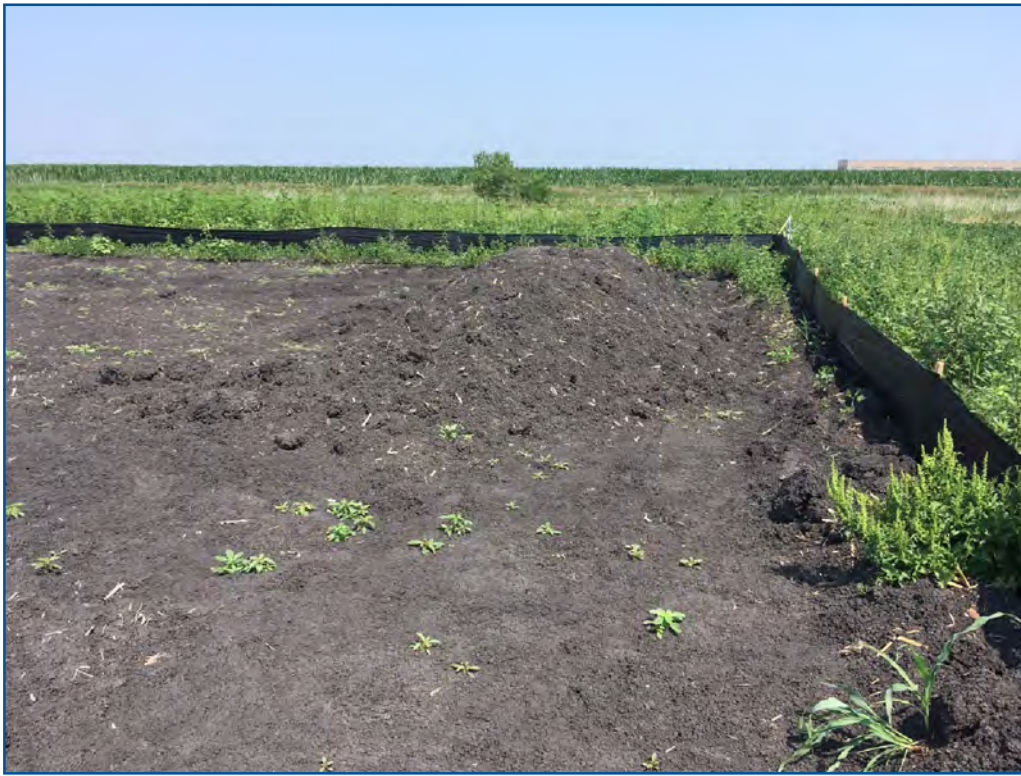
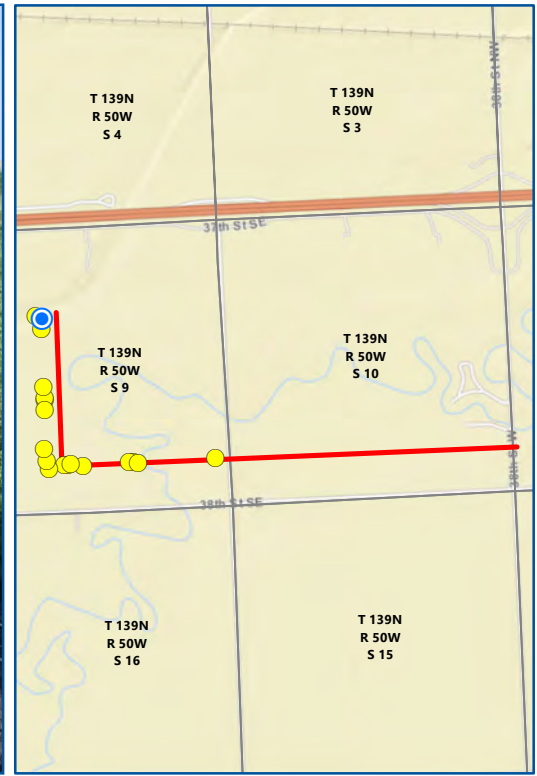
Map 2 of 18

Date: 7/13/2021  
 Photo Direction: North  
 Comment: Silt fence at south end of drilling stage area; no erosion observed

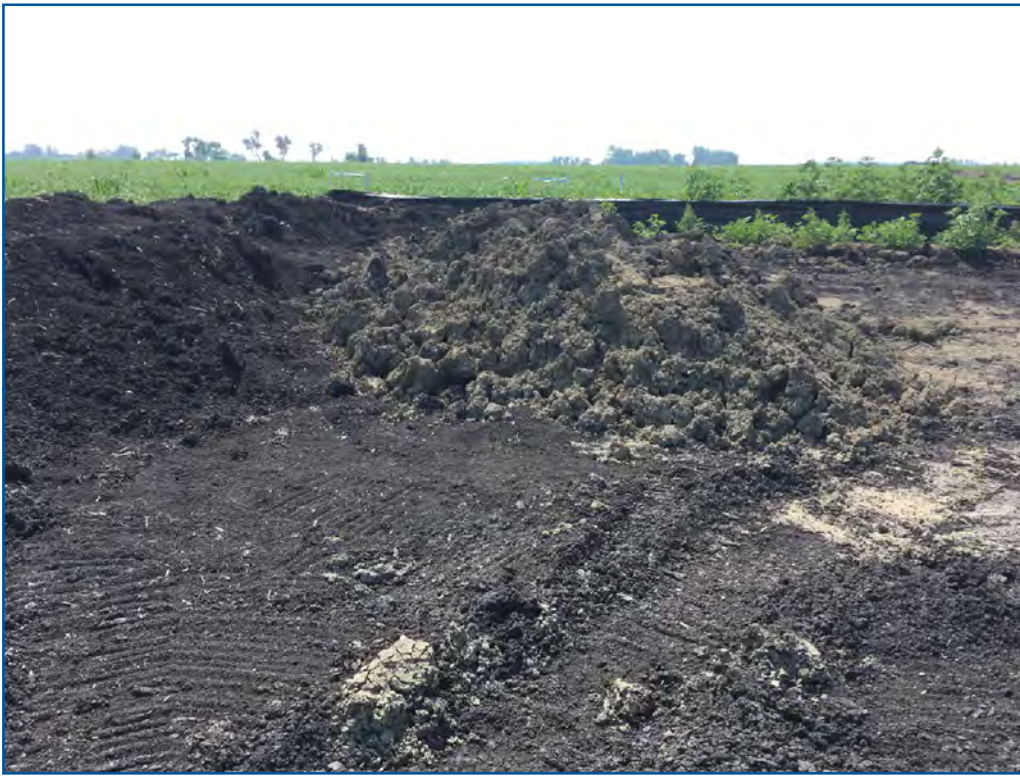
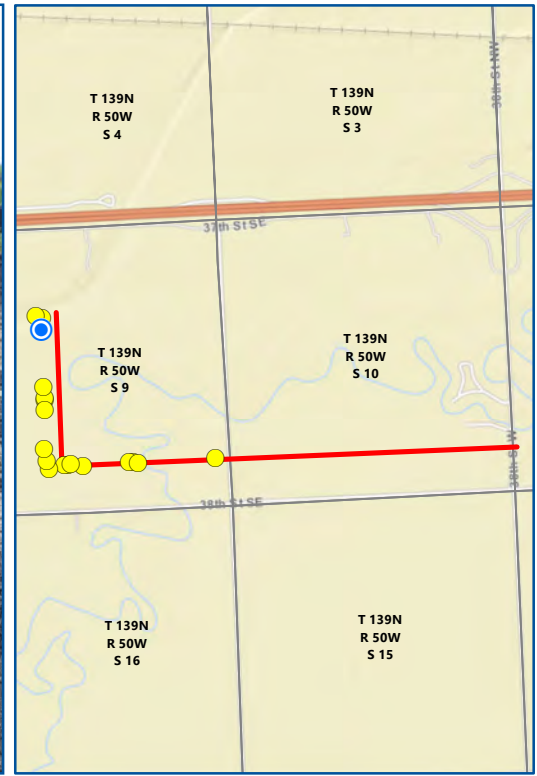
Map 3 of 18

Date: 7/13/2021  
 Photo Direction: South  
 Comment: Small subsoil stockpile near  
 topsoil stockpile with inadequate  
 separation

Issues	Recommendations
<b>Isolated locations of inadequate physical separation of subsoil and topsoil</b>	Create further separation of stockpiles. Where this is not feasible, install silt fence to separate piles until soils are replaced.
<b>Isolated locations of small amounts of topsoil remaining in place during trench excavation.</b>	Ensure that all topsoil has been stripped before excavating and stockpiling subsoil through increased inspections.

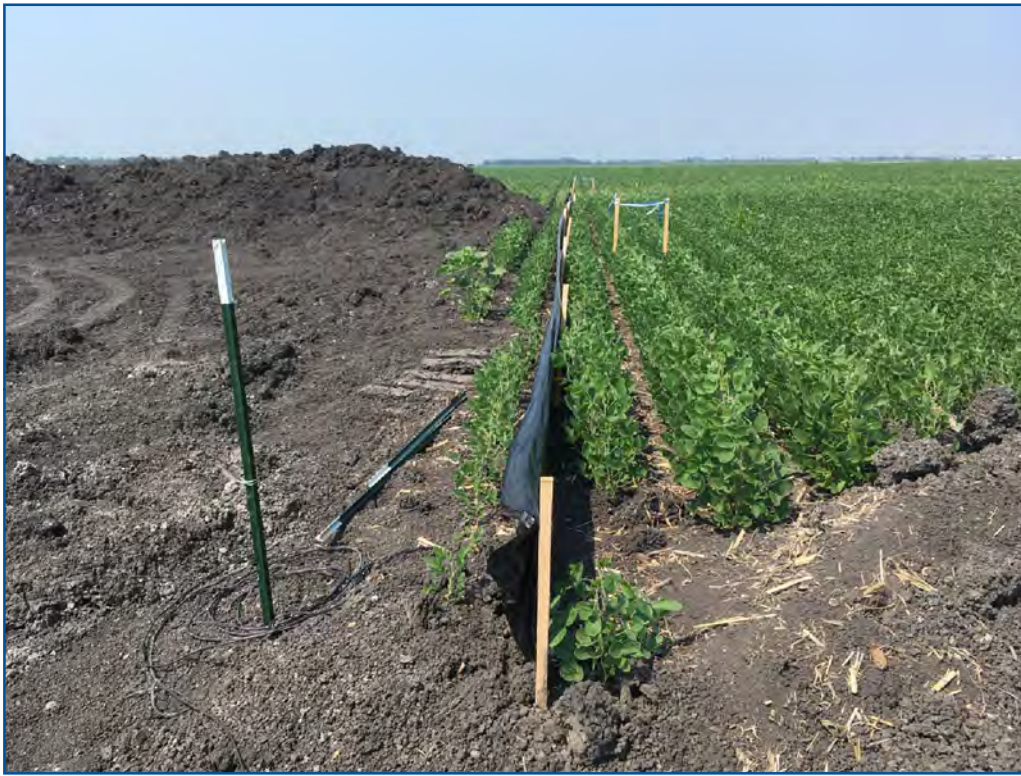
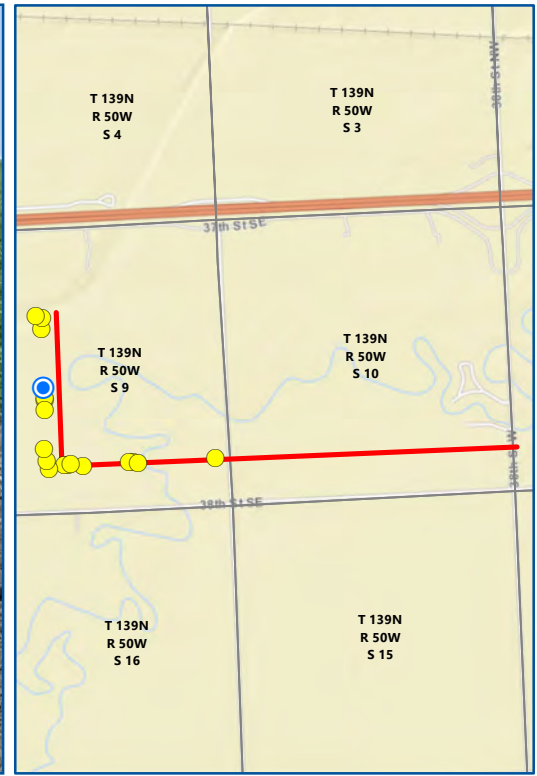
Map 4 of 18

Date: 7/13/2021  
 Photo Direction: West  
 Comment: Silt fence; no erosion observed

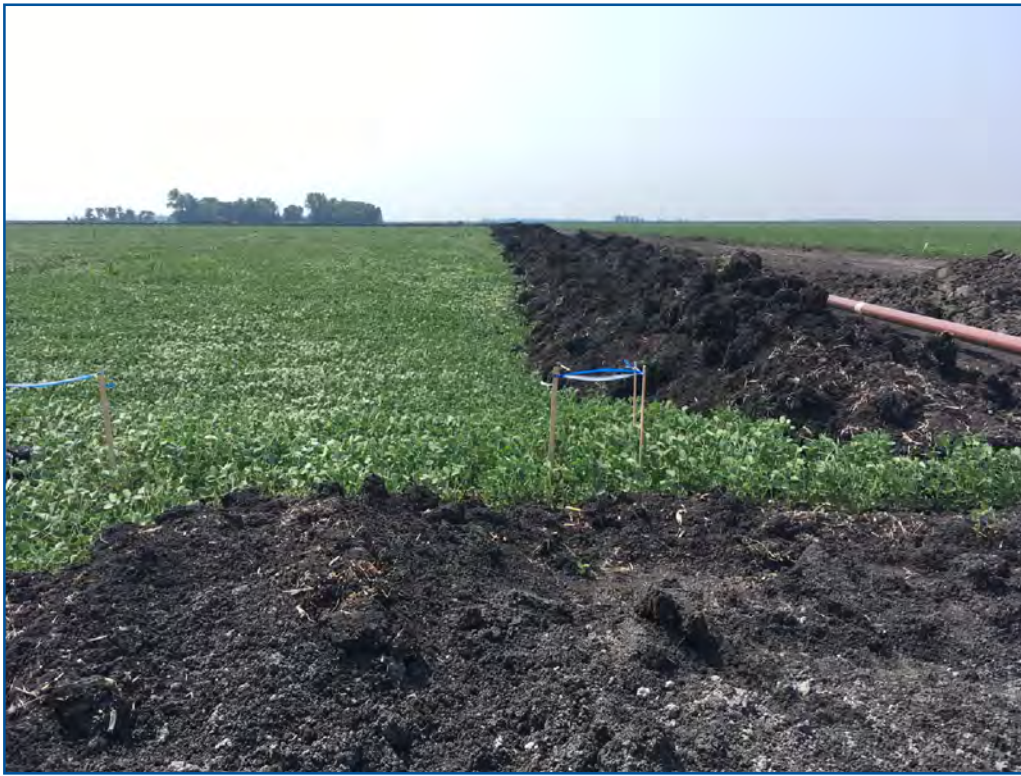
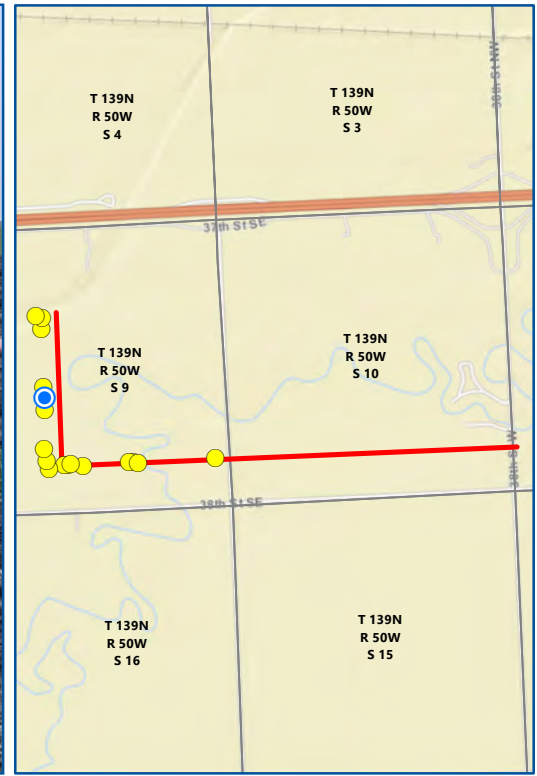
Map 5 of 18

Date: 7/13/2021  
 Photo Direction: South  
 Comment: Topsoil stockpile with no silt fence due to flat grade; no erosion observed

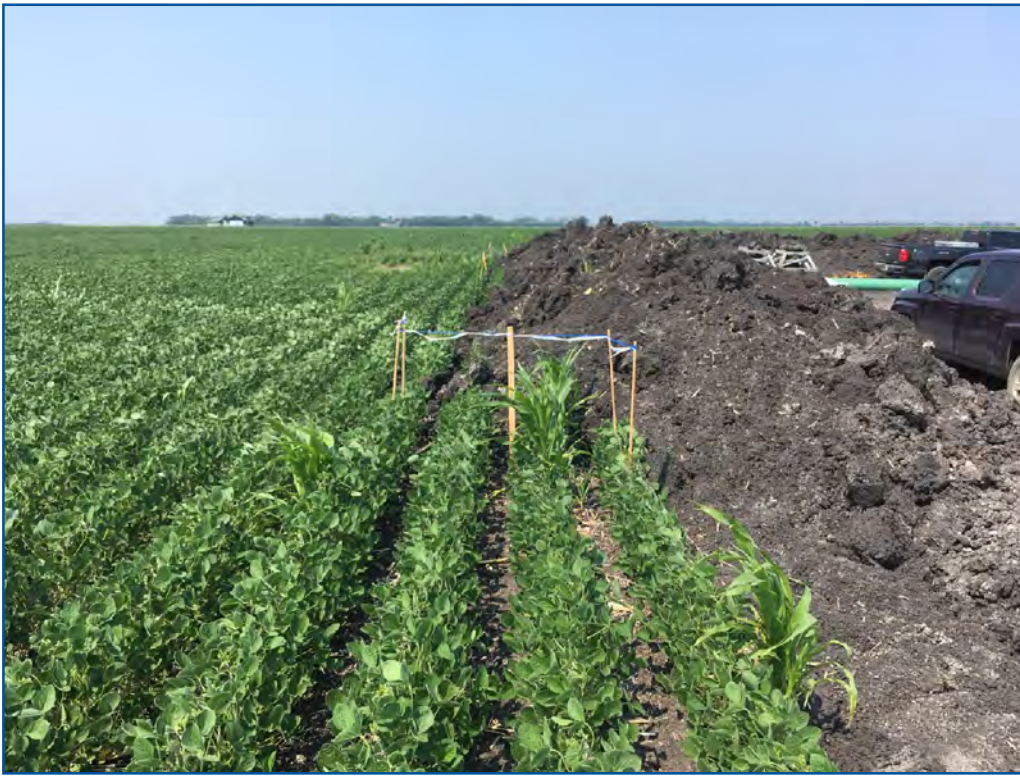
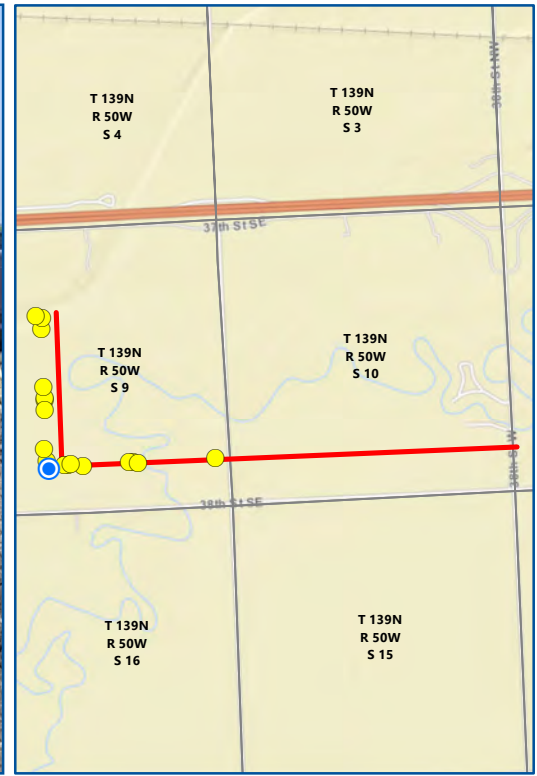
Date: 7/13/2021  
 Photo Direction: West  
 Comment: Topsoil stockpile without silt fence due to flat grade; no erosion observed

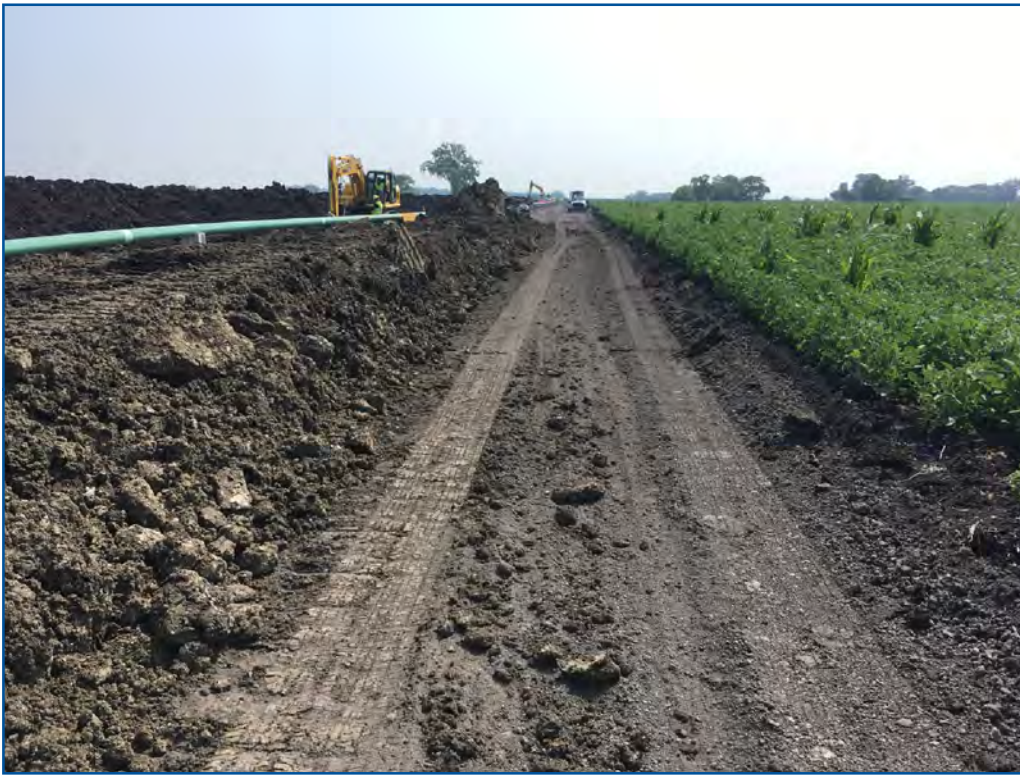
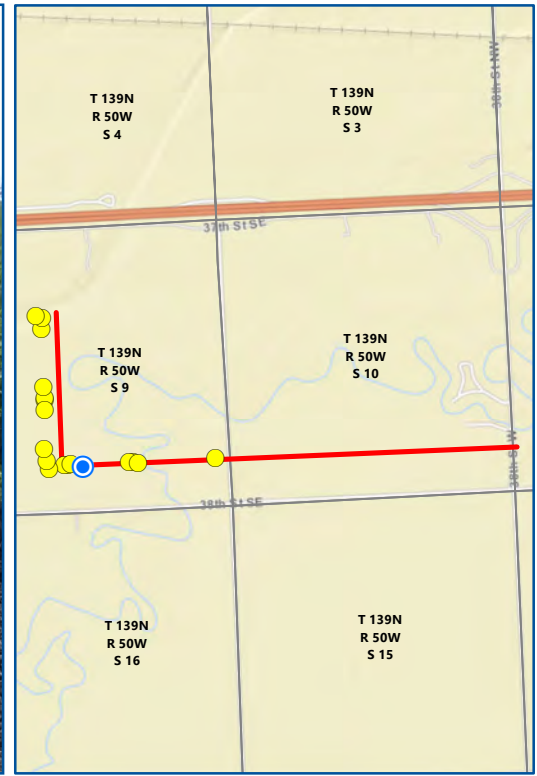
Map 14 of 18

Date: 7/13/2021  
 Photo Direction: East  
 Comment: Erosion berm and subsoil stockpile

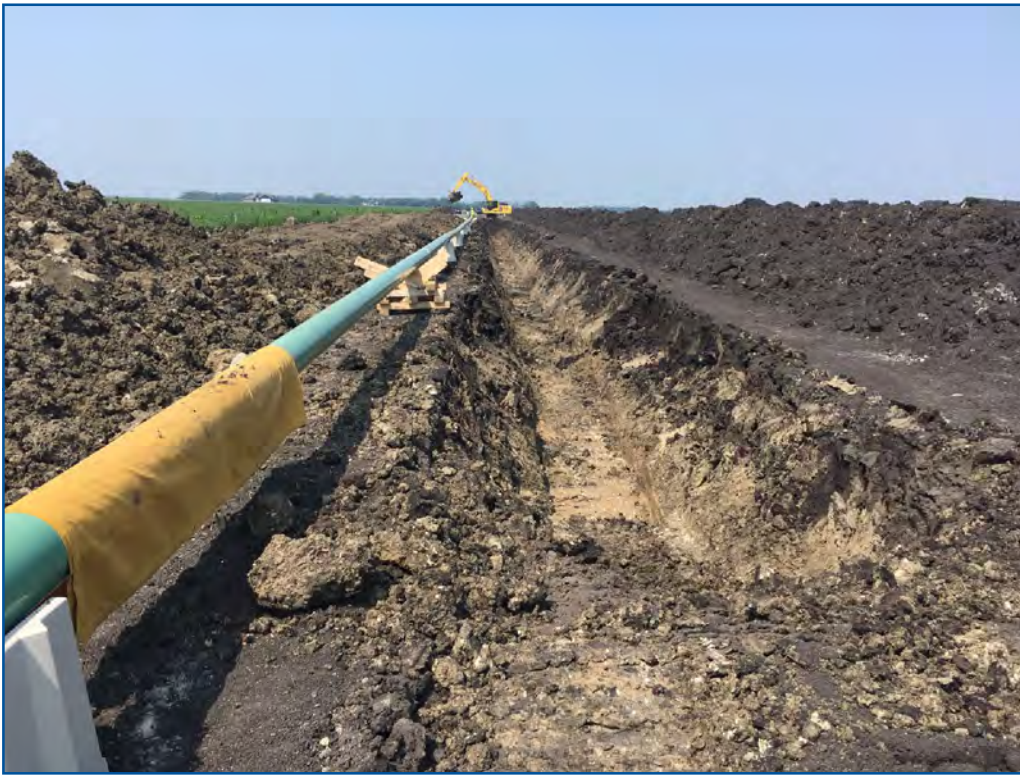
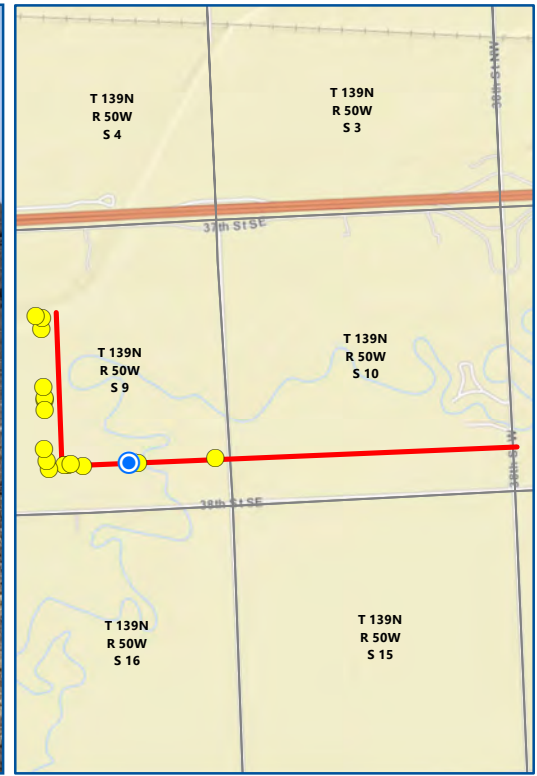
Map 15 of 18

Date: 7/13/2021  
 Photo Direction: West  
 Comment: Subsoil and topsoil segregation;  
 active excavation 9 feet below ground  
 surface

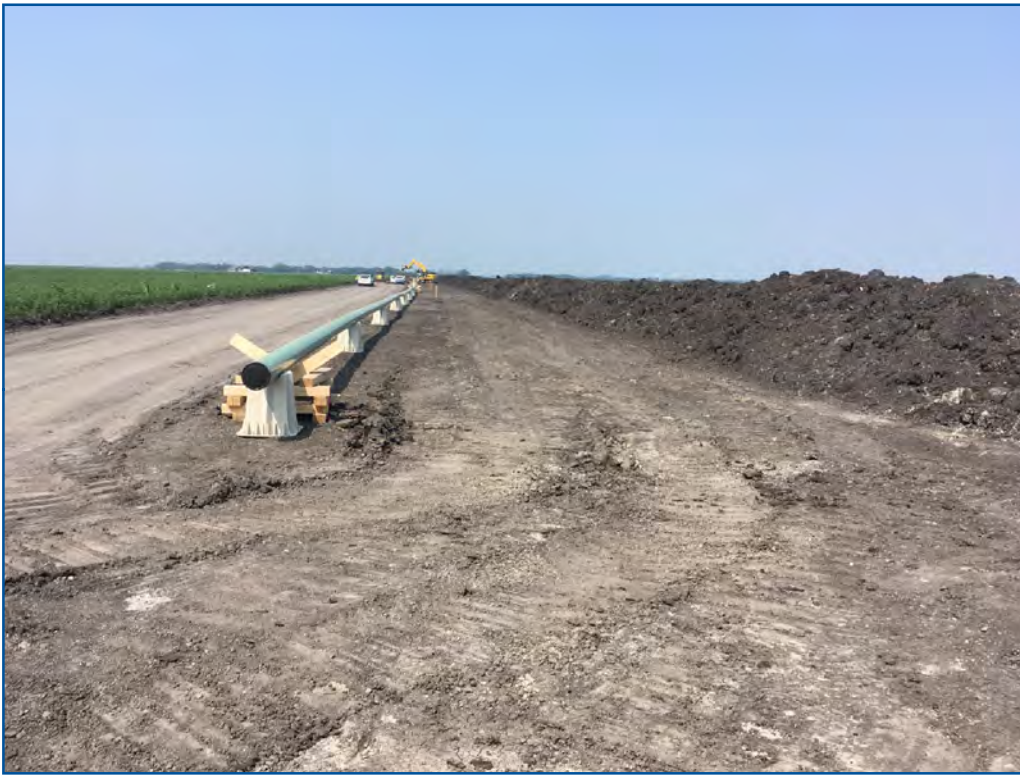
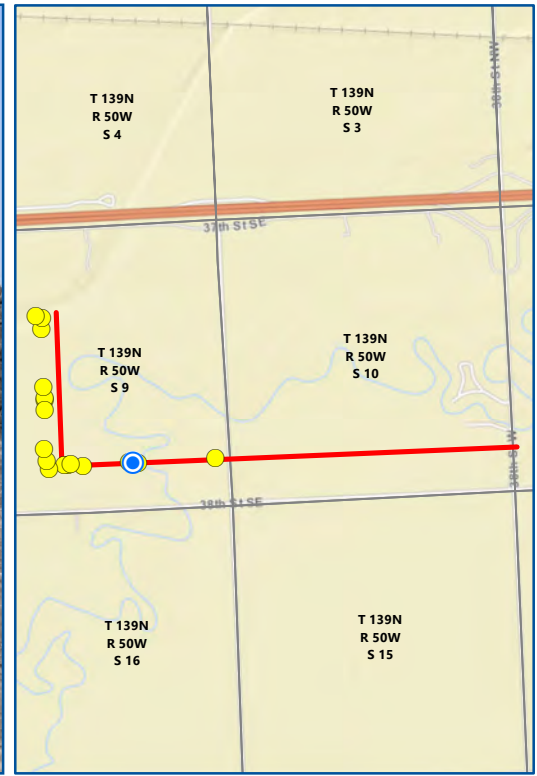
Map 16 of 18

Date: 7/13/2021  
 Photo Direction: West  
 Comment: Pipeline staging area

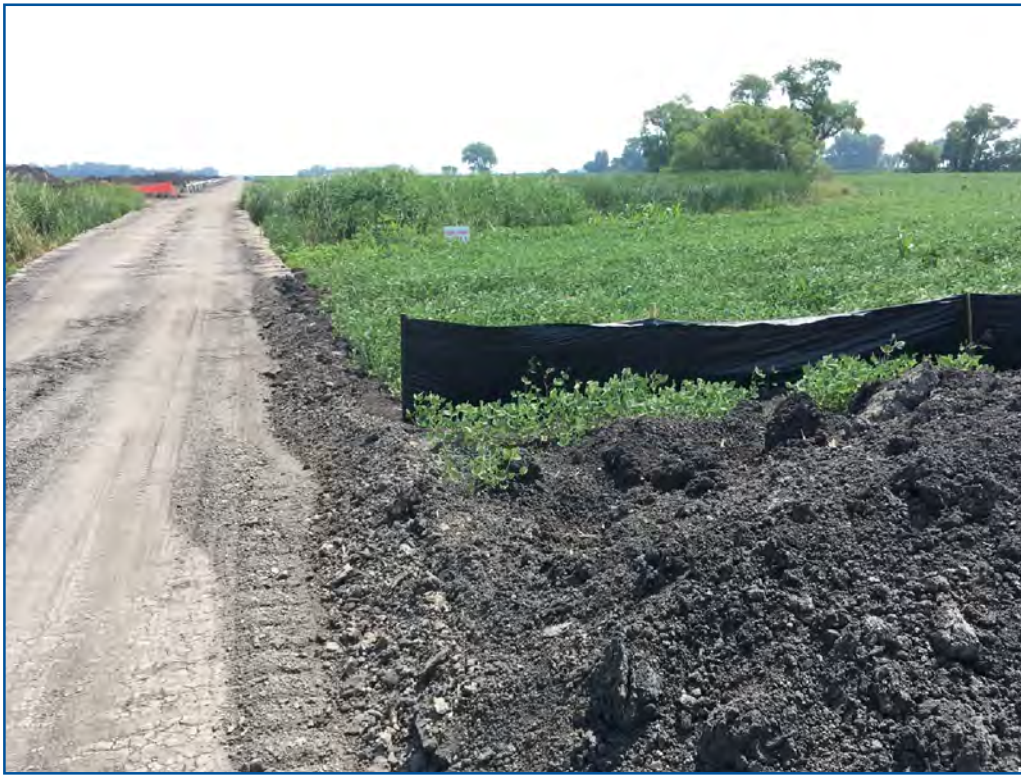
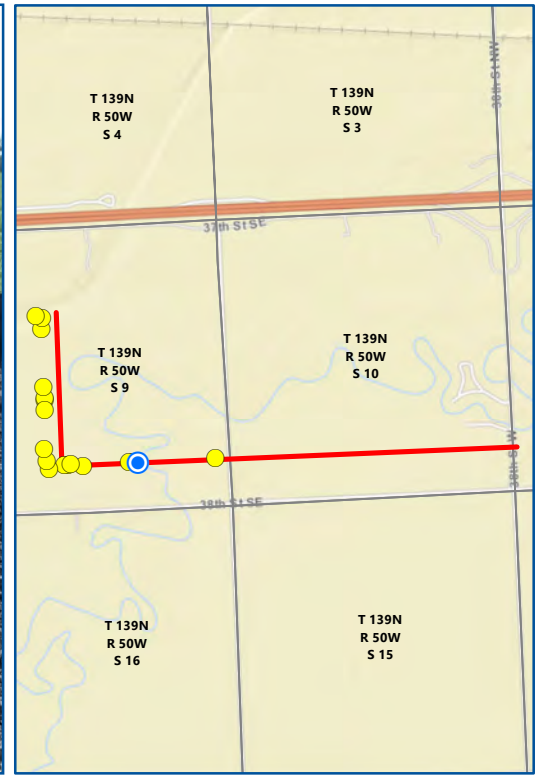
Map 17 of 18

Date: 7/13/2021  
 Photo Direction: East  
 Comment: Silt fence up gradient of wetland; no erosion observed
