Bridger Pipeline LLC

8-inch Crude Oil Pipeline – McKenzie County

Case No. PU-20-430

Construction Inspection Report

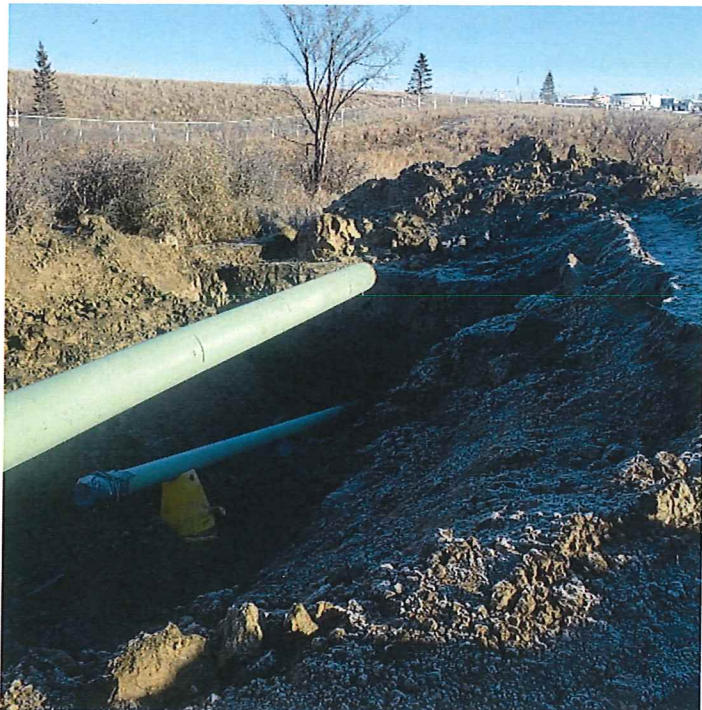
P1 – STA 7+26 BK_Bore End

- STA 7+26 to STA 10+80 (See P1, P3, P6, P9)
- STA 12+20 to STA 15+42 (See P10-P13, P15, P41)
- STA 20+50 to STA 21+73 (See P19)
- STA 67+25 to END STA tie-in (See P38, P39)

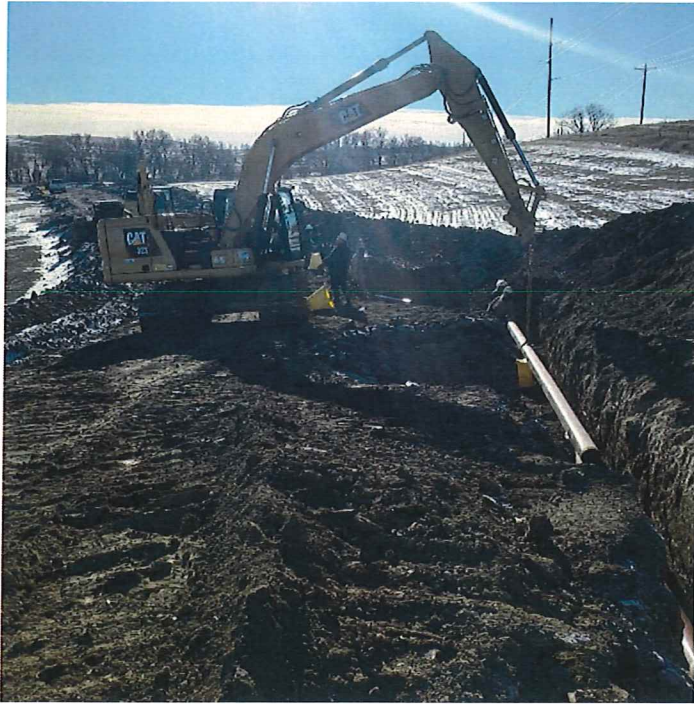
P19 – STA 21+73 AH_Pipe Installment

*Inspector visited site to view trench excavation, above ground pipe assembly, pipeline installment within trench, and pipeline tie-in areas for borings. Subsoil appears frozen in areas of windrow. Topsoil remains segregated in its own windrow Left of pipeline centerline while subsoil piled in windrow right of pipeline centerline. All of trench has been excavated and several depth checks were conducted by use of tape measure. Depth of exposed trenches from bottom to top of subsoil ranged from 5.9 to 6.4 feet. With the inclusion of topsoil placement, top of pipe to finish surface distance should exceed 5 feet in areas of pipe still to be installed. Loenbro is currently working above ground at station tie-in at project end but decides to move personnel to STA 21+73 to install pipe at PI (point of reverse curvature) location (See P19, P20).

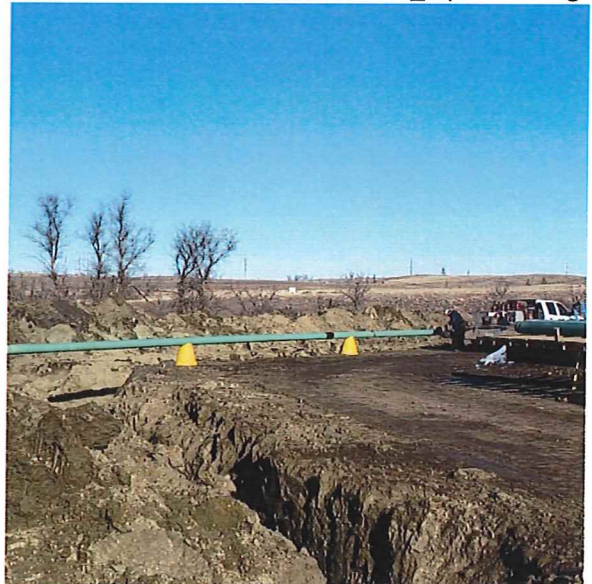
P41 – STA 14+50 BK_Pipe Welding

* Pipe fitters move down to STA 14+50 to continue pipe assembly along stretch from STA 12+20 to STA 15+42 (See P41).
