# Report of Geohazard Evaluation South Bend Pipeline Segment West Central North Dakota

Tetra Tech Project No. 117-0533085

August 28, 2020

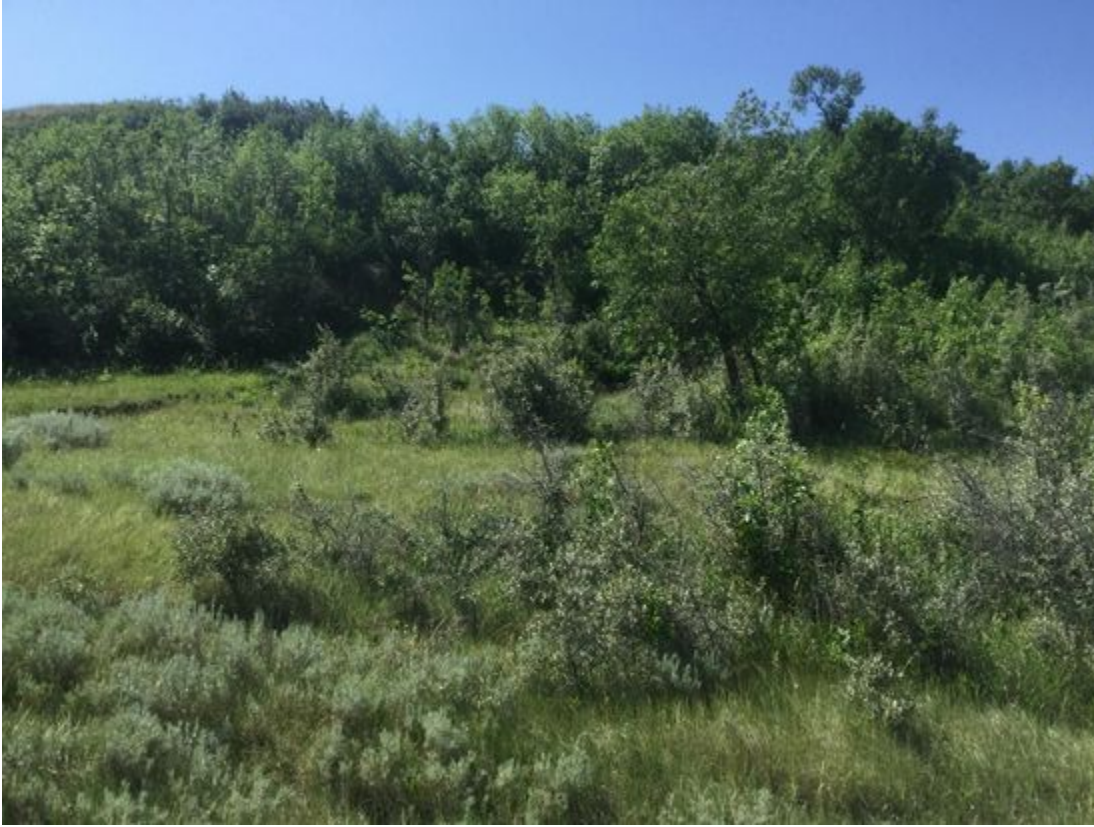
**Photo Description:** Looking up slope at the north-facing slope from near the proposed pipeline corridor.

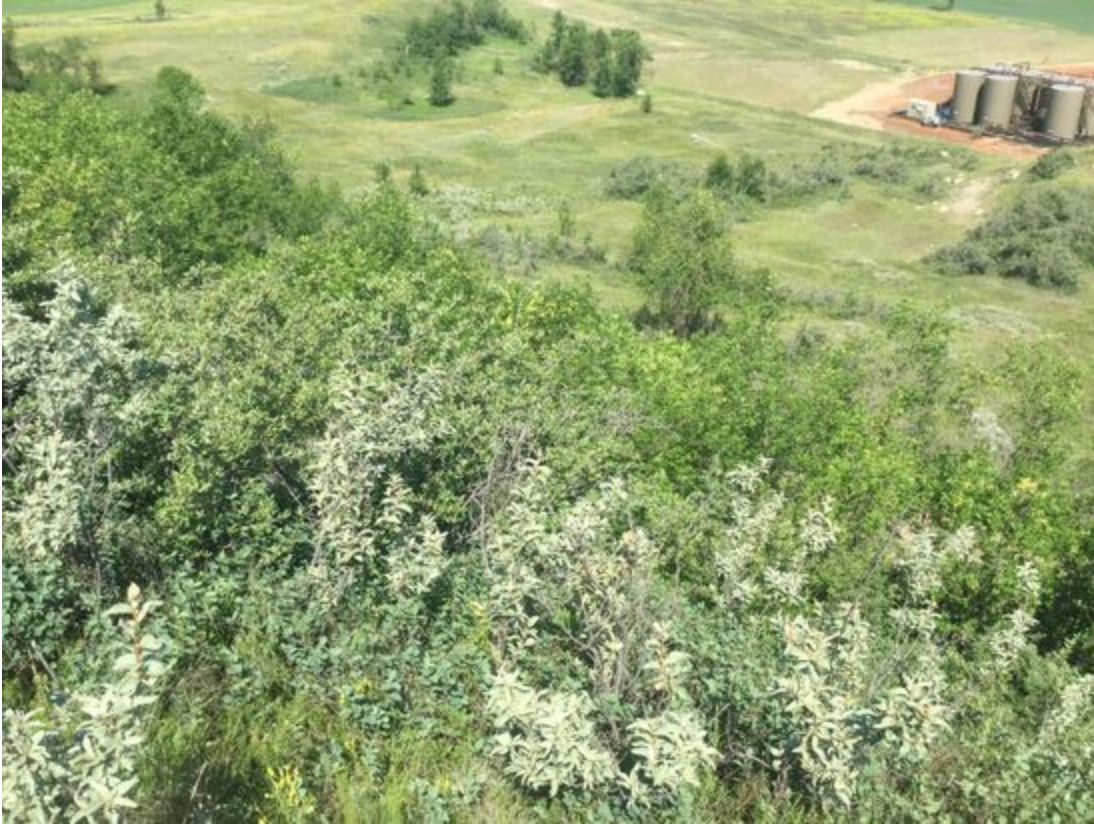
**Photo #6**

**Photo Description:** Looking downslope toward proposed pipeline corridor from the crest of the north-facing slope.

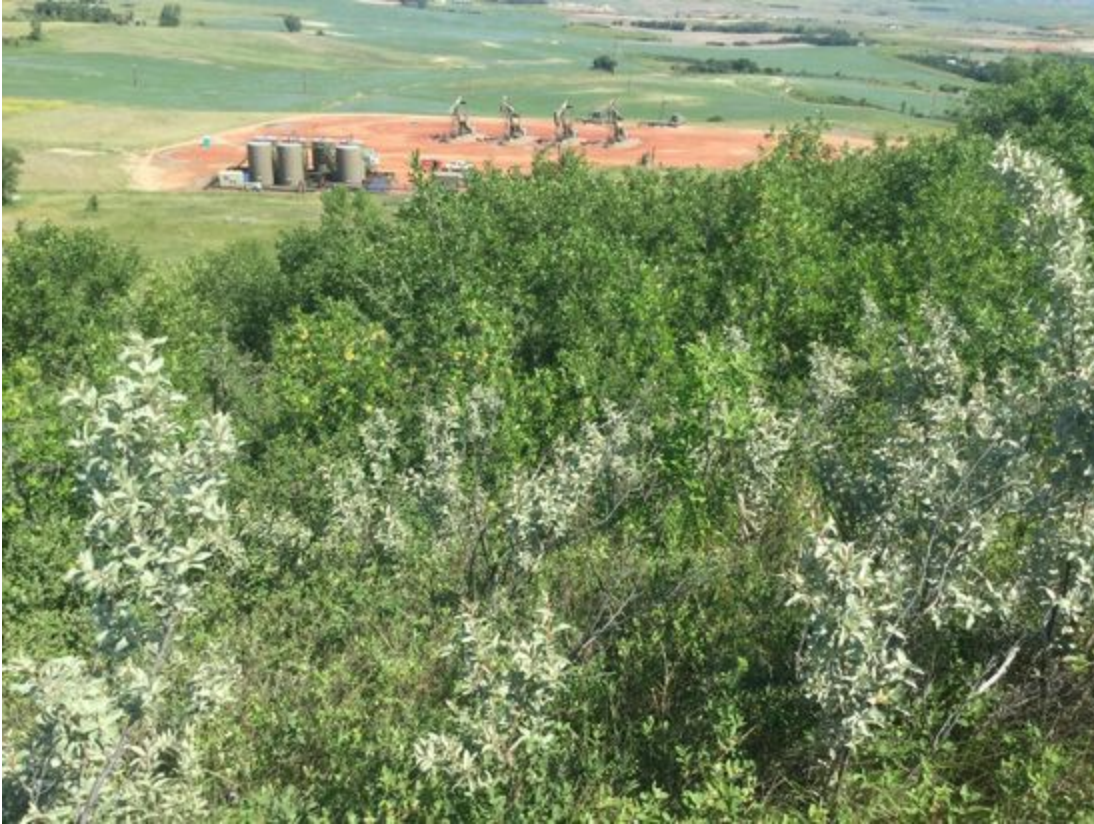
**Photo #7**

**Photo Description:** Looking downslope toward proposed pipeline corridor from the crest of the northwest-facing slope.

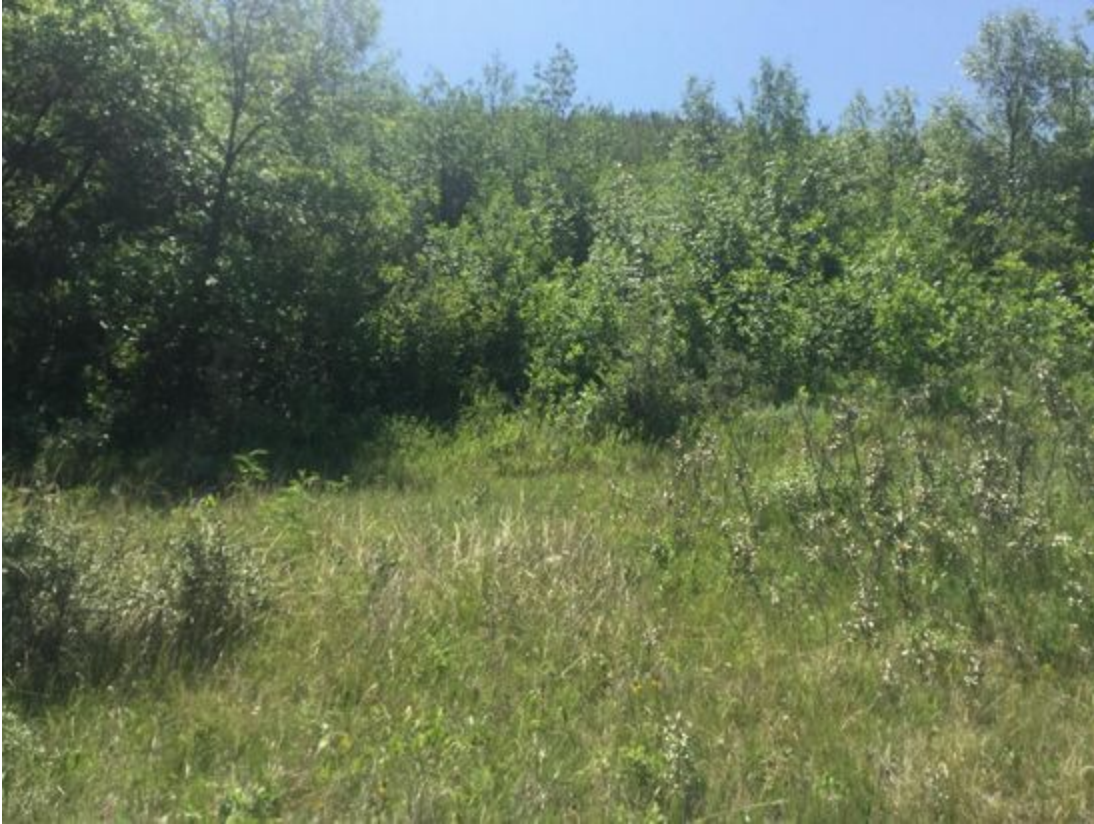
**Photo #8**

**Photo Type:** Looking upslope | **Photo Bearing:** 114 degrees  
**Photo Description:** Looking upslope toward the northwest-facing slope.  
-----

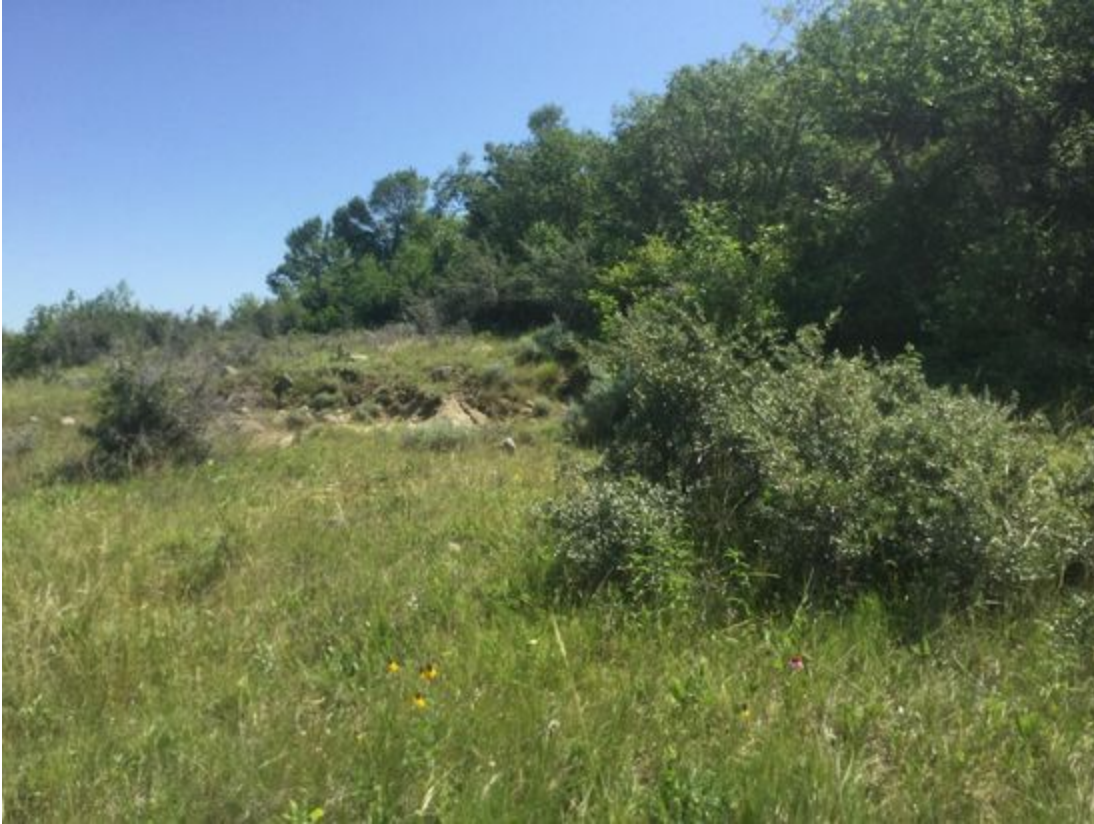
**Photo #9**

**Photo Type:** Looking across slope | **Photo Bearing:** 53 degrees  
**Photo Description:** Looking across the toe of the northwest-facing slope.  
-----

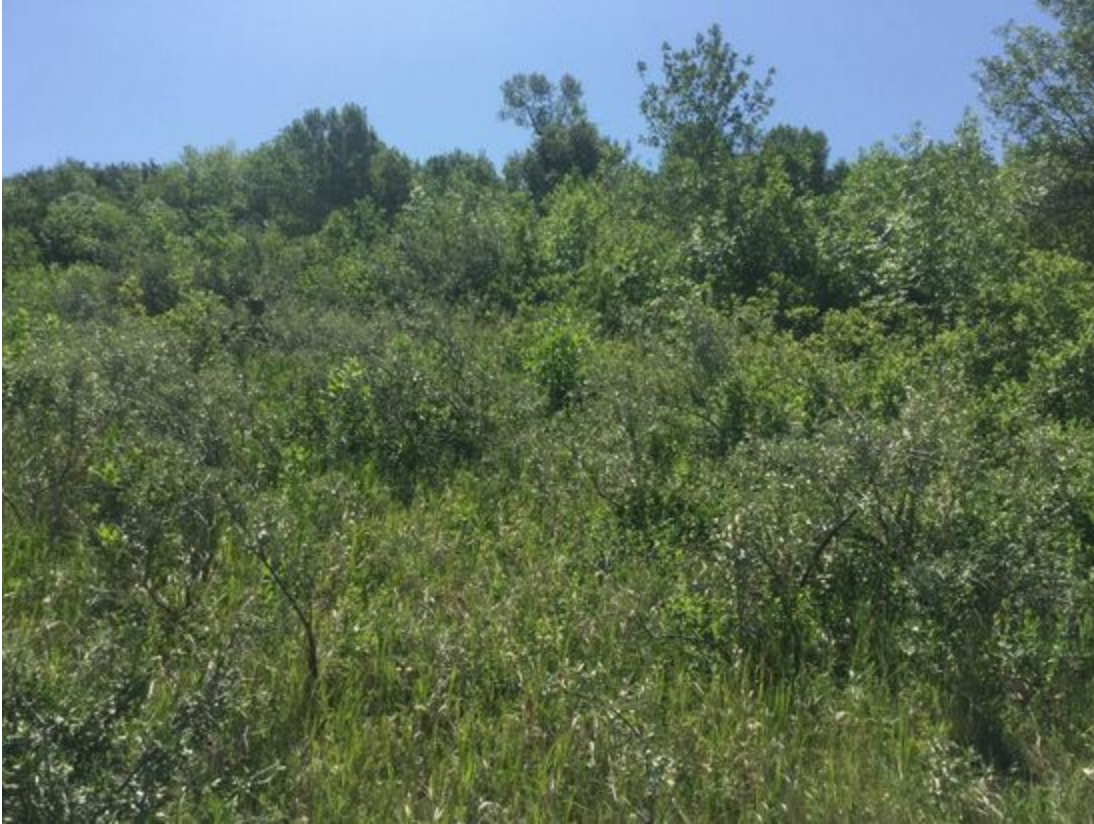
**Photo Description:** Looking upslope near the convergence of the north-facing and northwest-facing slopes.

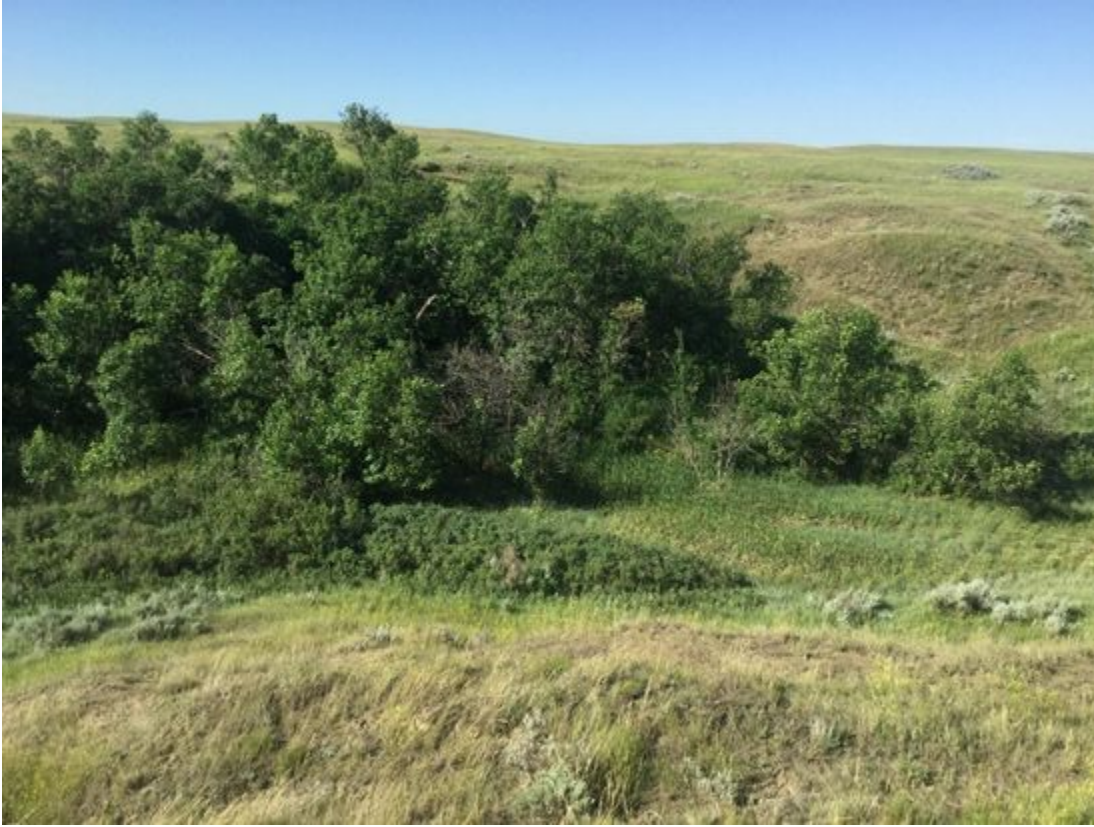
**Photo #1**

**Photo Type:** Looking upslope | **Photo Bearing:** 204 degrees  
**Photo Description:** Looking at slope from opposite drainage bank.

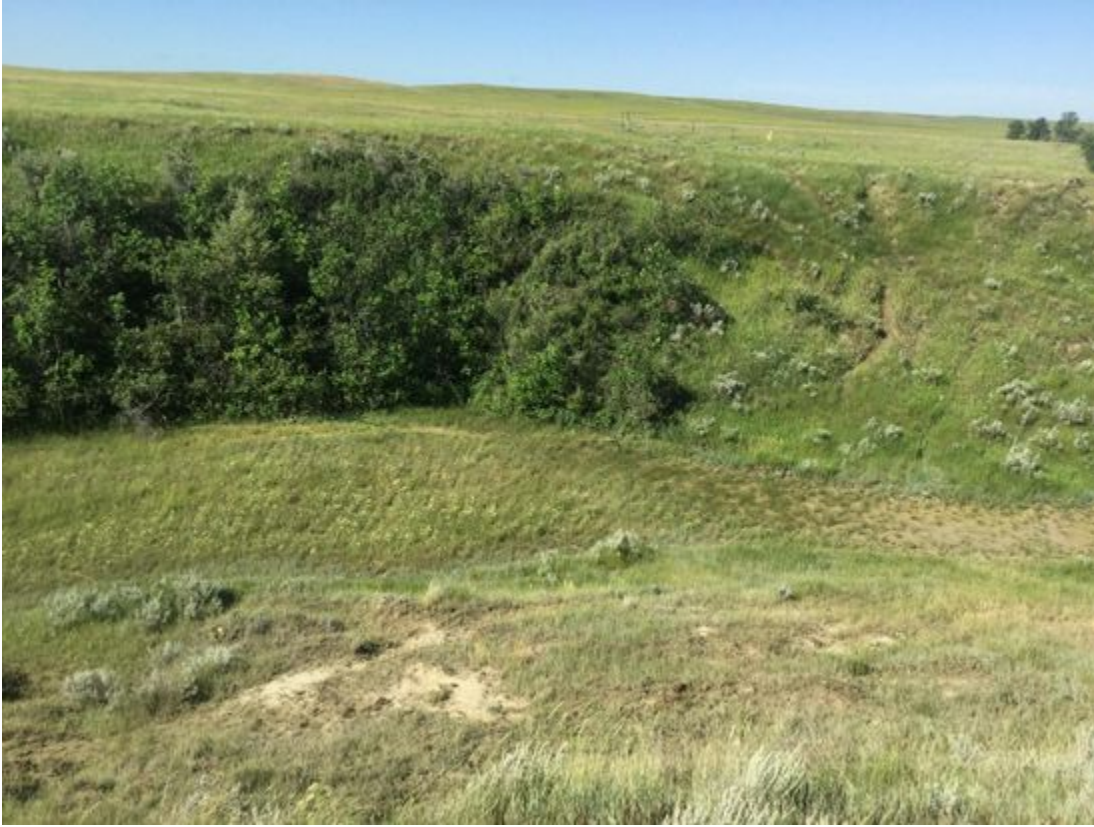
**Photo #1**

**Photo Type:** Looking upslope | **Photo Bearing:** 212 degrees  
**Photo Description:** Looking at the slope face from opposite drainage bank.  
-----
