PU-21-048
Bridger Pipeline, LLC.
South Bend 16-inch Crude Oil
Pipeline
Construction Inspection Report

September 2022

Stantec Consulting Services Inc.
3303 Fiechtner Drive, Suite 100
Fargo, ND 58103

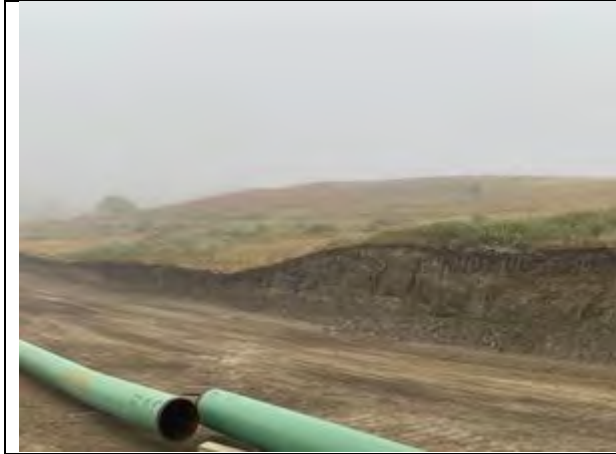
Observation Point: 4

Stripping efforts on steep side slopes (**Observation Points 4, 6, 11, 32, 33, and 37**) were also observed. These areas commonly resulted in large stockpiles on the upslope side of the ROW in order to create a flat workspace and did not contain any trenches at the time of inspection. Stantec was unable to closely

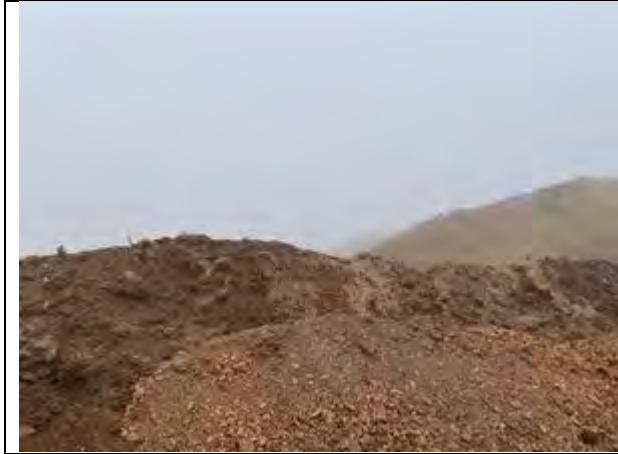
Observation Point: 8
Date Taken: September 15, 2022
Direction Photo is Taken:
Spread: Loenbro

Photo Description: Amount of subsoil mixing minimized on stockpiles.

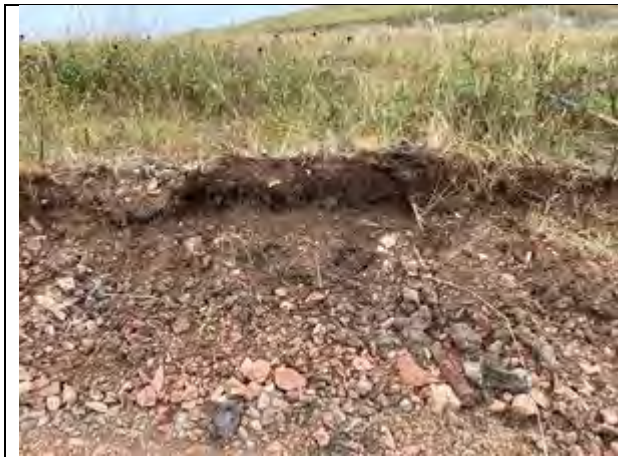
Observation Point: 9 (Photo 1)
Date Taken: September 15, 2022
Direction Photo is Taken:
Spread: Loenbro

Photo Description: Subsoil/C material on shallow topsoil stockpile. Stripping was too deep in first lift. Granted, the coarse frags are shallow. 40 ft area of mixing. Assumed not purposely done and a minor issue.

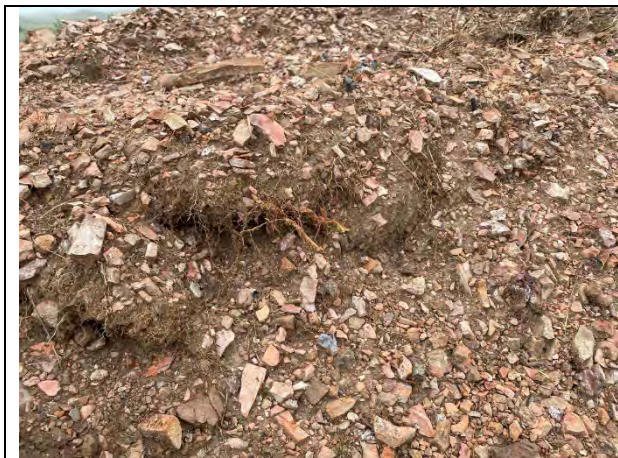
Observation Point: 9 (Photo 2)
Date Taken: September 15, 2022
Direction Photo is Taken:
Spread: Loenbro

Photo Description: Subsoil/C material on shallow topsoil stockpile. Stripping was too deep in first lift. 40 ft area of mixing.

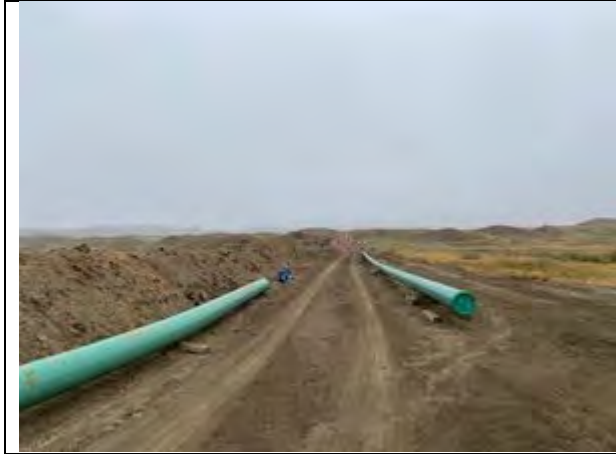
Observation Point: 10
Date Taken: September 15, 2022
Direction Photo is Taken: Northwest
Spread: Loenbro

Photo Description: Alignment agrees with route shapefile. The ROW is not trenched yet.

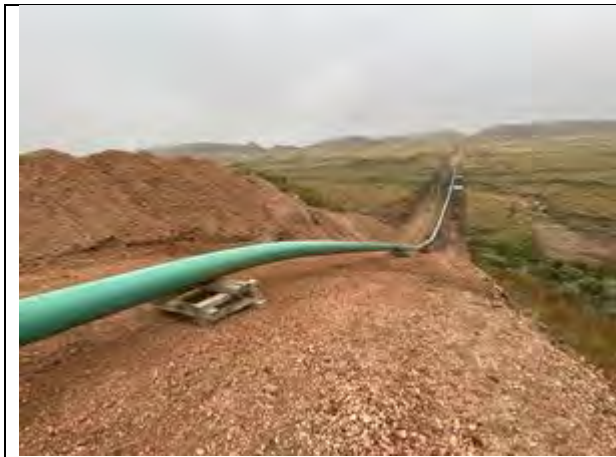
inspect the stockpiles due to the height of the side slope cut and could not confirm appropriate segregation of topsoil. Erosion control BMP's were observed in swales of steep slope areas (**Observation Points 24 [Photo 2] and 25**). Stantec also noticed no topsoil was stripped at **Observation Point 11** but may have been due to no natural topsoil at this landform.

Observation Point: 11
Date Taken: September 15, 2022
Direction Photo is Taken: Northeast
Spread: Loenbro

Photo Description: No topsoil salvaged, as little to none is present on this hilltop. Right of way view in badland/rocky area. Wetlands are in the background, with areas of the ROW under water.

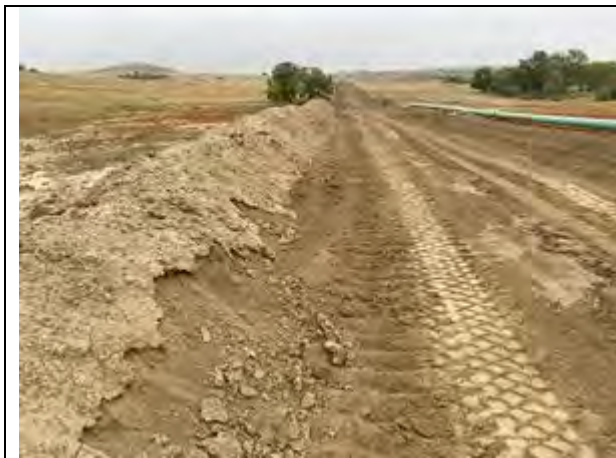
Right-of-way areas on flatter topography were observed to have contain in-situ soil that commonly contained plant roots, but was determined to be subsoil and not in violation of ND PSC rulings (**Observation Points 12, 29, 45, and 46**). A Bridger personnel confirmed that topsoil was stripped up to 12-inches where suitable. **Observation Point 26** (and near **Observation Point 27**) did not appear to contain any stripping at all despite heavy equipment traffic. Unstripped topsoil on the ROW could be susceptible to compaction or subsoil mixing during trenching and soil backfilling, which should be salvaged during trench operations, and compaction mitigated during reclamation.

Observation Point: 12
Date Taken: September 15, 2022
Direction Photo is Taken: Northeast
Spread: Loenbro

Photo Description: Suitable ROW segregation.

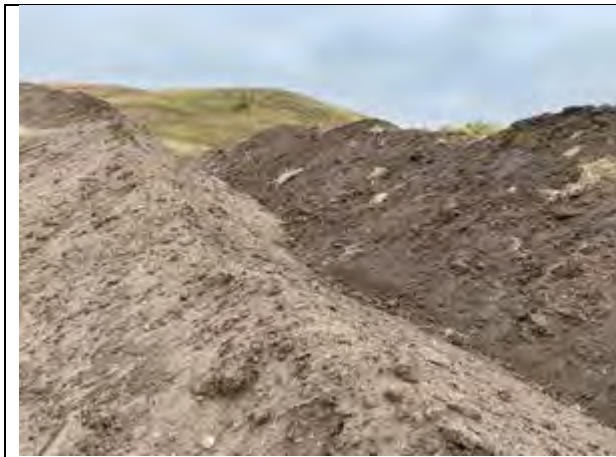
Observation Point: 16

Photo Description: The stockpiling and segregation is appropriate. Areas with overlapping stockpiles will most likely mix upon replacement.

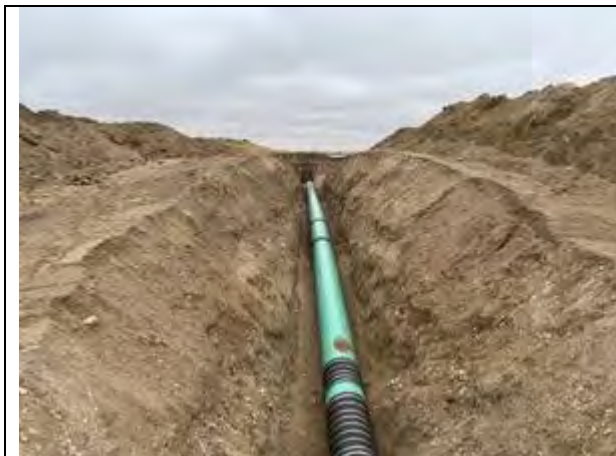
Observation Point: 17

Photo Description: Pipeline confirmed to be buried below 48 inches assuming topsoil replacement is >5 inches.

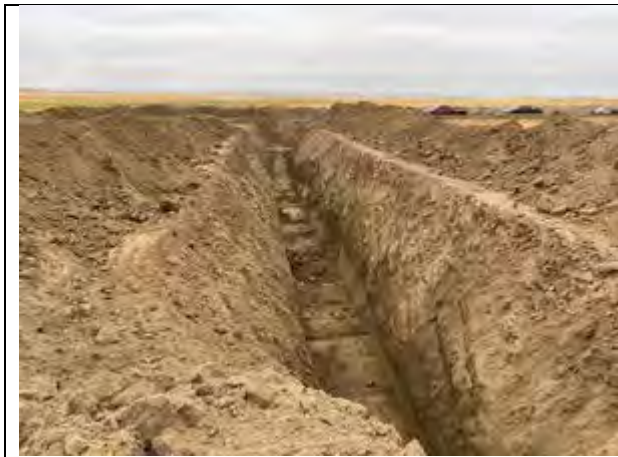
Photo Description: Additional excavation around existing pipelines, and brine lines.

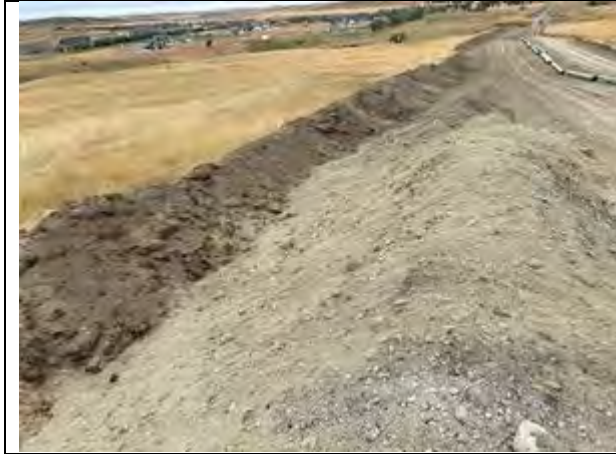
Photo Description: Minor mixing of subsoil stockpile on top of topsoil. Nearby geologically unstable area outside of active ROW.

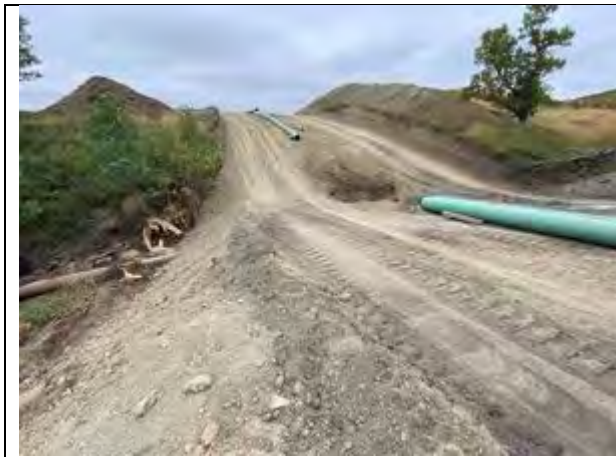
Photo Description: Construction near geologically unstable area. Uncertain where topsoil stockpile is in this portion of ROW.

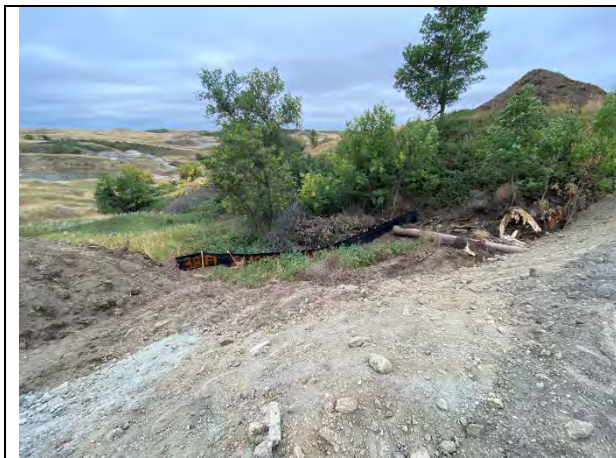
Photo Description: Construction through geologically unstable area. Adequate buffer is Bridger's planned physical mitigation strategy. Silt Fence installed in swale.

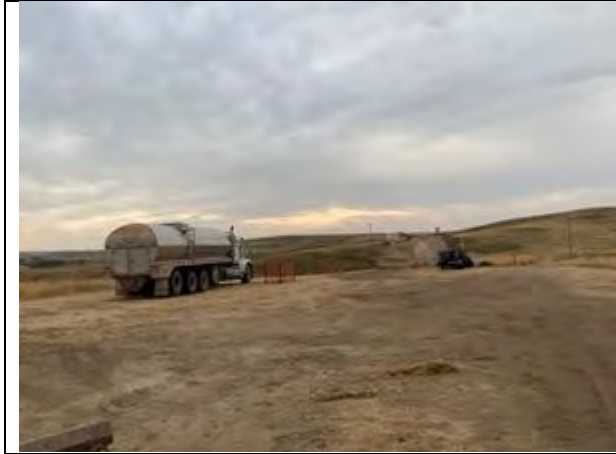
Observation Point: 26

Photo Description: In-situ Topsoil still remaining in ROW workspace. Recommend additional topsoil salvage during trenching and decompaction during replacement.

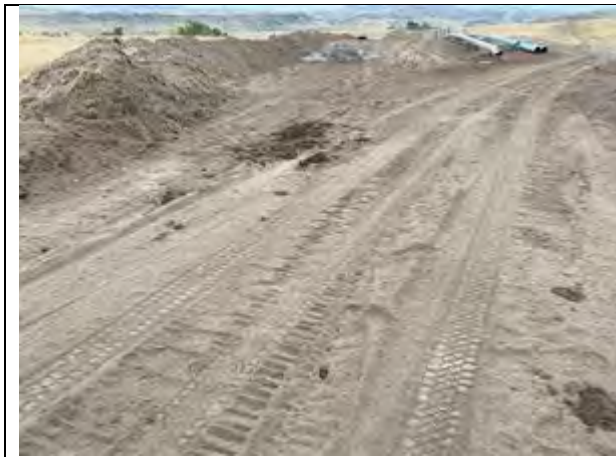
Observation Point: 27 (Photo 1)

Photo Description: Topsoil remains unstripped in approach area. Recommend additional topsoil salvage prior to trenching and decompaction during replacement.

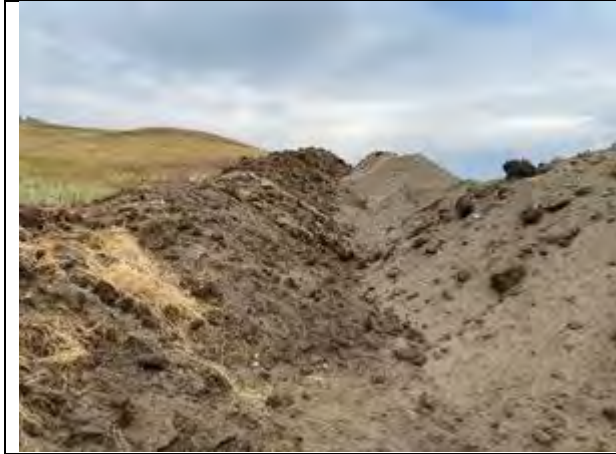
Photo Description: Topsoil and subsoil separated with minor stockpile mixing.

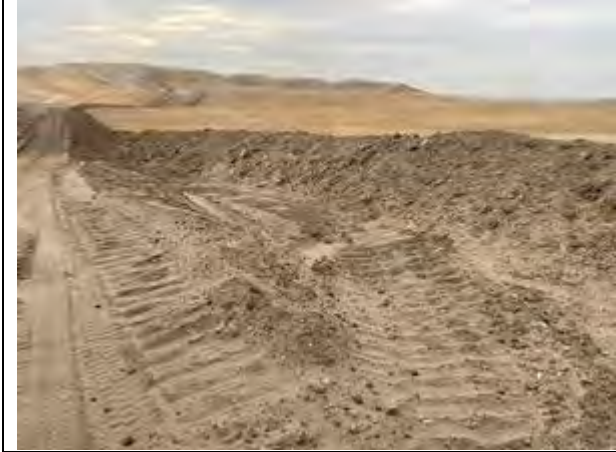
Photo Description: Topsoil segregated correctly and not mixing with subsoil.

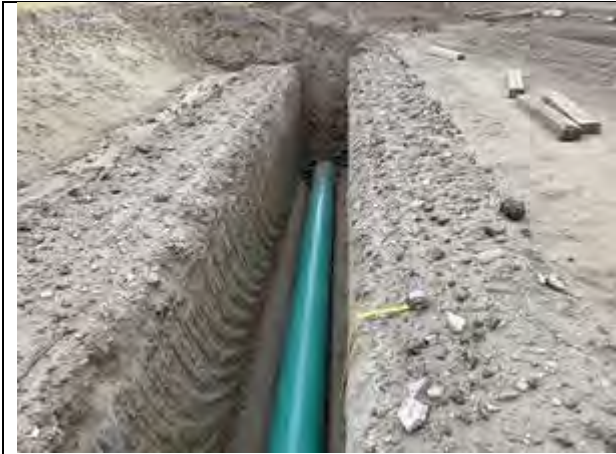
Photo Description: Pipeline depth \geq 48 inches below grade. Backfilling in progress with appropriate grading.

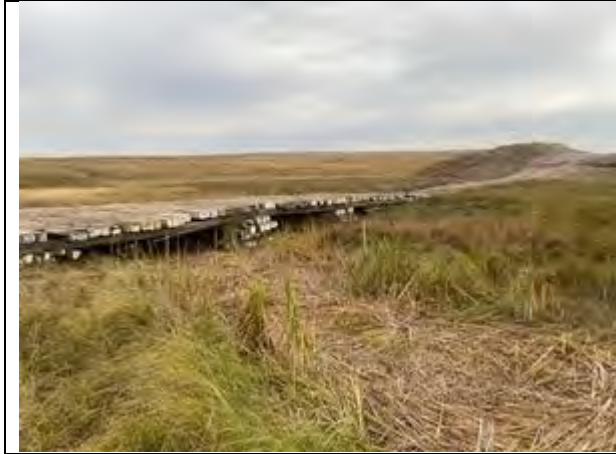
Photo Description: Use of timber mat through wetland.

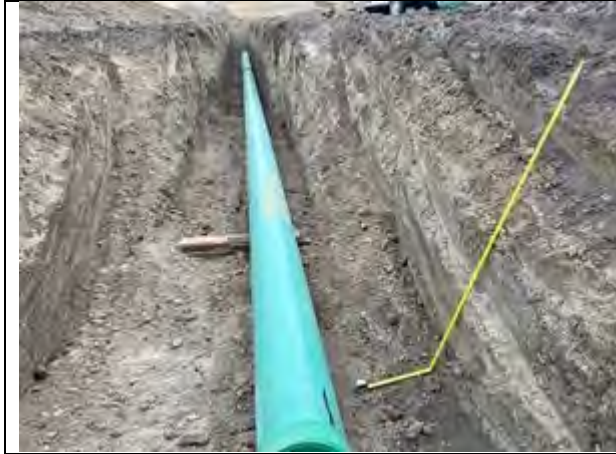
Photo Description: Adequate pipe depth.

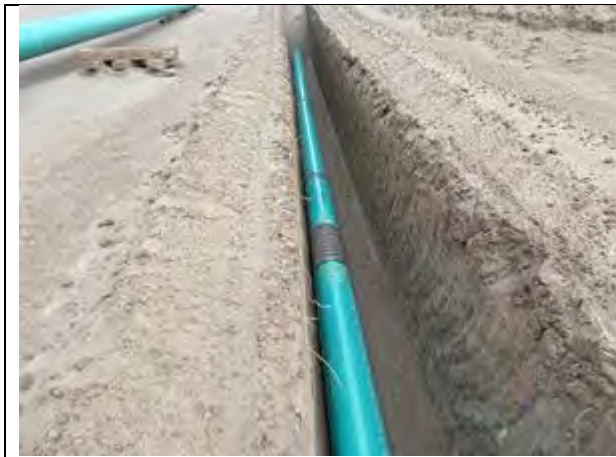
Photo Description: Pipeline confirmed to be ≥ 48 inches deep.
