PU-21-048
Bridger Pipeline, LLC.
South Bend 16-inch Crude Oil
Pipeline
As-Built Inspection Report

May 2023

Stantec Consulting Services Inc.
3303 Fiechtner Drive, Suite 100
Fargo, ND 58103

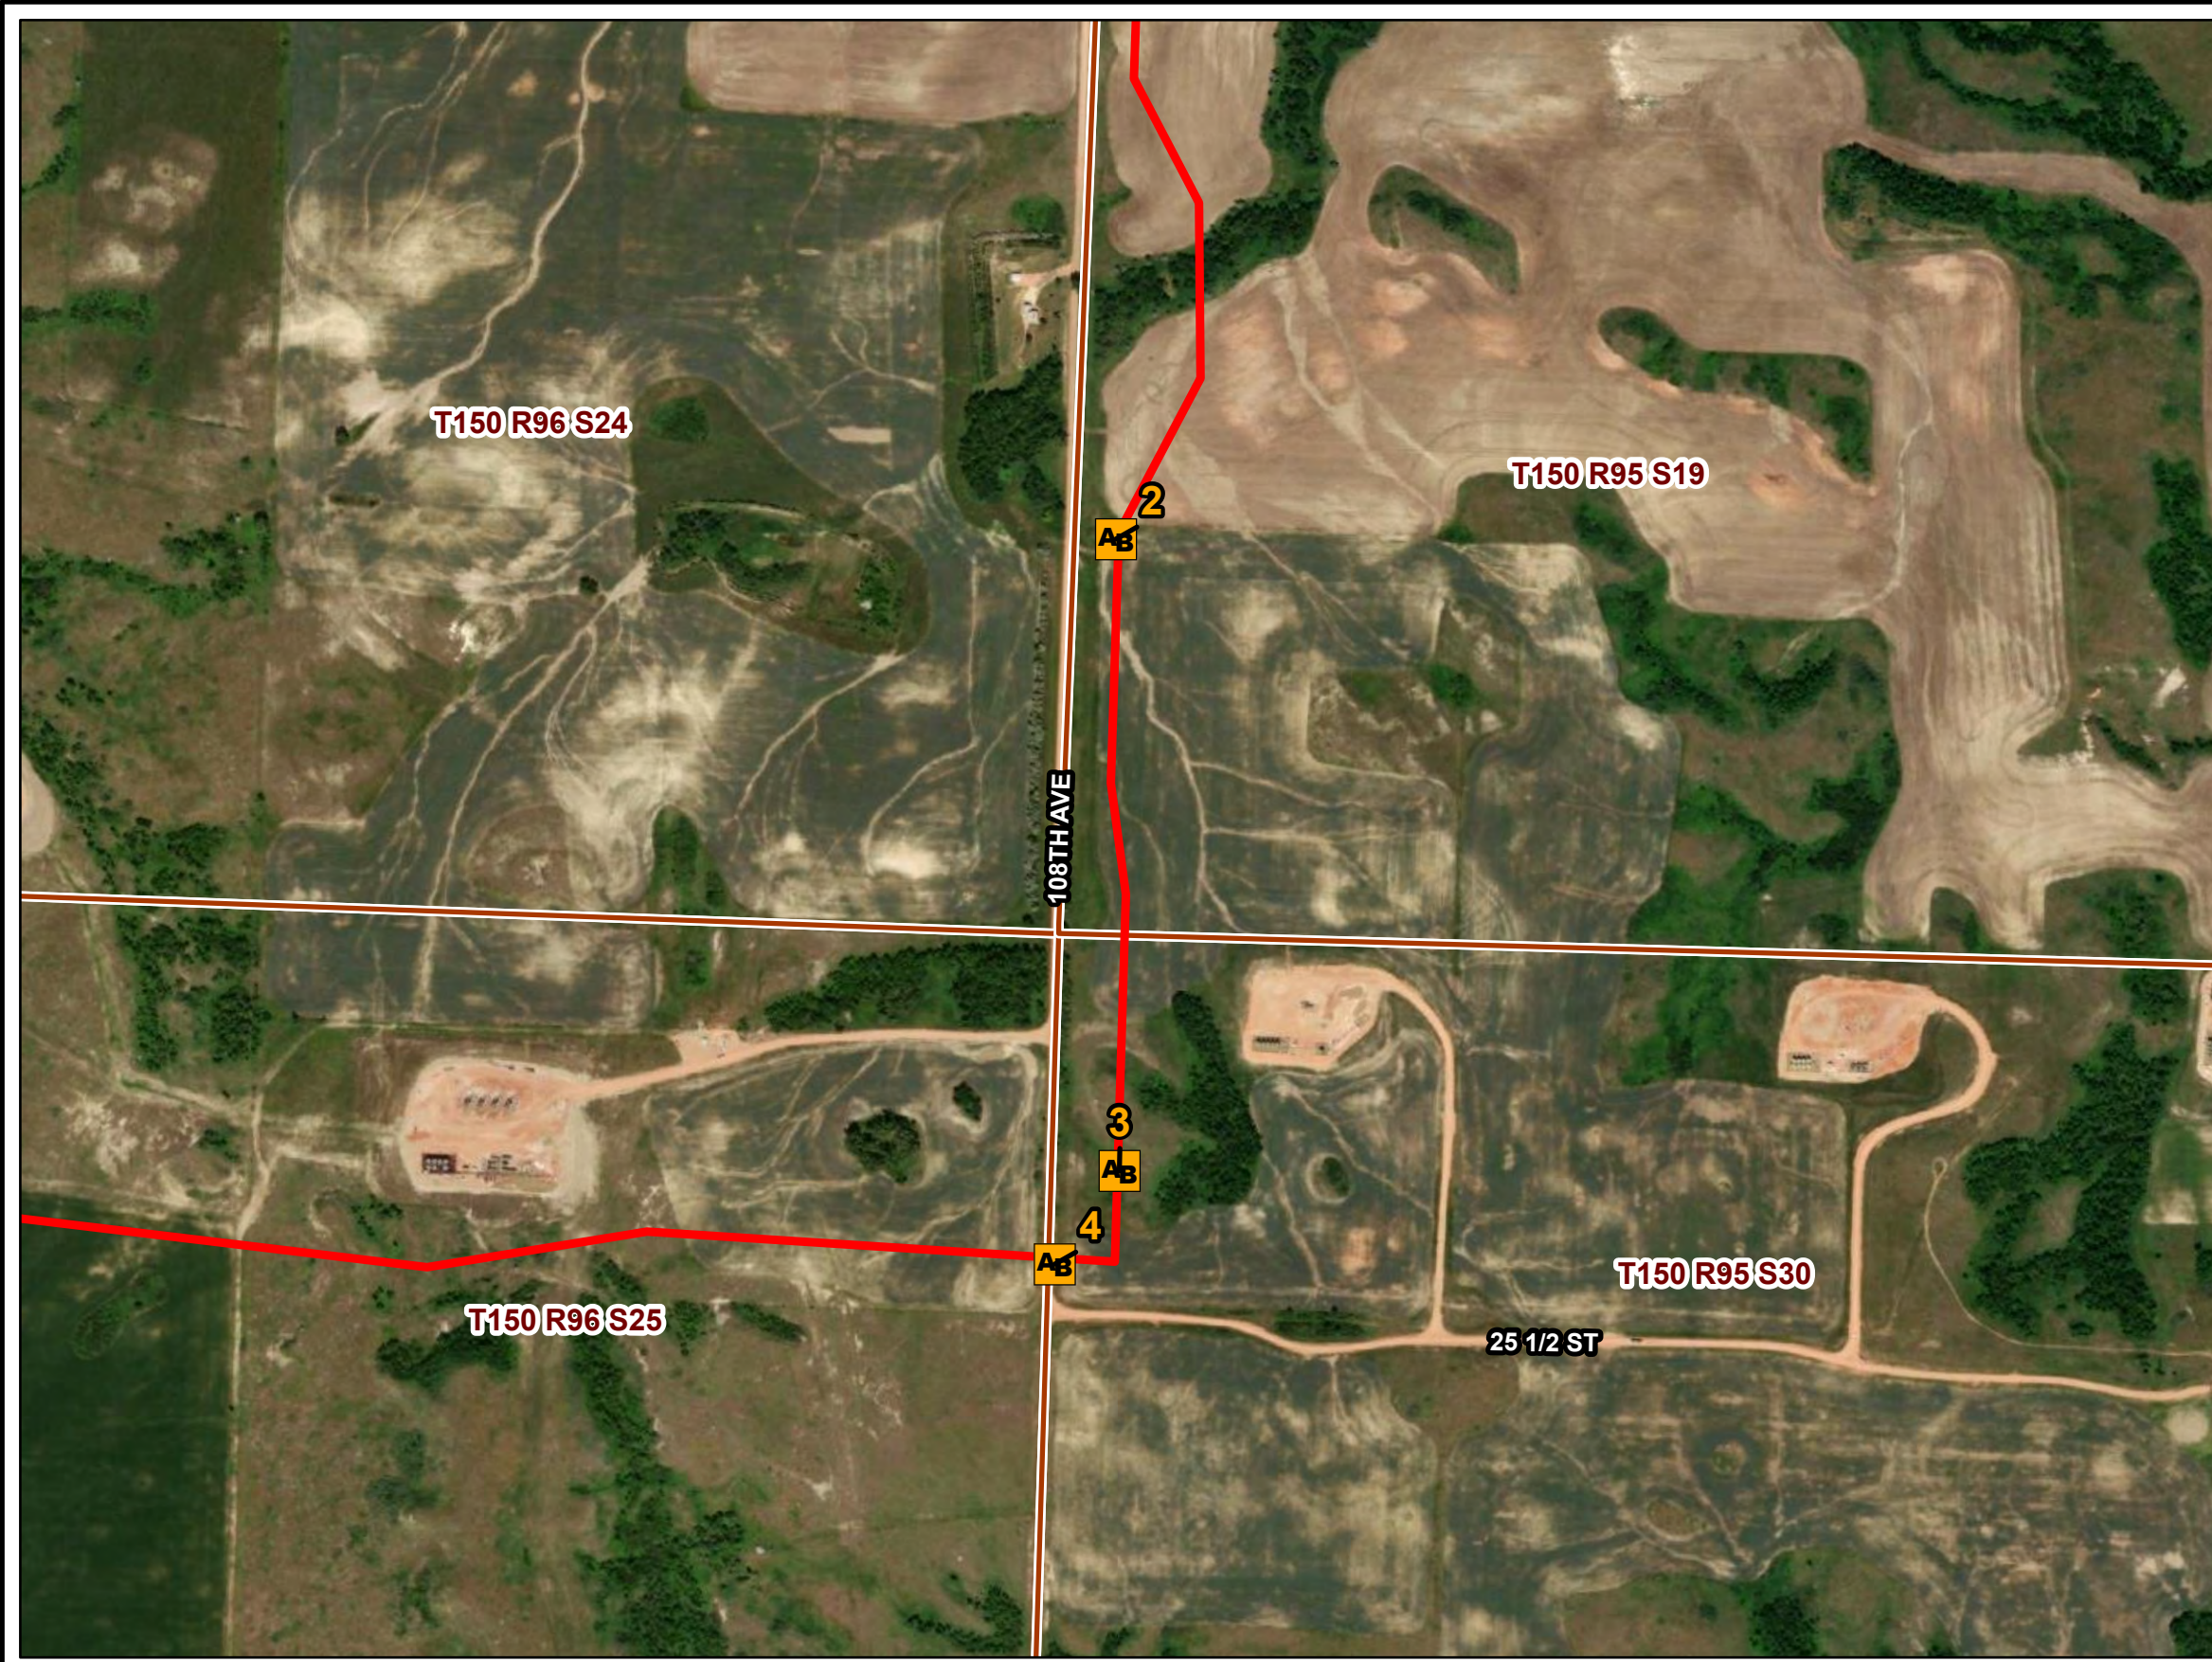
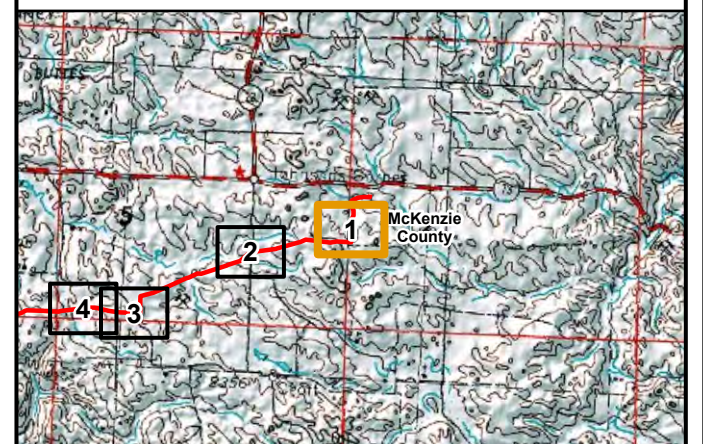
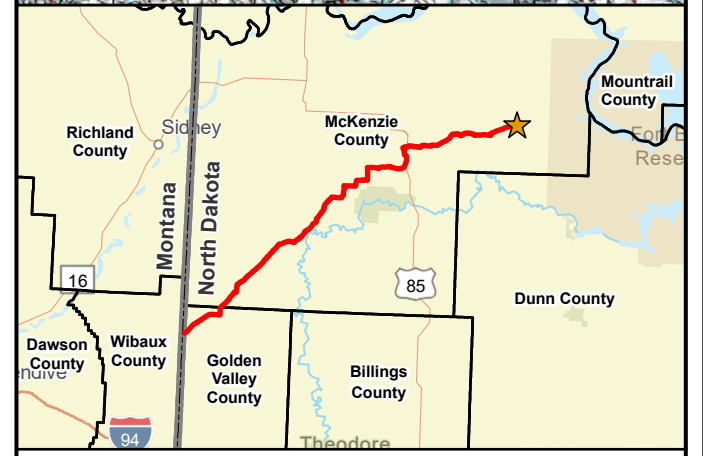
**Bridger Pipeline
Figure 1**

All road crossing permits detail specifications to be followed which include no disturbance and restoration clauses. At all road crossings inspected, Stantec visually confirmed crossings were conducted through boring operations and have not altered the road surface (**Figure 1, 3; Appendix A, Observation Point Photolog 4, 8**).

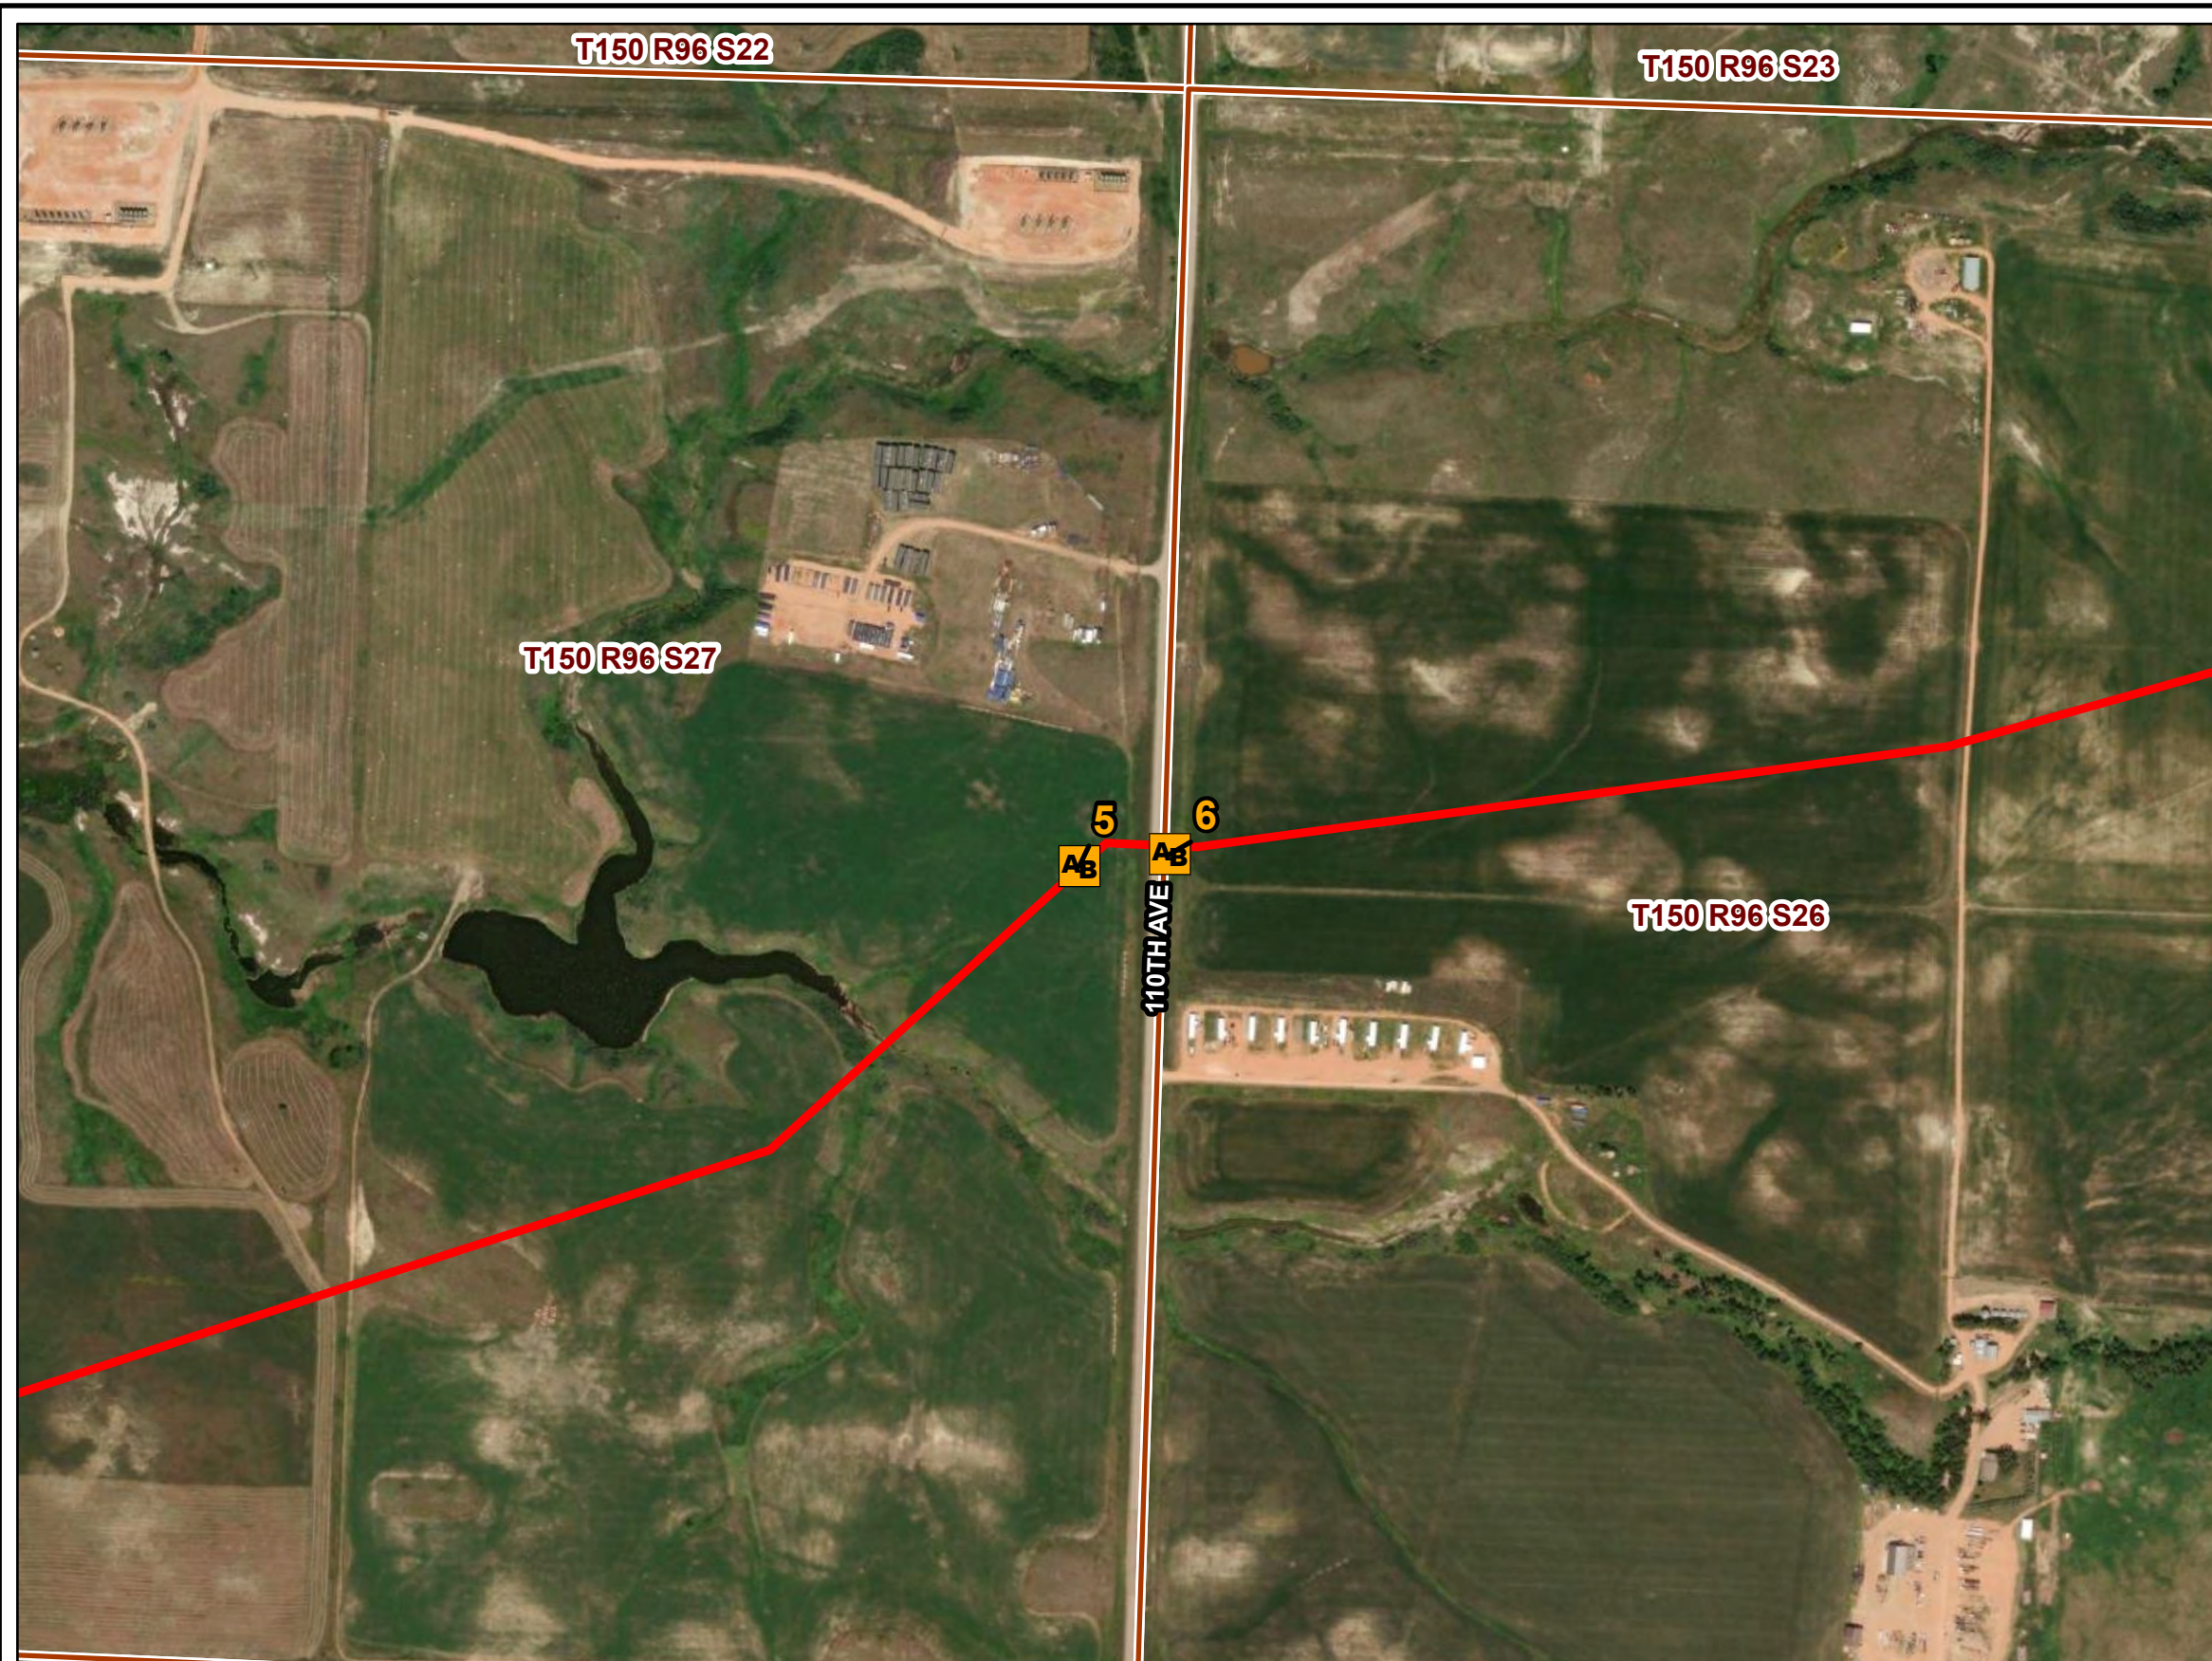
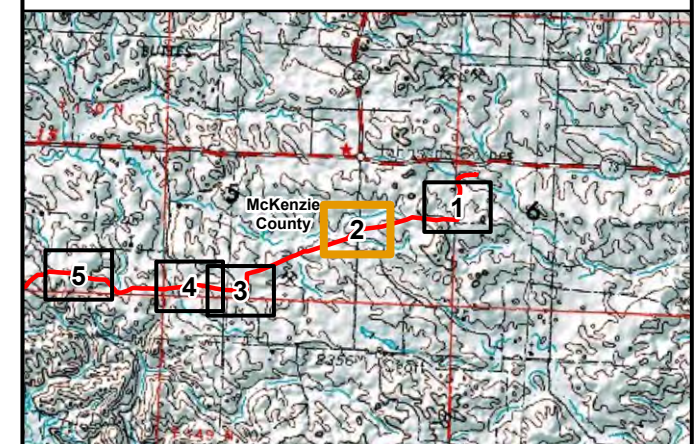
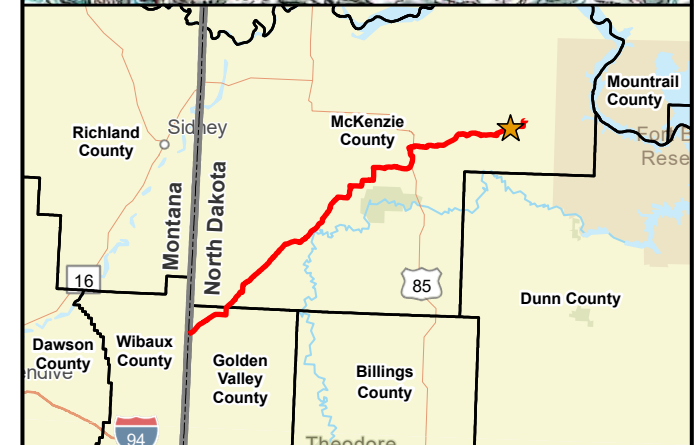
**Bridger Pipeline
Figure 2**

Bridger committed to repairing and replacing all fences and gates (PSC Order Provision #22, Docket #65, 8 June 2022). Generally, existing fences and/or gates that were impacted by pipeline construction appeared to be replaced or repaired as needed (**Figures 2, 4, 12, 19, 25; Appendix A, Observation Photolog 6, 9, 12, 41, 48, 69**). At one location, the fence was replaced, but the wires were broken (**Figure 6; Appendix A, Observation Photolog 6, 9, 12, 41, 48, 69**). It is unclear if this fence damage occurred during reclamation efforts. Fence should be repaired as soon as possible as to not interfere with landowner agricultural practices.

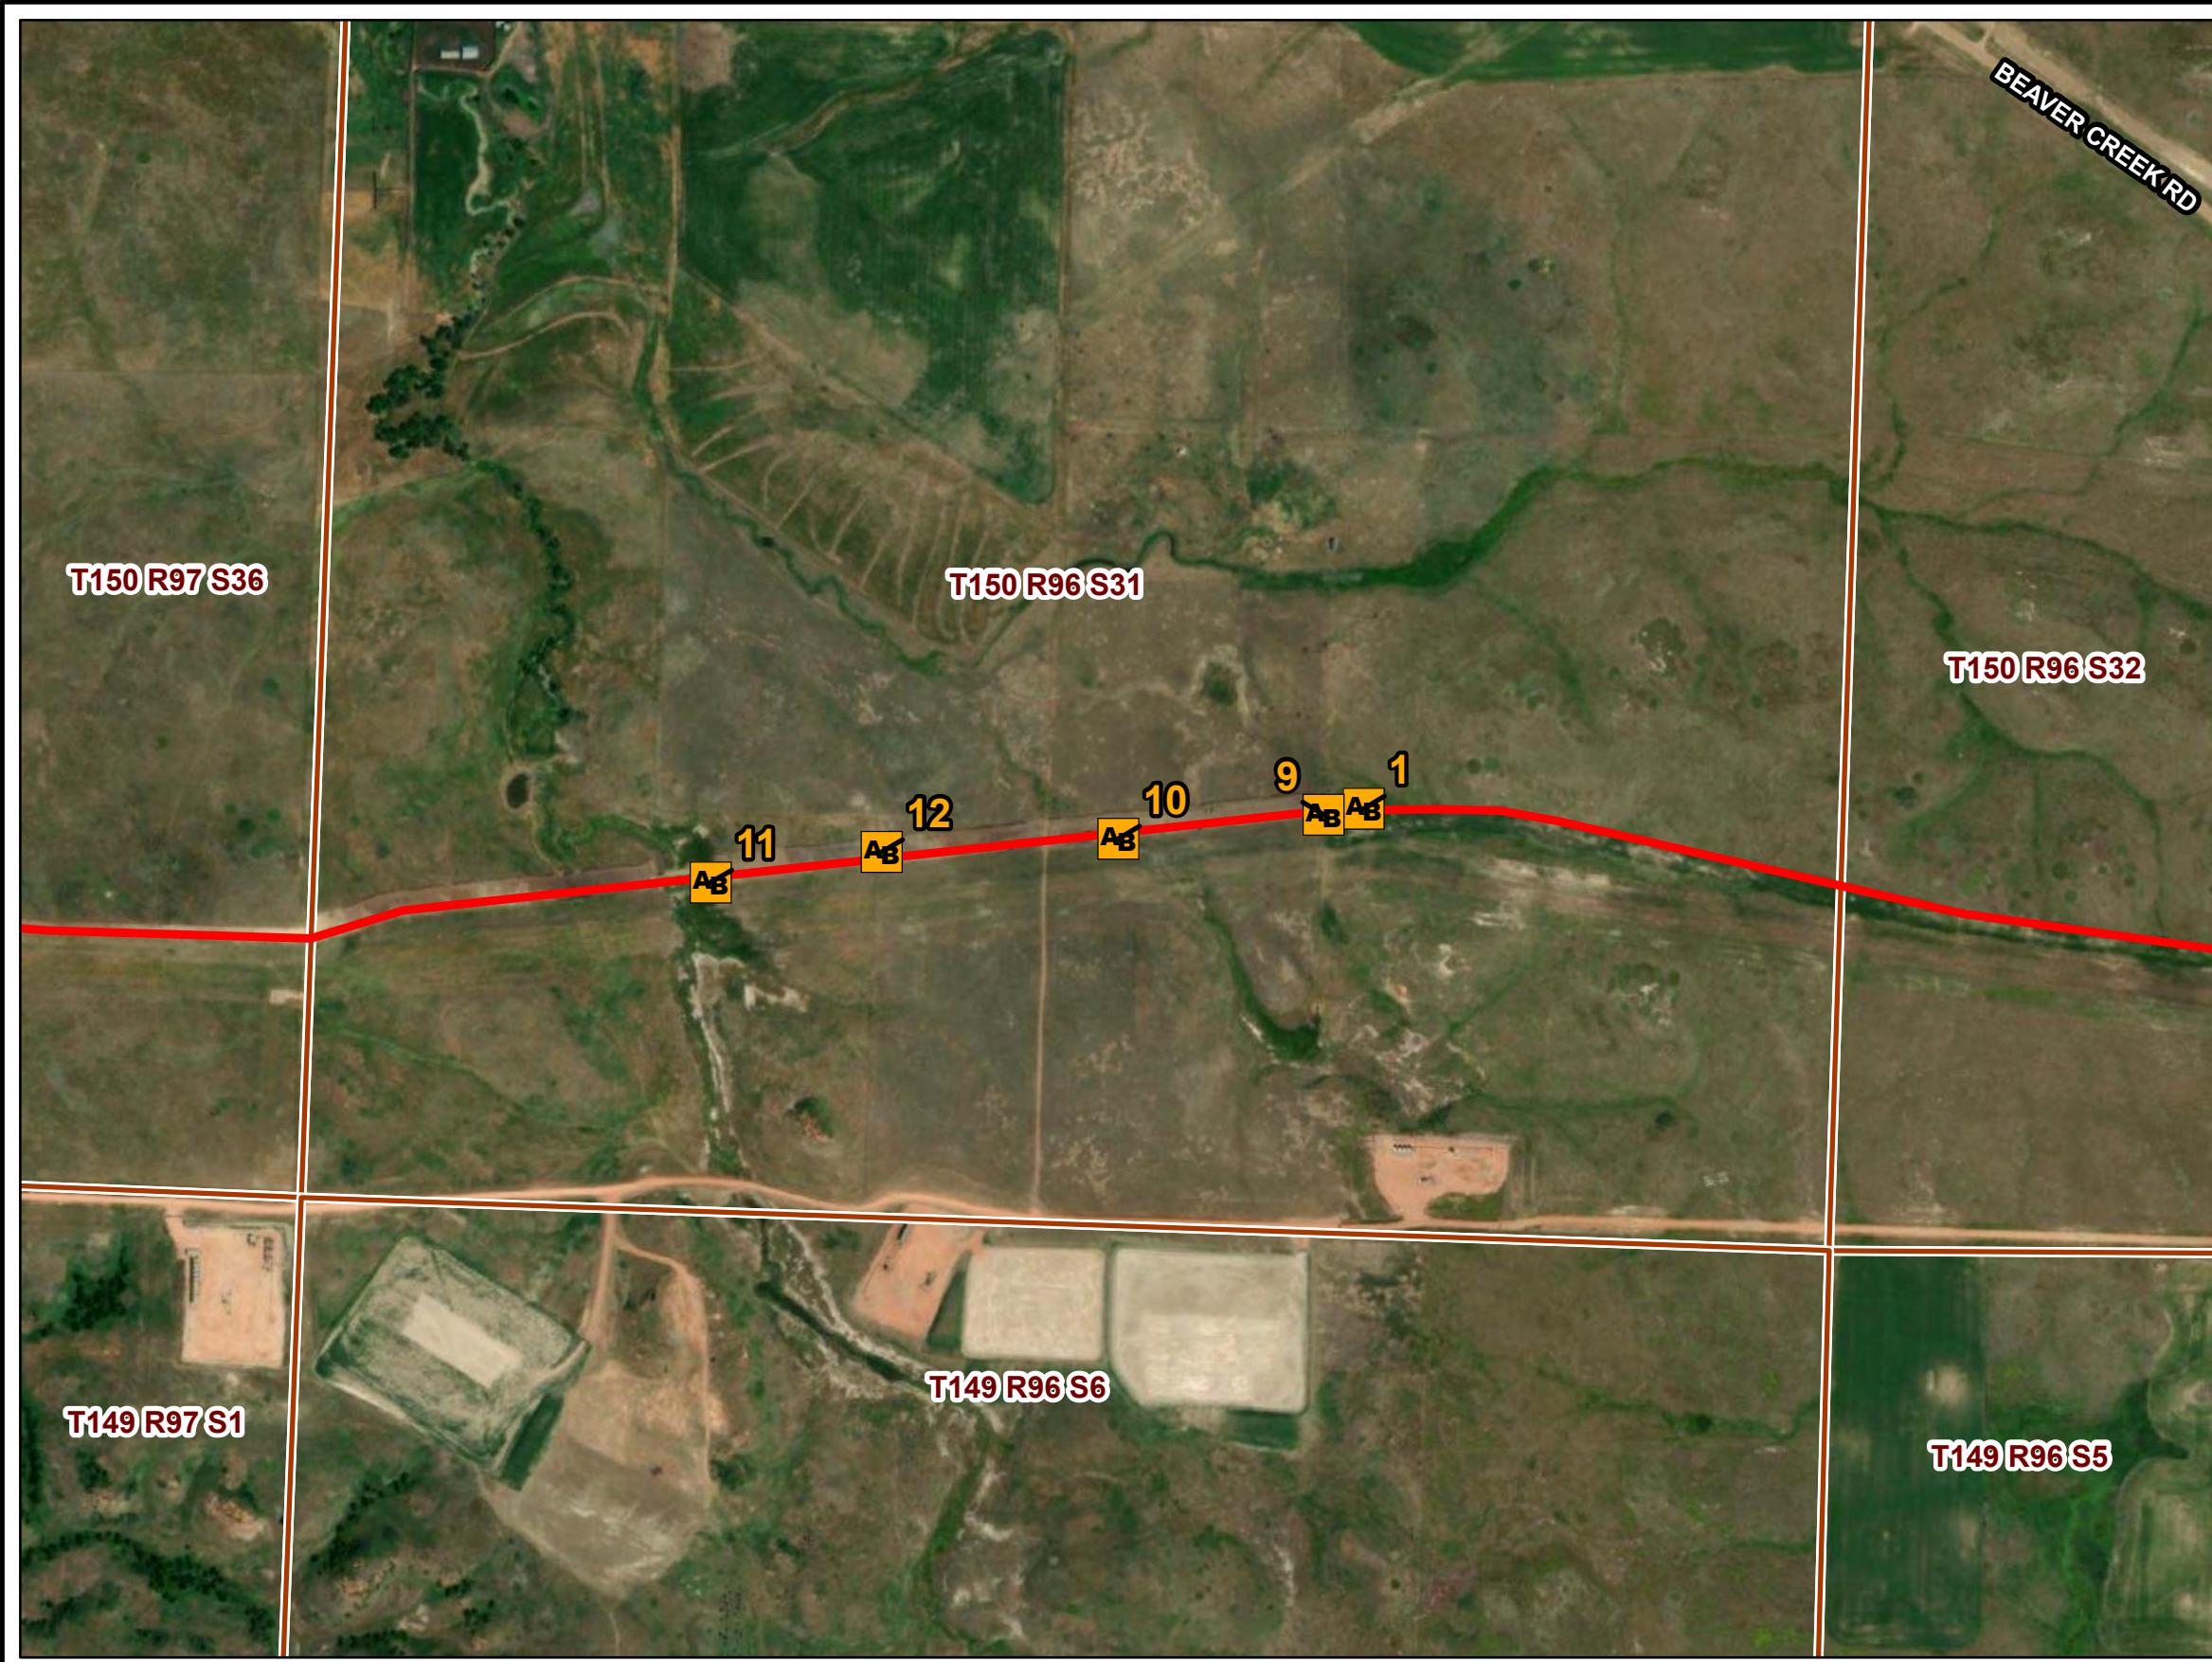
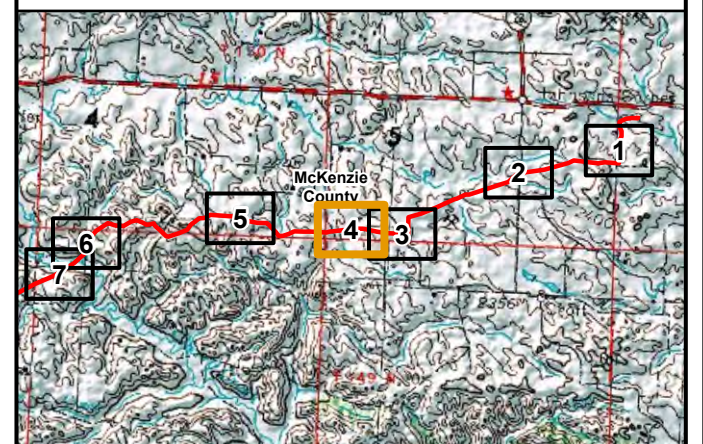
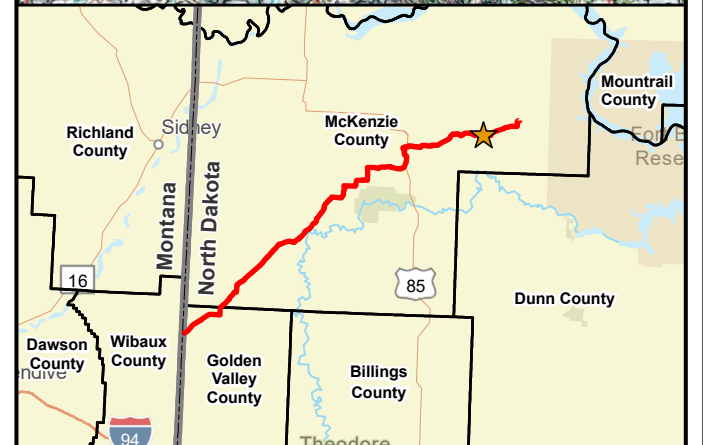
**Bridger Pipeline
Figure 4**

The Project alignment crosses several wetlands and/or streams and were inspected to ensure compliance with the PSC order provisions. Impacts to wetlands can be mitigated through use of BMP's such as silt fences or timber mats but must be removed following construction. Timber mats at wetland/Stream crossings were removed and no mats were observed at wetland/stream crossings along the route. One area of potential concern is where tracked vehicles appeared to cross a wet drainage area leaving impressions in which water was flowing (**Figure 4; Appendix A, Observation Point Photolog**

11). It is unclear when this crossing occurred and if it was associated with the pipeline construction. Construction in wetland and streams was observed to be conducted via HDD boring techniques per FoF #12.

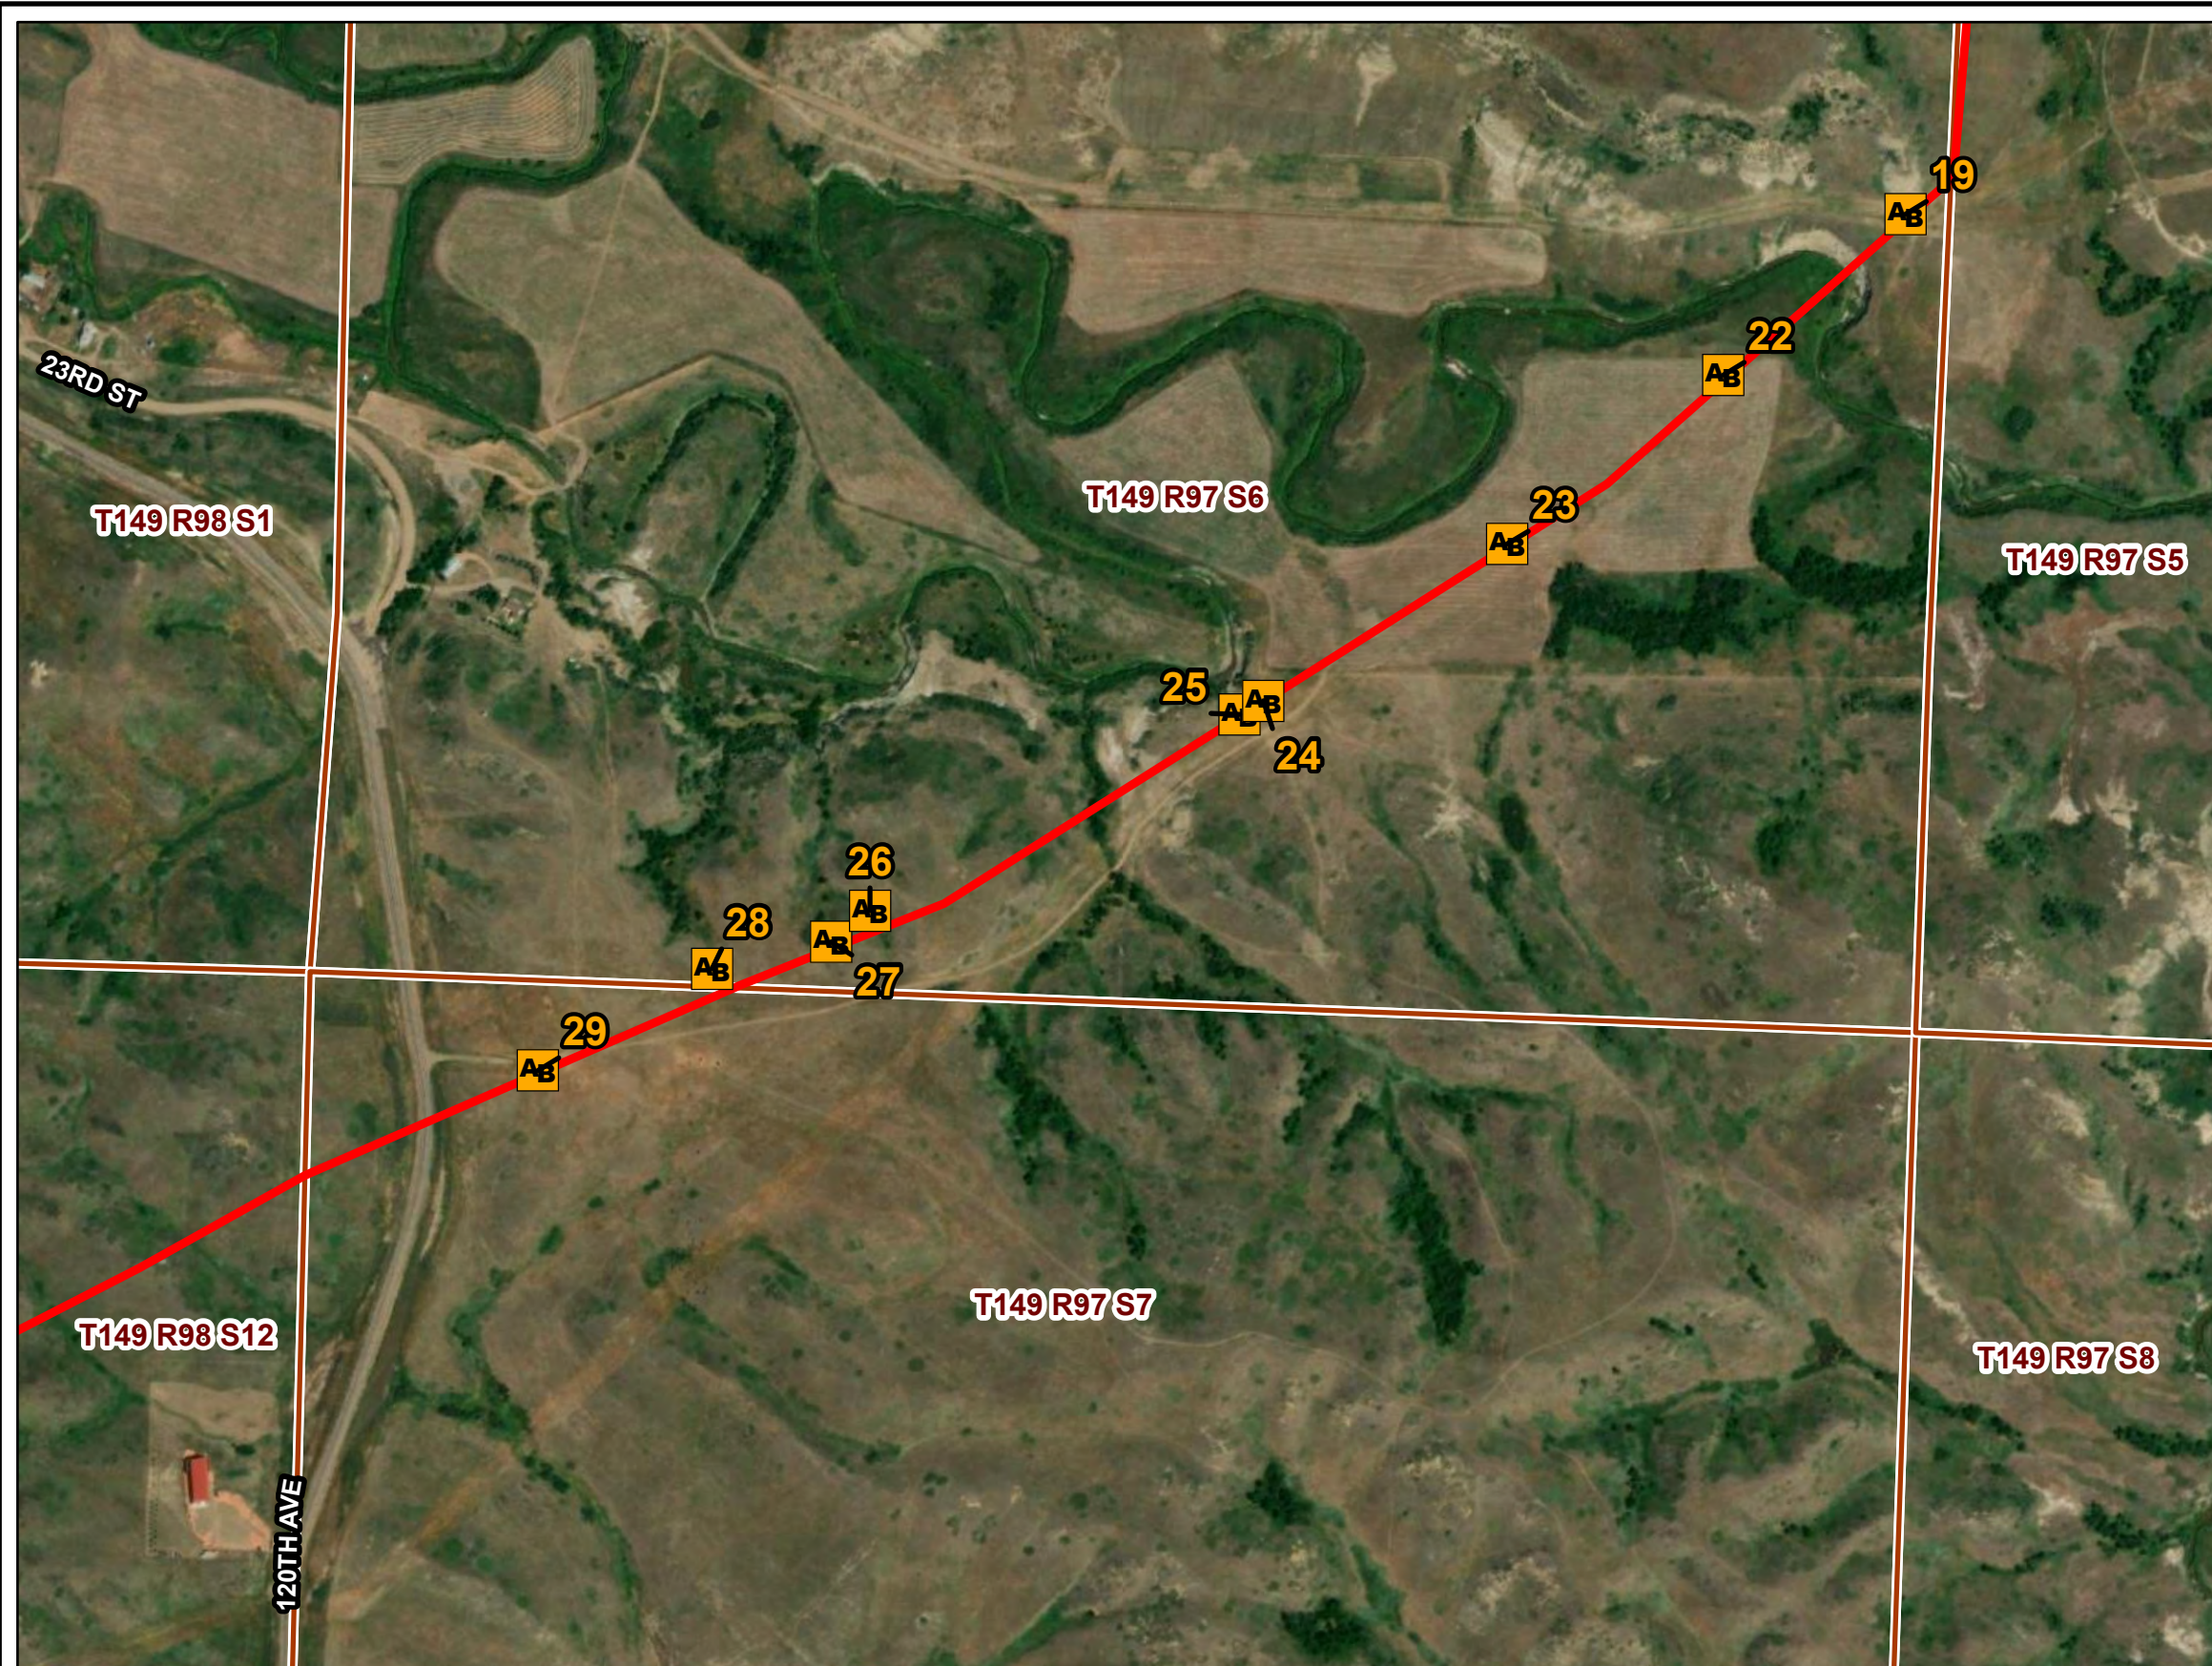
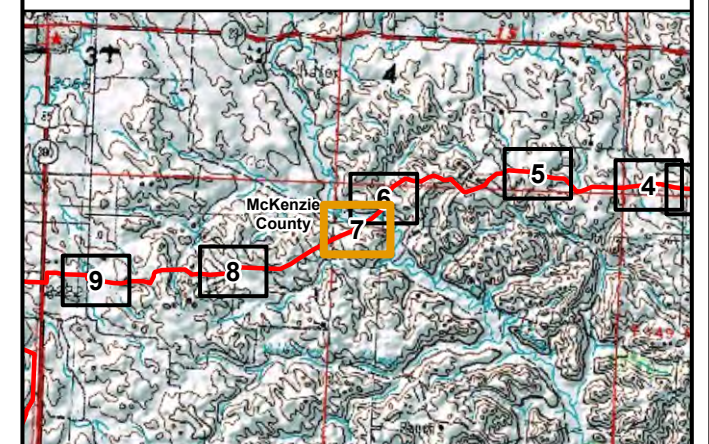
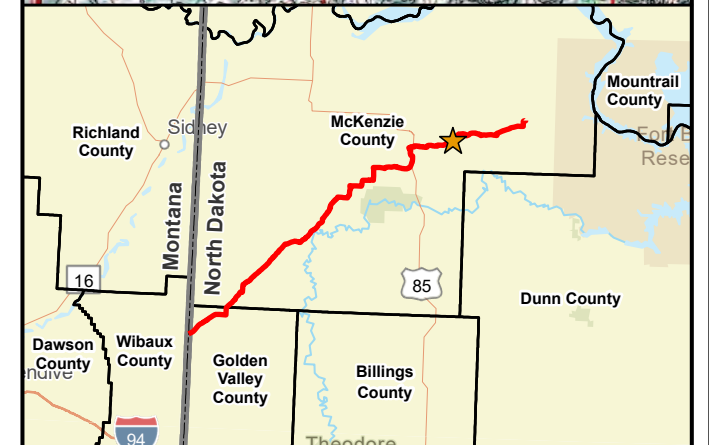
**Bridger Pipeline
Figure 7**

Prior construction inspection of right-of-way areas on flatter topography were observed to not contain any stripping and would be susceptible to compaction. Current inspection of these areas did not show any signs of compaction and soil respread and grading appeared to be in compliance with PSC Order #18 (**Figure 7; Appendix A, Observation Point Photolog 29**).

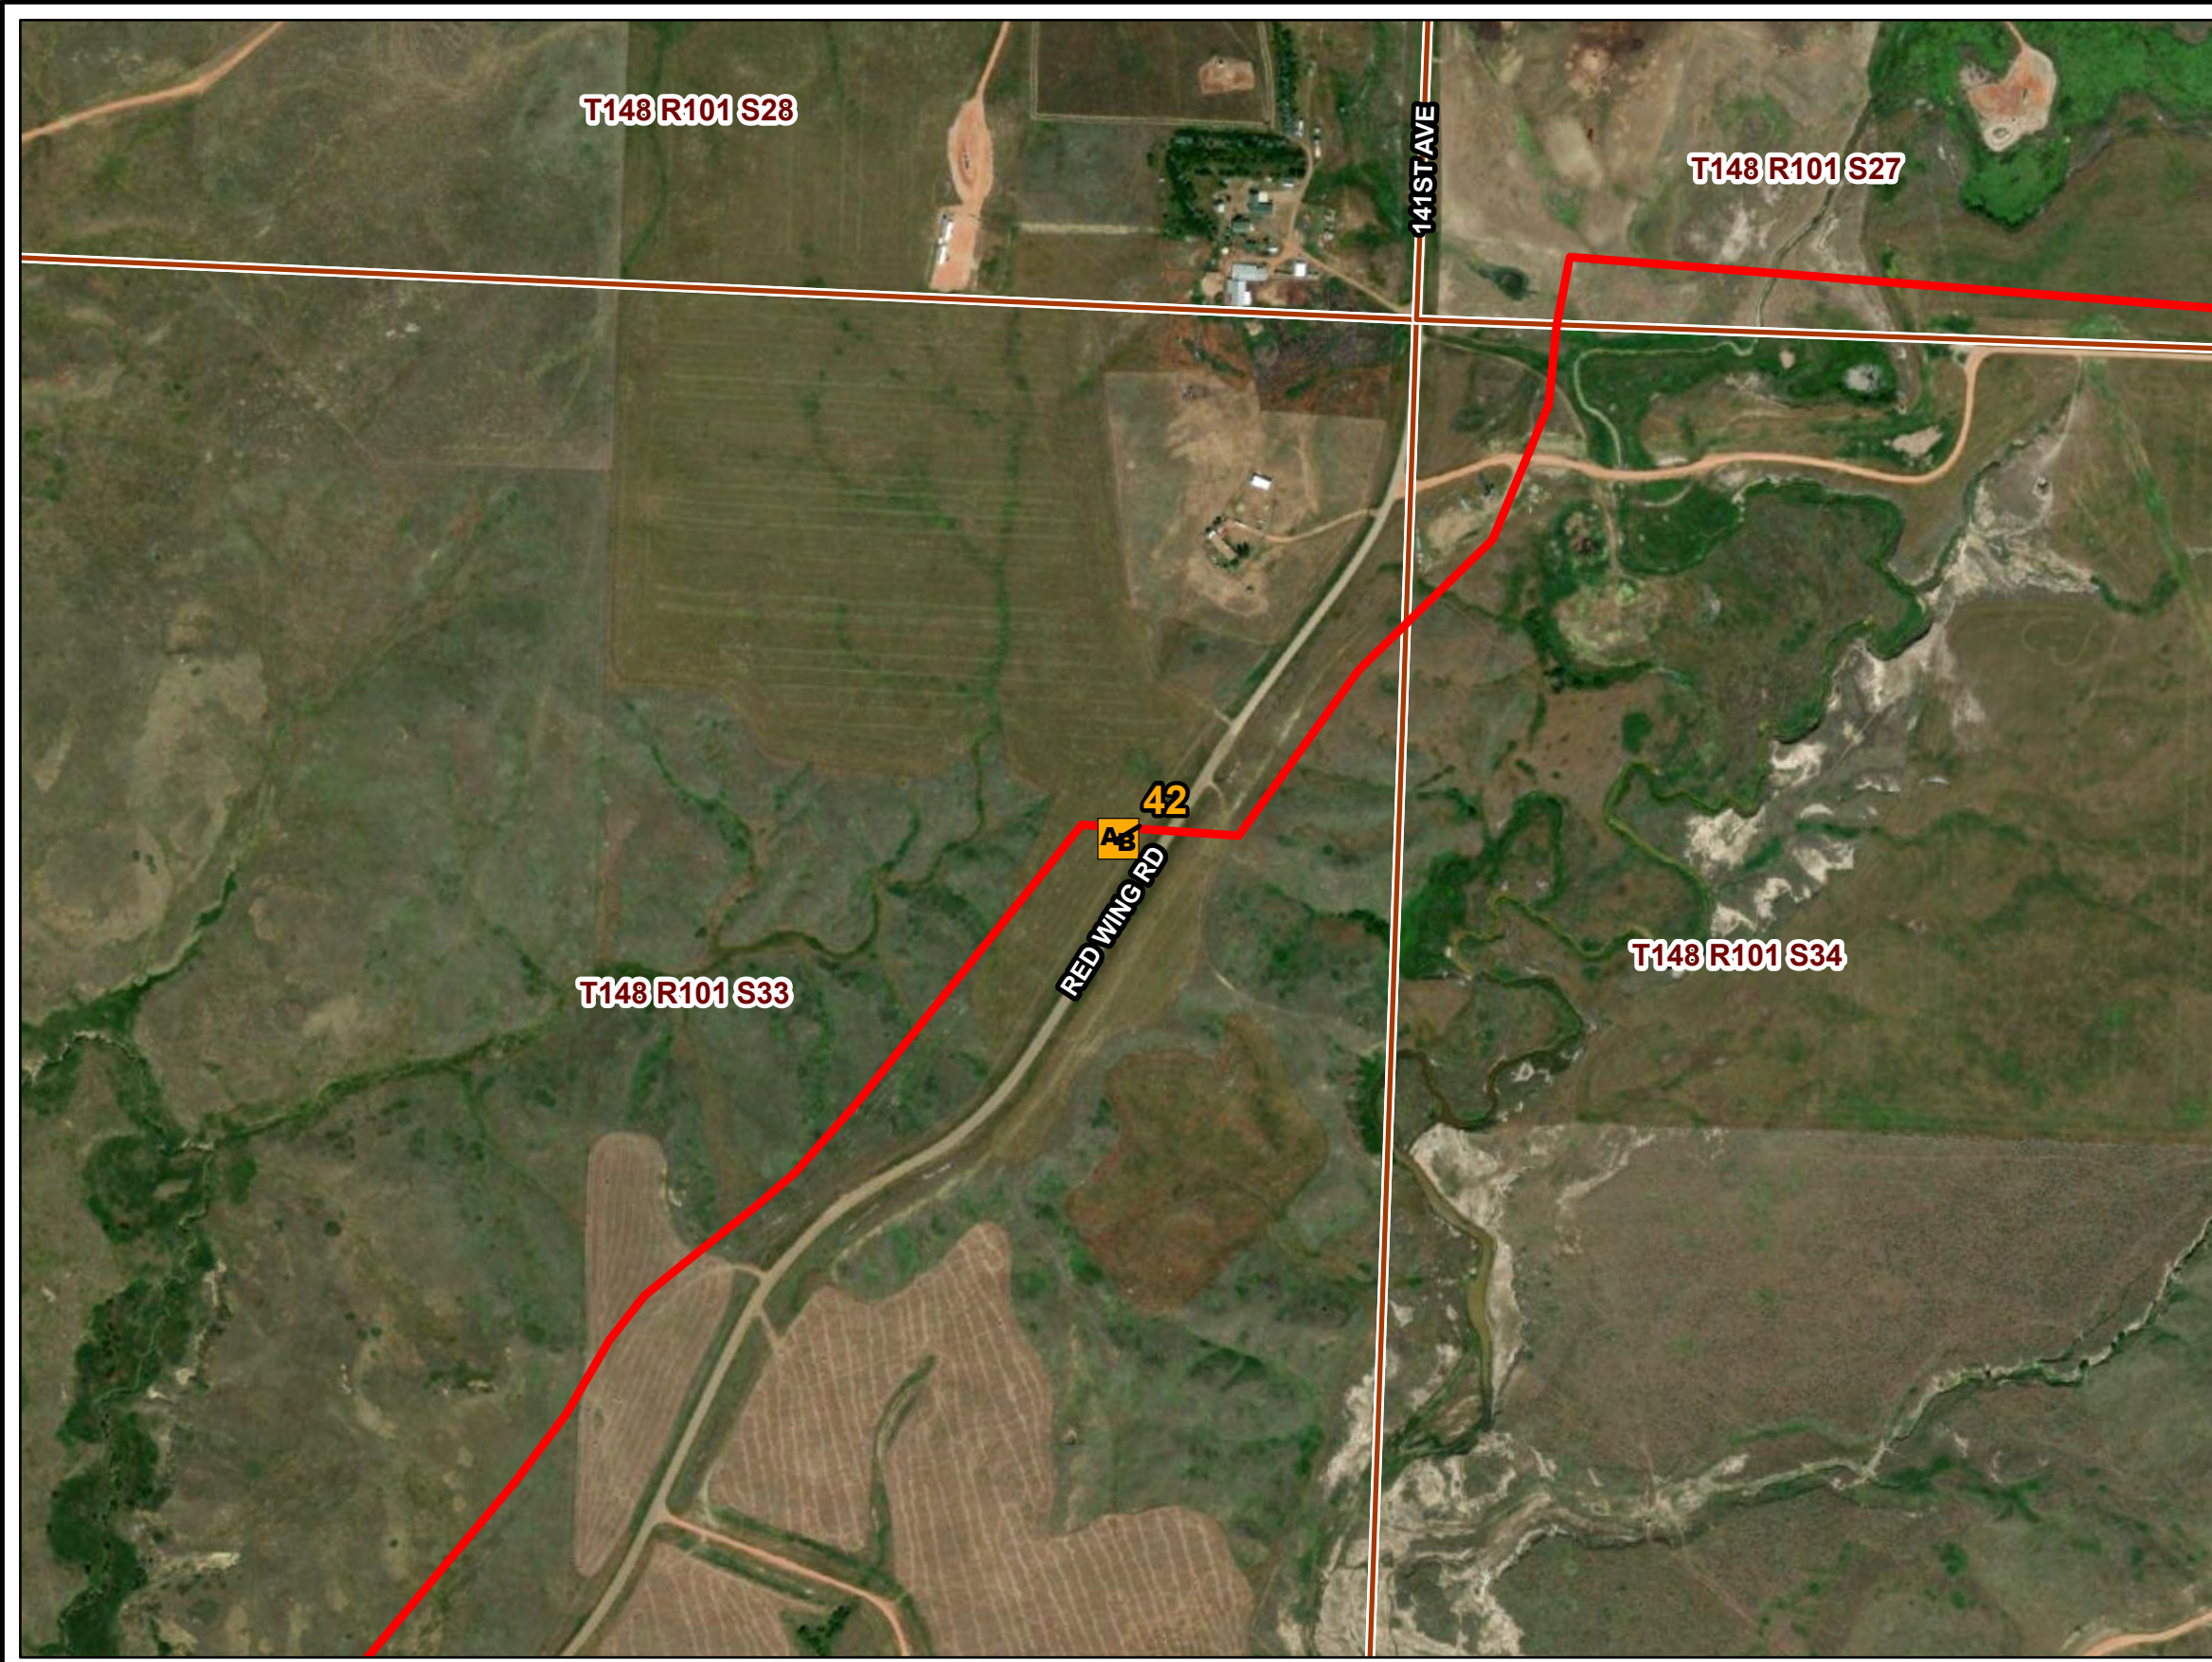
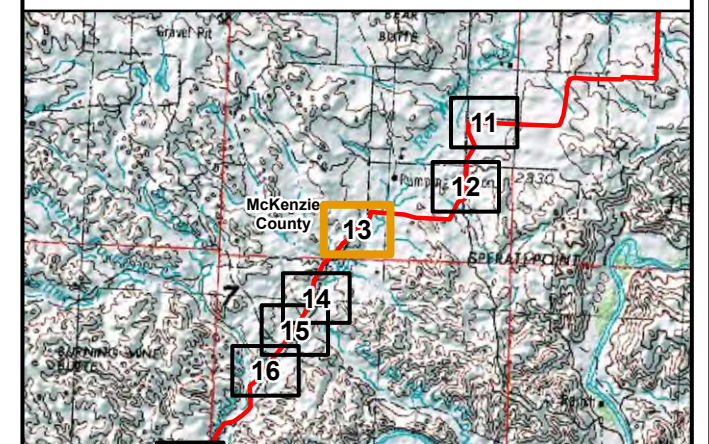
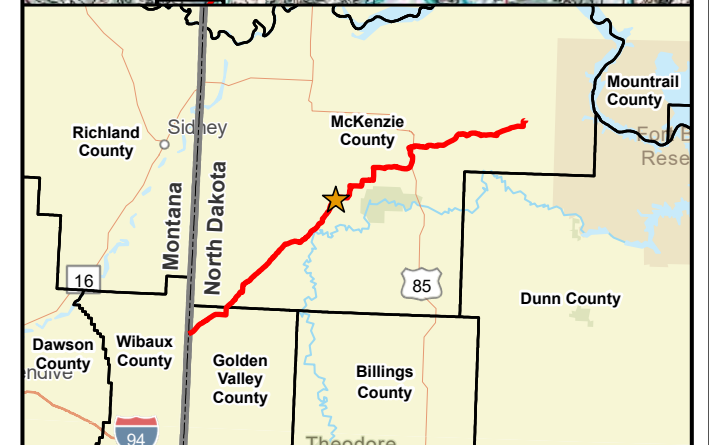
Bridger Pipeline
Figure 13

Construction waste removal along the route was generally acceptable. Construction mats and timbers were generally removed or staged for removal, but a few remain in place (**Figures 13, 16, 17; Appendix A, Observation Photolog 42, 45, 46**). It was unclear if the timbers and tires remaining at one location were discarded, or intentionally left to support upcoming revegetation activities (**Figures 20, 22, 24; Appendix A, Observation Photolog 50, 59, 64**). Items should be removed now if not needed, or as soon as revegetation activities are complete.
