PU-21-048
Bridger Pipeline, LLC.
South Bend 16-inch Crude Oil
Pipeline
As-Built Inspection Report

May 2023

Stantec Consulting Services Inc.
3303 Fiechtner Drive, Suite 100
Fargo, ND 58103

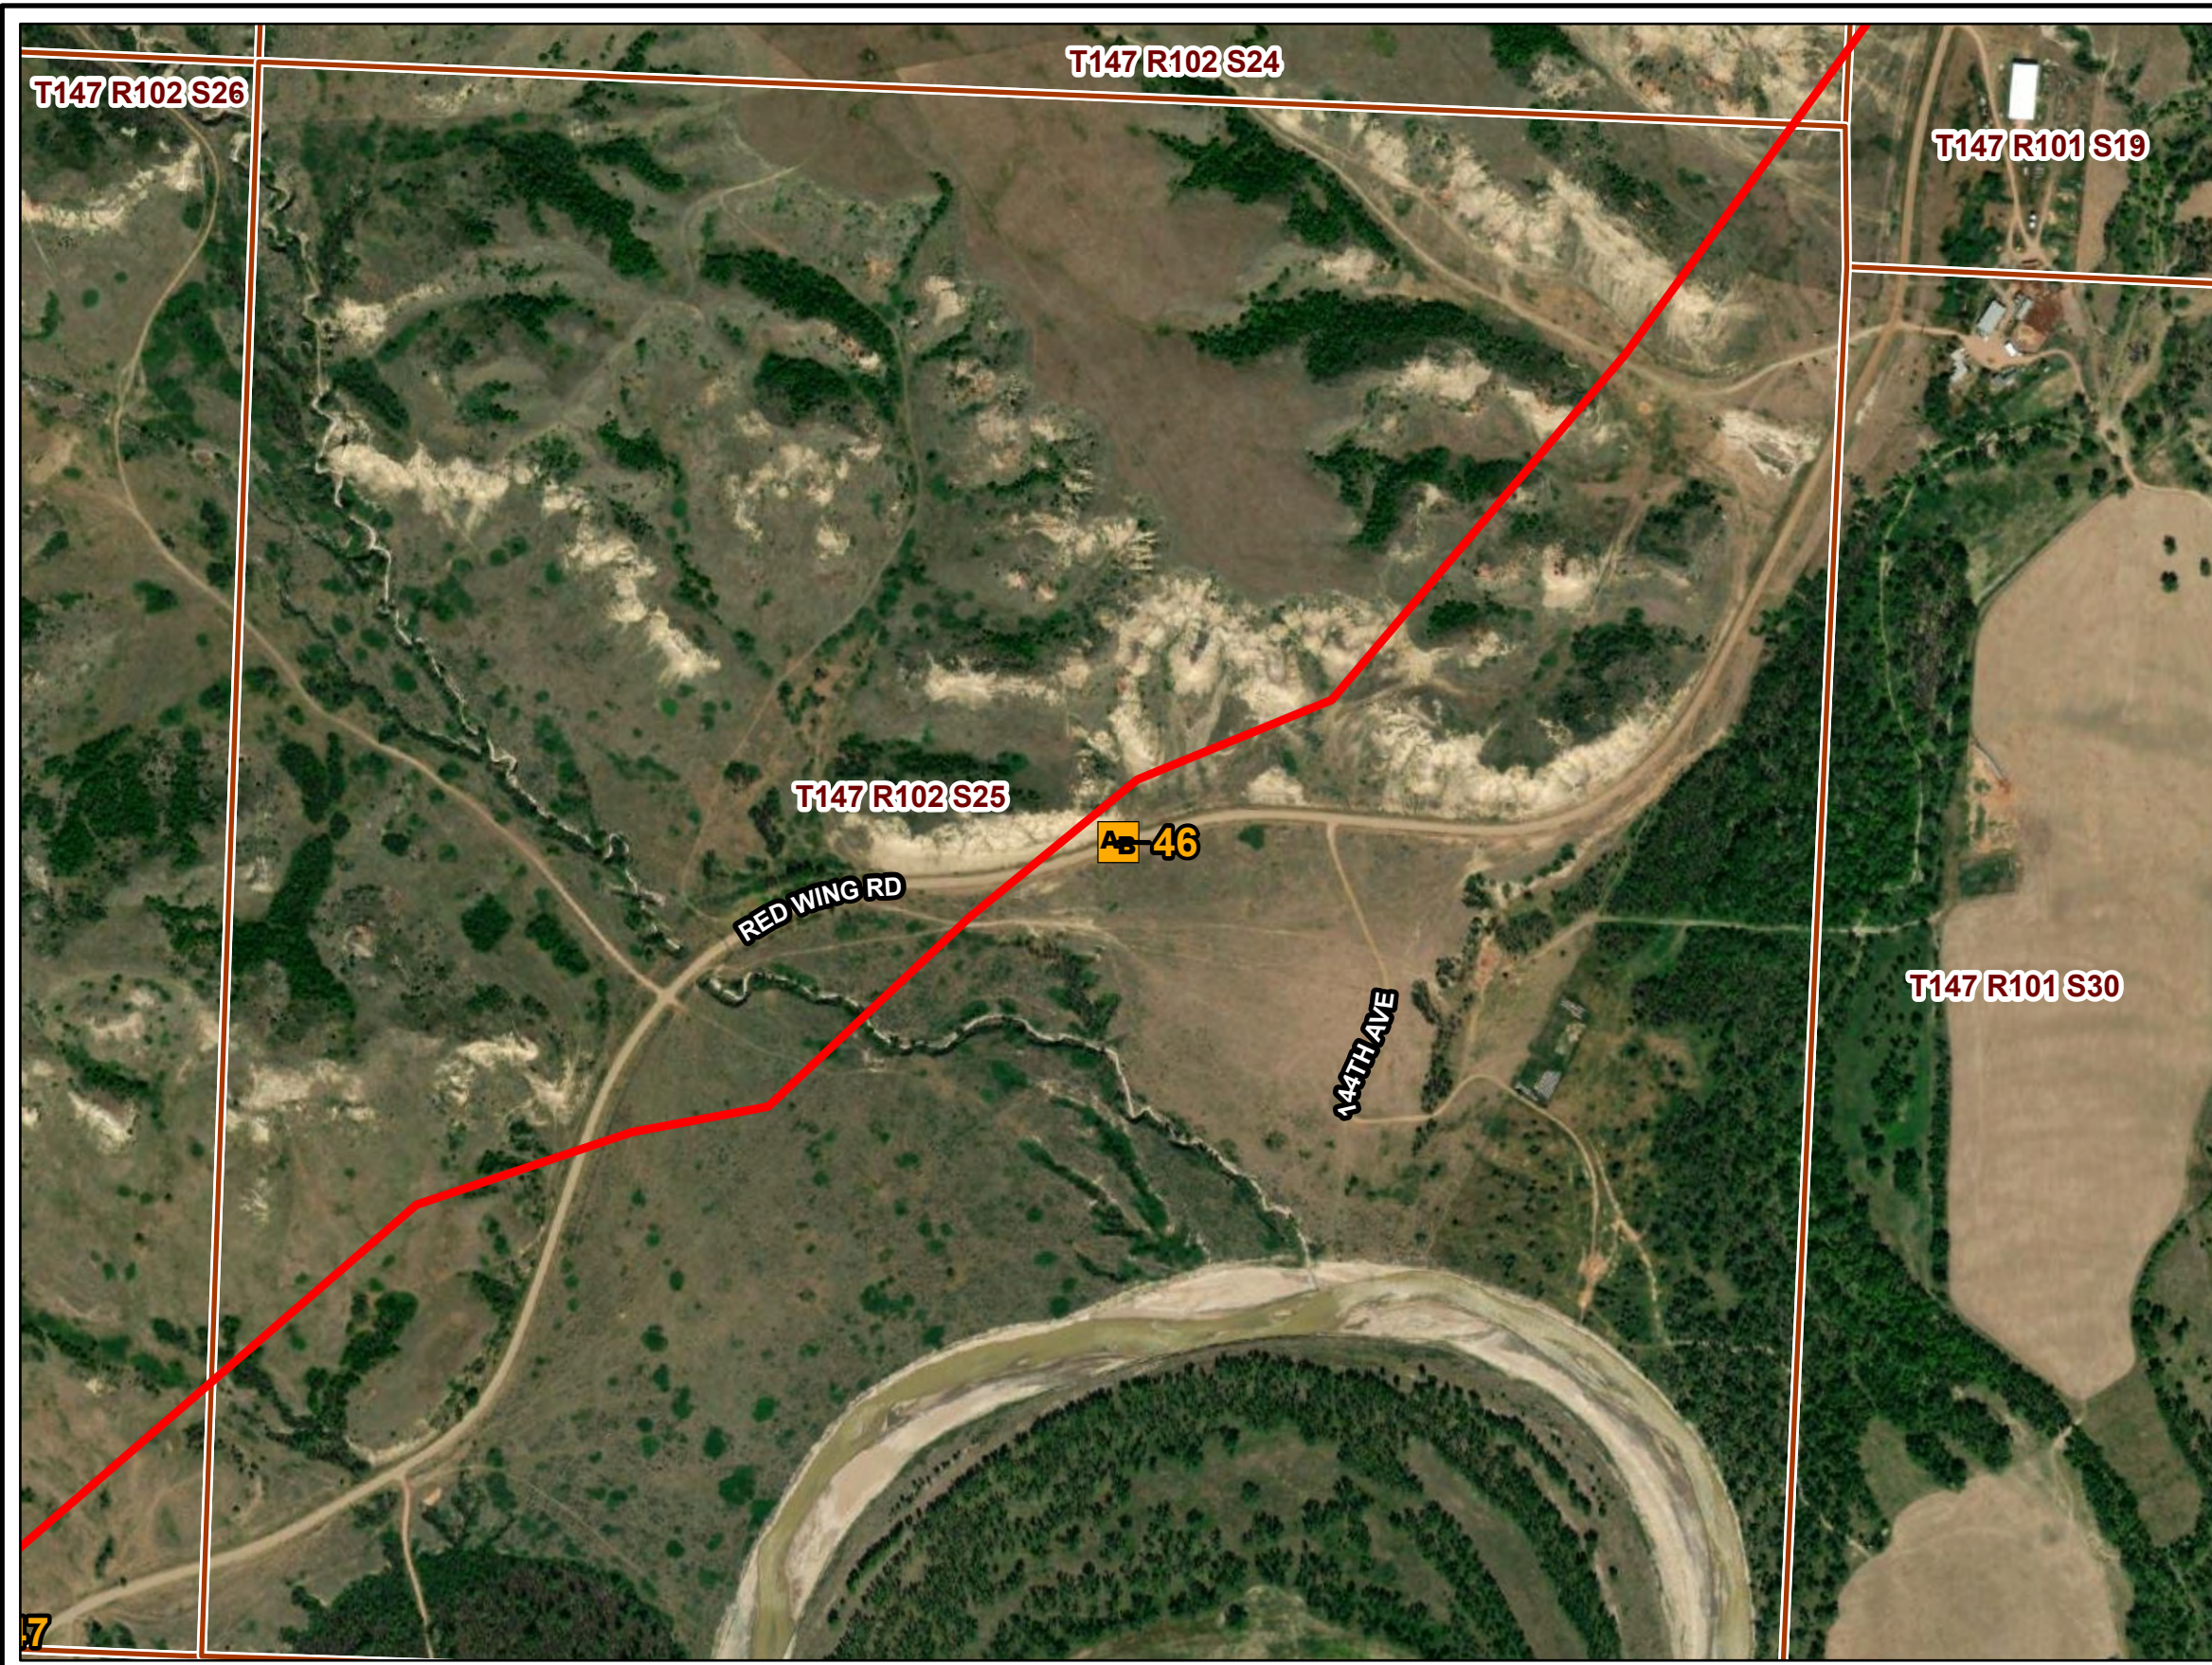
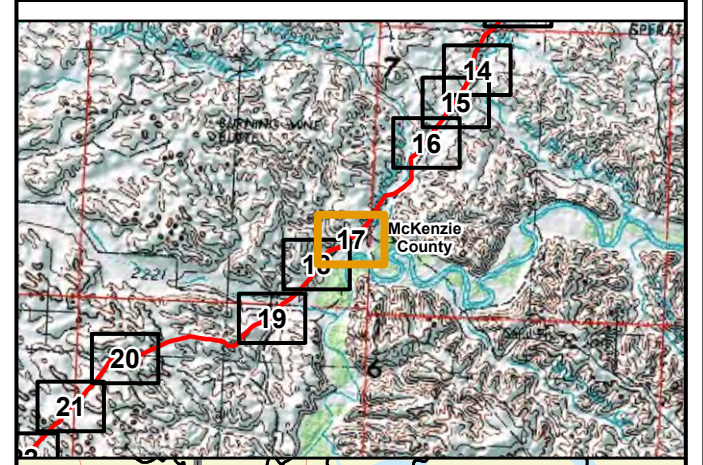
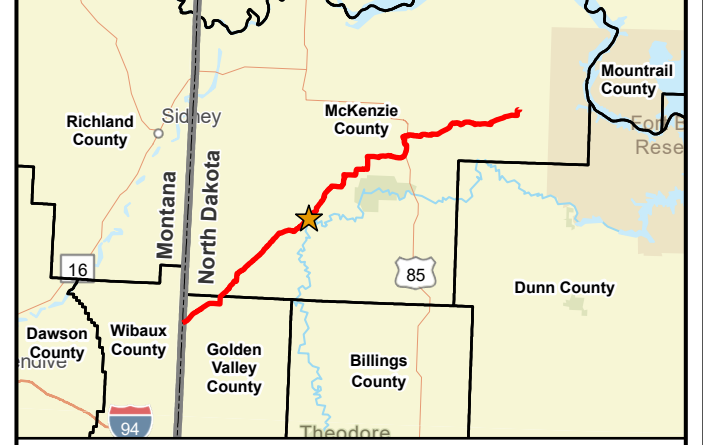
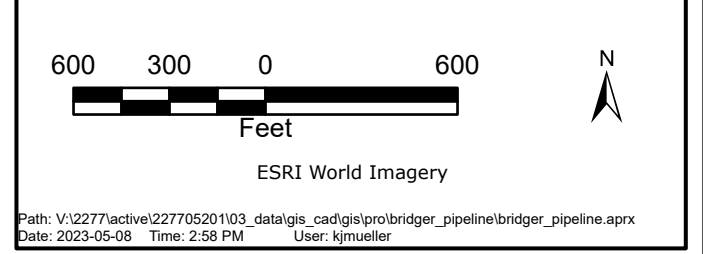
**Bridger Pipeline
Figure 17**

Construction waste removal along the route was generally acceptable. Construction mats and timbers were generally removed or staged for removal, but a few remain in place (**Figures 13, 16, 17; Appendix A, Observation Photolog 42, 45, 46**). It was unclear if the timbers and tires remaining at one location were discarded, or intentionally left to support upcoming revegetation activities (**Figures 20, 22, 24; Appendix A, Observation Photolog 50, 59, 64**). Items should be removed now if not needed, or as soon as revegetation activities are complete.

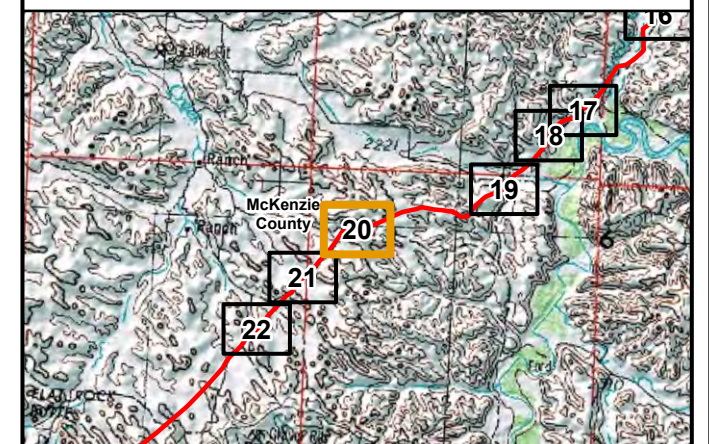
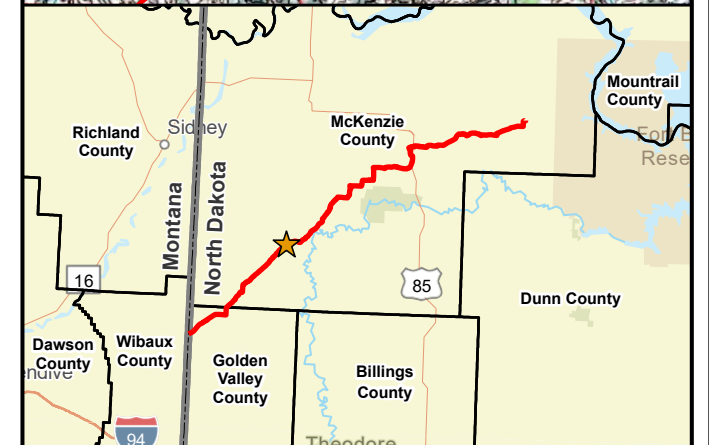
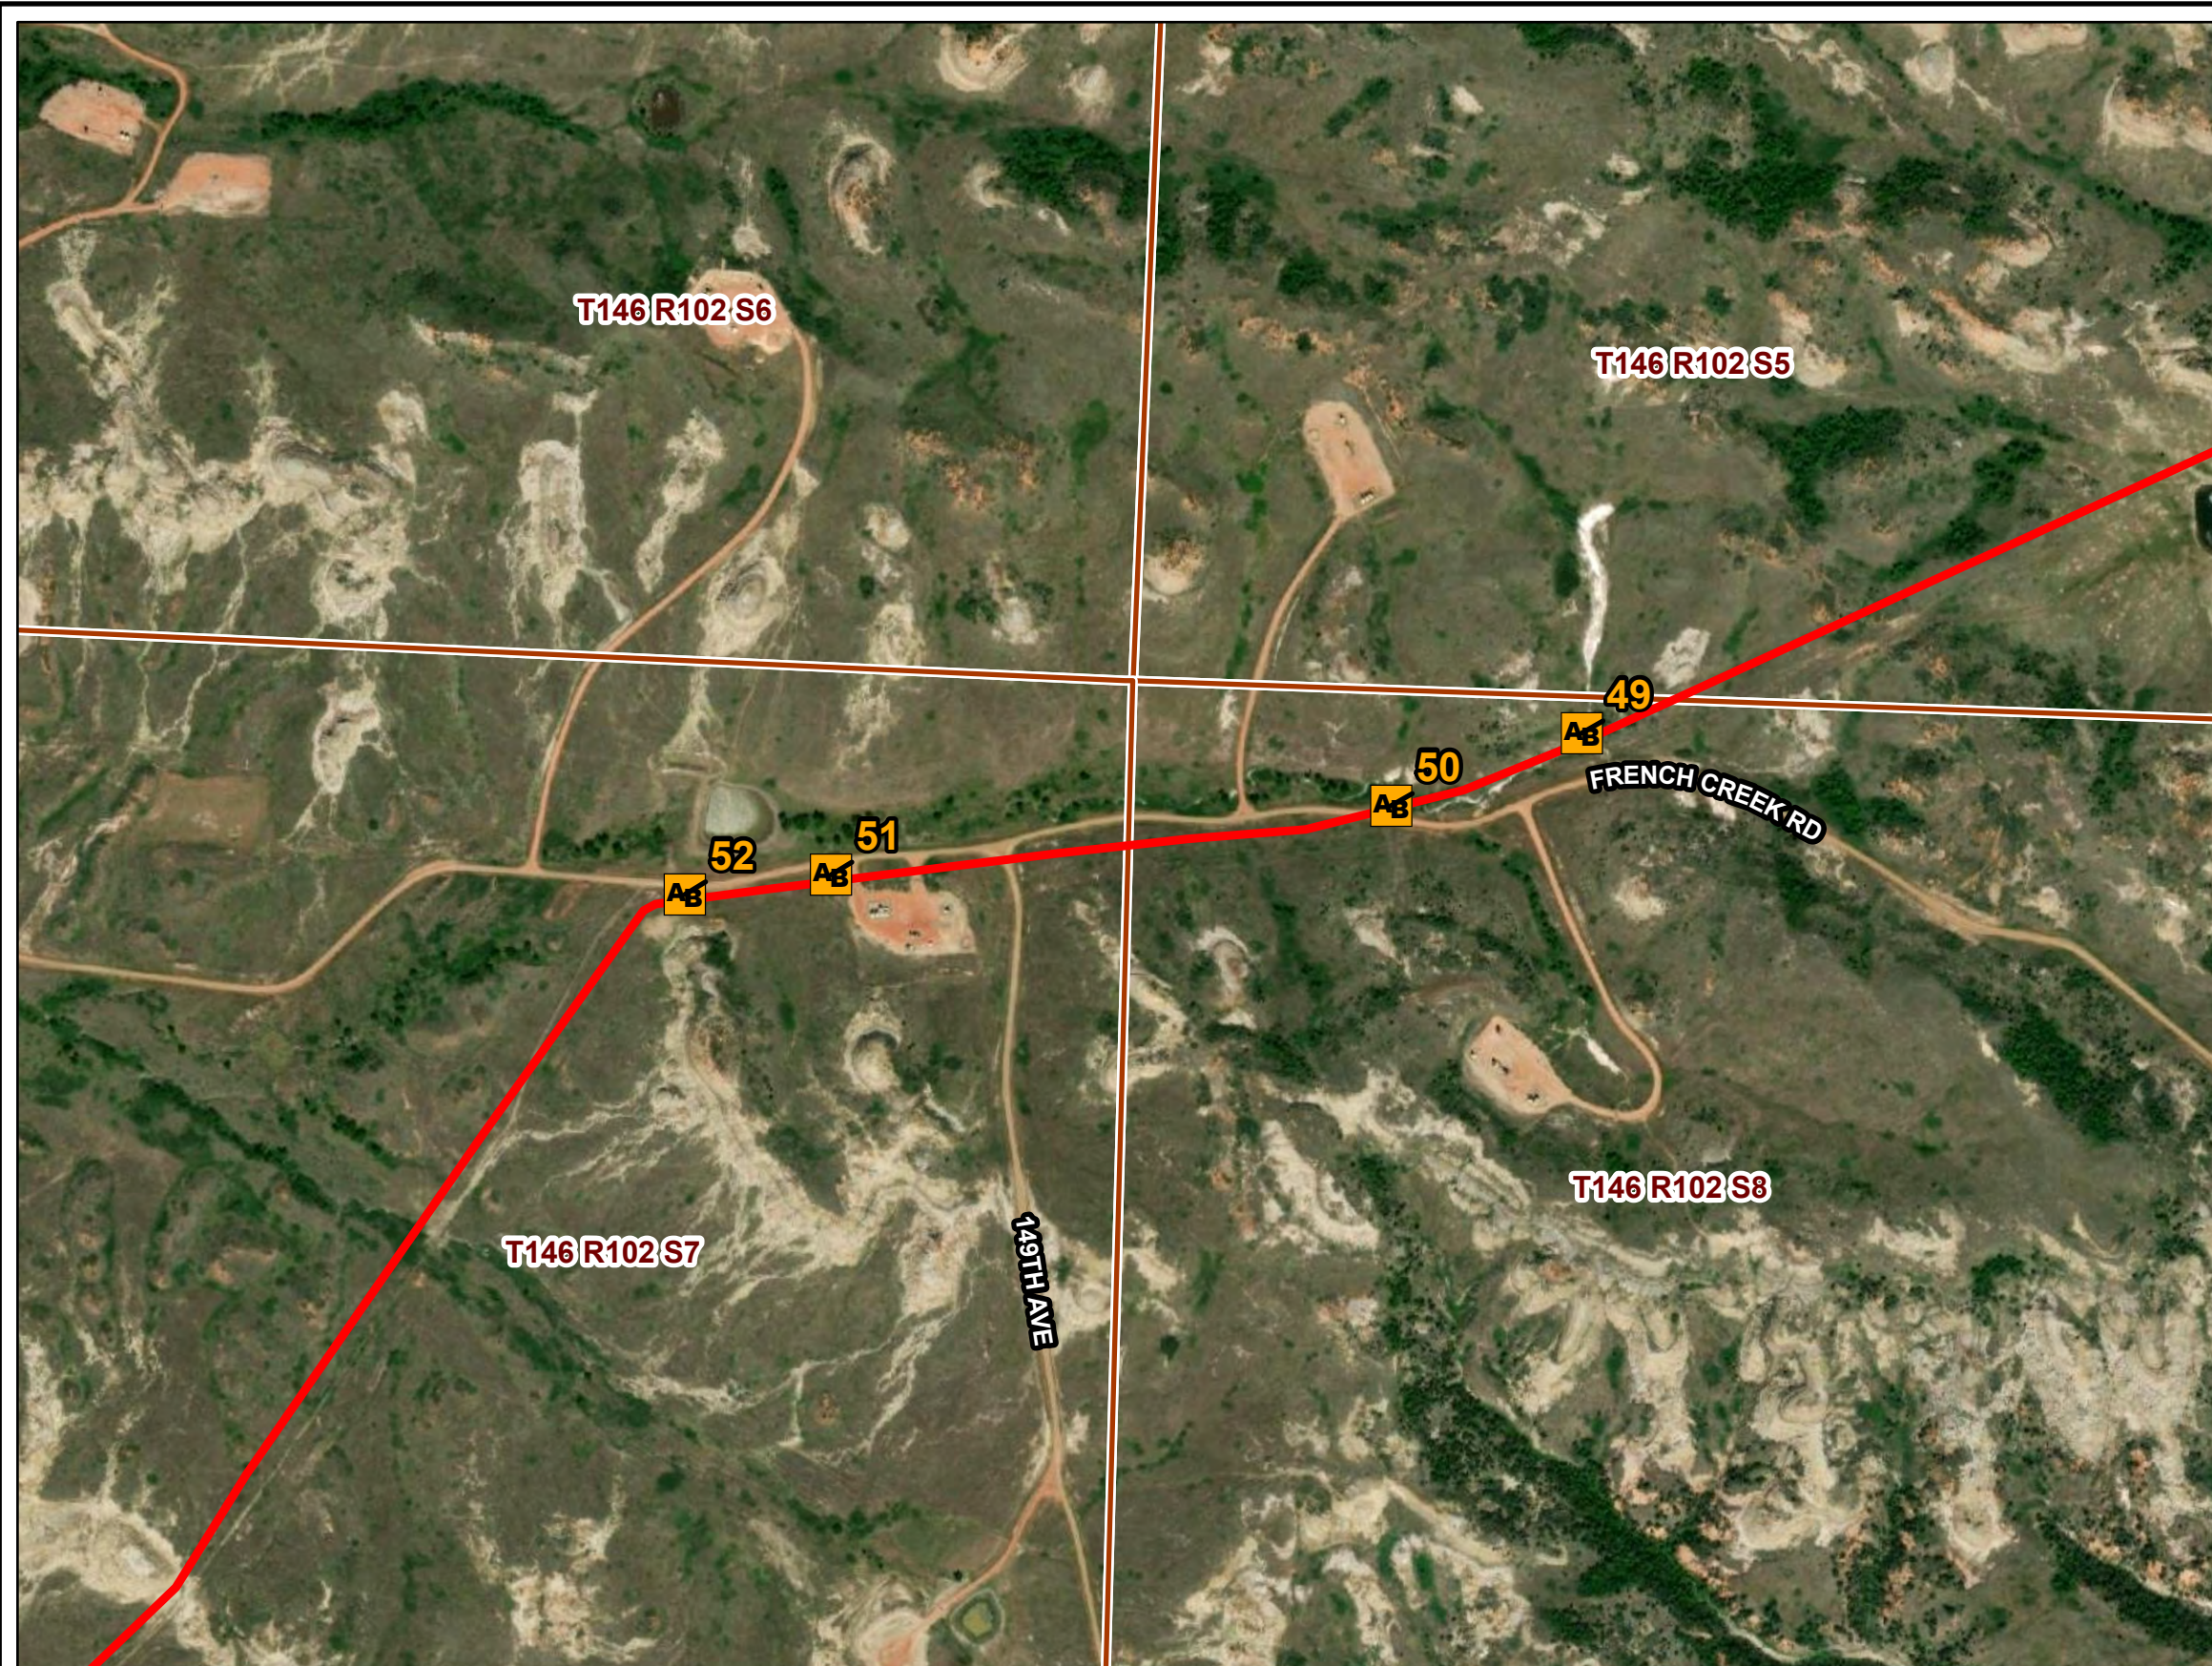
Bridger Pipeline
Figure 20

Overall, Stantec did not observe signs of widespread egregious soil respread techniques or disregard for PSC Order #12. Soil grading and slope contouring were generally appropriate and in compliance with PSC Order #12 and 18 (**Appendix A, Observation Point Photolog 3, 5, 7, 8, 14, 15, 18, 23, 29, 34, 35, 37, 42, 44, 48, 71, 73, 78**). A few areas need to be recontoured before reseeding activities (**Figures 20,**

23, 24; Appendix A, Observation Point Photolog 51, 60, 64, 65). Right-of-way soil respread and grading was found to be relatively clear of any significant amounts of subsoil mixing. Previous construction inspection documented that an area contained subsoil/parent material on the topsoil stockpile for approximately 40 linear feet due to incorrect stripping depth and there was no subsoil stockpile at this point. Stantec recommended inspecting the topsoil replacement here to ensure subsoil material is not used for final cover during reclamation. Inspection of the area indicated that the subsoil material was not used for final cover during the reclamation and the subsoil and topsoil were respread in compliance with PSC Order 12 (**Figures 22, 23; Observation Point Photolog 59, 60**).

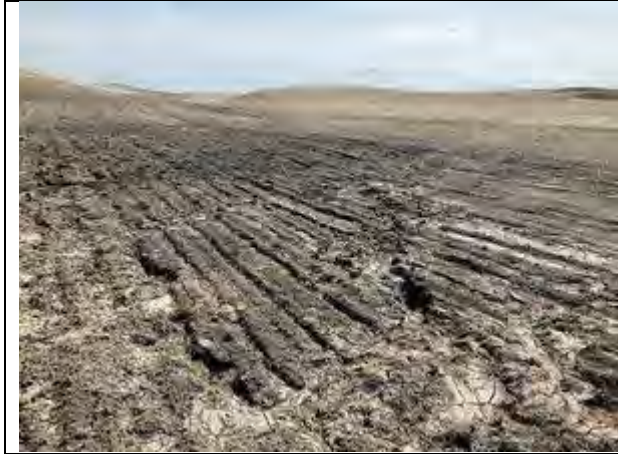
Observation Point: 1
Date Taken: April 26, 2023
Direction Photo is Taken: Southeast

Photo Description: Topsoil movement forming trenches in respread soil. Soil erosion prevention measures needed

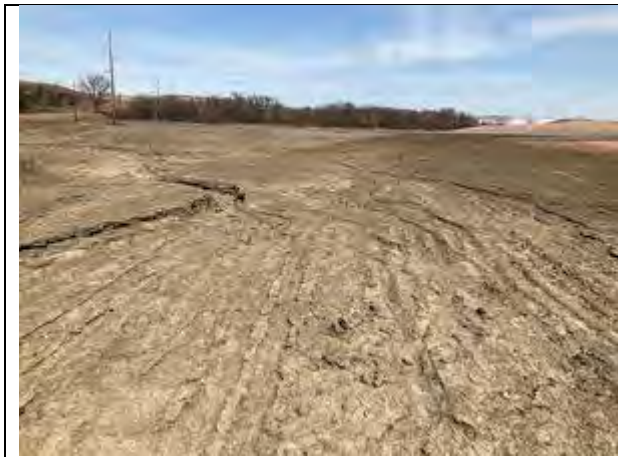
Observation Point: 2
Date Taken: April 26, 2023
Direction Photo is Taken: North

Photo Description: Topsoil movement forming trenches in respread soil. Soil erosion prevention measures needed

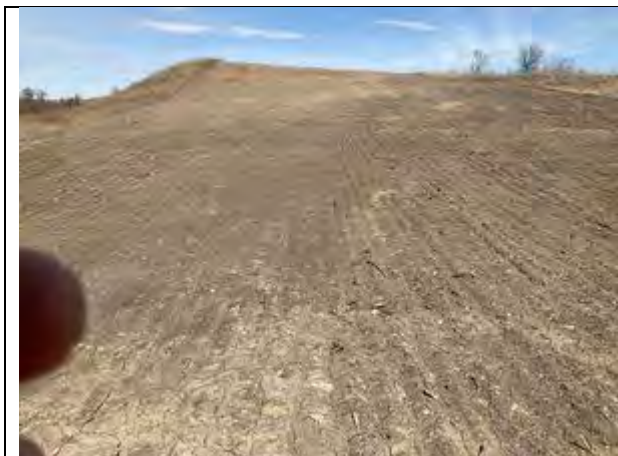
Observation Point: 3
Date Taken: April 26, 2023
Direction Photo is Taken: North

Photo Description: Soil in place and good contouring

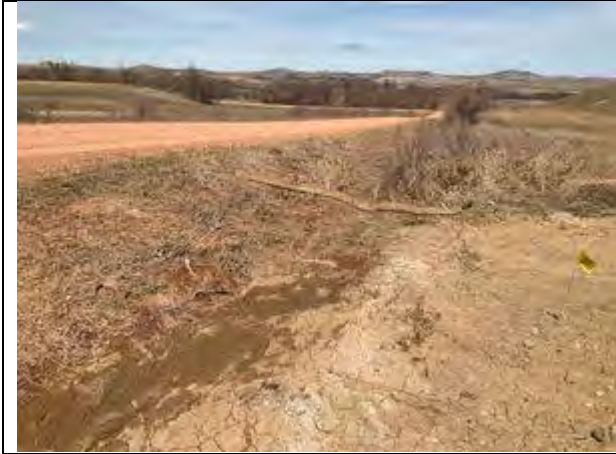
Observation Point: 4
Date Taken: April 26, 2023
Direction Photo is Taken: North

Photo Description: Soil erosion prevention measures in place and boring under road.

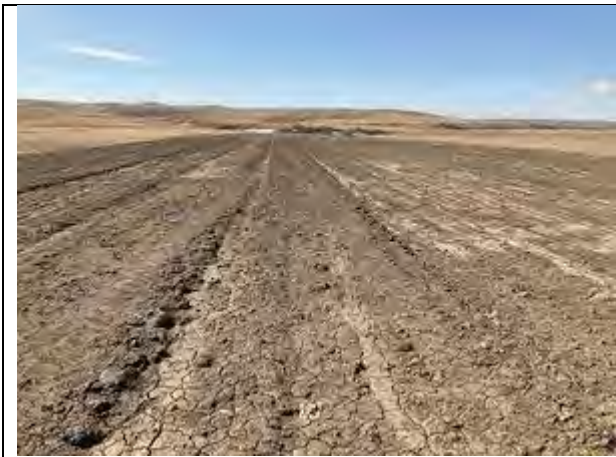
Observation Point: 5
Date Taken: April 26, 2023
Direction Photo is Taken: Southwest

Photo Description: Soil in place and good contouring

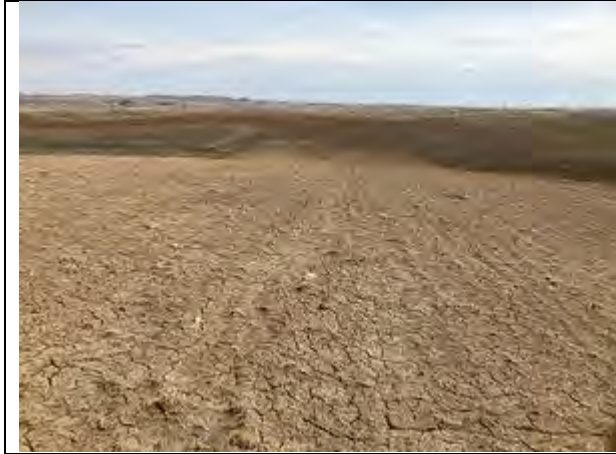
Observation Point: 7
Date Taken: April 26, 2023
Direction Photo is Taken: East

Photo Description: Soil in place and good contouring

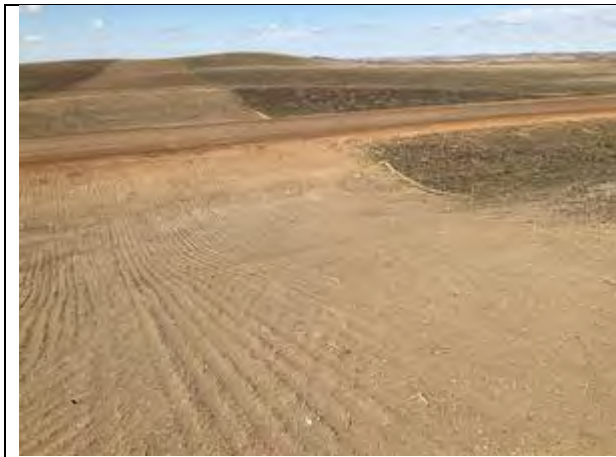
Observation Point: 8
Date Taken: April 26, 2023
Direction Photo is Taken: West

Photo Description: Soil erosion prevention measures in place

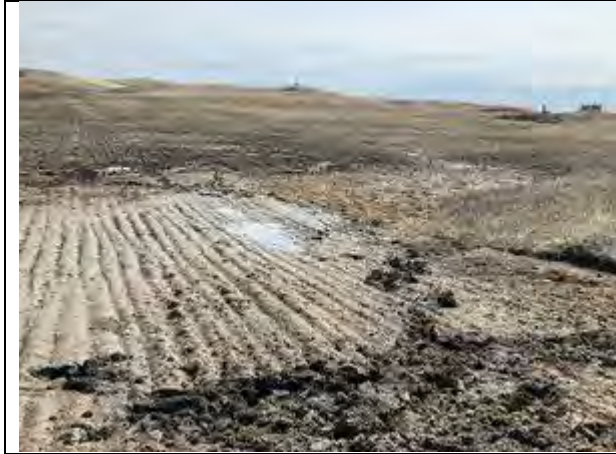
Observation Point: 10
Date Taken: April 26, 2023
Direction Photo is Taken: Southeast

Photo Description: Topsoil movement forming trenches in respread soil. Erosion prevention measures needed

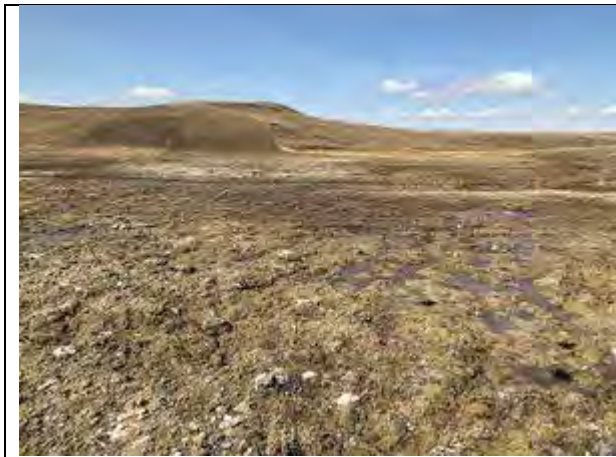
Observation Point: 11
Date Taken: April 26, 2023
Direction Photo is Taken:

11). It is unclear when this crossing occurred and if it was associated with the pipeline construction. Construction in wetland and streams was observed to be conducted via HDD boring techniques per FoF #12.

Photo Description: Vehicle tracks across stream crossing and topsoil movement forming trenches in respread soil. Erosion prevention measures needed.

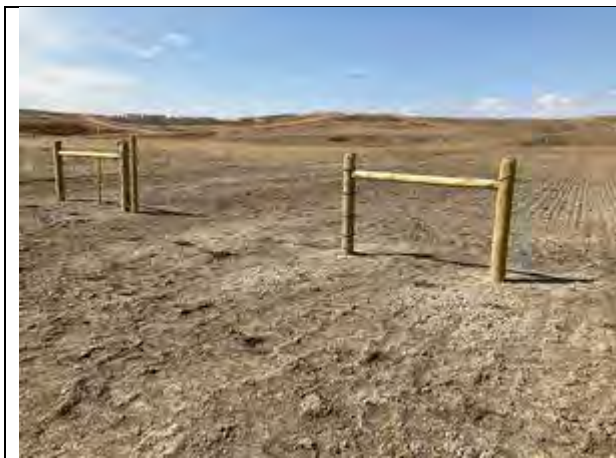
Observation Point: 12
Date Taken: April 27, 2023 8:57 AM
Direction Photo is Taken: West
Spread:

Photo Description: Fencing in place

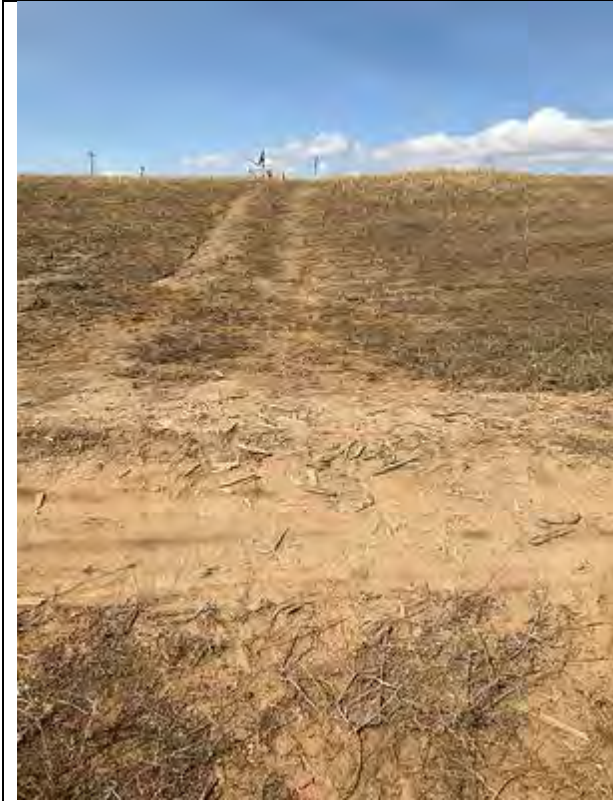
Observation Point: 13
Date Taken: April 26, 2023
Direction Photo is Taken: West

Photo Description: Construction pads removed

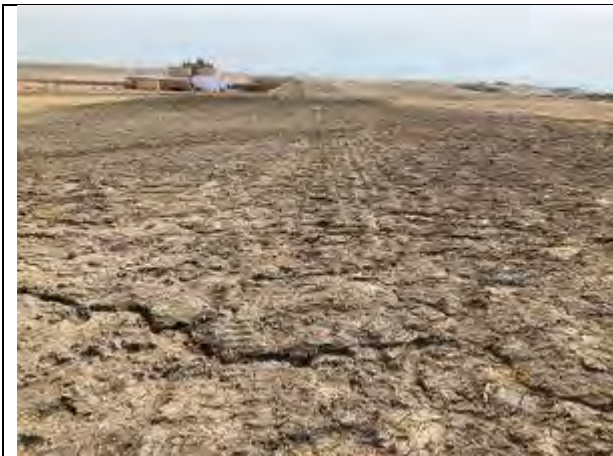
Observation Point: 14
Date Taken: April 26, 2023
Direction Photo is Taken: East

Photo Description: Soil in place and good contouring

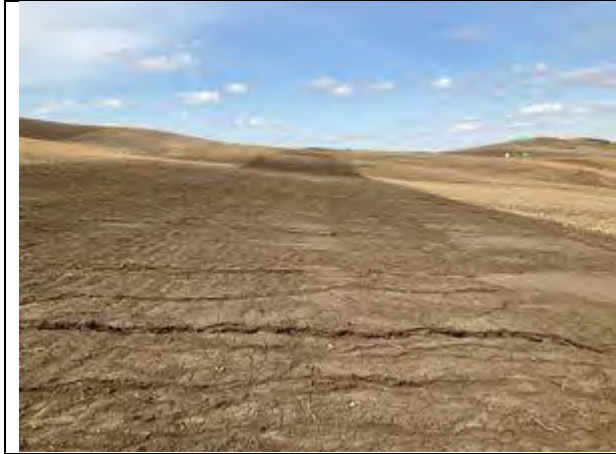
Observation Point: 15
Date Taken: April 26, 2023
Direction Photo is Taken: West

Photo Description: Soil in place and good contouring

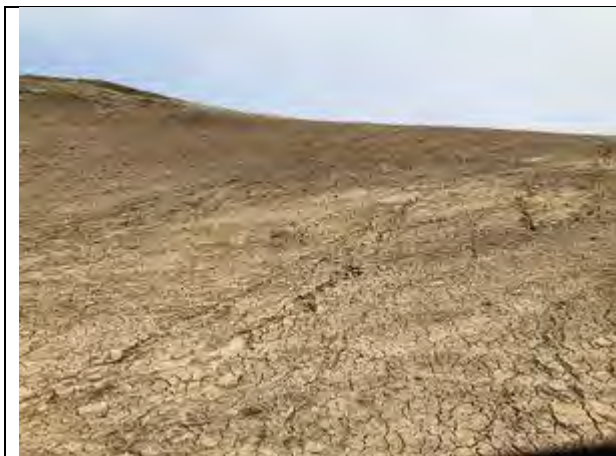
Observation Point: 17
Date Taken: April 26, 2023
Direction Photo is Taken: North

Stantec observed soil respread and grading efforts on steep side slopes (**Appendix A, Observation Point Photolog 17, 19, 20, 57**) which resulted in contouring appropriate and in compliance with PSC Order #12. Further inspection at several points along the route revealed various stages of soil movement from water erosion (**Figures 1-27; Appendix A, Observation Photolog 1, 2, 10, 24, 25, 26, 28, 30, 31, 33, 36, 38, 39, 40, 49, 50, 51, 52, 53, 54, 55, 58, 62, 67, 68, 70, 72, 75, 76, 77, 79, 80**). Soil subsidence and substantial gully formation was observed in Section 6-T149N-R97W (**Figure 7; Appendix A, Observation Photolog 24 & 25**) and presents a safety hazard. Stantec alerted the PSC of this issue in email correspondence on 27 April 2023. Erosion and sediment control measures were observed occasionally in swales along the route as per PSC Finding of Fact #29 (**Figures 1, 2, 3, 6, 15, 18; Appendix A, Observation Photolog 4, 6, 8, 21, 44, 47**) but were generally lacking across the majority of the route or not functioning properly (**Figures 21, 23, 24, 26; Appendix A, Observation Photolog 55, 60, 63, 66, 74**). Soil erosion and sediment loss may be a violation of the North Dakota Department of Environmental Quality (NDDEQ) Construction and Environmental Disturbance Requirements (PSC Docket #48, 12 May 2022). Additional erosion and sediment control measures along the route will help prevent further soil movement. Further vegetation establishment can help to prevent soil erosion and sediment loss. Based on filed progress reports, re-seeding was initiated Fall of 2022 along some portions of the ROW and additional measures to establish vegetation along the route should be implemented as soon as weather conditions permit in 2023.

Photo Description: Steep side slope may erode with precipitation without erosion prevention measures

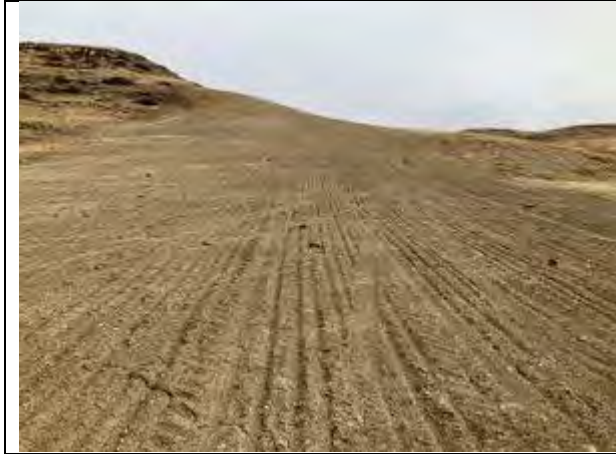
Observation Point: 18
Date Taken: April 26, 2023
Direction Photo is Taken: Northeast
Photo Description: Soil in place and good contouring
Latitude: 47.75935582
Longitude: -103.13093291

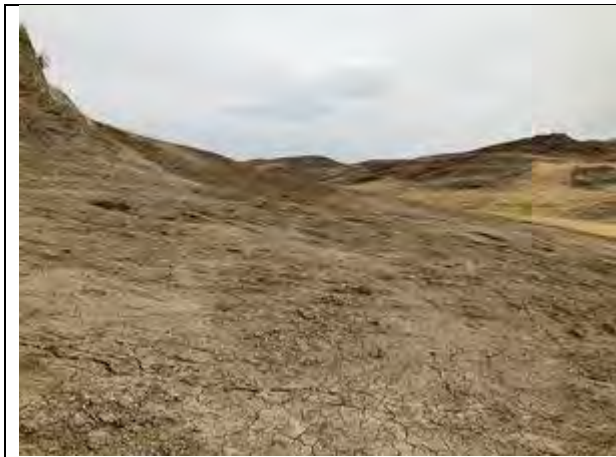
Observation Point: 19
Date Taken: April 26, 2023
Direction Photo is Taken: East
Photo Description: Steep side slope may erode with precipitation without soil erosion prevention measures
Latitude: 47.75405178
Longitude: -103.13378074

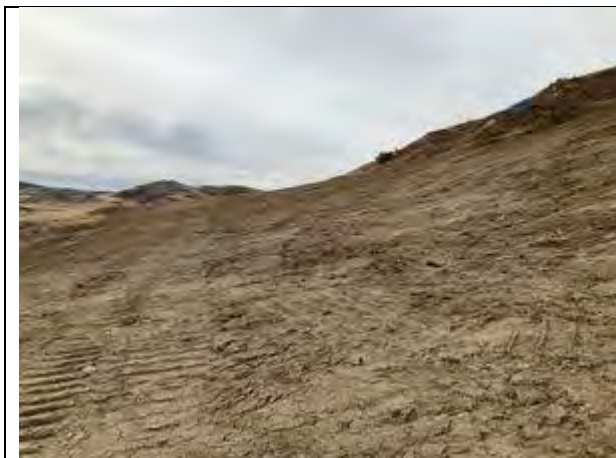
Observation Point: 20
Date Taken: April 26, 2023
Direction Photo is Taken: South
Photo Description: Steep side slope may erode with precipitation without soil erosion prevention measures
Latitude: 47.75728942
Longitude: -103.13295698

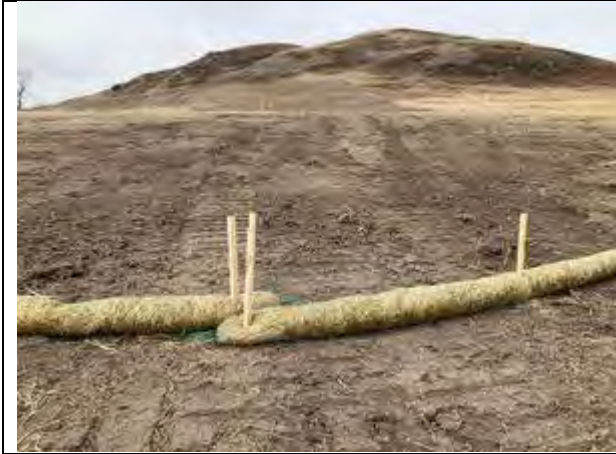
Observation Point: 21
Date Taken: April 26, 2023
Direction Photo is Taken: Southwest

Photo Description: Soil erosion prevention in place

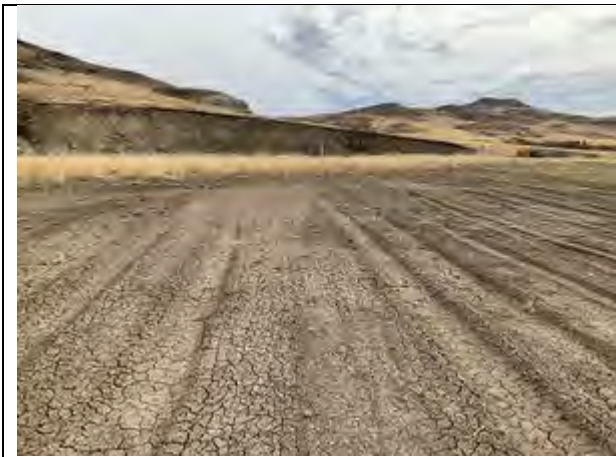
Observation Point: 22
Date Taken: April 26, 2023
Direction Photo is Taken: East

Photo Description: Tunnel under stream in place

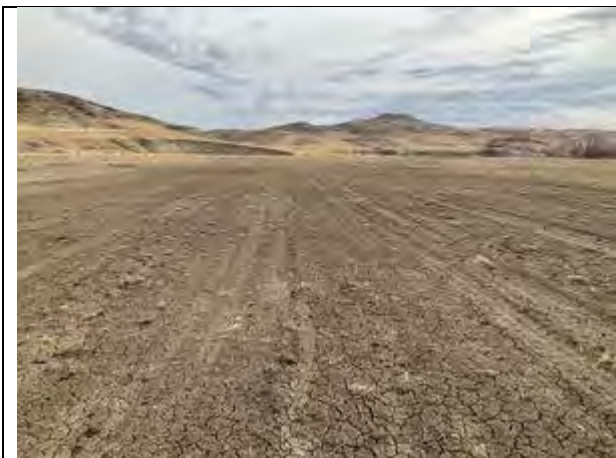
Observation Point: 23
Date Taken: April 26, 2023
Direction Photo is Taken: East

Photo Description: Soil in place and good contouring

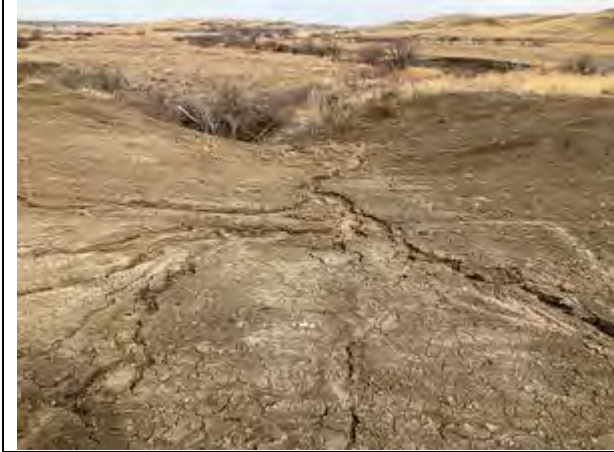
Observation Point: 24
Date Taken: April 26, 2023
Direction Photo is Taken: Northwest

Photo Description: Topsoil movement forming trenches in respread soil. Soil erosion prevention measures needed.

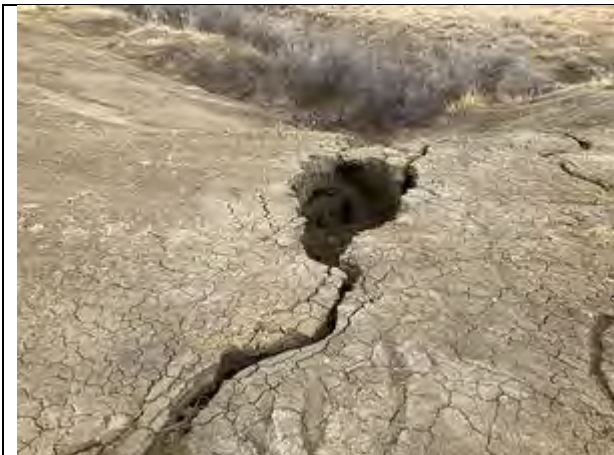
Observation Point: 25
Date Taken: April 26, 2023
Direction Photo is Taken: Northwest

Photo Description: Topsoil and subsoil movement forming large trench in respread soil. Soil respread and erosion prevention measures needed.

- Request Bridger to repair observed soil subsidence and install erosion control in order to prevent sediment washing into Cherry Creek (Observation Point 25).

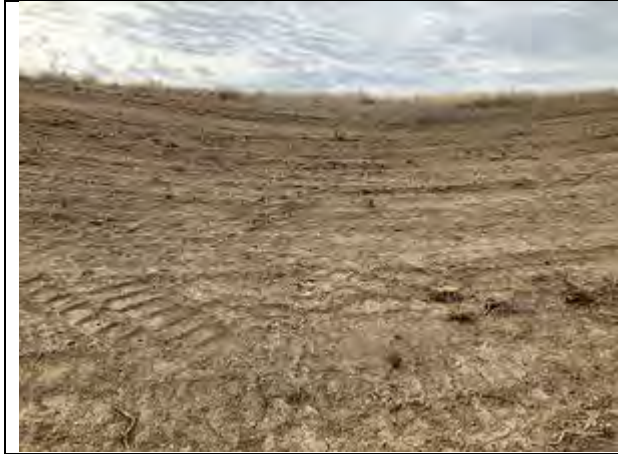
Observation Point: 27
Date Taken: April 26, 2023
Direction Photo is Taken: Southeast

Photo Description: Soil in place but erosion prevention measures needed to prevent soil movement.

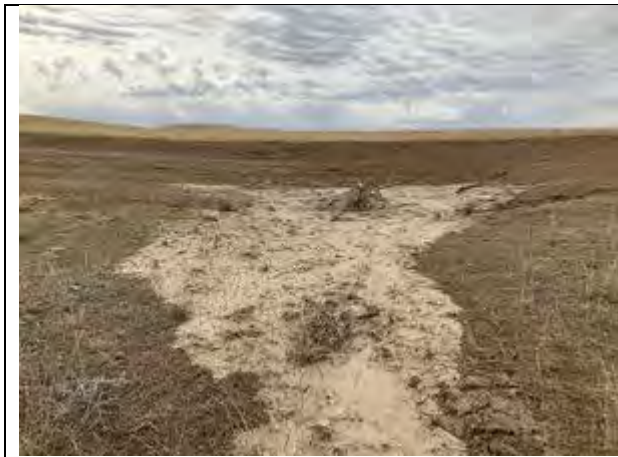
Observation Point: 28
Date Taken: April 26, 2023
Direction Photo is Taken: Southeast

Photo Description: Topsoil movement forming trenches in respread soil. Add erosion prevention measures.

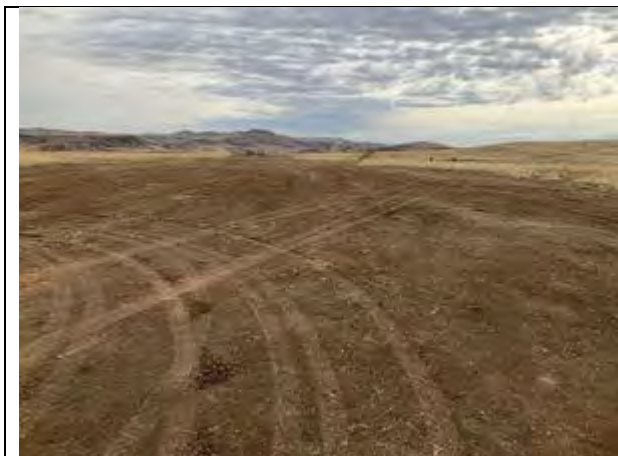
Observation Point: 29
Date Taken: April 26, 2023
Direction Photo is Taken: Northeast

Prior construction inspection of right-of-way areas on flatter topography were observed to not contain any stripping and would be susceptible to compaction. Current inspection of these areas did not show any signs of compaction and soil respread and grading appeared to be in compliance with PSC Order #18 (**Figure 7; Appendix A, Observation Point Photolog 29**).

Photo Description: Soil in place and good contouring

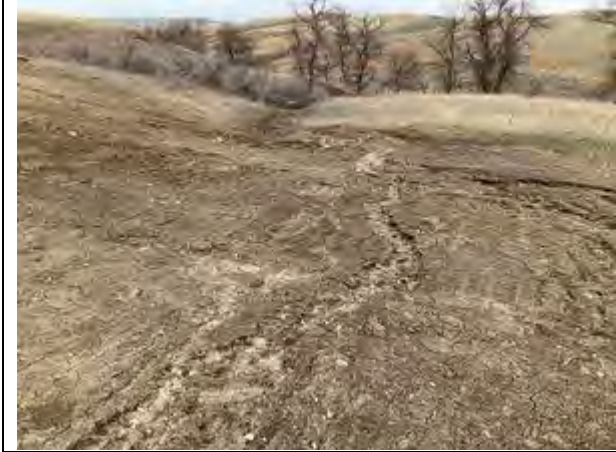
Observation Point: 30
Date Taken: April 26, 2023
Direction Photo is Taken: Northwest

Photo Description: Topsoil movement forming trenches in respread soil. Add erosion prevention measures.

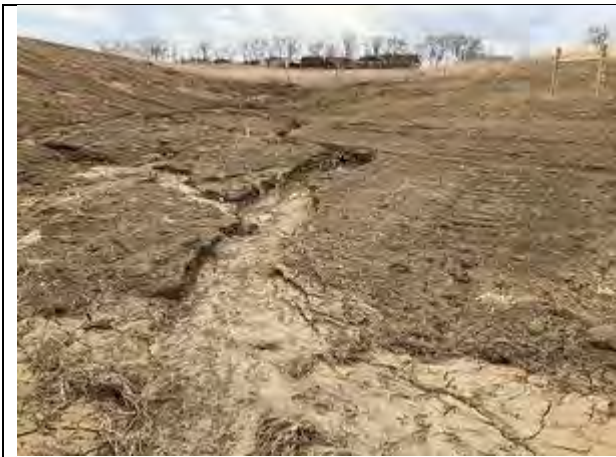
Observation Point: 31
Date Taken: April 26, 2023
Direction Photo is Taken: Southeast

Photo Description: Topsoil movement forming trenches in respread soil. Add erosion prevention measures.

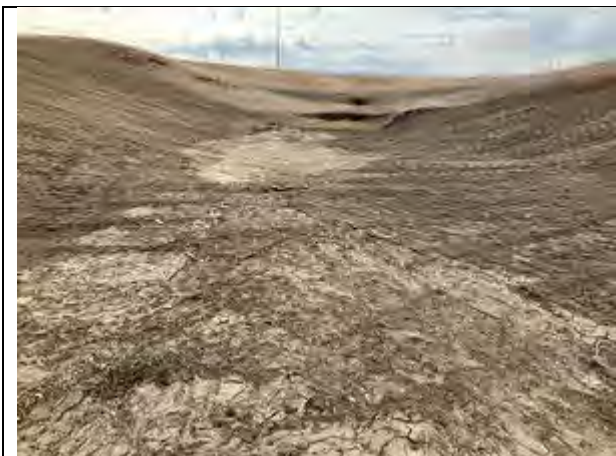
Observation Point: 32
Date Taken: April 26, 2023
Direction Photo is Taken: Southeast

Photo Description: Topsoil movement and washing downslope. Add soil erosion prevention measures

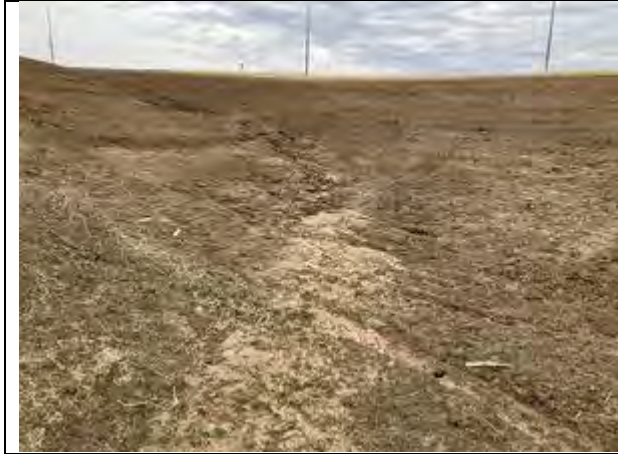
Observation Point: 33
Date Taken: April 26, 2023
Direction Photo is Taken: Northeast

Photo Description: Topsoil movement forming trenches in respread soil. Add erosion prevention measures

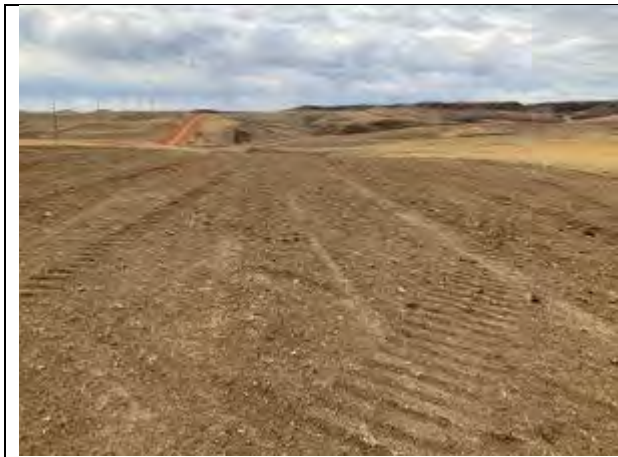
Observation Point: 34
Date Taken: April 26, 2023
Direction Photo is Taken: South

Photo Description: Respread soil in place and good contouring

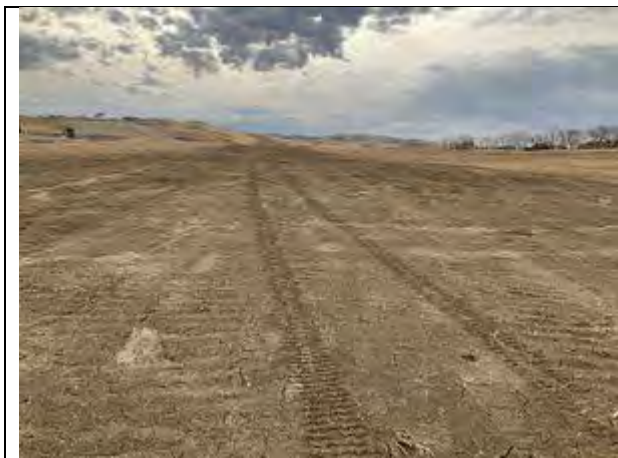
Observation Point: 35
Date Taken: April 26, 2023
Direction Photo is Taken: East

Photo Description: Soil in place and good contouring

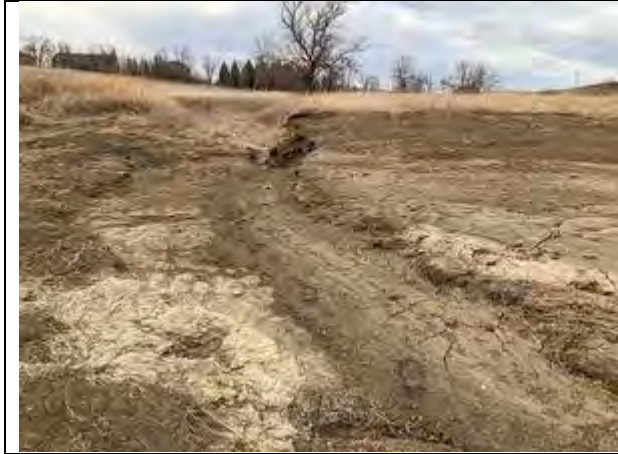
Observation Point: 36
Date Taken: April 26, 2023
Direction Photo is Taken: South

Photo Description: Topsoil movement forming trenches in respread soil. Add erosion prevention measures.

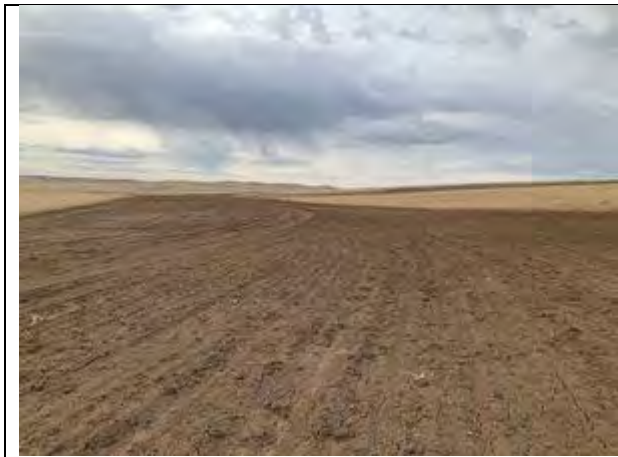
Observation Point: 37
Date Taken: April 26, 2023
Direction Photo is Taken: Southeast

Photo Description: Soil in place and good contouring

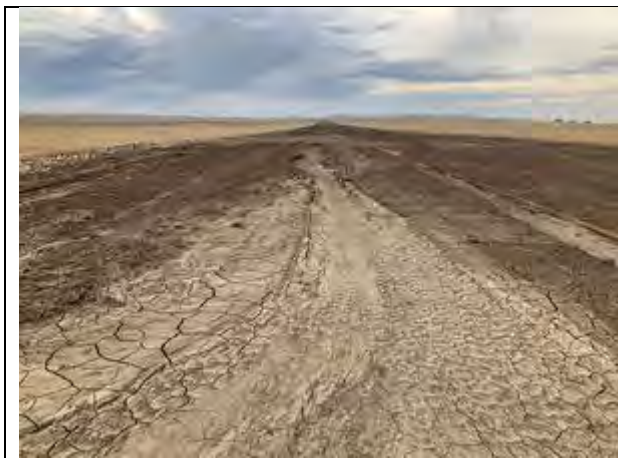
Observation Point: 38
Date Taken: April 26, 2023
Direction Photo is Taken: East

Photo Description: Topsoil movement in respread soil. Soil erosion prevention measures needed.

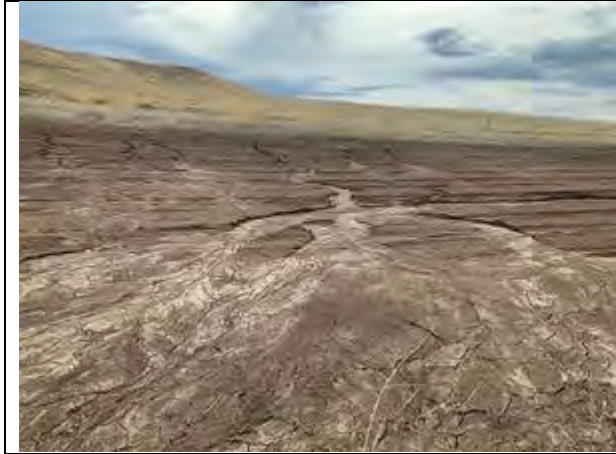
Observation Point: 39
Date Taken: April 27, 2023 9:11 AM
Direction Photo is Taken: East
Spread:

Photo Description: Topsoil movement in respread soil. Add soil erosion prevention measures.

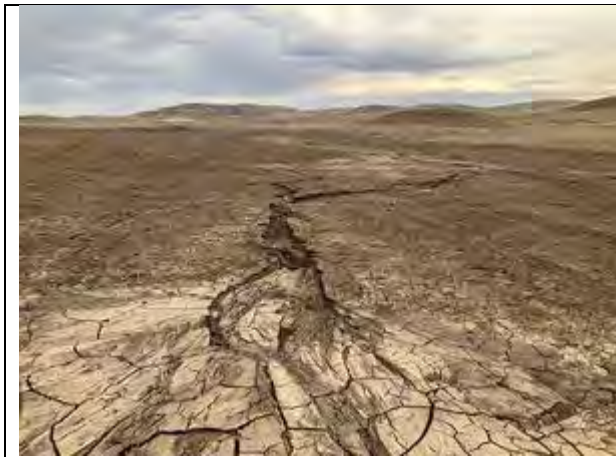
Observation Point: 40
Date Taken: April 26, 2023
Direction Photo is Taken: East

Photo Description: Soil movement creating trenches in respread soil. Add soil erosion prevention measures.

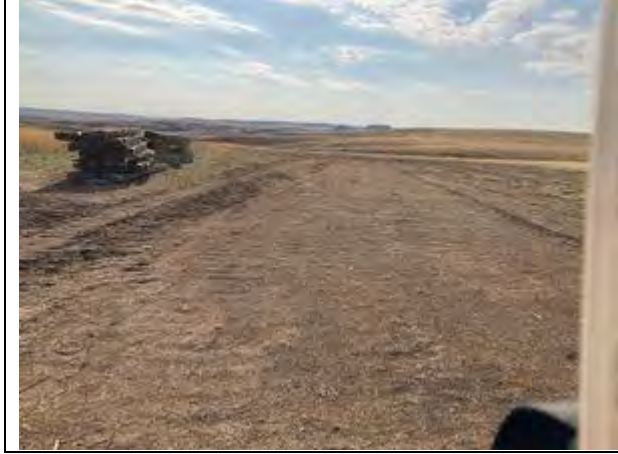
Observation Point: 42
Date Taken: April 25, 2023
Direction Photo is Taken: West

Photo Description: Soil respread looks good. Construction pads to be picked up

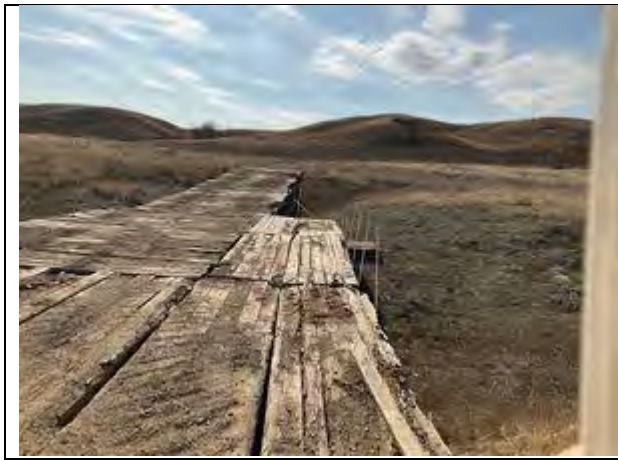
Observation Point: 43
Date Taken: April 25, 2023
Direction Photo is Taken: West

Photo Description: Temporary access and pads in place and need to be removed after reclamation
