PU-21-048
Bridger Pipeline, LLC.
South Bend 16-inch Crude Oil
Pipeline
As-Built Inspection Report

May 2023

Stantec Consulting Services Inc.
3303 Fiechtner Drive, Suite 100
Fargo, ND 58103

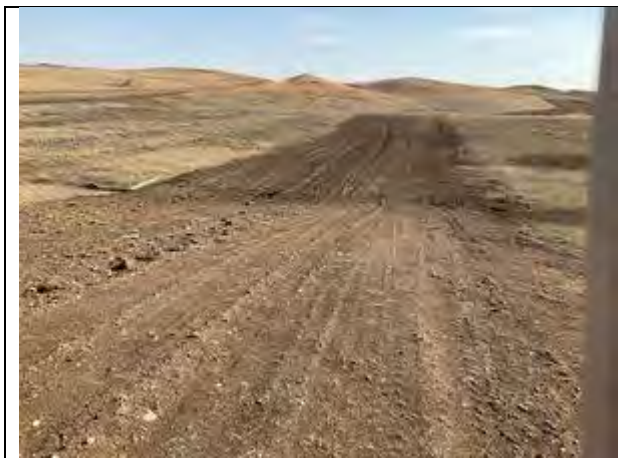
Observation Point: 44
Date Taken: April 25, 2023
Direction Photo is Taken: Southwest

Photo Description: Straw wattle in place to prevent soil erosion

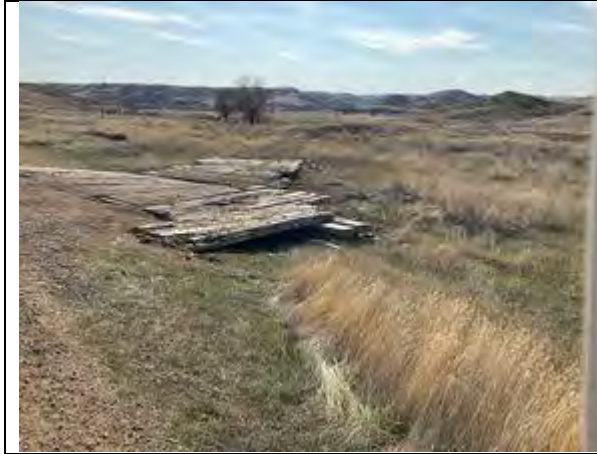
Observation Point: 45
Date Taken: April 25, 2023
Direction Photo is Taken: Southwest

Photo Description: Temporary access and pads in place. Remove pads after area is reclaimed.

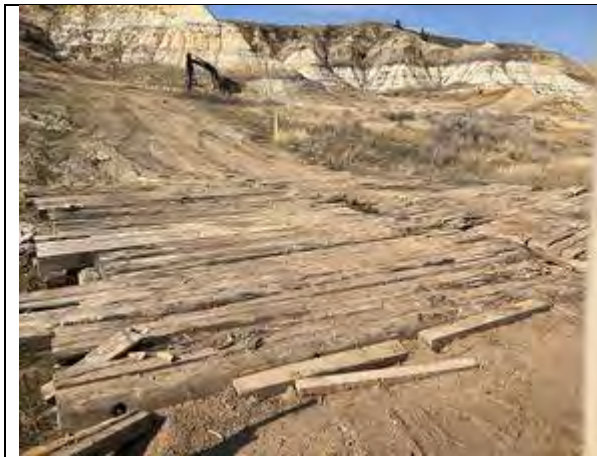
Observation Point: 46
Date Taken: April 25, 2023
Direction Photo is Taken:

Photo Description: Temporary bridge in place. Remove after area is reclaimed.

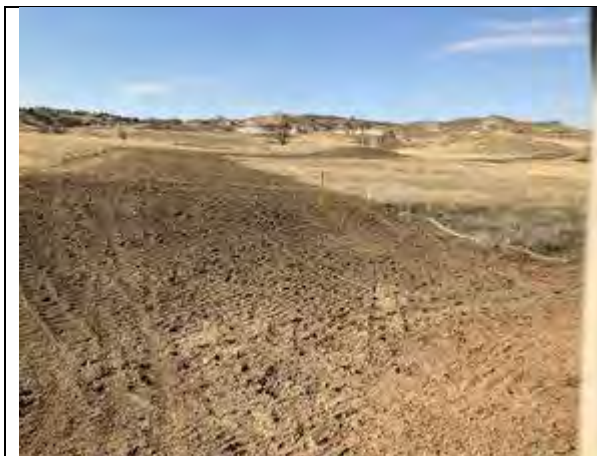
Observation Point: 47
Date Taken: April 25, 2023
Direction Photo is Taken: North

Photo Description: Straw wattle in place and preventing soil erosion.

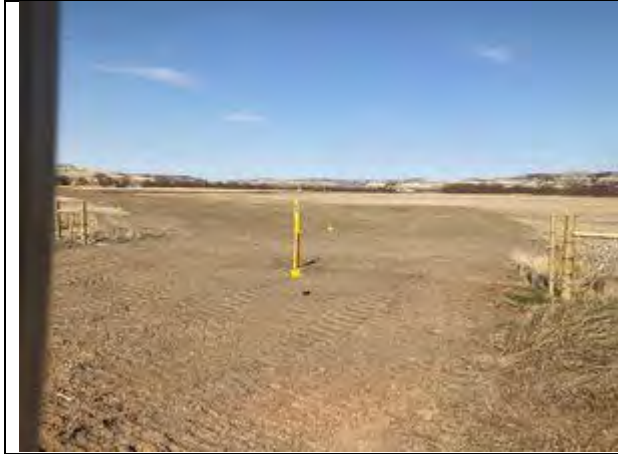
Observation Point: 48
Date Taken: April 25, 2023
Direction Photo is Taken: Northeast

Photo Description: Fence rebuilt and slope regraded

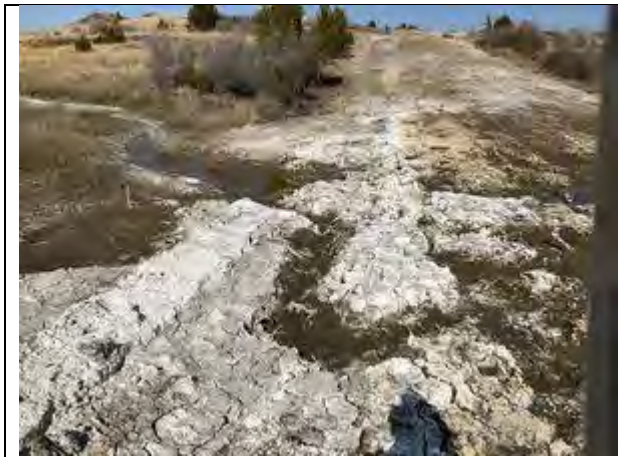
Observation Point: 49
Date Taken: April 25, 2023
Direction Photo is Taken:

Photo Description: Topsoil movement in respread soil. Add erosion prevention measures. Water flowing over respread soil.

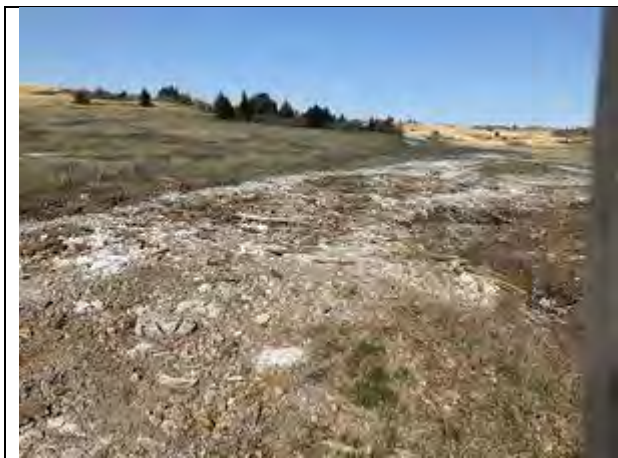
Observation Point: 50
Date Taken: April 25, 2023
Direction Photo is Taken:

Photo Description: Topsoil movement in respread soil and construction debris remaining.

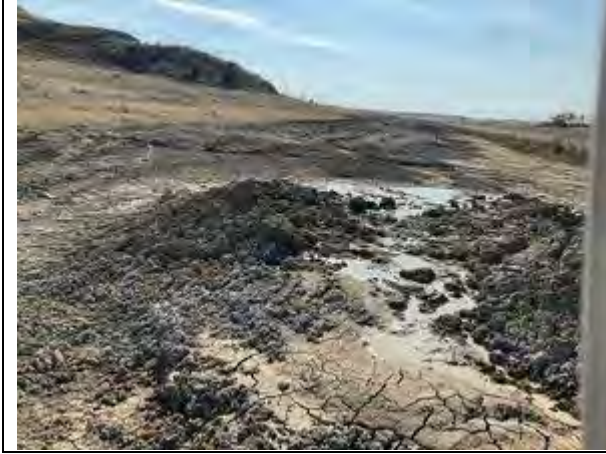
Observation Point: 51
Date Taken: April 2, 2023
Direction Photo is Taken: West

Photo Description: Soil erosion and ungraded soil remaining

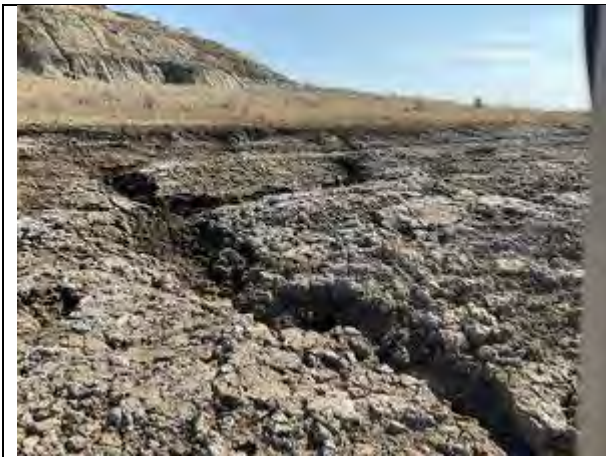
Observation Point: 52
Date Taken: April 25, 2023
Direction Photo is Taken: South

Photo Description: Topsoil movement in respread soil. Add soil prevention measures

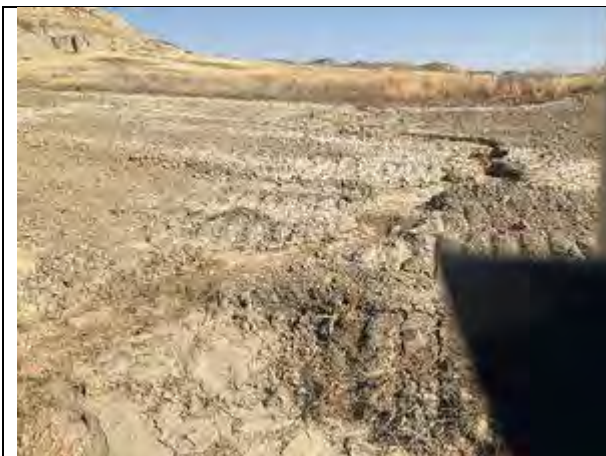
Observation Point: 53
Date Taken: April 25, 2023
Direction Photo is Taken: Southeast

Photo Description: Soil trench forming and eroding in low point. Add erosion prevention measures.

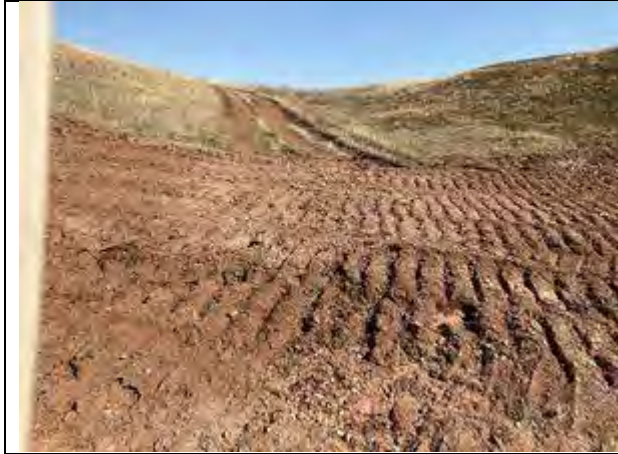
Observation Point: 56
Date Taken: April 25, 2023
Direction Photo is Taken: Northeast

Photo Description: Steep side slope may erode with precipitation. Add wattles or silt fence to prevent soil erosion

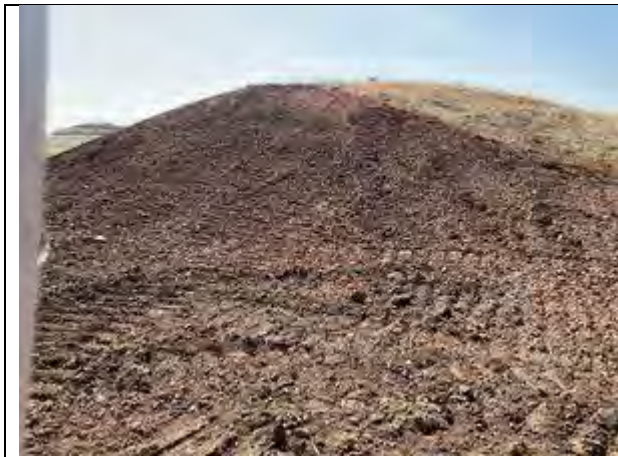
Observation Point: 57
Date Taken: April 25, 2023
Direction Photo is Taken:

Photo Description: Steep slope may wash out if not revegetated soon.

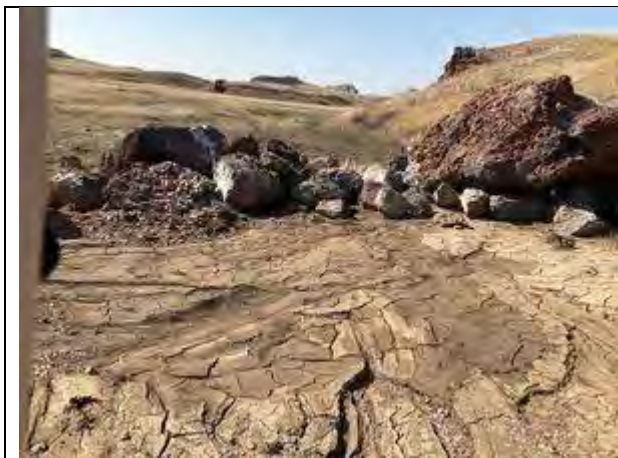
Observation Point: 58
Date Taken: April 25, 2023
Direction Photo is Taken:

Photo Description: Soil movement forming trenches. Add soil erosion prevention measures.

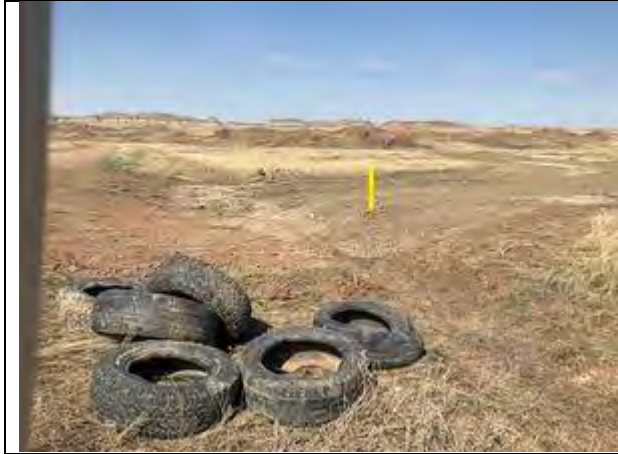
Observation Point: 59
Date Taken: April 25, 2023
Direction Photo is Taken: North
Photo Description: Construction trash remaining on site.
Latitude: 47.45412358
Longitude: -103.76014065

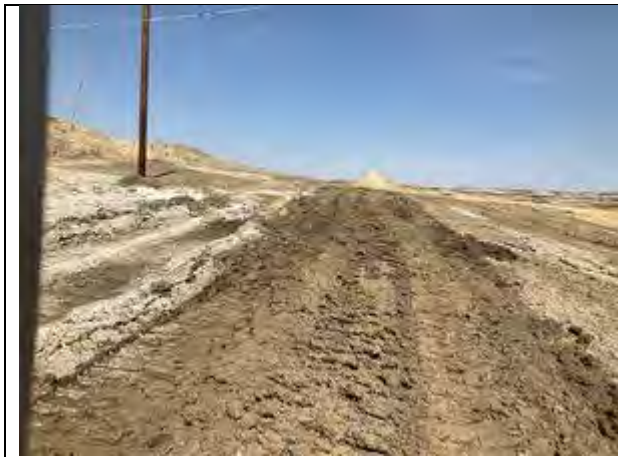
Observation Point: 60
Date Taken: April 25, 2023
Direction Photo is Taken: Northeast
Photo Description: Large ruts from heavy equipment. May contribute to soil movement if not regraded.
Latitude: 47.39246305
Longitude: -103.84866432

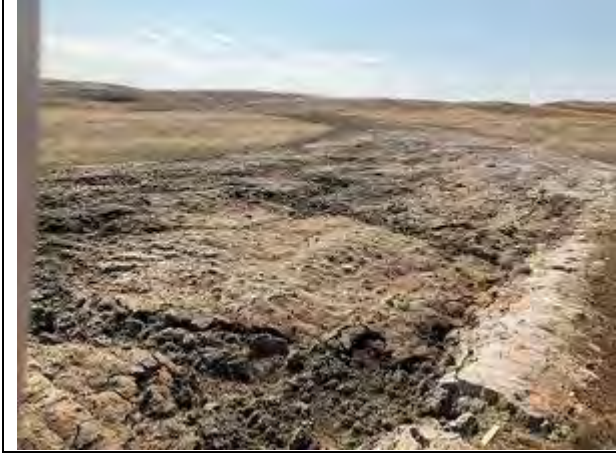
Observation Point: 65
Date Taken: April 25, 2023
Direction Photo is Taken: Southwest

Photo Description: Soil not graded to natural slope.

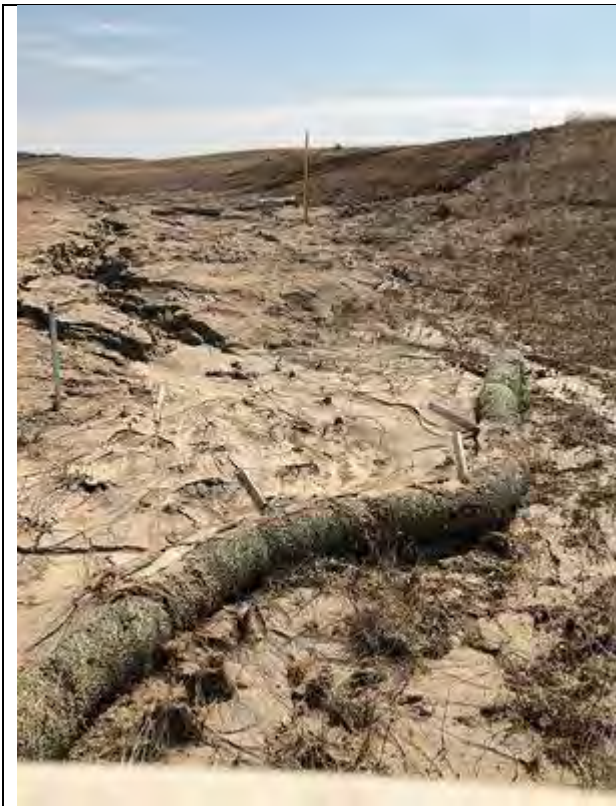
Observation Point: 66
Date Taken: April 25, 2023
Direction Photo is Taken: South

Photo Description: Wattle is not adequately stopping soil movement.

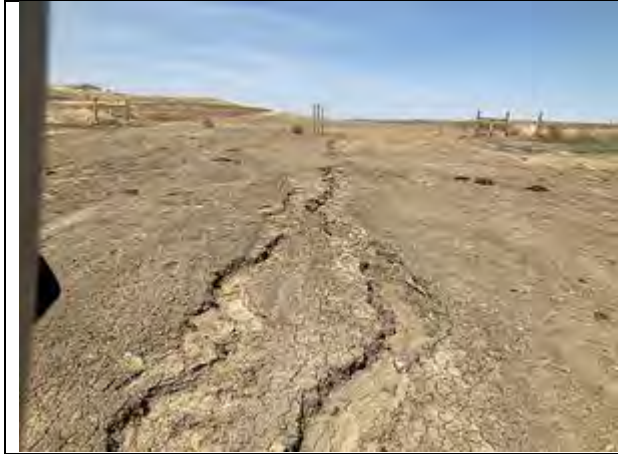
Observation Point: 67
Date Taken: April 25, 2023
Direction Photo is Taken: North

Photo Description: Soil movement and trench formed. Add wattles to prevent soil movement.

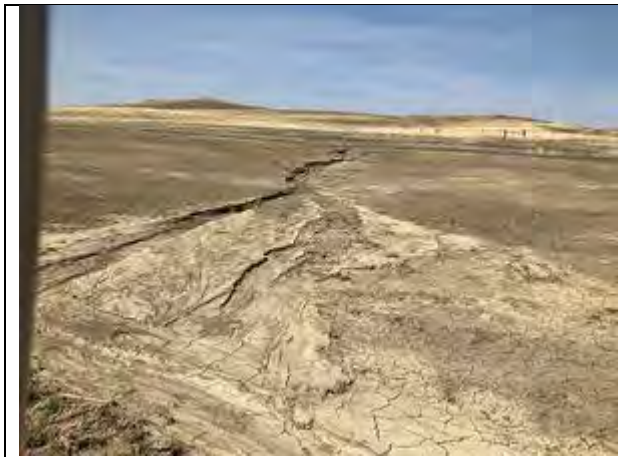
Observation Point: 68
Date Taken: April 25, 2023
Direction Photo is Taken: North

Photo Description: Soil erosion and trench formed. Add wattles to prevent soil movement.

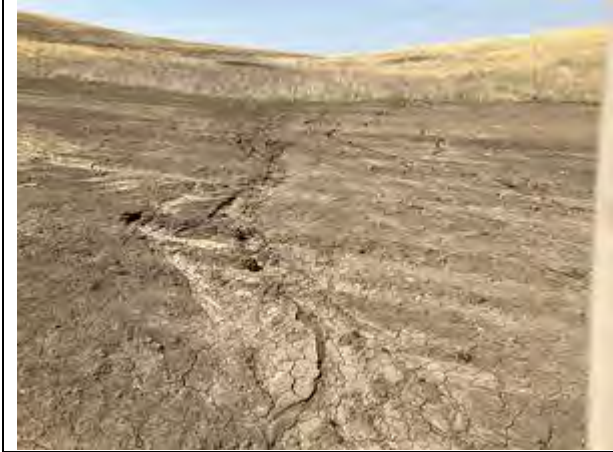
Observation Point: 70
Date Taken: April 25, 2023
Direction Photo is Taken: Southwest

Photo Description: Topsoil movement and gully formation at bottom of slope. Add soil erosion prevention measures.

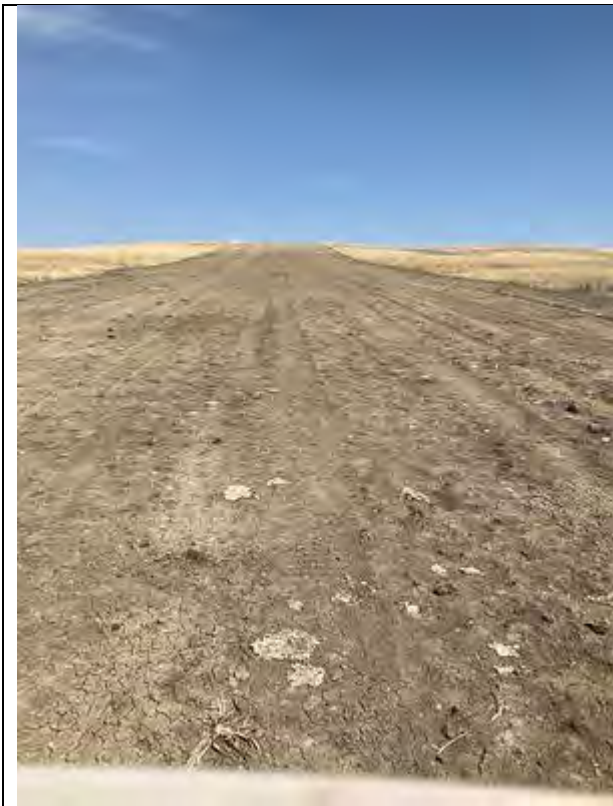
Observation Point: 71
Date Taken: April 25, 2023
Direction Photo is Taken: East

Photo Description: Good respread and stable soil

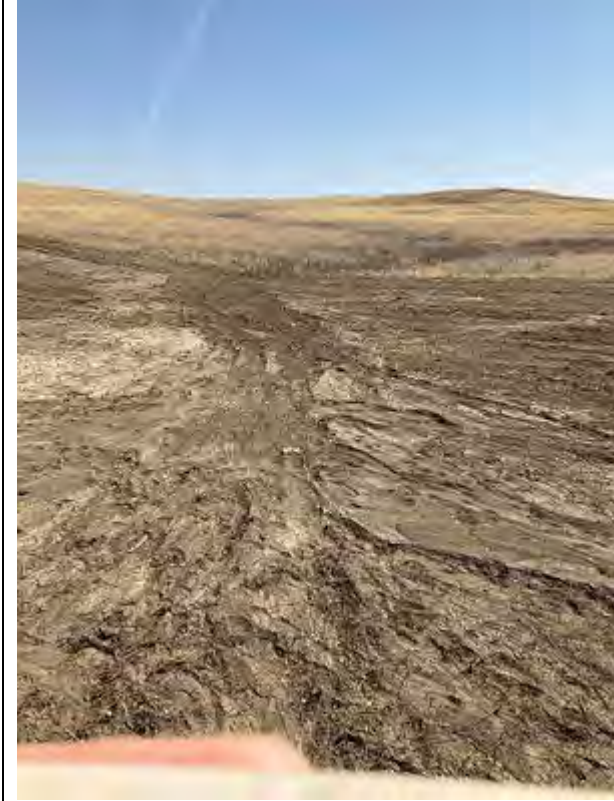
Observation Point: 72
Date Taken: April 25, 2023
Direction Photo is Taken: Northeast

Photo Description: Soil erosion starting to occur at bottom of slope. Add straw wattle to prevent continued erosion.

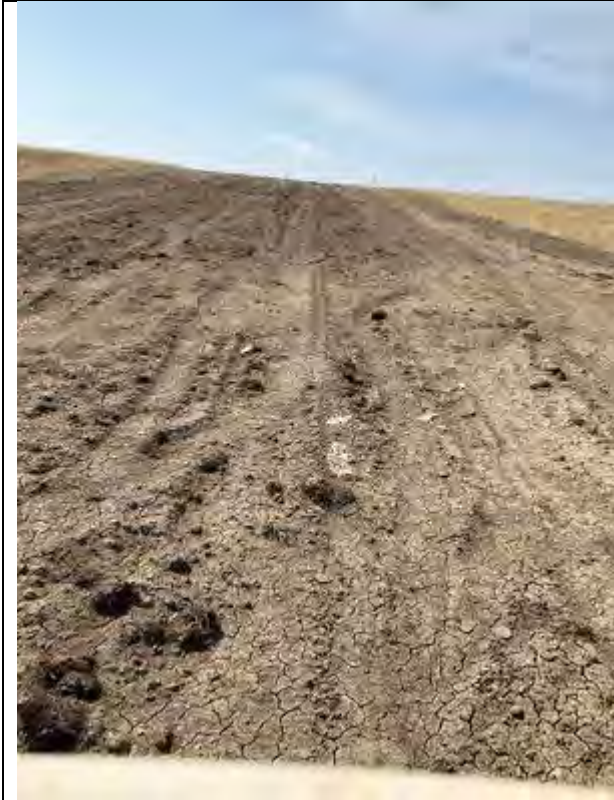
Observation Point: 73
Date Taken: April 25, 2023
Direction Photo is Taken: West

Photo Description: Stable soil and good contouring.

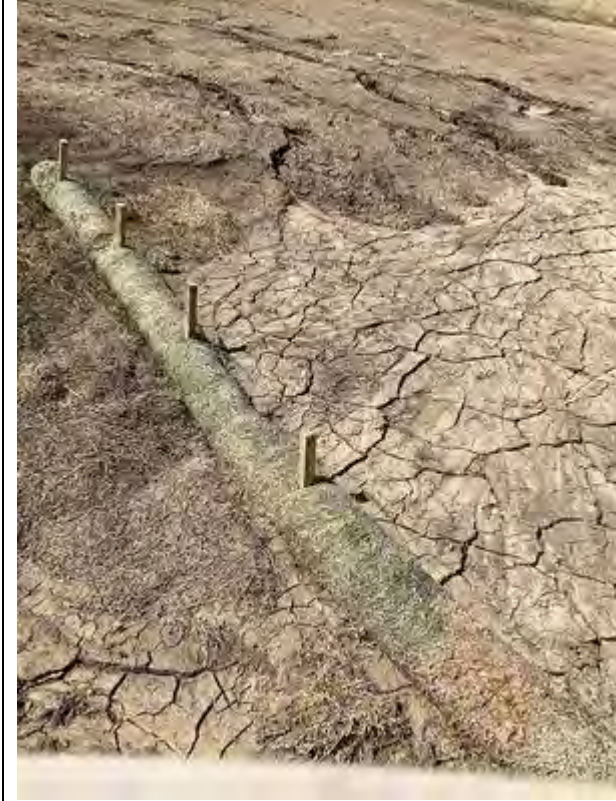
Observation Point: 74
Date Taken: April 25, 2023
Direction Photo is Taken: North

Photo Description: Straw wattle almost full

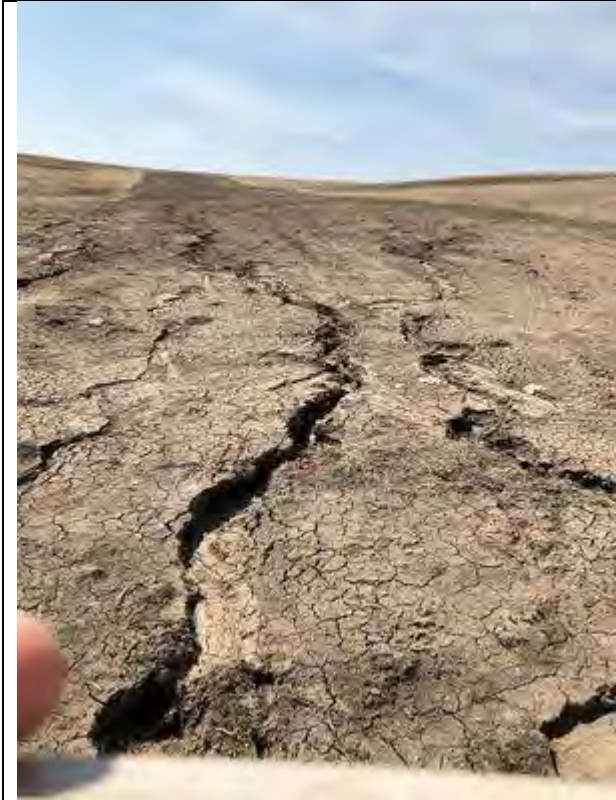
Observation Point: 75
Date Taken: April 25, 2023
Direction Photo is Taken: West

Photo Description: Topsoil erosion forming trench downslope. Add soil erosion prevention measures.

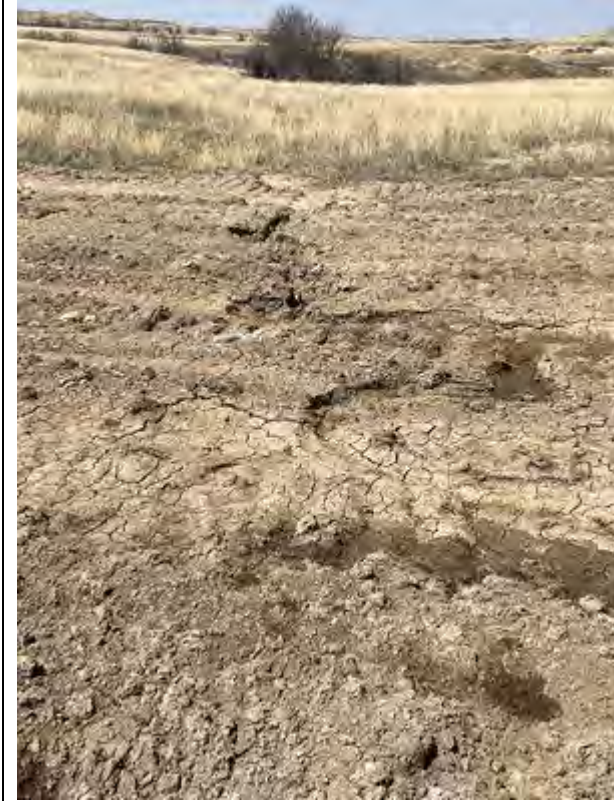
Observation Point: 76
Date Taken: April 25, 2023
Direction Photo is Taken: North

Photo Description: Topsoil erosion across respread soil. Add soil prevention measures.

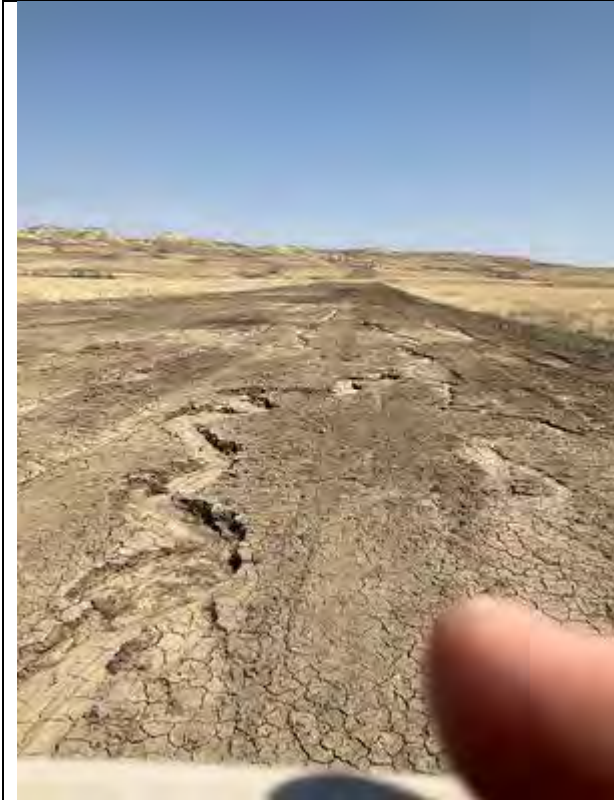
Observation Point: 77
Date Taken: April 25, 2023
Direction Photo is Taken: East

Photo Description: Topsoil erosion at bottom of slope forming trench. Add soil erosion prevention measures.

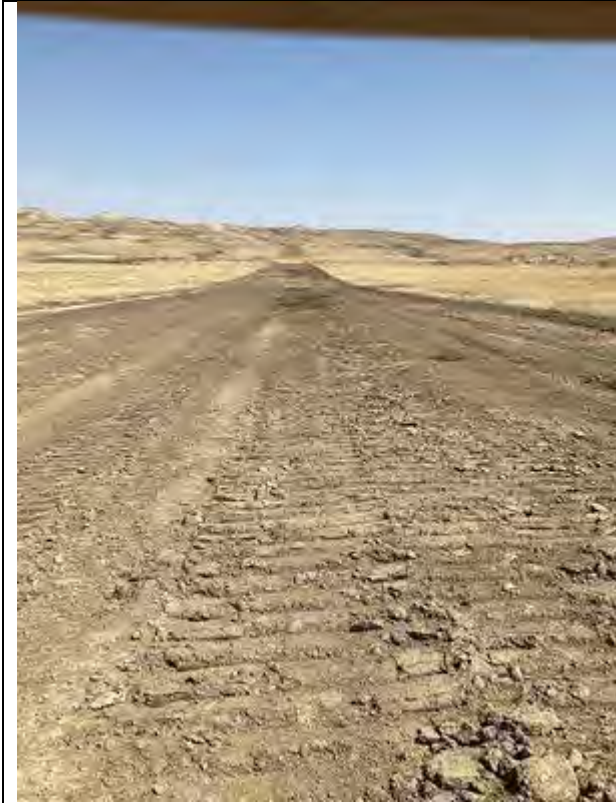
Observation Point: 78
Date Taken: April 2, 2023
Direction Photo is Taken: East

Photo Description: Topsoil respread is appropriate and good contouring.

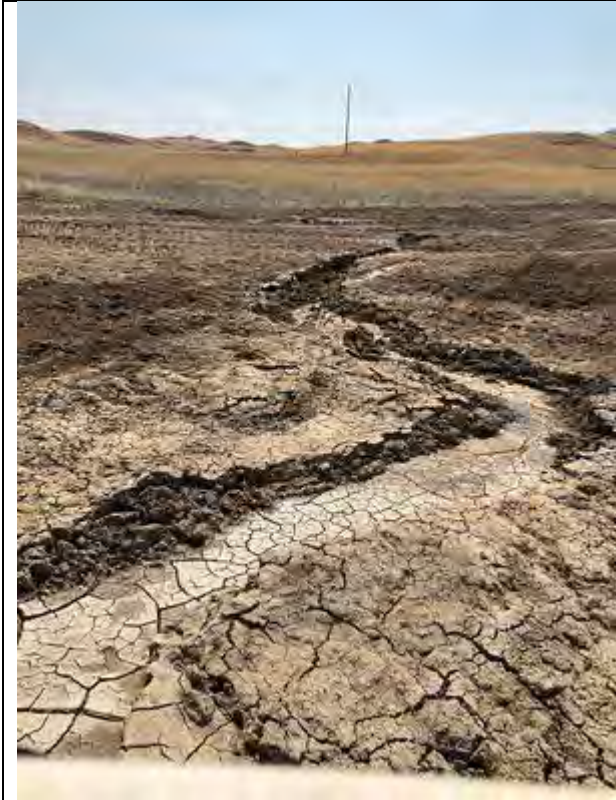
Observation Point: 79
Date Taken: April 25, 2023
Direction Photo is Taken: South

Photo Description: Topsoil erosion at bottom of slope forming trench. No erosion prevention measures in place.

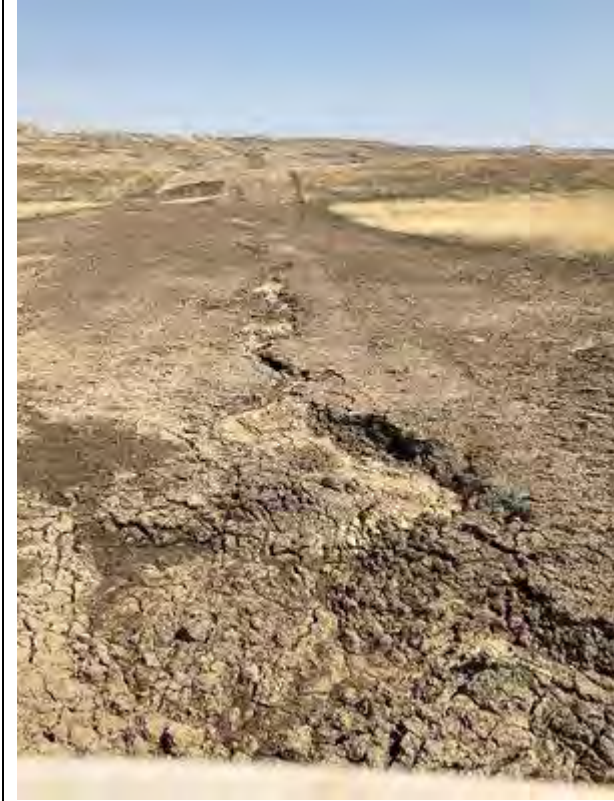
Observation Point: 80
Date Taken: April 25, 2023
Direction Photo is Taken: East

Photo Description: Topsoil erosion and trench formation on slope facing east. Add soil erosion prevention measures.
